PVP2011-58001

Road Tunnels and Fires: Implications for the Transport of Used Nuclear Fuel

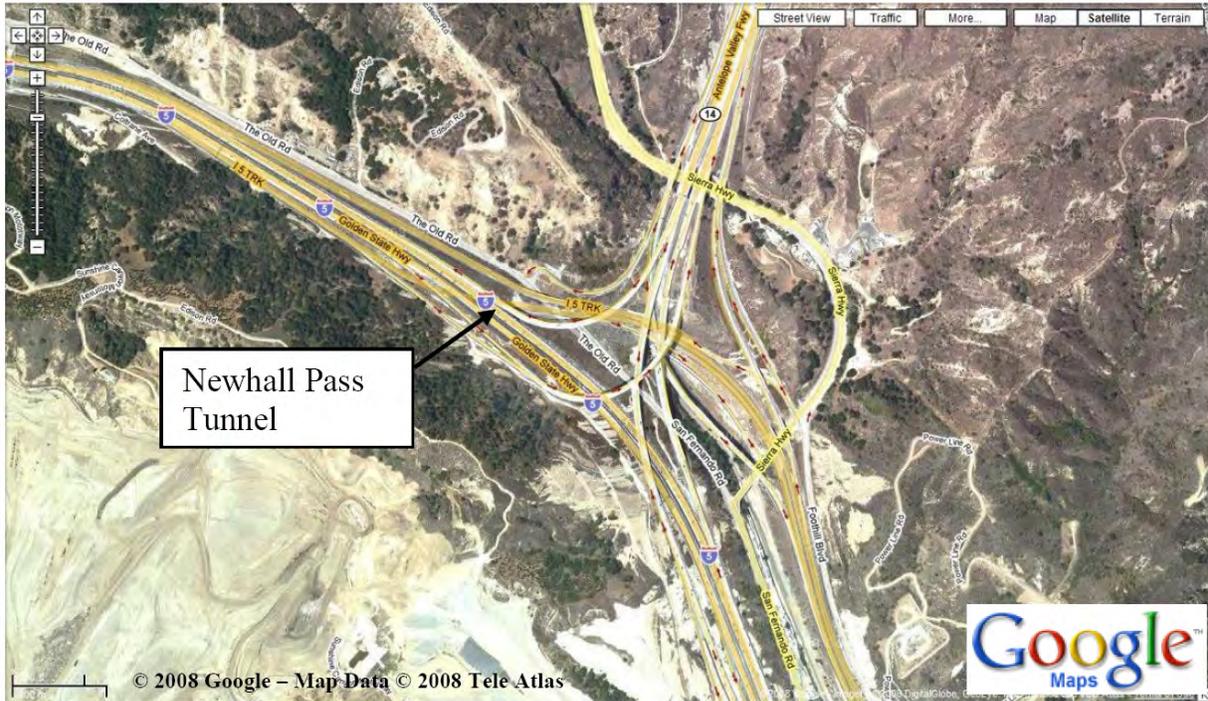
Figure 1. California Interstate 5 and Highway 14 Interchange

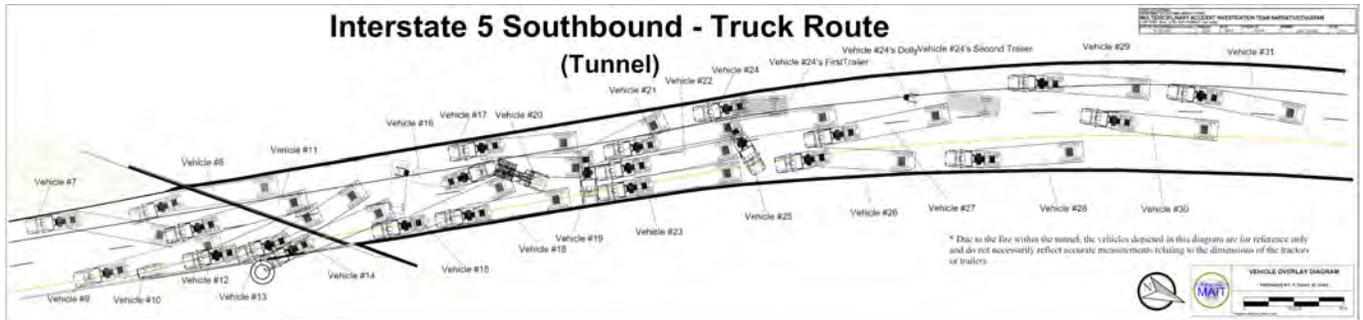
fluid dynamics code FDS (Version 5)[2][3], developed by NIST, to calculate the gas and wall temperatures in the tunnel as the fire progressed. The geometry of the tunnel, amount of combustible materials, and weather conditions were considered in the modeling effort. The information from the materials analyses will be used as a consistency check with the fire model results and to provide additional support for temperature range estimates of the Newhall Pass tunnel fire.

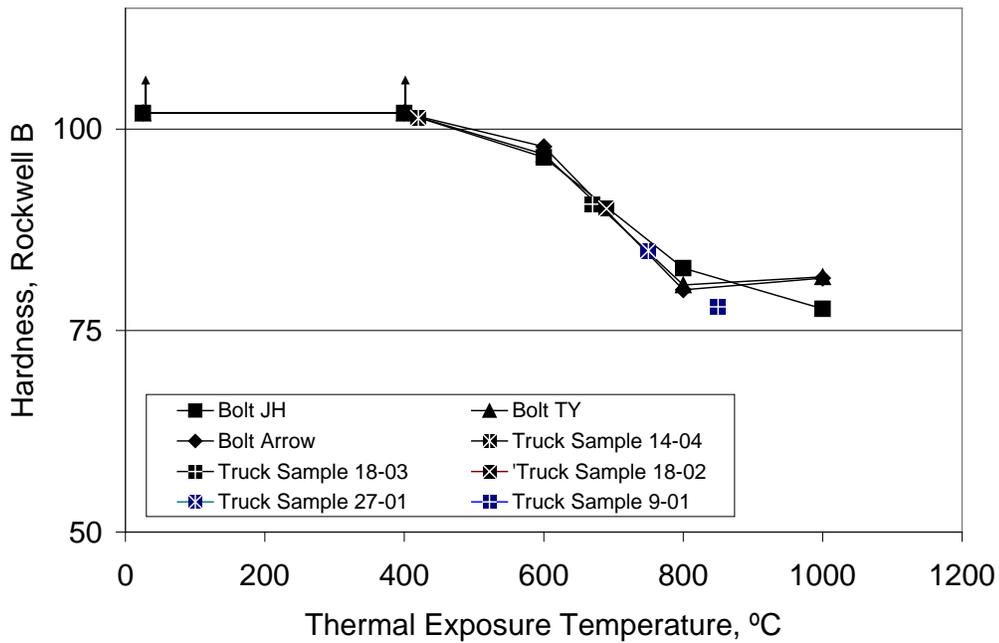
Figure 6. Effect of exposure temperature on the hardness of truck samples and commercially available Grade 5 bolts
