PROPOSED UNIT 3 COOLING TOWERS

**UNIFIED STREAM METHODOLOGY
STREAM ASSESSMENT FOR THE
PROPOSED UNIT 3 COOLING TOWERS**

Dominion North Anna Power Station

July 2009

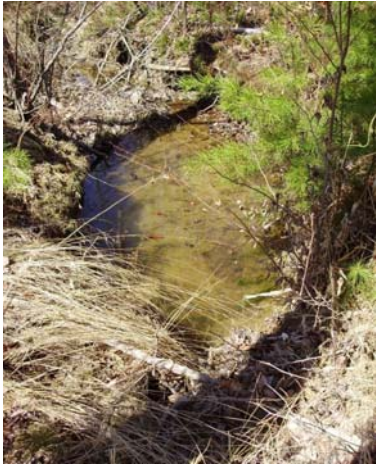
Looking north at drop in bank
