SUBJECT: Provides summary of 1990 ISI rept.

WISCONSIN PUBLIC SERVICE CORPORATION

Docket 50-305 Operating License DPR-43 Kewaunee Nuclear Power Plant 1990 ISI Summary Report

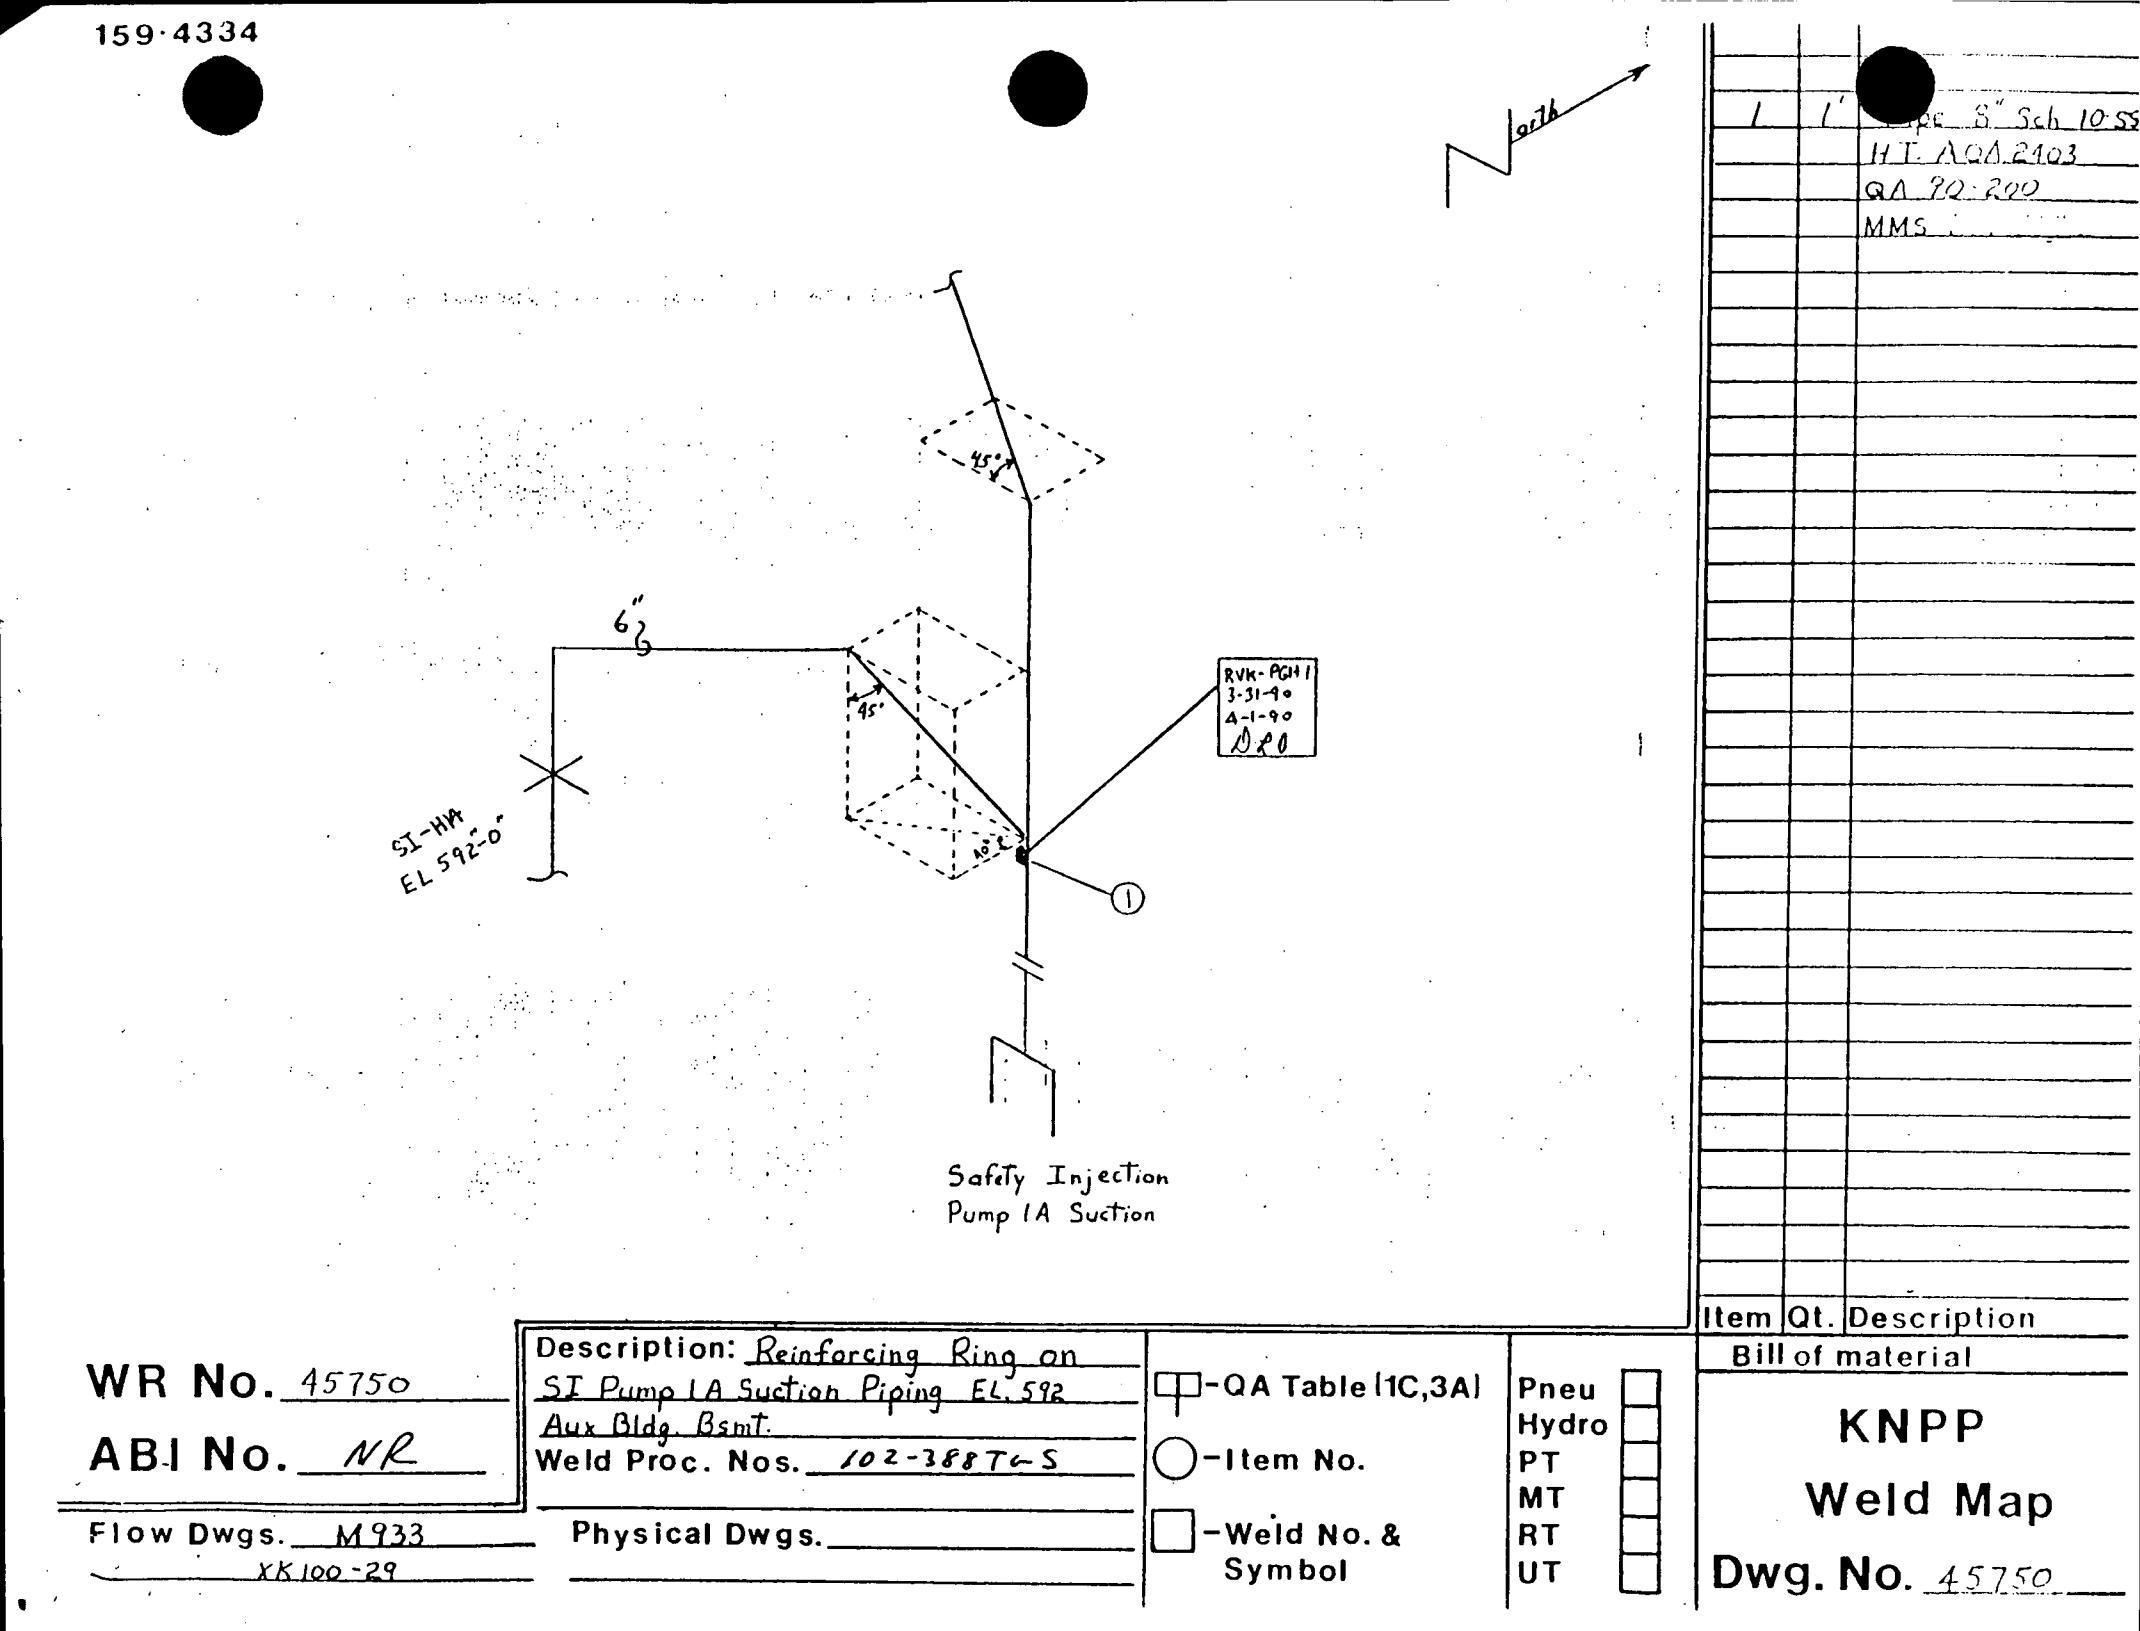
•		
State of Wisconsin WELDED Department of Industry, Labor and Human Relations REC	R E P A I R O R D	Safety & Buildings Divisi P.O. Box 7969 Madison, Wiscosnin 53707 Telephone: (608) 266-1904
Repair completed on:	Wisconsin Reg. No:	
Power Boiler Heating Boiler	National Board No:	
Pressure Vessel Miniature Boiler ,	Serial No:	
Manufacturer:	Other No:	Power Piping
WORK COMPLETED BY:	ти ти	IF PLANT OF.
Name:	Owner's Name:	
Wisconsin Public Service Corporation	Wisconsin Public S	ervice Corn
Street Address	Location of Renair.	Jerree outpr
600 N. Adams P.O. Box 19002	Revaunes Nucles L	OWER Diant
City/Town/Village: Zin Code:	Tradudee MUCICAL I	Wel ITaul
Green Bay, WI 54307-9002 Repair Program No:	<u>N 490, Highway 42</u>	
Description of Repair - attach additional page	<u>L Rewaunee, WI</u>	54716-9510
(use reverse side of this page for sketch)	II needed:	
	·	······································
` .		,
<u> </u>		,
