REGULATOR INFORMATION DISTRIBUTION SYSTEM

Docket 50-305  
Operating License DPR-43  
Response to Request for Additional Information on Fire Protection

RESPONSES TO REQUESTS FOR ADDITIONAL INFORMATION

### ANALYSIS OF CIRCULATING WATER PUMP OIL FIRE

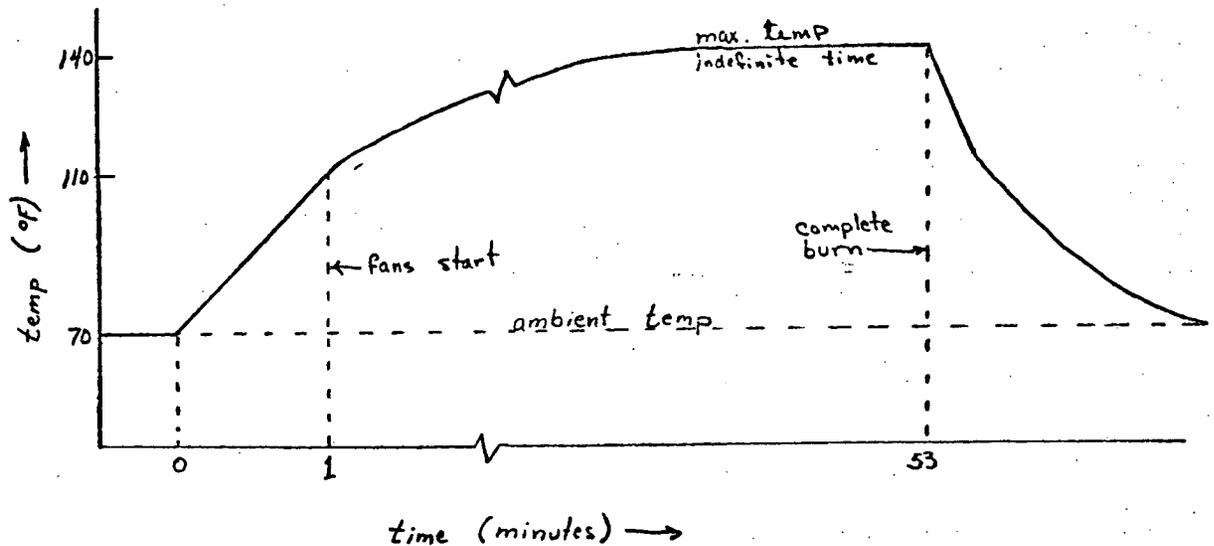
1. -Heat input would be at such a rate as to raise the temperature of the room from ambient at a rate of  $39.32^{\circ}\text{F}$ .
2. The fans would come on when the rooms temperature increased to  $110^{\circ}\text{F}$  and would extract heat at a rate directly dependent upon the air temperature.
3. A balance would be reached when the heat exhausted equaled the heat input and the temperature would remain at that level.
4. The temperature profile would look like the following:

5. Assuming an initial temperature of  $\sim 70^{\circ}\text{F}$  in the room, the fans would start  $\sim 1$  minute into room heatup. Maximum temperature would be reached in relatively short time, but would not exceed  $140^{\circ}\text{F}$ .

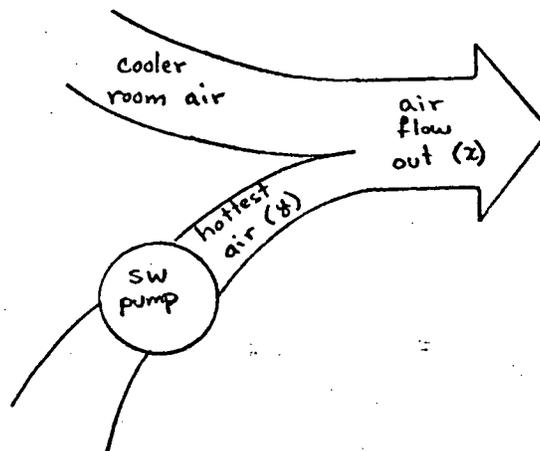
1. The BTU input remains fixed at 133,064 BTUs/minute. The sensitivity of this calculation will only depend on the quantity and temperature of the air exhausted. The quantity remains fixed at 100,000 scfm but there is a temperature gradient of the air flows to the fan that may result in the Service Water Pump seeing a higher temperature. The graphics below is shown to illustrate this effect.

2. The only parameter that will affect the end result of this discussion is the ratio of the quantity of hot air (y) to total air flow out (x). Since both quantities should have the same relative heat capacity characteristics we could directly equate this ratio to temperature.

3. The above illustration is simplified. A more realistic view would show a diverse temperature gradient throughout the room being drawn toward the fans. We'll assume that the maximum temperature flow channel passes directly by the Service Water Pumps, and we'll also assume that maximum temperature channel to have a ratio to average gradient temperature of 2 to 1. This makes  $\frac{y}{x} = 2$ .

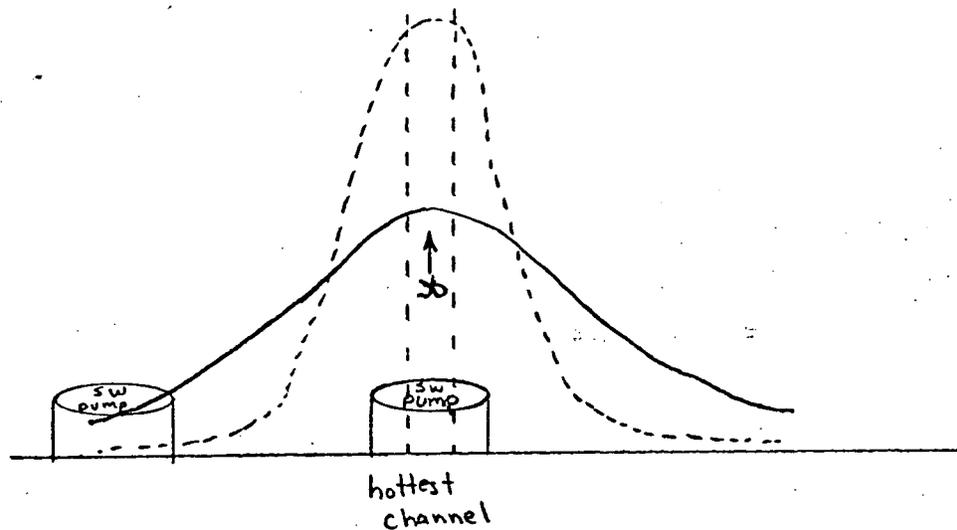
The following illustration shows the gradient affects of the flow path exiting toward the exhaust fans.

7. The result of this analysis shows that you can choose to make the air stream affects as hot as possible to take out one pump, but the higher you raise the factor  $y/x$  the less probable the adjacent pump will be affected.
