Enclosure: IE Circular No. 77-06, "Effects of Hydraulic Fluid on

Electrical Cables"

EFFECTS OF HYDRAULIC FLUID ON EDECTRICAL CABLES

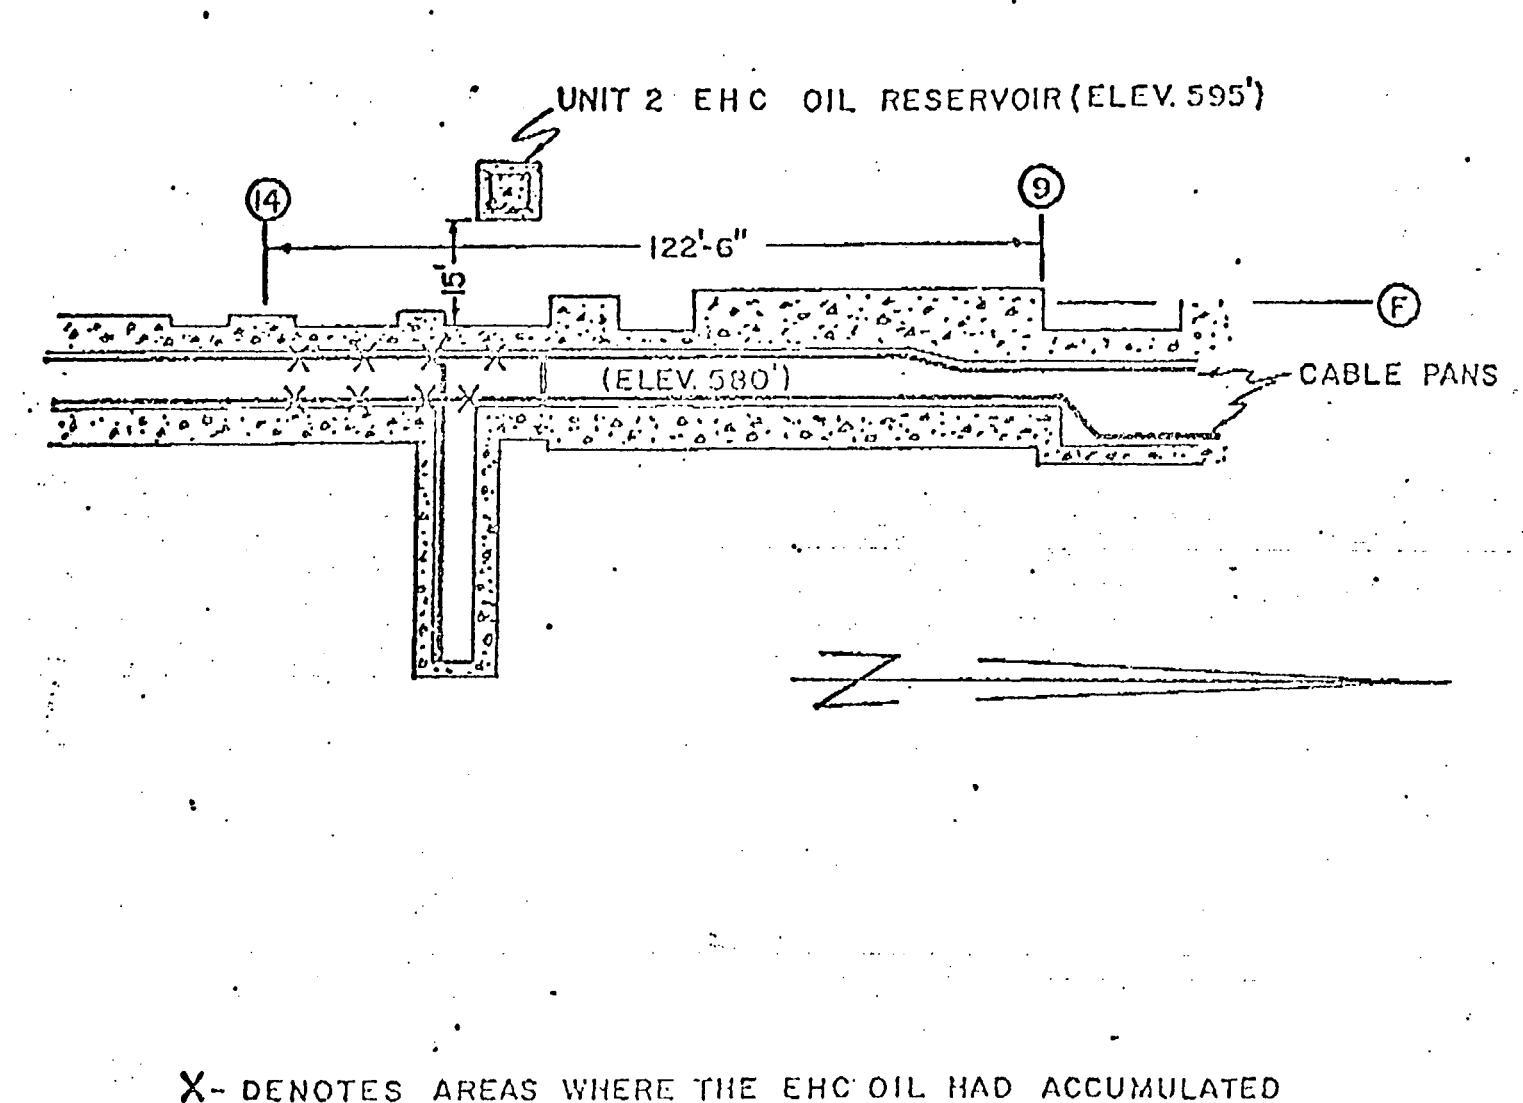
FIGURE, I

Figure 1 shows the approximate locations where EHC fluid accumulated. Figure 2 illustrates the postulated path of EHC fluid migration from the EHC fluid reservoir to the Unit 2 cable tunnel area. The accumulation of EHC fluid around the EHC fluid reservoir foundation, and subsequent migration between the finish floor and rough slab, via small cracks in the concrete, is the postulated cause of the EHC fluid problem.

UNIT 2 CABLE TUNNEL PARTIAL PLAN

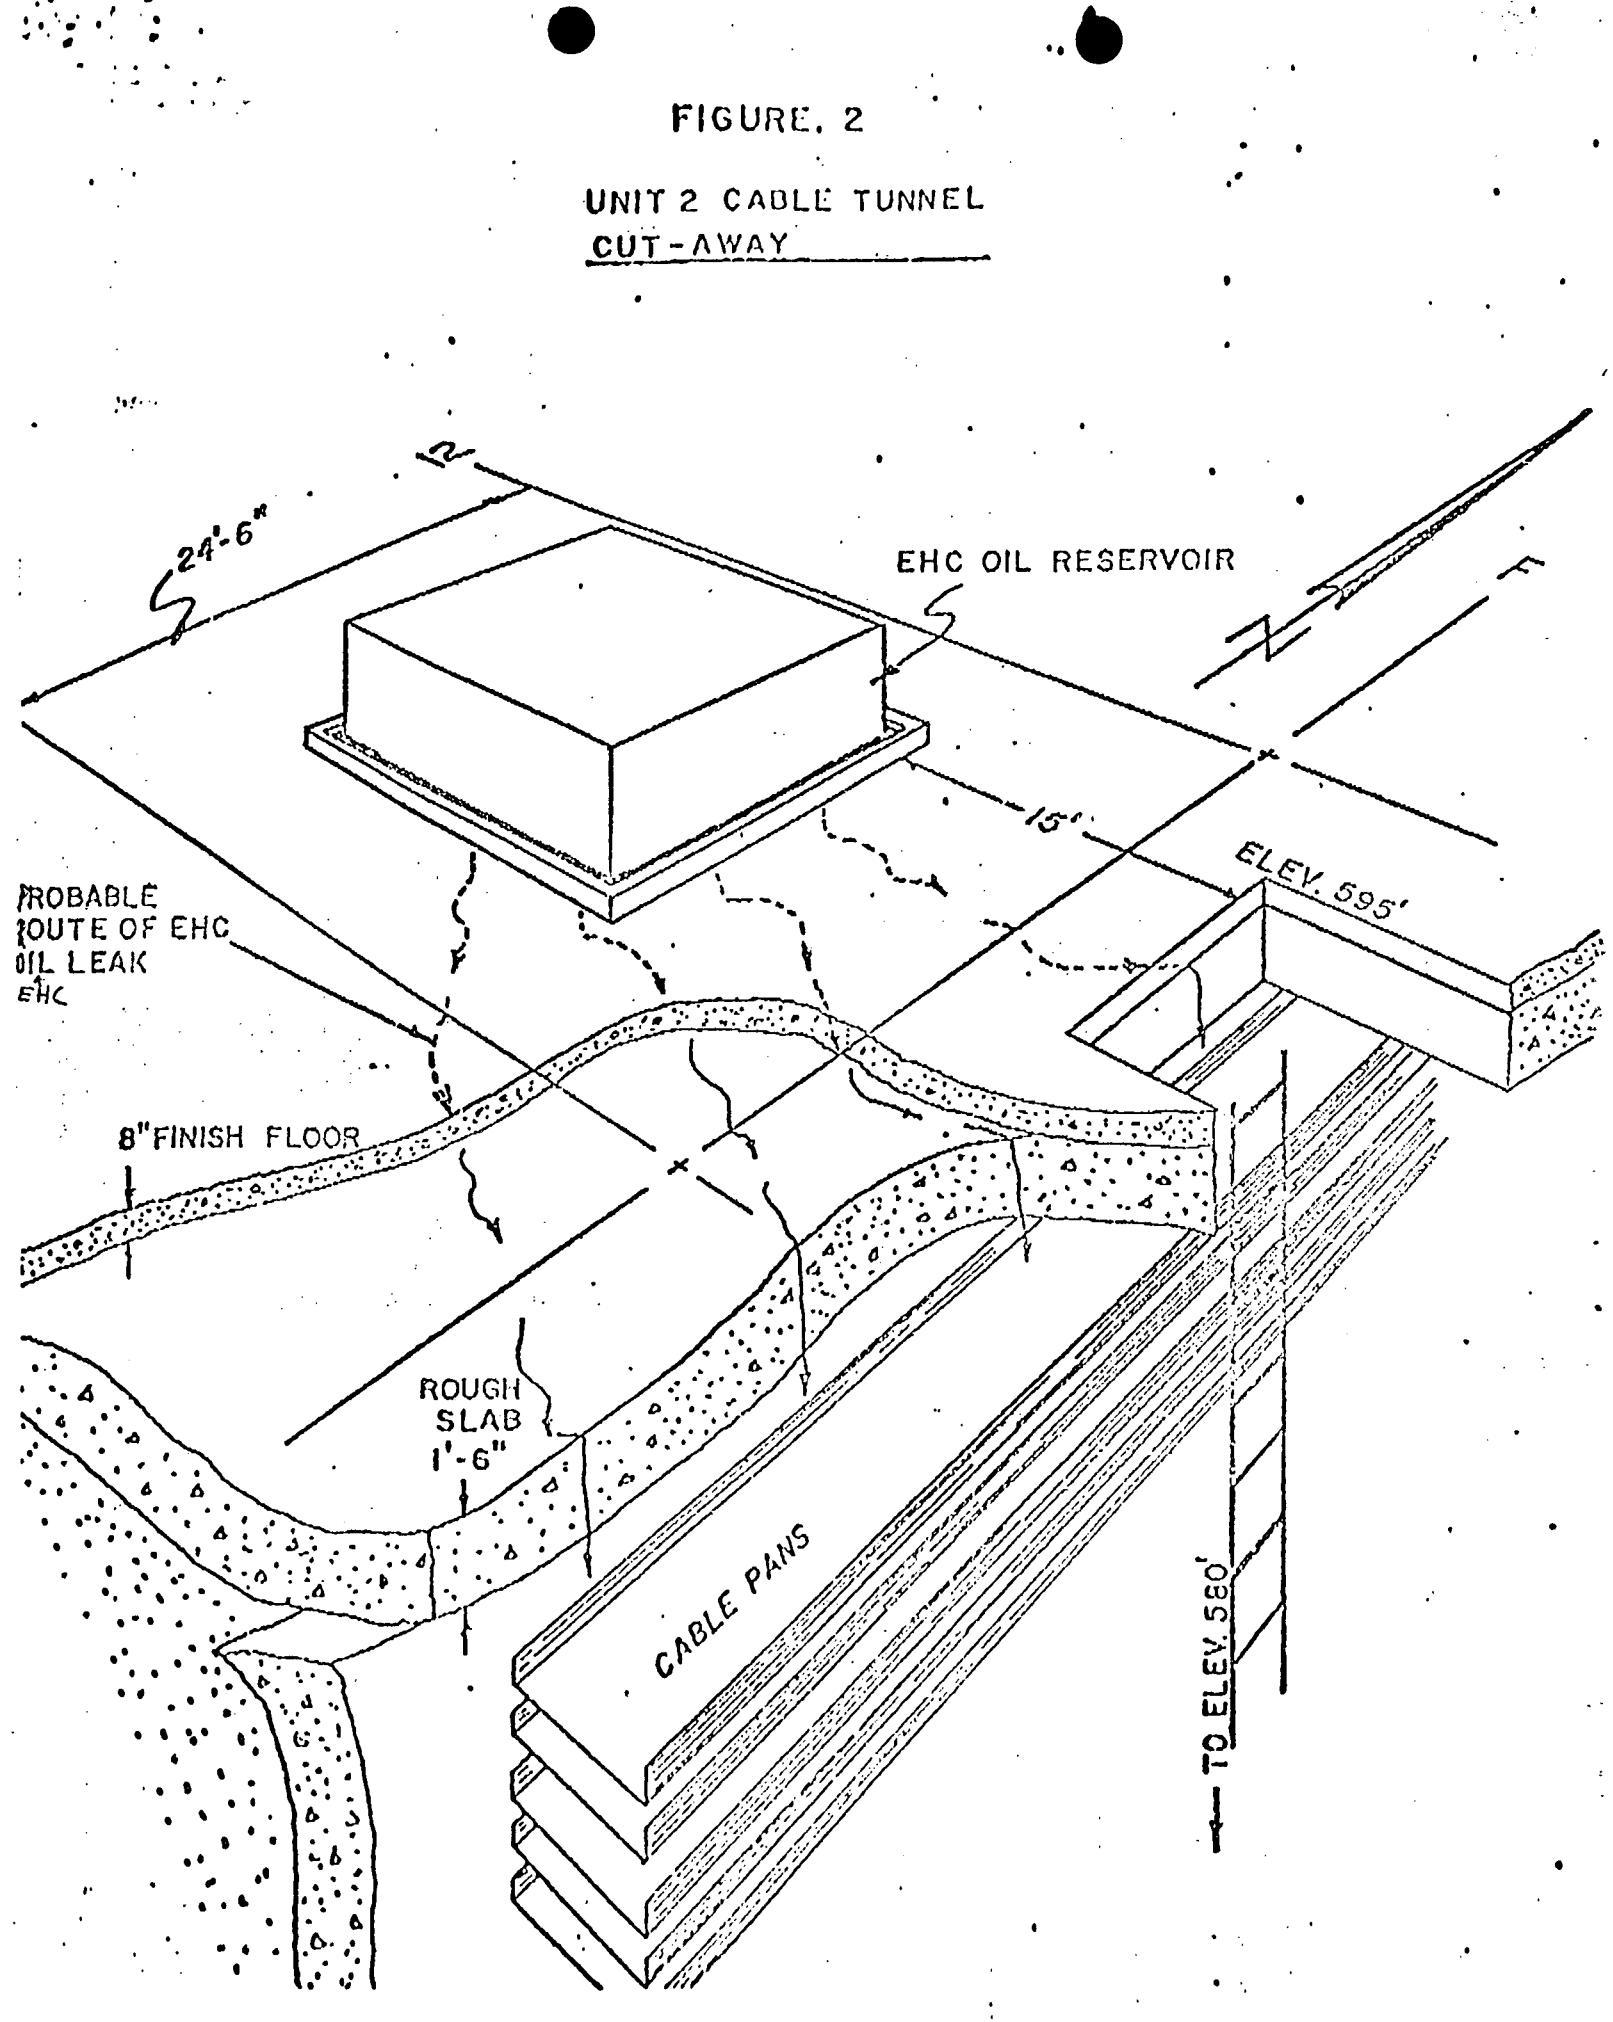
The rough slab serves as the celling in the Unit 2 cable tunnel and minor small cracks in the celling served as a leak path out of the concrete and onto the cable trays and floor. Portions of cables within these trays thus became saturated with the ENC fluid.

At the present time, all the cables in the affected area of the Unit 2 cable tunnel are being protected from the continuing EHC fluid leakage. The leakage has subsided and once it has stopped the celling area will be cleaned and a protective sealer will be applied to prevent any possible leakages.

The EHC fluid reservoir foundation must also be sealed with the same protective sealer once leakages have been resolved. The sealer has been ordered from the Carboline Company, type 187 HFP, which is a recommended EHC fluid sealant.
