SUBJECT: LER 88-004-00:on 880609,HPCI sys inoperability from inadequate periodic insp of governor actuator. W/8

> Subject: Duane Arnold Energy Center Docket No: 50-331 Op. License DPR-49 Licensee Event Report #88-004

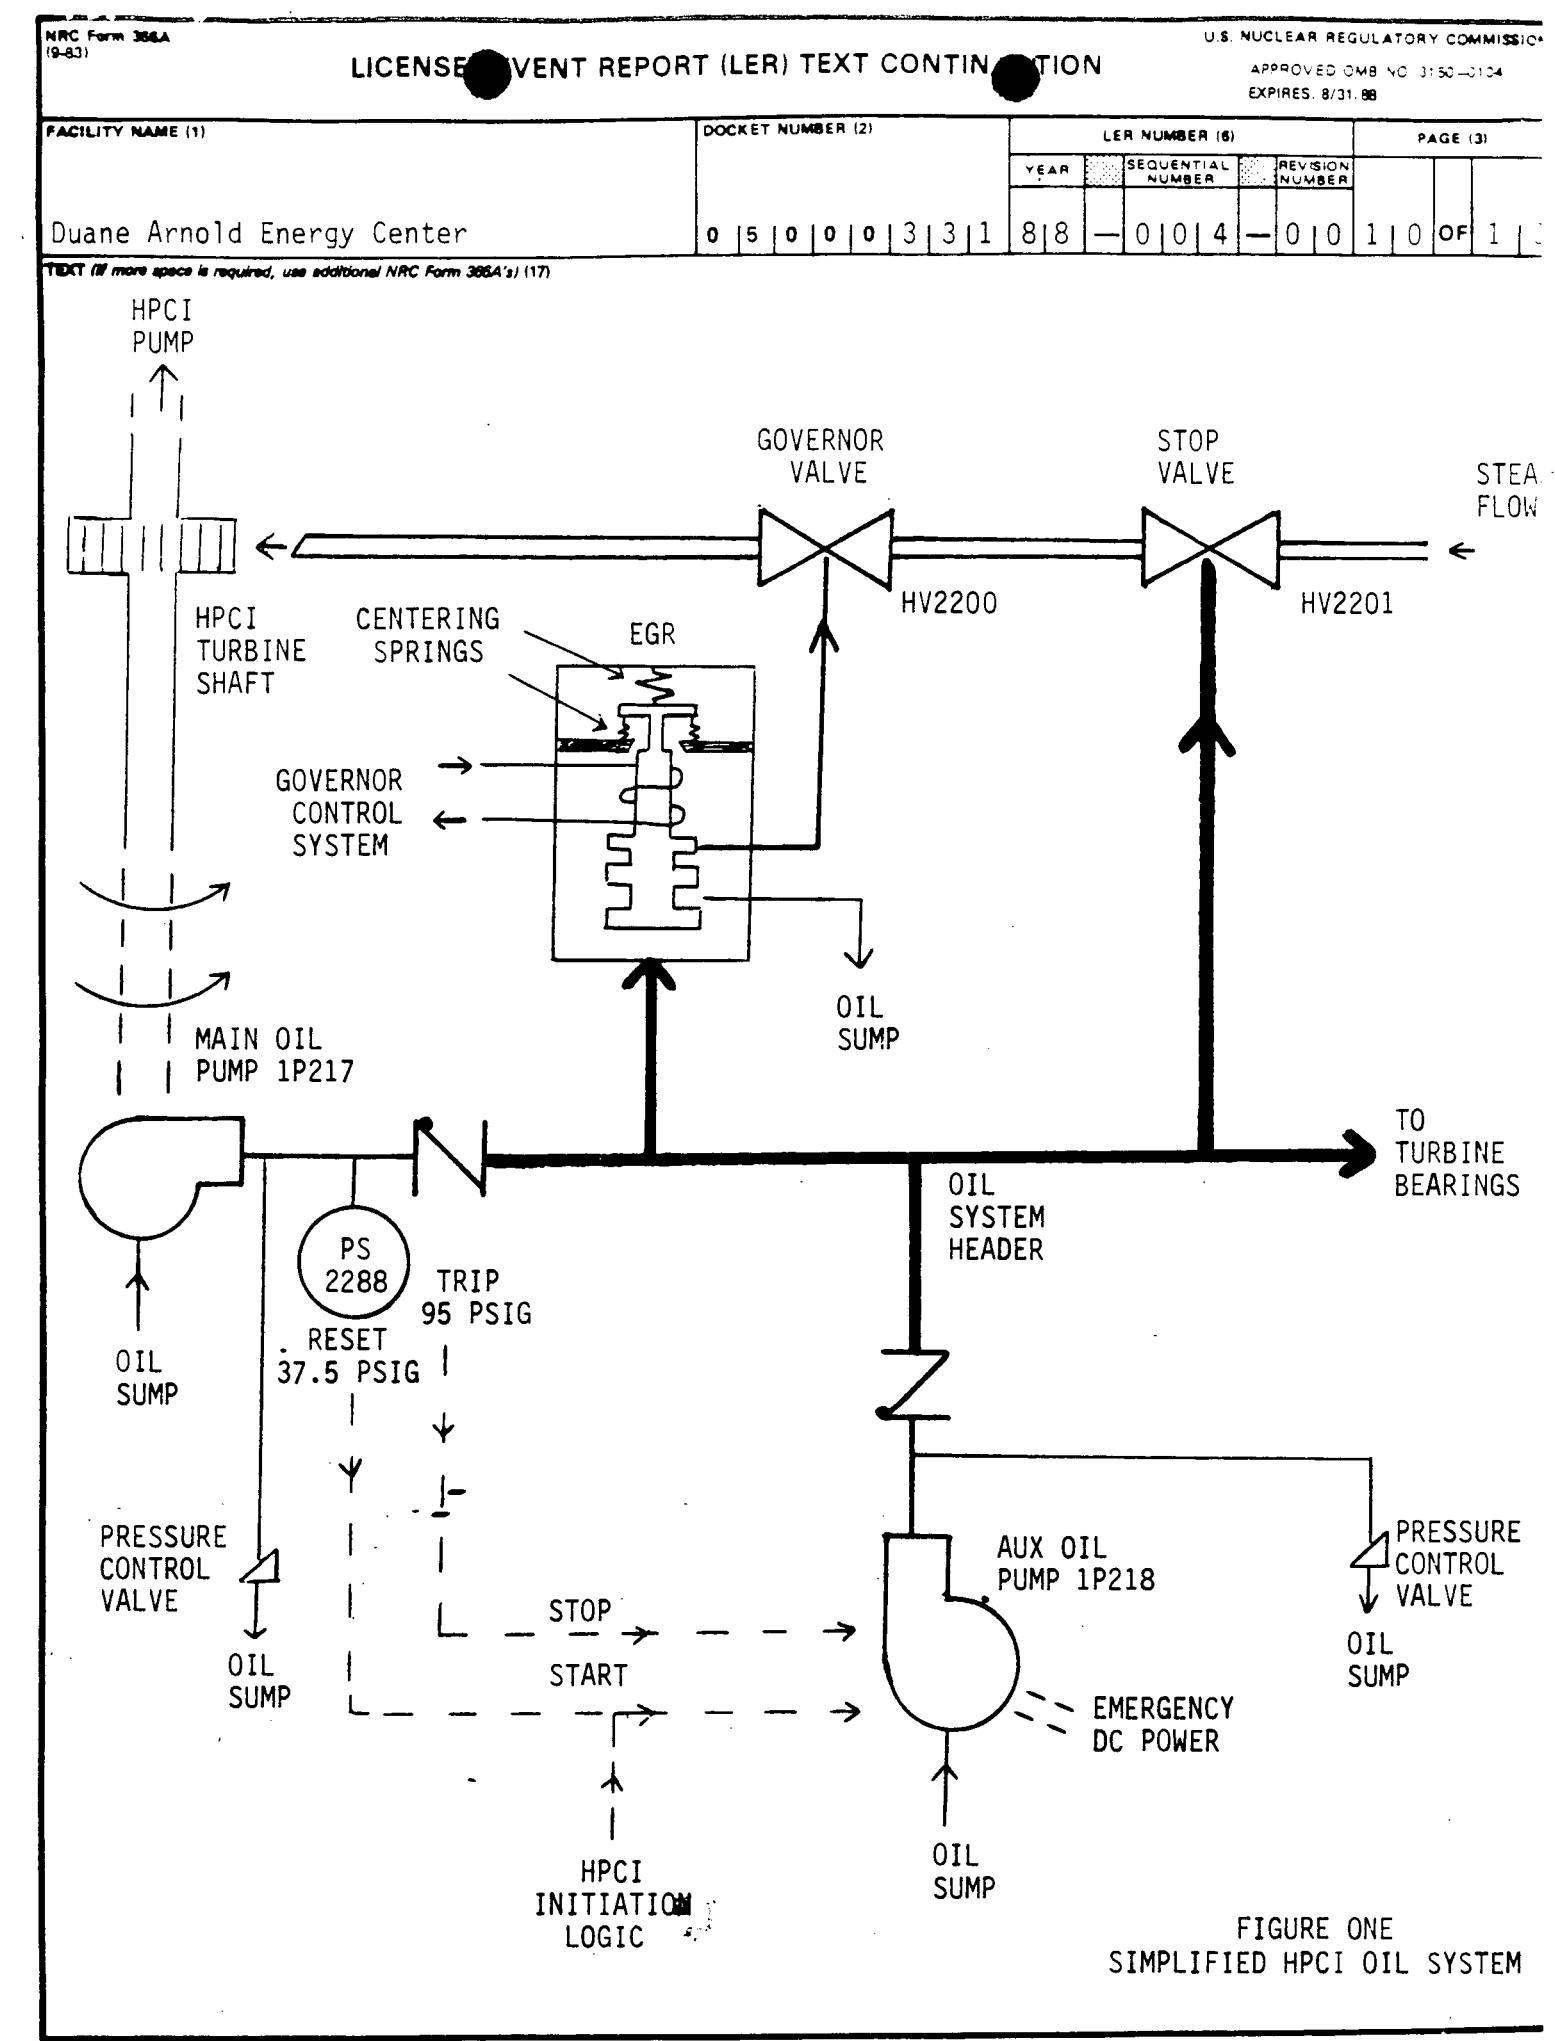
The first HPCI subsystem is the HPCI turbine oil system. (See Figure One). Control for this system is provided to ensure an adequate supply of oil will be available to control and lubricate the HPCI turbine. There are two pumps in the HPCI turbine oil system: the Main Oil Pump, which is driven by the turbine shaft, and the Aux Oil Pump, which is DC motor-driven. Each of these pumps can feed the main HPCI oil system header. When not operating the pumps are each separated from the system header by a check valve.

Upon receipt of a HPCI initiation signal, the HPCI Aux Oil Pump starts and provides sufficient oil pressure and flow for HPCI turbine bearing lubrication and operation of the governor and stop valves. The stop valve opens and the governor valve is used to control the turbine speed. As the HPCI turbine increases in speed, the shaft-driven Main Oil Pump develops increased oil pressure and flow. The discharge pressure of the Main Oil Pump is monitored by pressure switch PS2288. By design, when the Main Oil Pump output oil pressure reaches 95 psi, PS2288 trips to shut off the Aux Oil Pump. On HPCI shutdown, when the HPCI turbine is tripped, the system oil pressure decreases as the shaft-driven Main Oil Pump winds down. By design, when the output pressure of the Main Oil Pump (which is the only system oil pump operating at the time) drops to 37.5 psig, PS2288 resets. This restarts the Aux Oil Pump to provide for bearing oil pressure and flow during turbine coastdown.
