Report No. IE-116

Metallurgical Examination and Stress Evaluation of Recirculation Inlet Nozzle Safe-End Cracking

Duane Arnold Energy Center

PARAMETER, Inc.

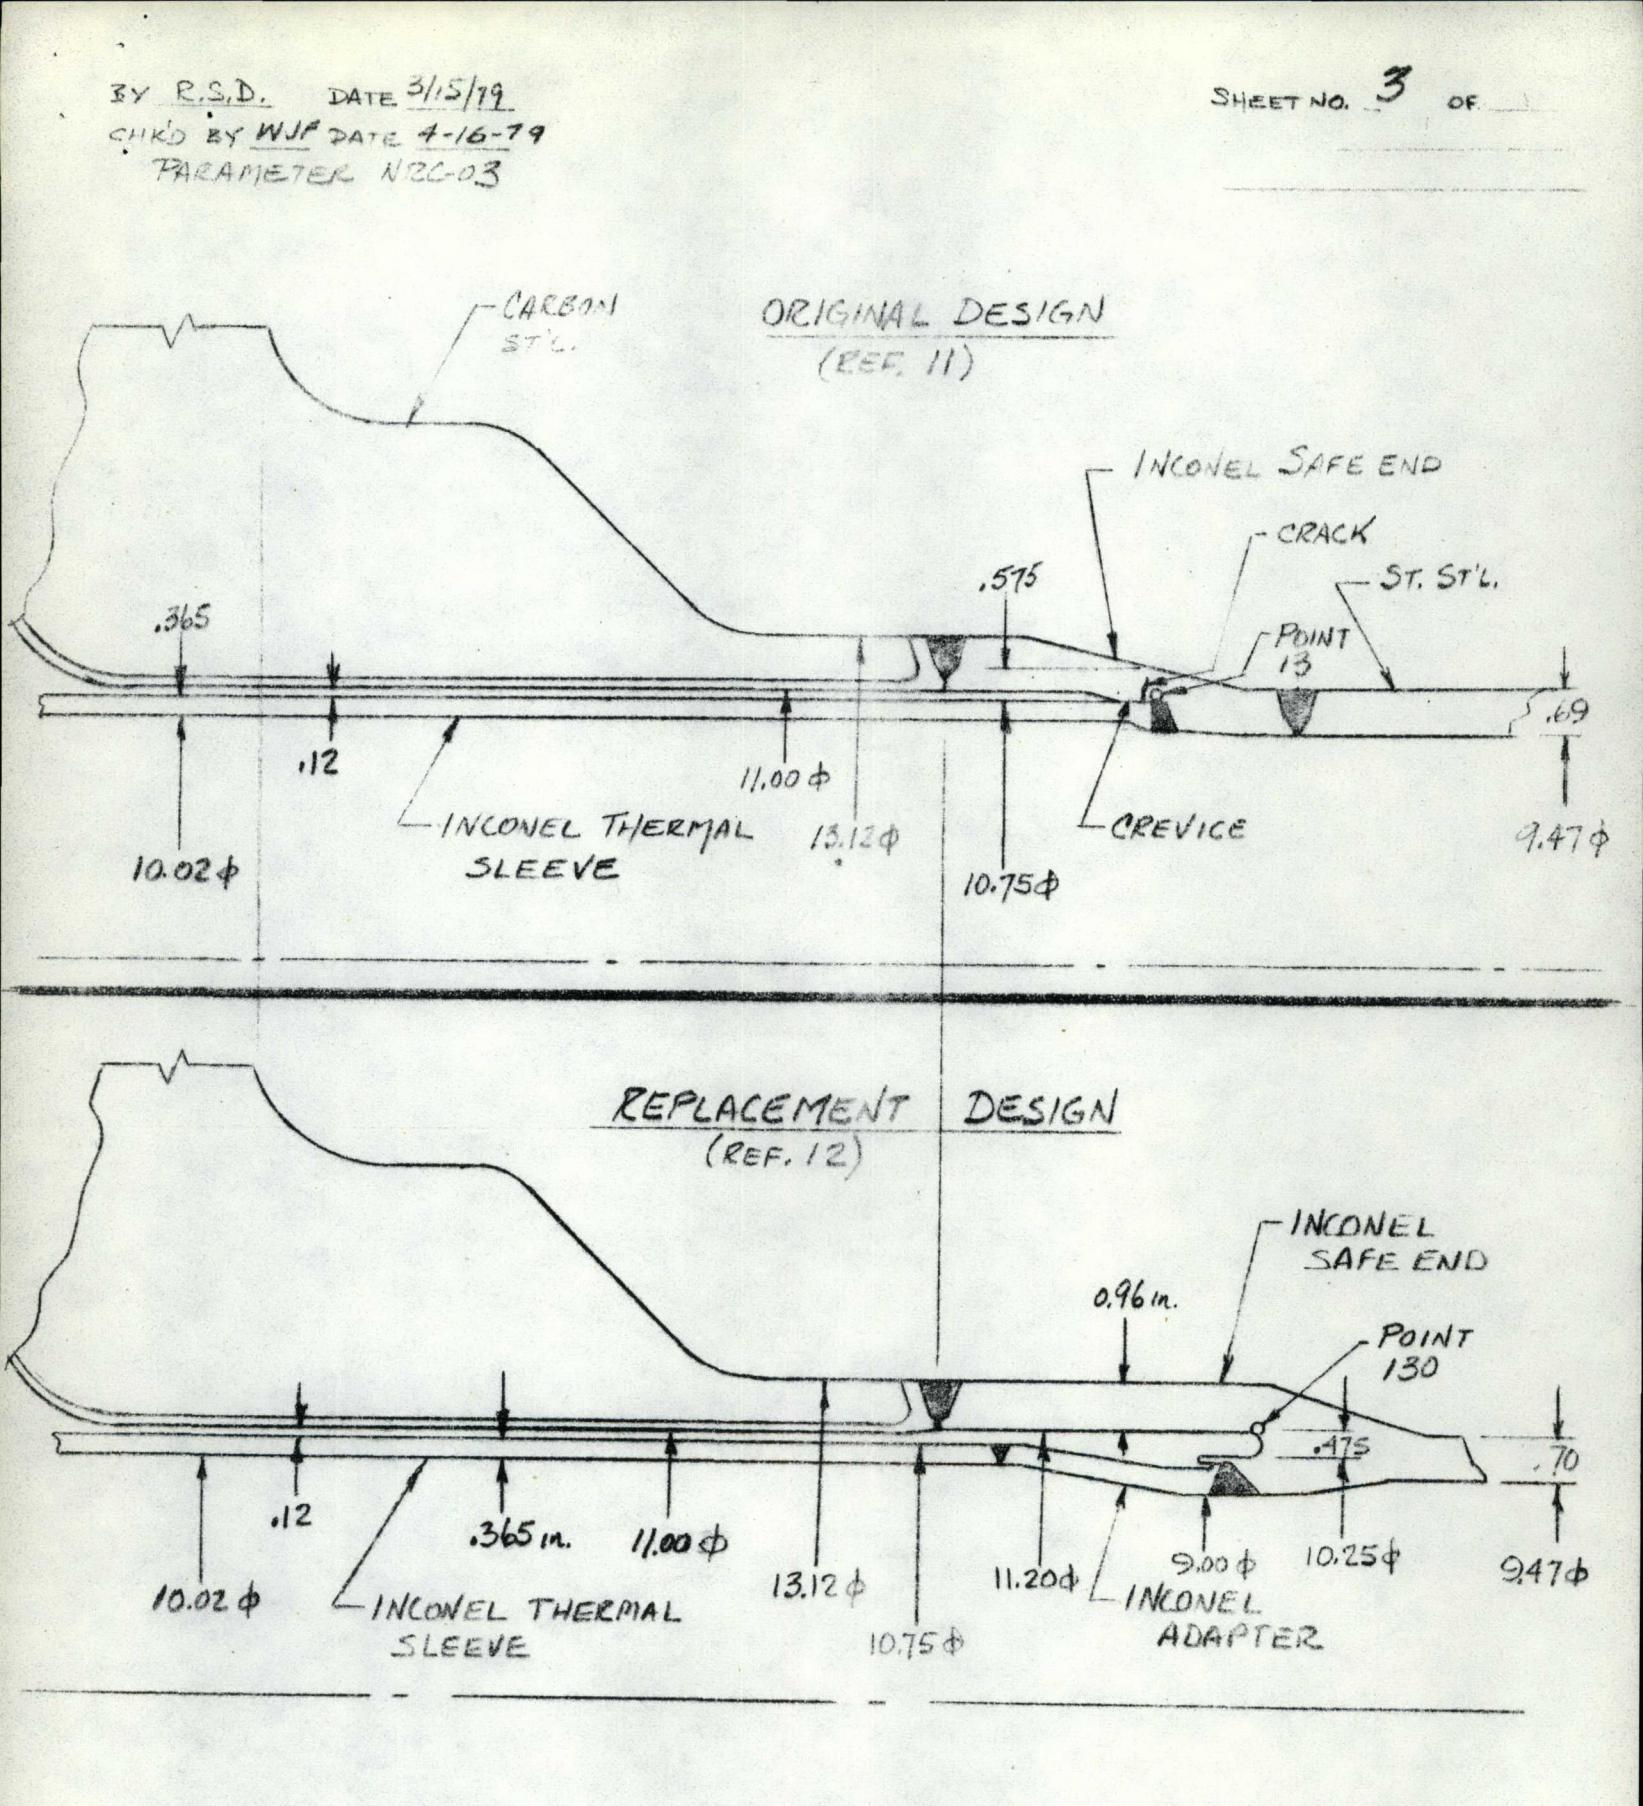
N-2 SAFE END ORIGINAL AND REPLACEMENT DESIGNS ____ DUANE ARNOLD ENERGY CENTER SCALE ~ APPROX. 1/4 PARAMETER NRC-03 ORIGINAL DELIGN

A comparison of the sketches of the two designs for the safe end show that the replacement design accomplishes the following:

- 1. The wall thickness is increased in the tapered section at the thermal sleeve attachment location which reduces stresses from operating loads.
- 2. The sleeve-to-safe-end weld joint is separated from the pressure boundary wall of the safe end, preventing any possible cracking in the weld heat affected zone from propagating through the pressure boundary wall. Weld location on the relatively flexible projection from the safe end accommodates circumferential weld shrinkage, reducing residual stresses from welding.
- 3. The crack-like crevice is eliminated, and is replaced with an annulus of controlled dimensions. This reduces the stress concentration by over 50%, and substantially reduces the tendency to trap corrosive contaminants at this location.

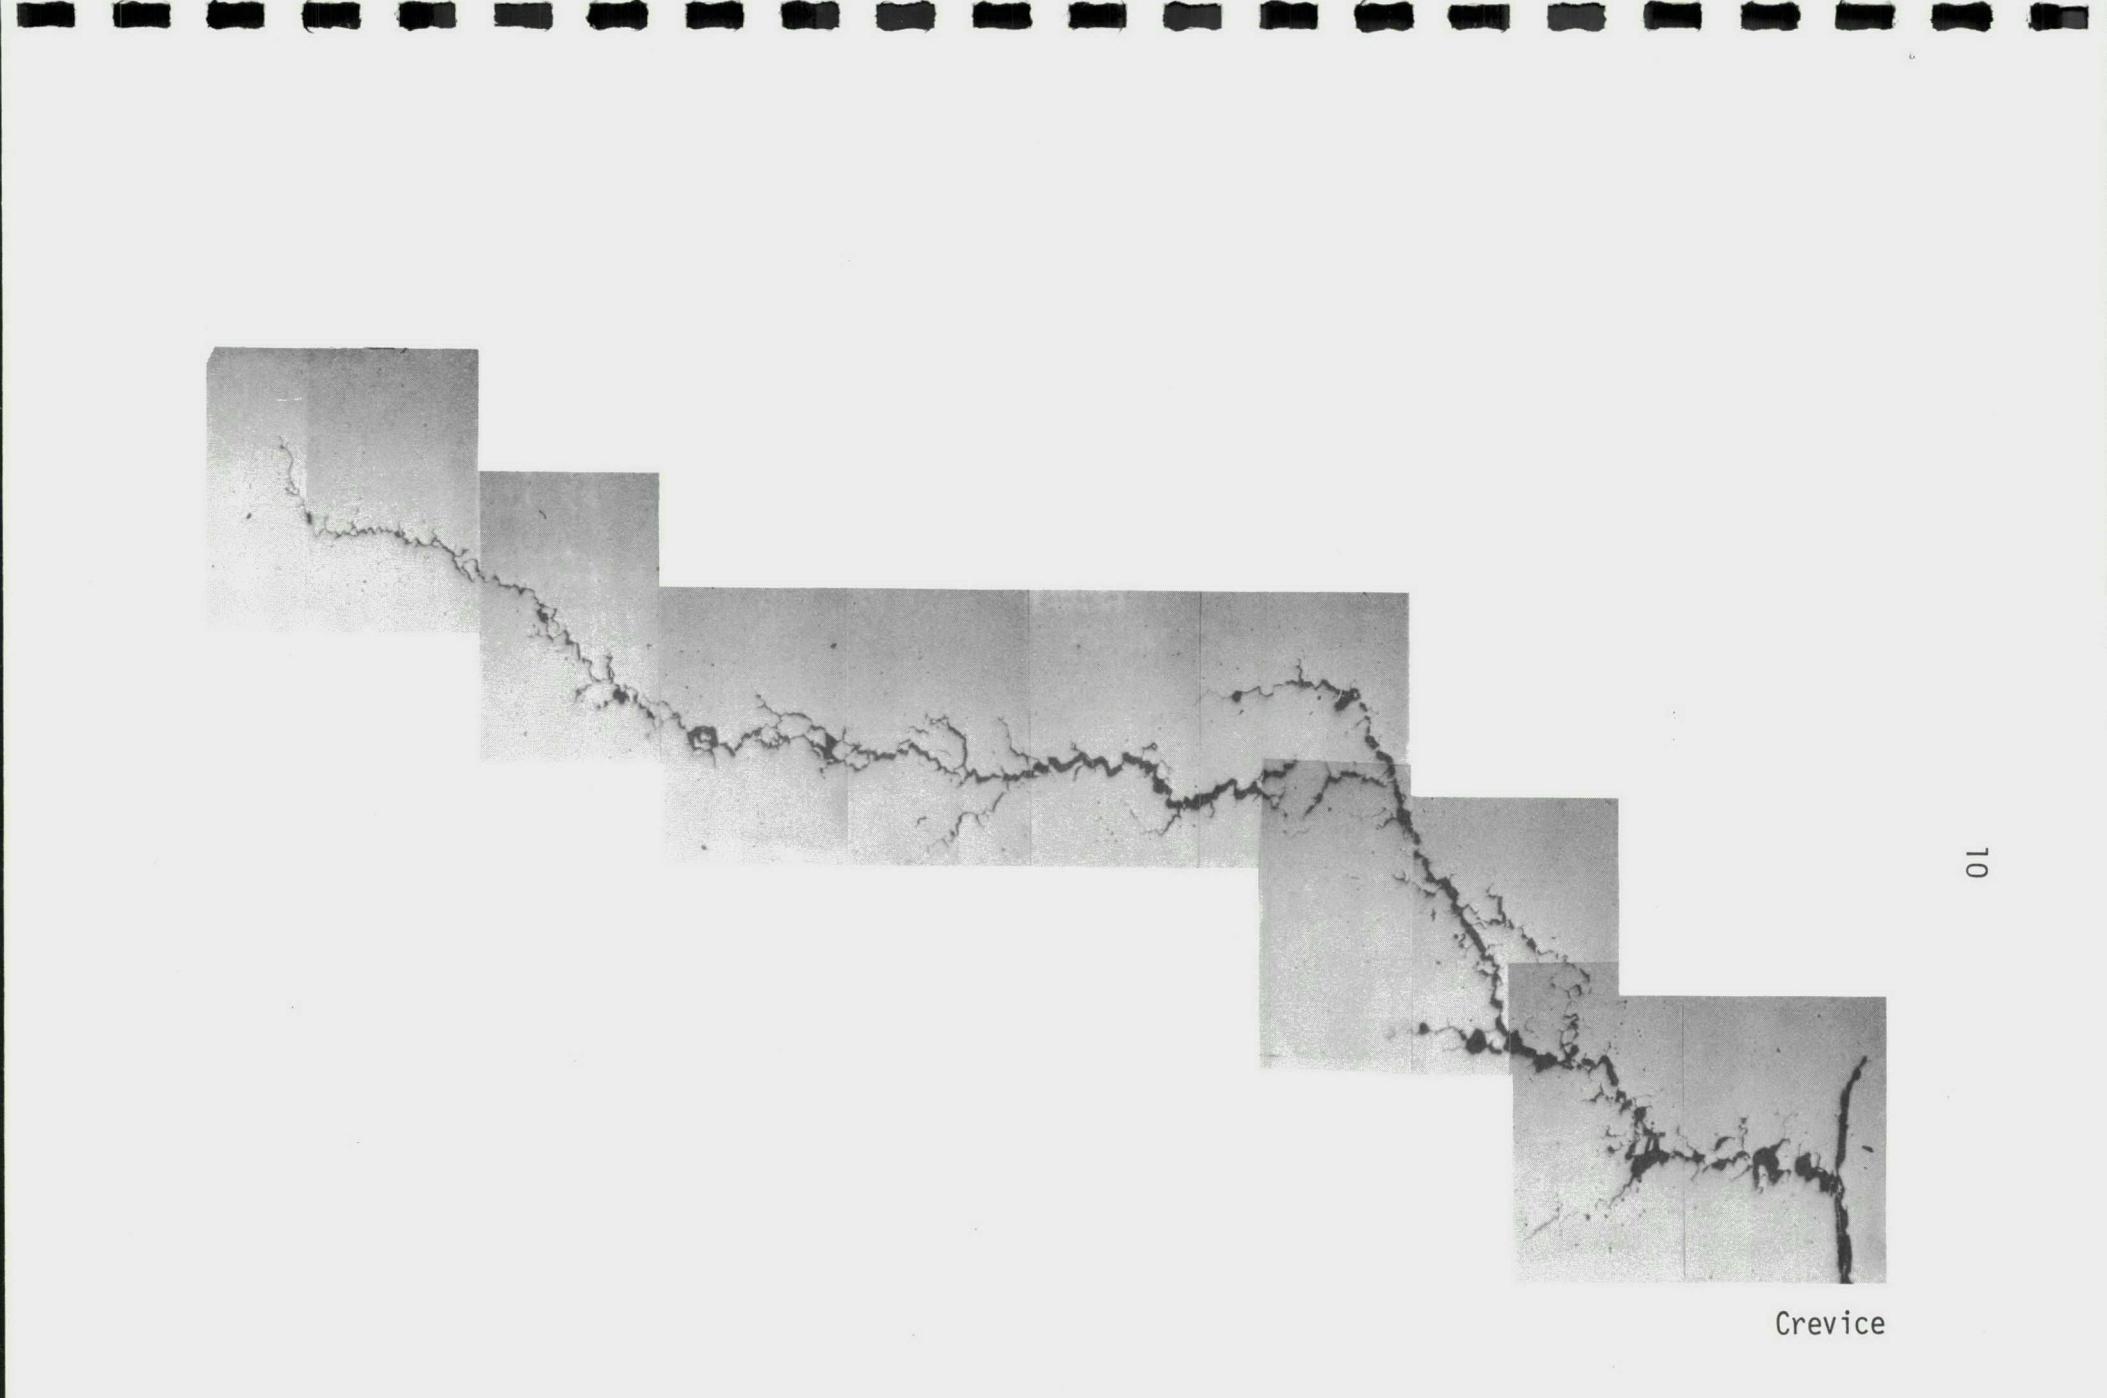
FIGURE 5. MICROGRAPH MONTAGE OF CRACK IN SAMPLE 2

The crack did not penetrate through the cross section of the safe end in any of the samples examined. In Samples 2 and 3 the crack had penetrated approximately 80% of the wall. In Sample 4, which was obtained

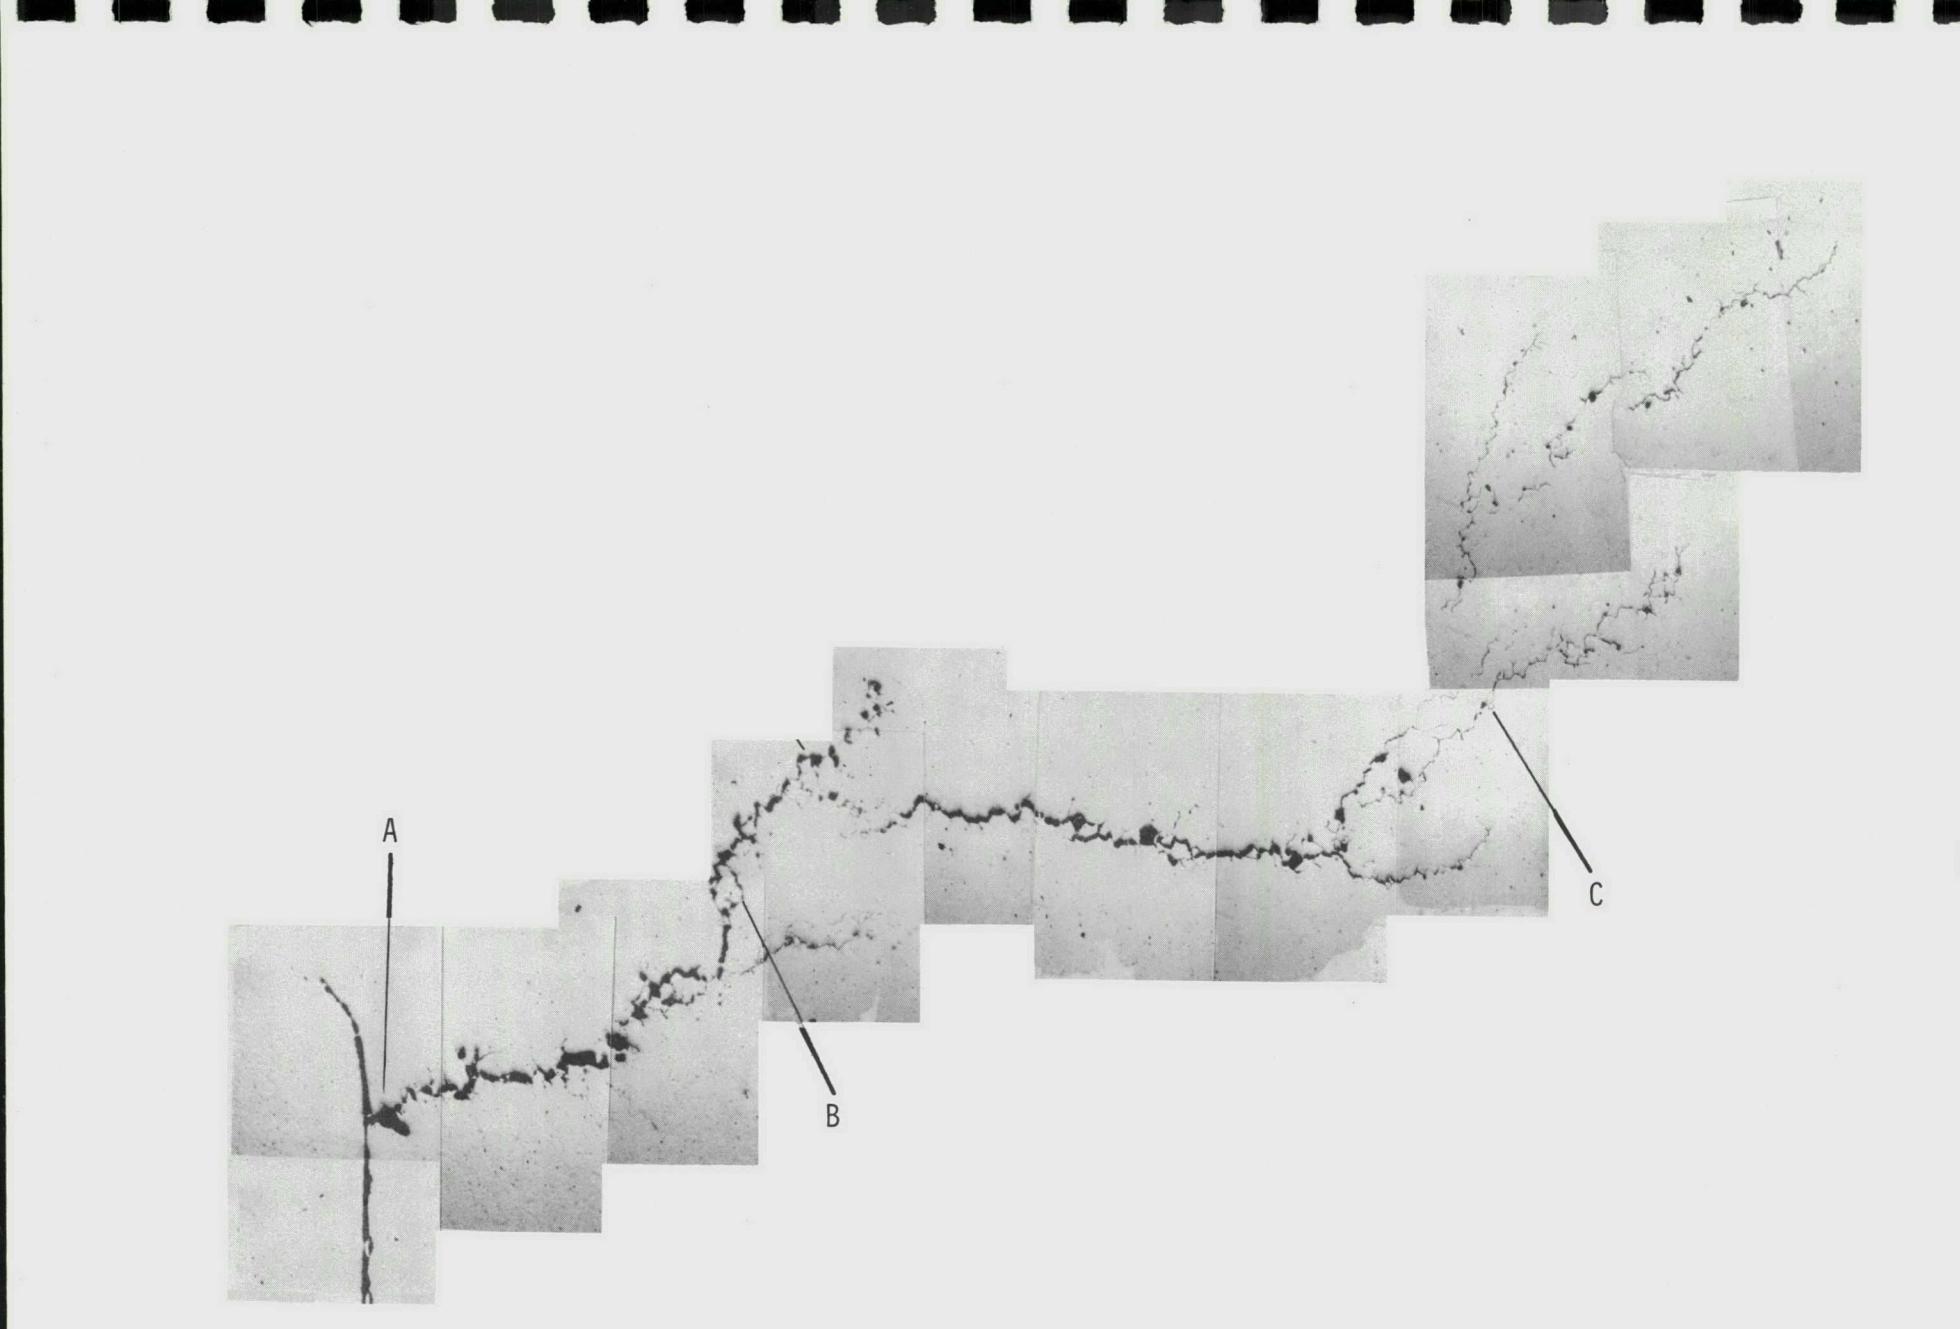
FIGURE 8. MICROGRAPH MONTAGE OF CRACK IN SAMPLE 3 AFTER ETCHING Details of areas labeled A, B, and C are presented at higher magnification in Figures 9 and 10.

All three samples contained cracks. The cracks were all intergranular in nature. In all samples, the initiation site of cracks was in the region of tight crevice between the sleeve and the safe end and radiated outward. The length of the tight crevice was found to be in the range 0.2-0.3 in. and the width was 0.002-0.005 in. No cracks were observed in the sleeve. In Samples 2 and 4 some grey areas were observed adjacent to tight branches of the cracks. These areas appeared to be of different composition. Similar areas were also observed along "tunnels" radiating from the cracks. The source of this grey phase area is not known.

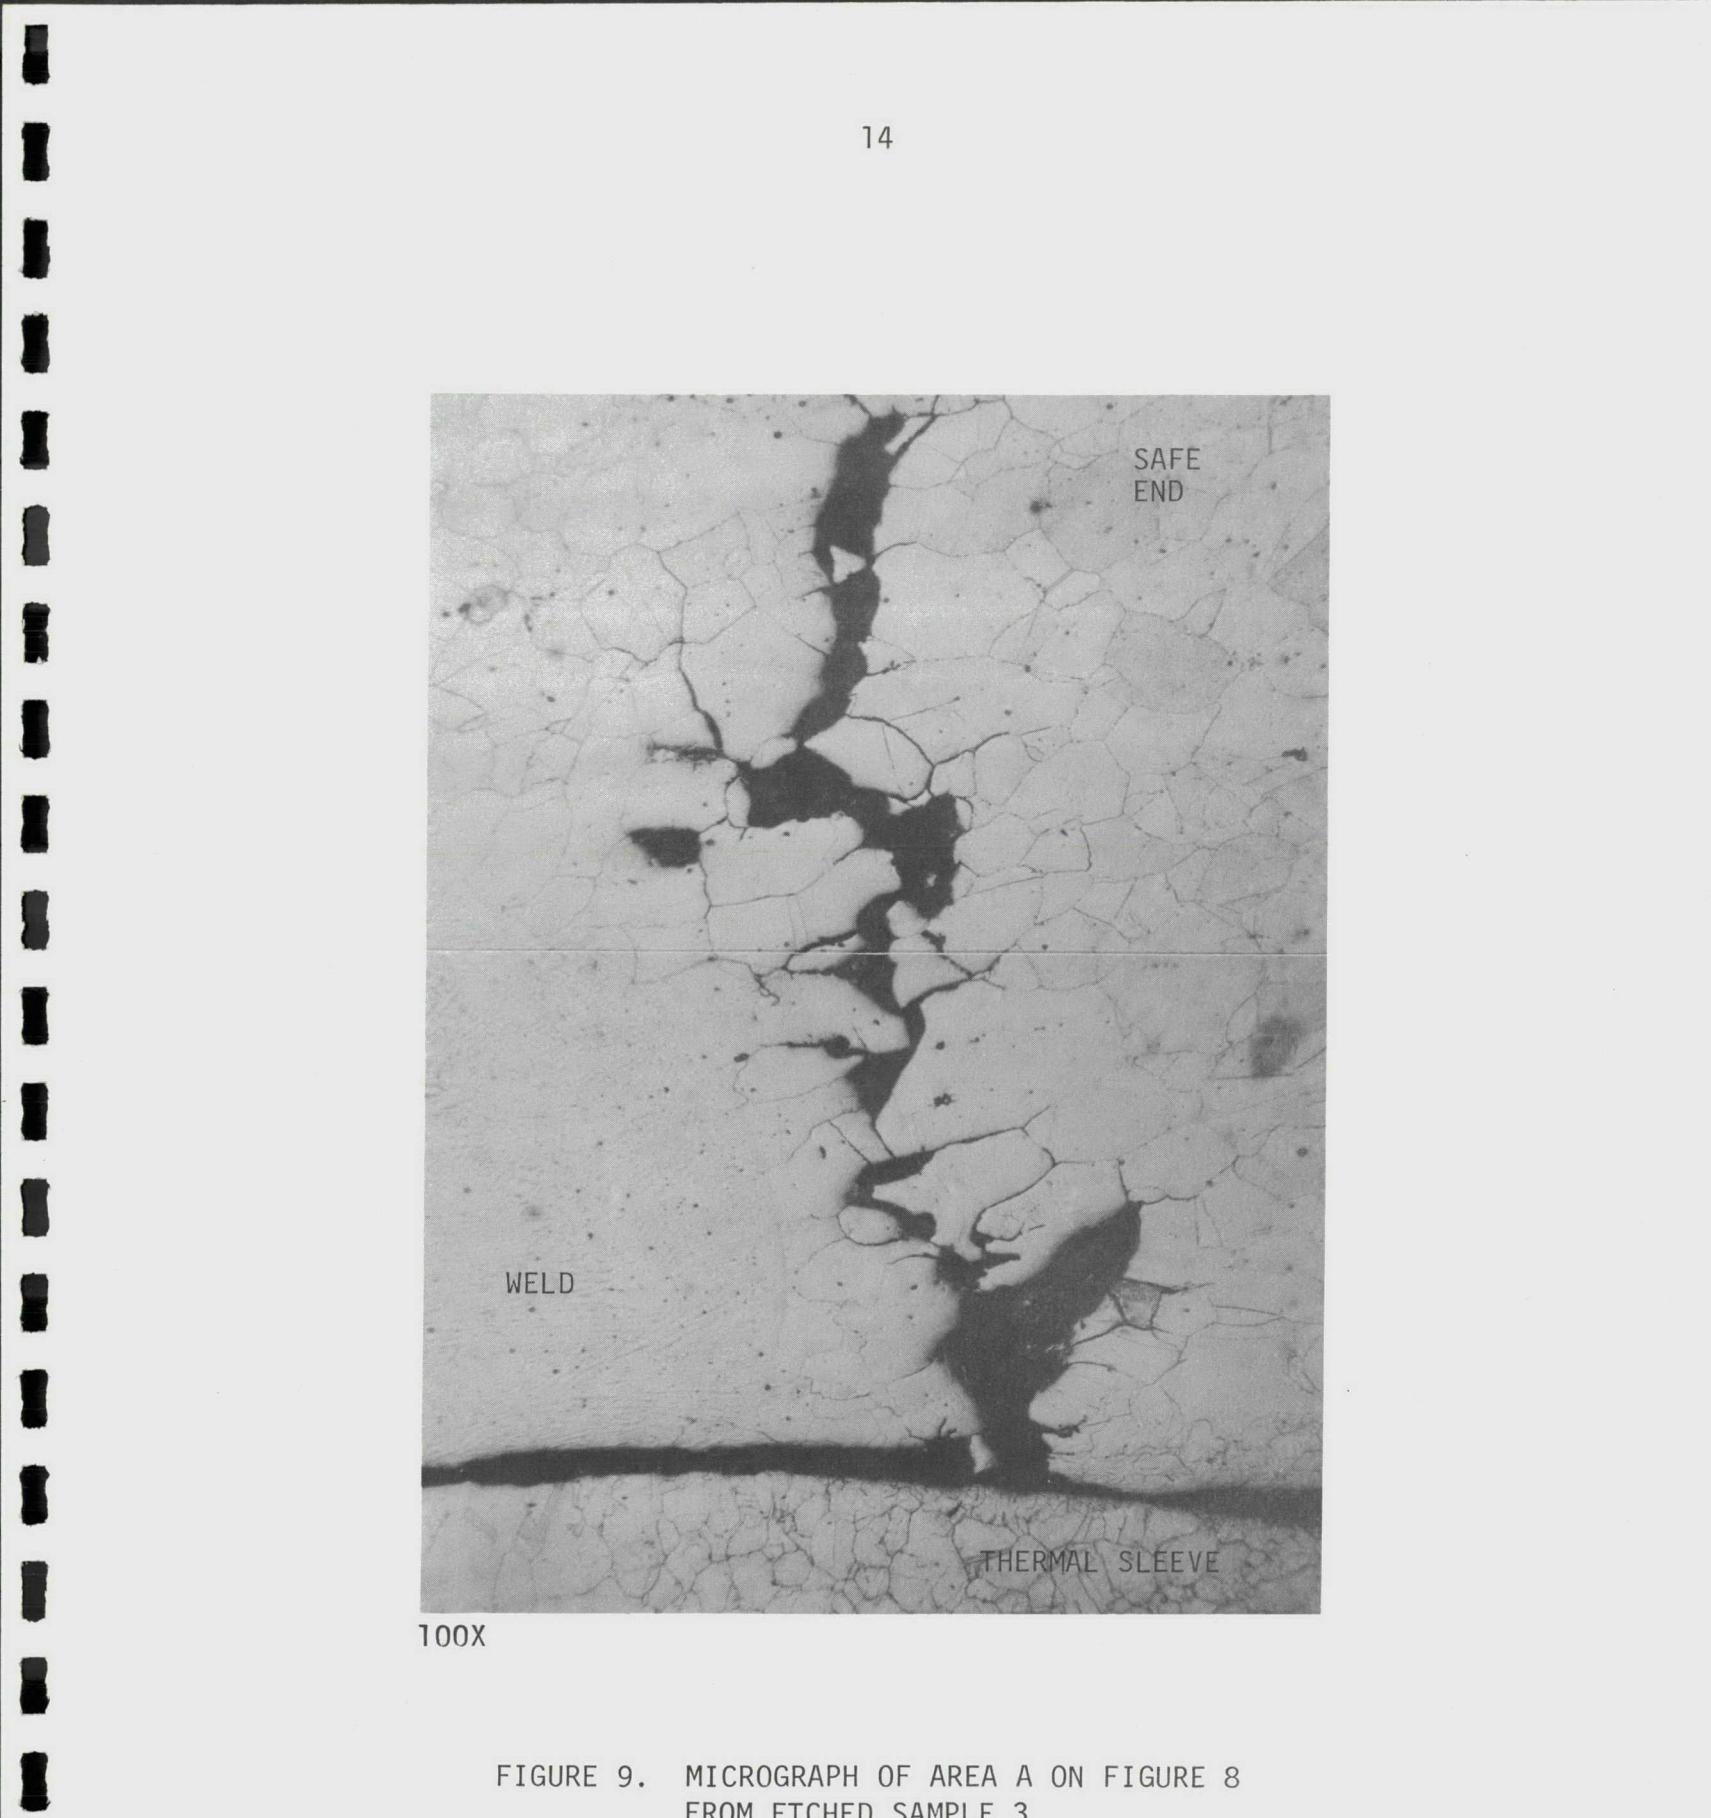
FIGURE 9. MICROGRAPH OF AREA A ON FIGURE 8 FROM ETCHED SAMPLE 3

- The location of the cracks in all cases were in the re-solution treated region of the heat affected zone of the weld joining the safe end to the sleeve. See Figures 9 and 11.

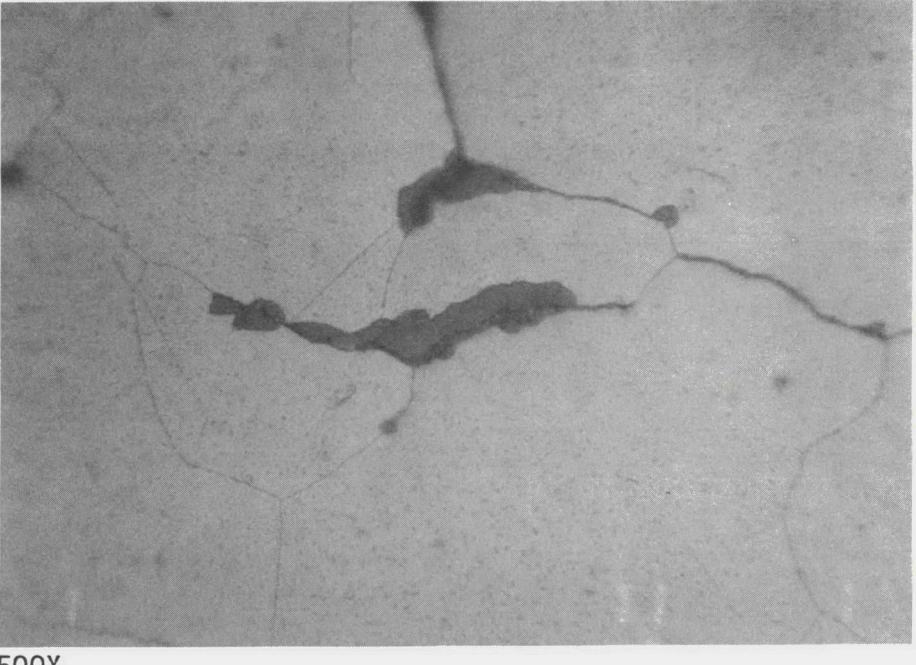
FIGURE 12. APPEARANCE OF THE GREY PHASE ADJACENT TO A TIGHT CRACK BRANCH

Sample was etched with aqua regia glycerine and acetic acid mixture to reveal chromium depleted regions.

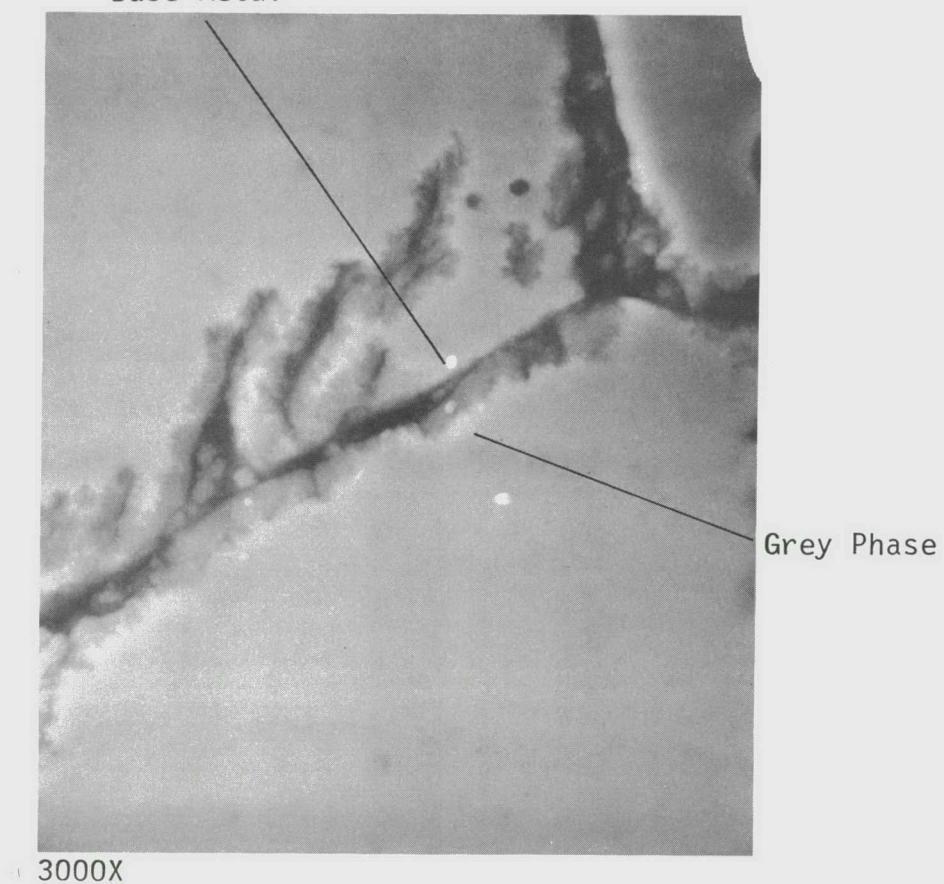
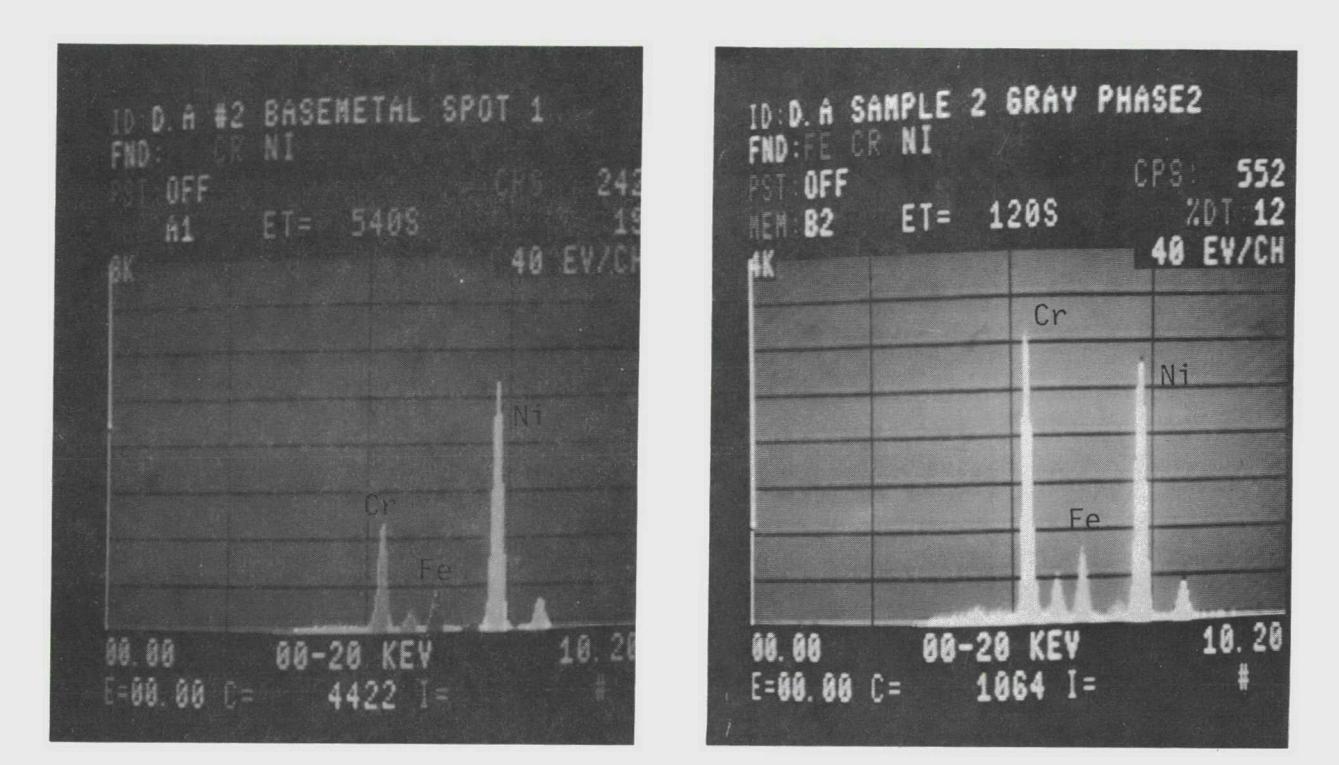
FIGURE 16. SEM MICROGRAPH OF GREY PHASE AND CORRESPONDING EDAX ANALYSES OF BASE METAL AND GREY PHASE

EDAX analysis of material observed within the crack both adjacent to the grey phase and in areas where no grey phase is found indicate an iron rich material relative to base metal compositions. Figures 17 and 18 present SEM micrographs and EDAX spot analysis performed well within the crack and at the crevice on Sample No. 4. As can be seen in Figure 17 the EDAX analysis of material within the crack indicates excessive iron relative to base metal analysis. However, no iron depletion can be observed in the material adjacent to the crack. EDAX analysis performed on material within the crevice (Figure 18) at a location near the crack origin indicate similar iron rich material. Comparison of the two relative iron contents from EDAX analysis at the crevice with analysis in the crack indicate a significantly higher iron content of material well within the crack.

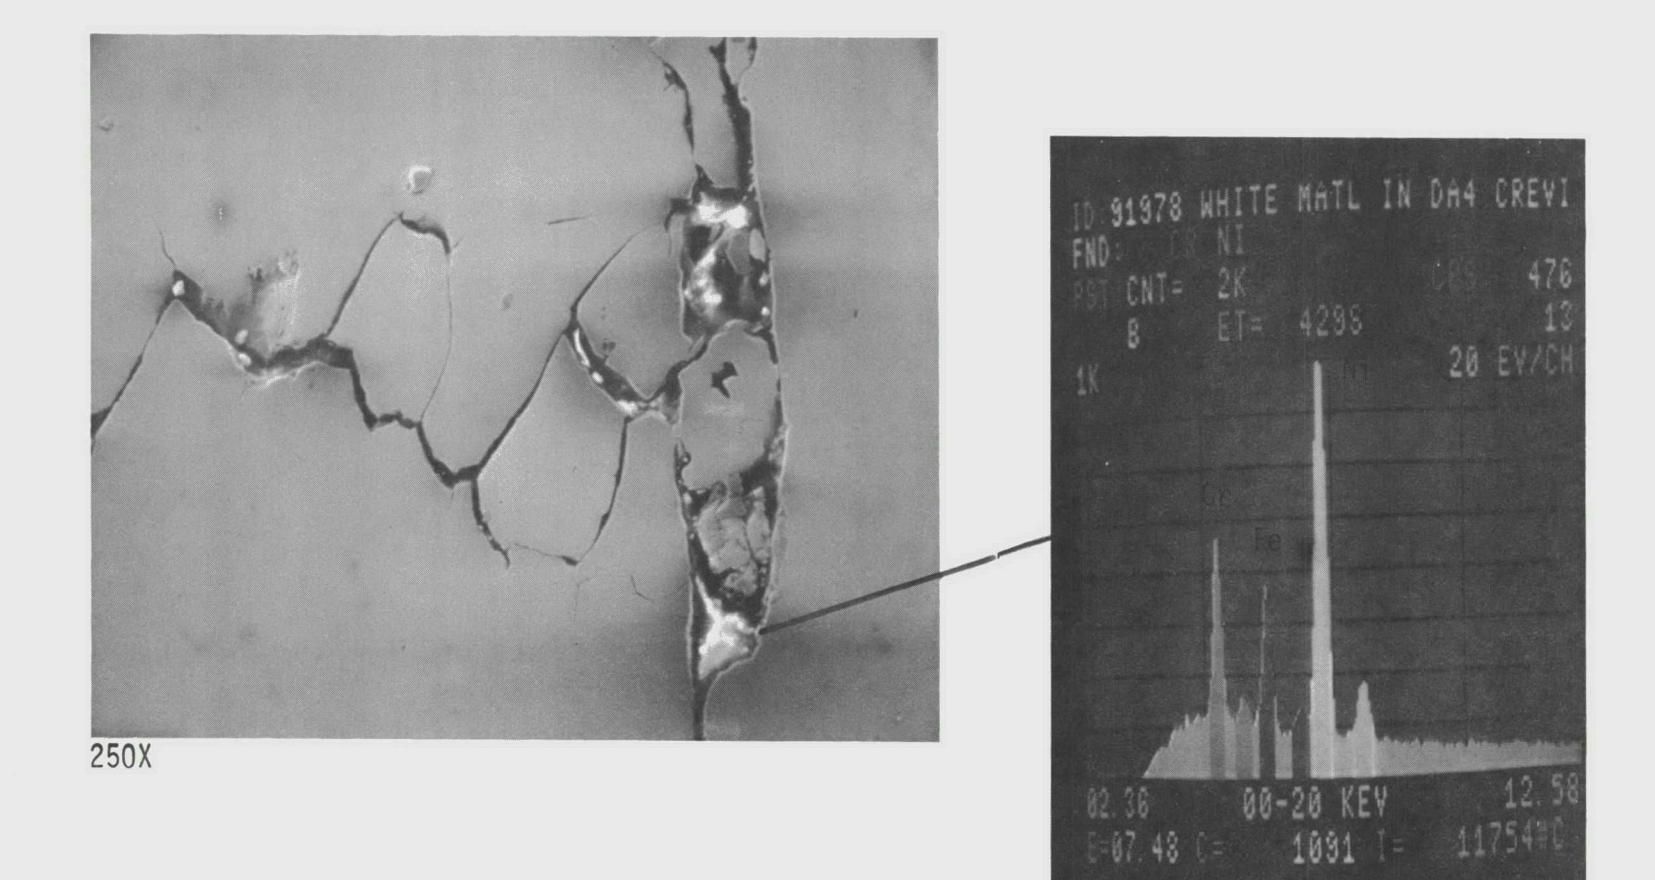
FIGURE 18. SEM MICROGRAPH AND CORRESPONDING EDAX ANALYSIS OF IRON RICH MATERIAL IN CREVICE OF SAMPLE 4

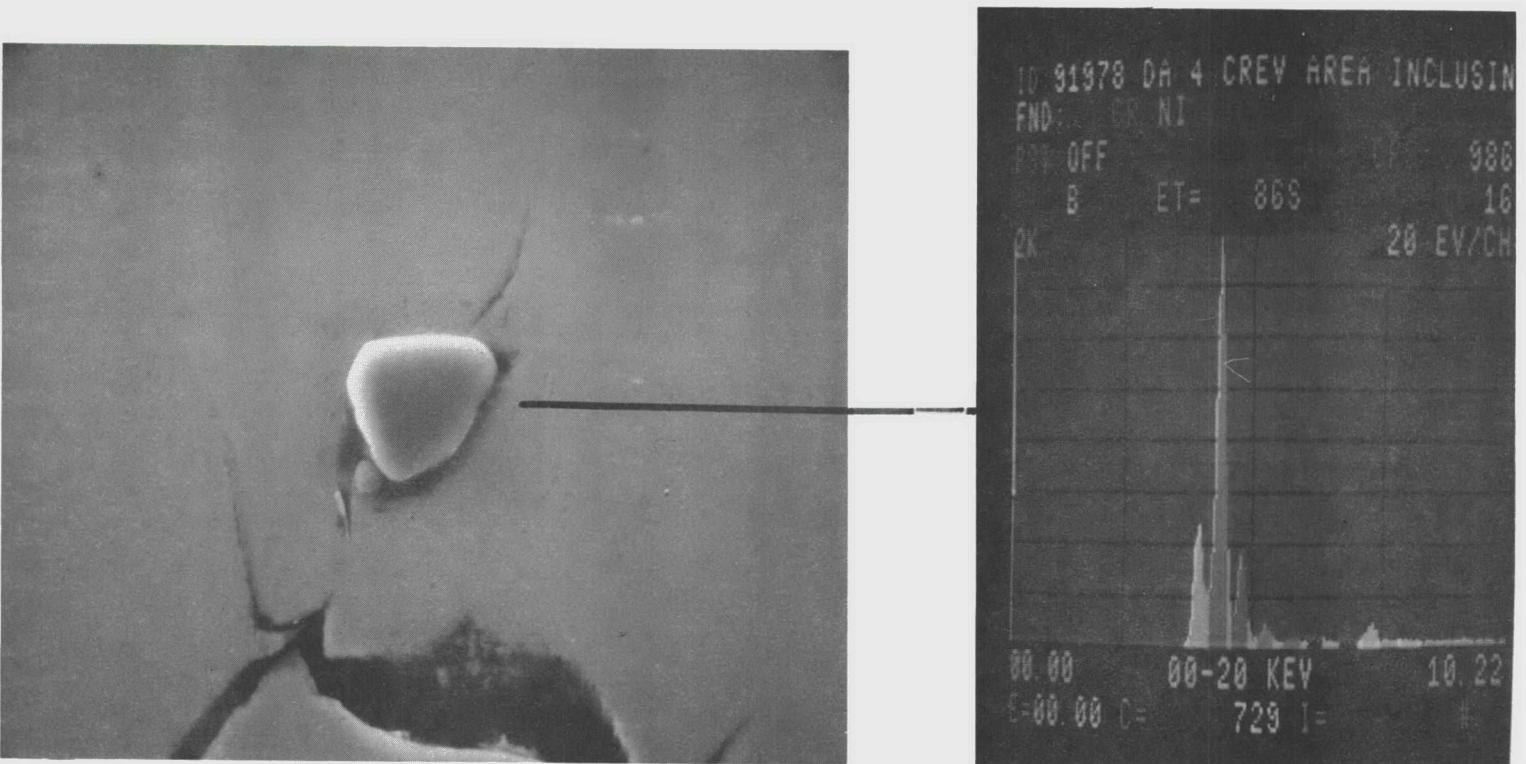
FIGURE 19. SEM MICROGRAPH AND CORRESPONDING EDAX ANALYSIS OF TITANIUM INCLUSION FROM SAMPLE 4

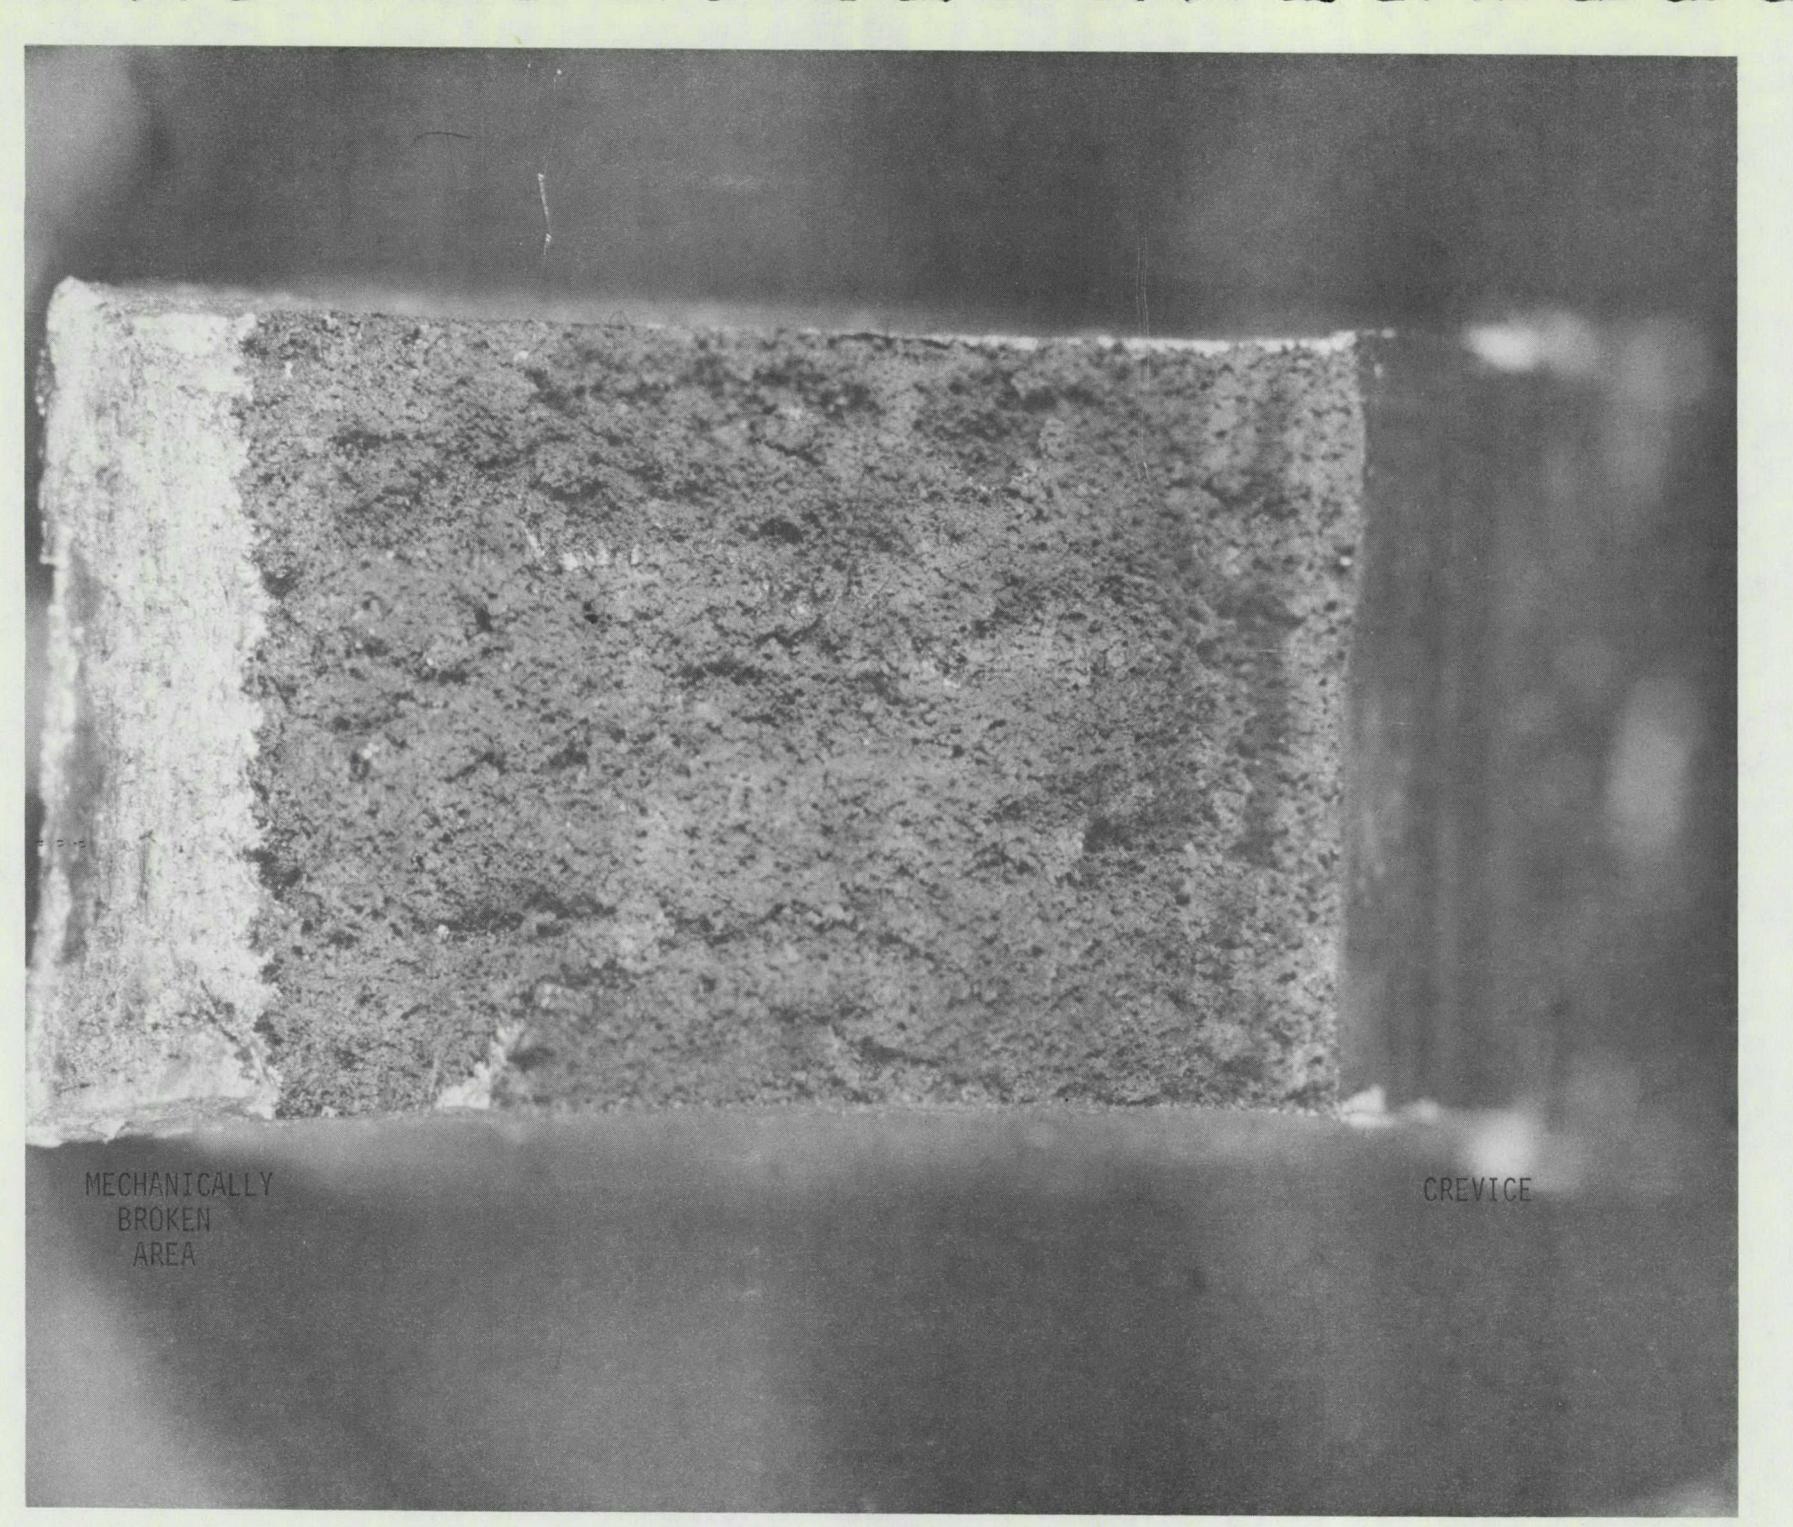
FIGURE 21. PHOTOMACROGRAPH OF FRACTURE SURFACE FROM SAMPLE 5

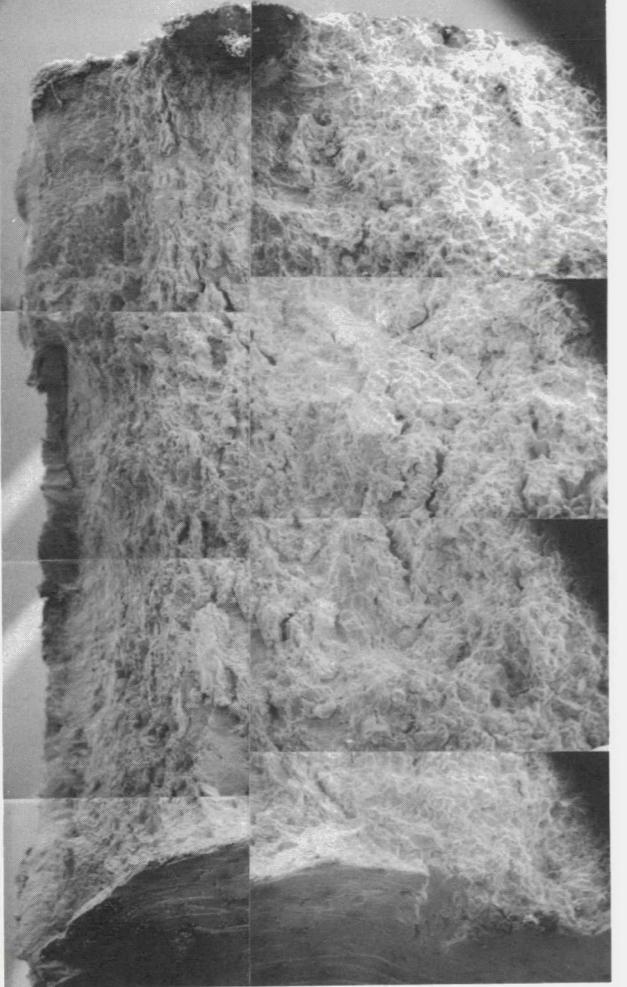
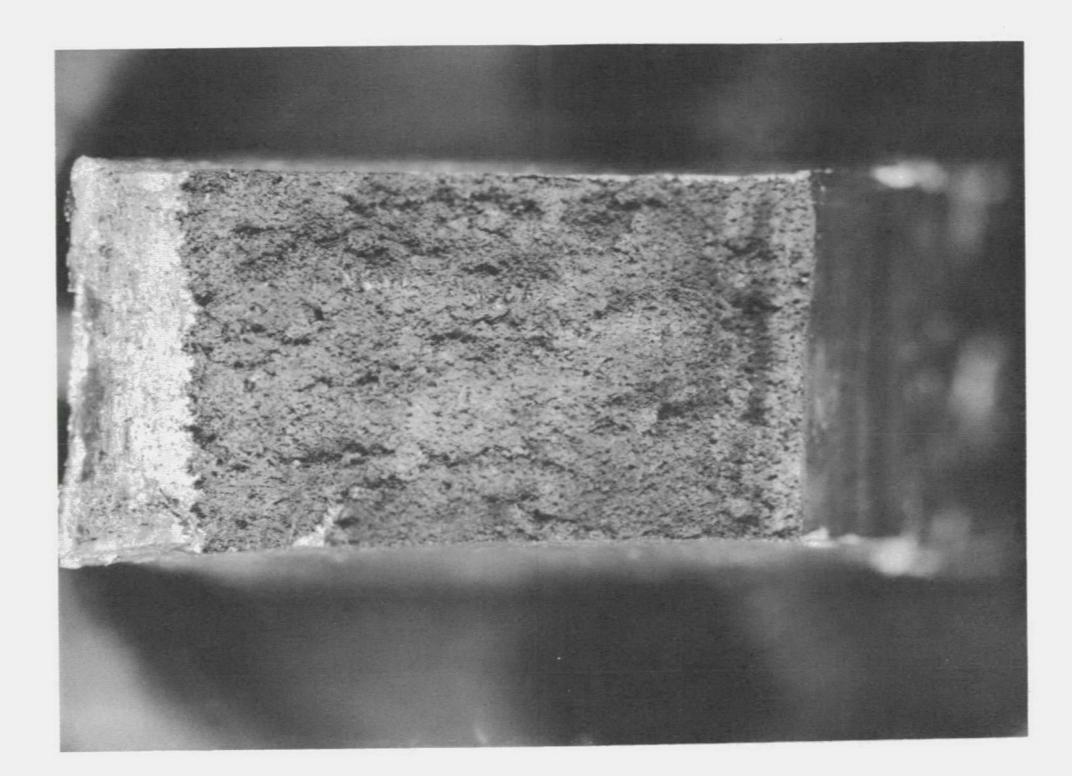
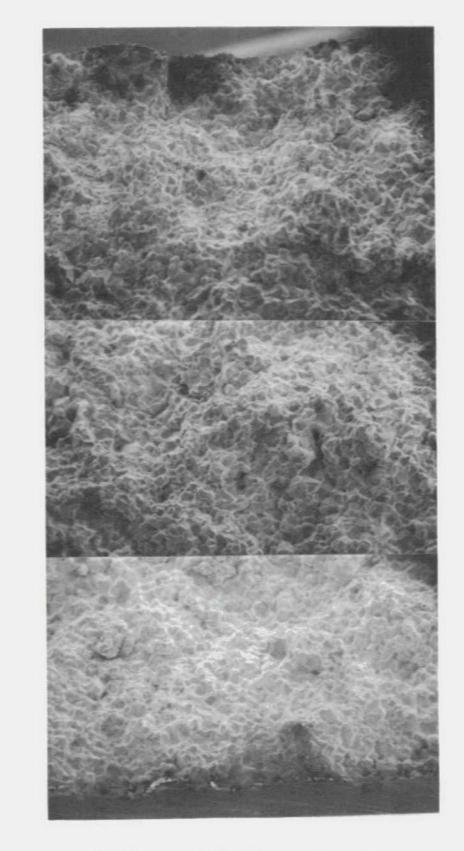
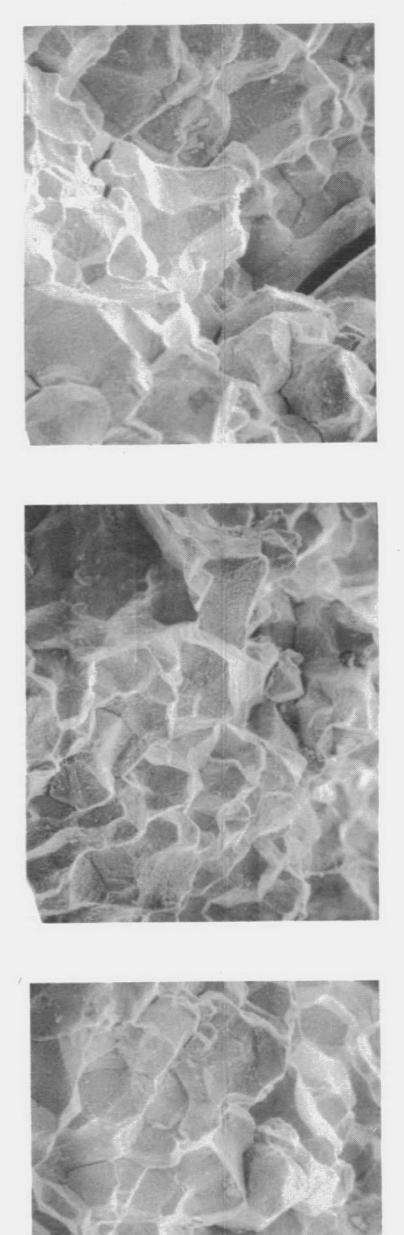
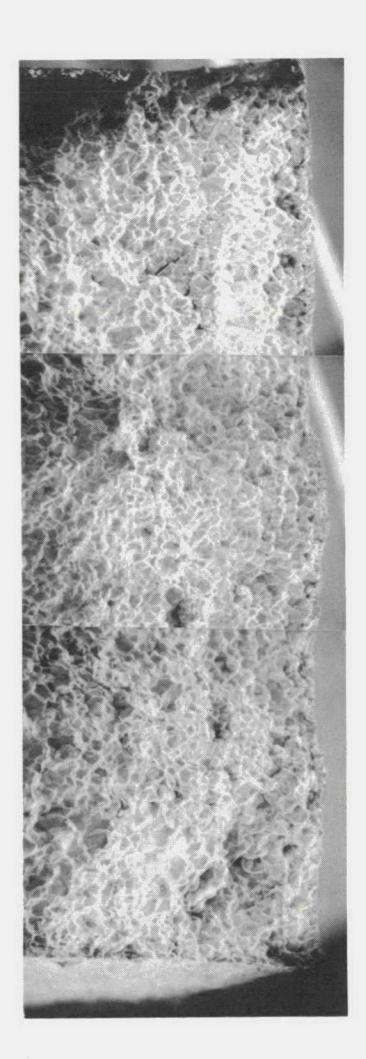
FIGURE 22. SEM MICROGRAPH MONTAGES OF SAMPLE 5 FRACTURE SURFACE (a) Crack Tip, (b) Mid Fracture, (c) Near Crevice

Detailed SEM examination was performed on the entire fracture surface. Figure 22 presents SEM fractograph montages at the beginning (near crevice) middle, and tip of the crack along the fracture surface. The mode of cracking, as indicated by the SEM fractographs, was intergranular fracture.
