Report No. IE-116

Metallurgical Examination and Stress Evaluation of Recirculation Inlet Nozzle Safe-End Cracking

Duane Arnold Energy Center

PARAMETER, Inc.

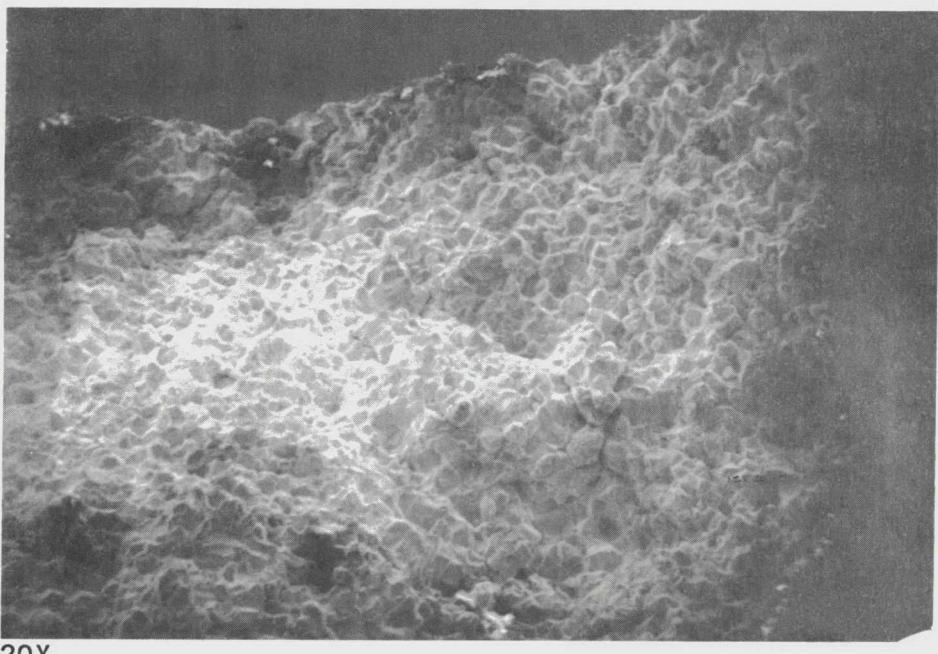
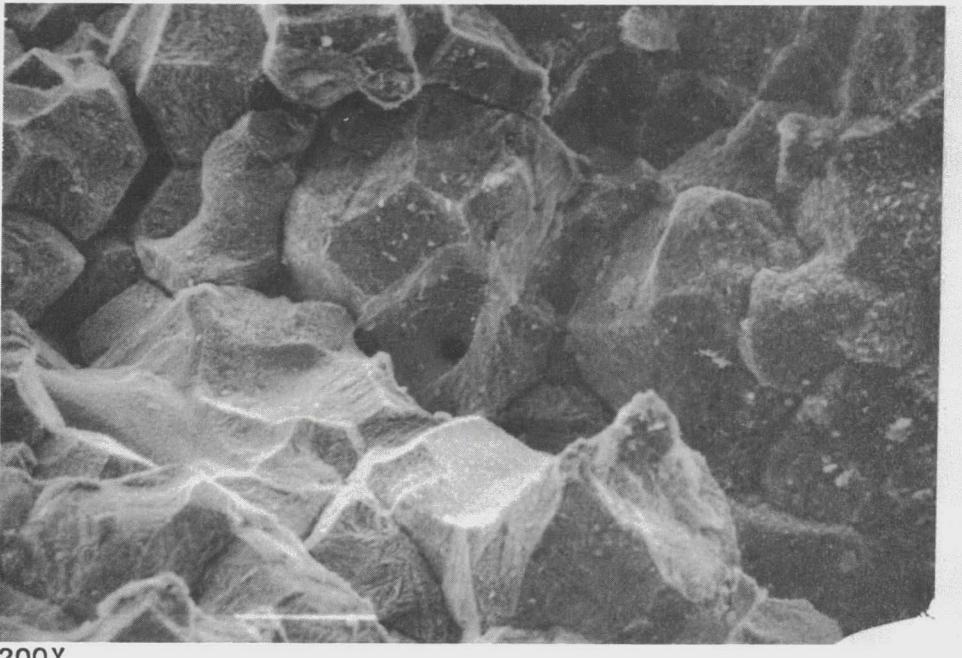
FIGURE 23. SEM FRACTOGRAPHS OF SAMPLE 5 NEAR CREVICE

(a) Typical area on fracture surface near crevice

(b) Actual area examined by EDAX analysis

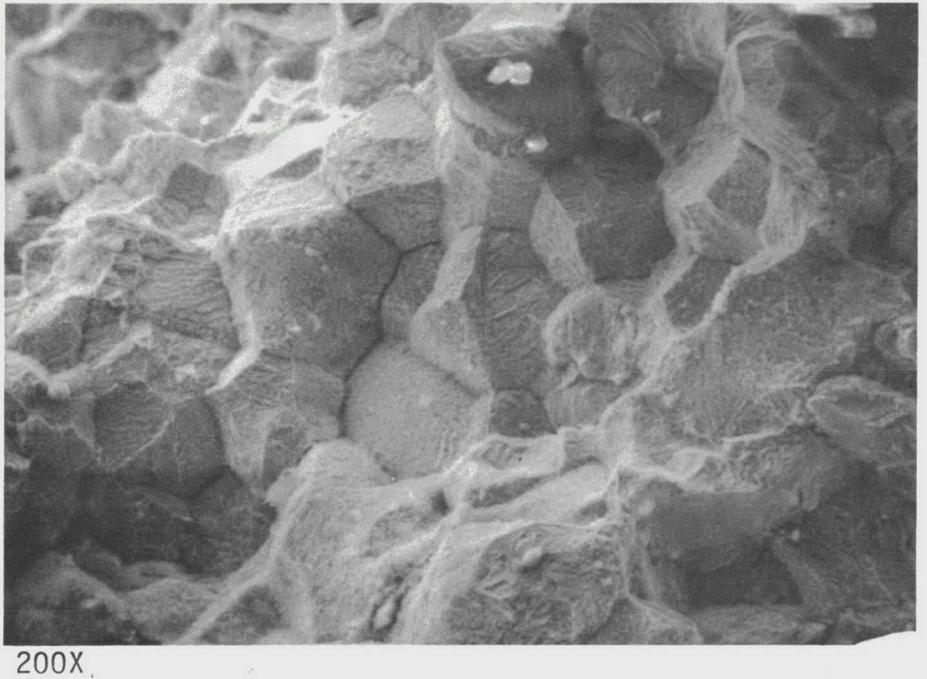
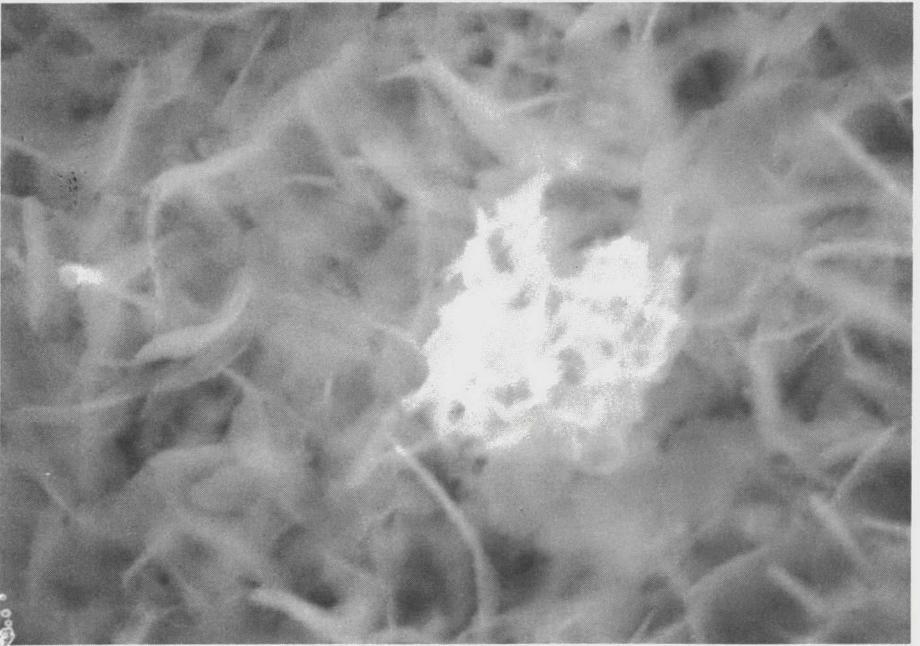
FIGURE 24. SEM FRACTOGRAPHS OF SAMPLE 5 AT MID FRACTURE

(a) Actual area examined by EDAX analysis

(b) Needle network of corrosion products on grain facet. Spot EDAX analysis indicated high sulfur content.

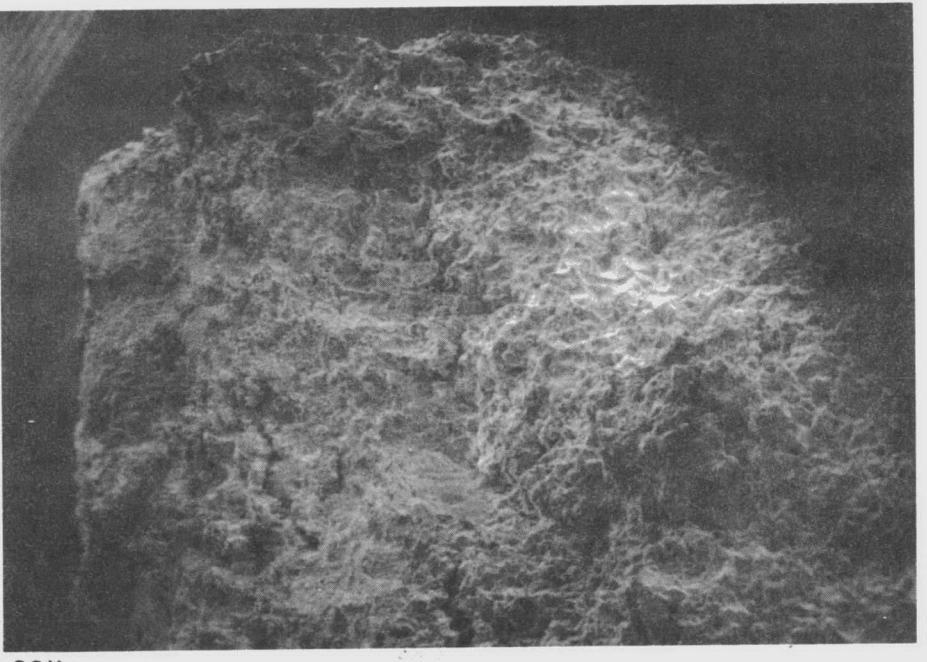
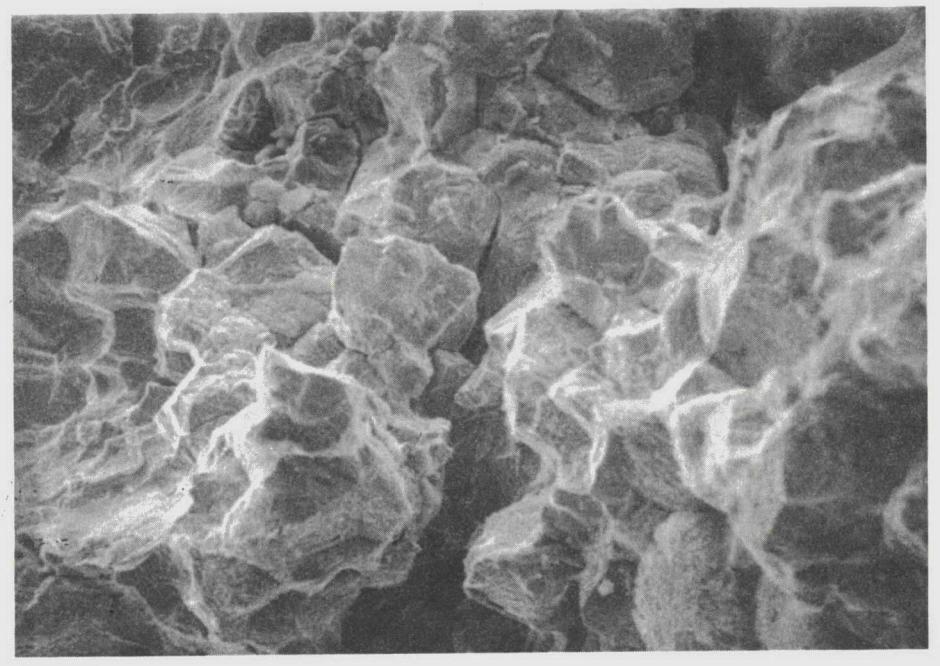
(a) Typical area on fracture surface at crack tip.

(b) Actual area examined by EDAX analysis.

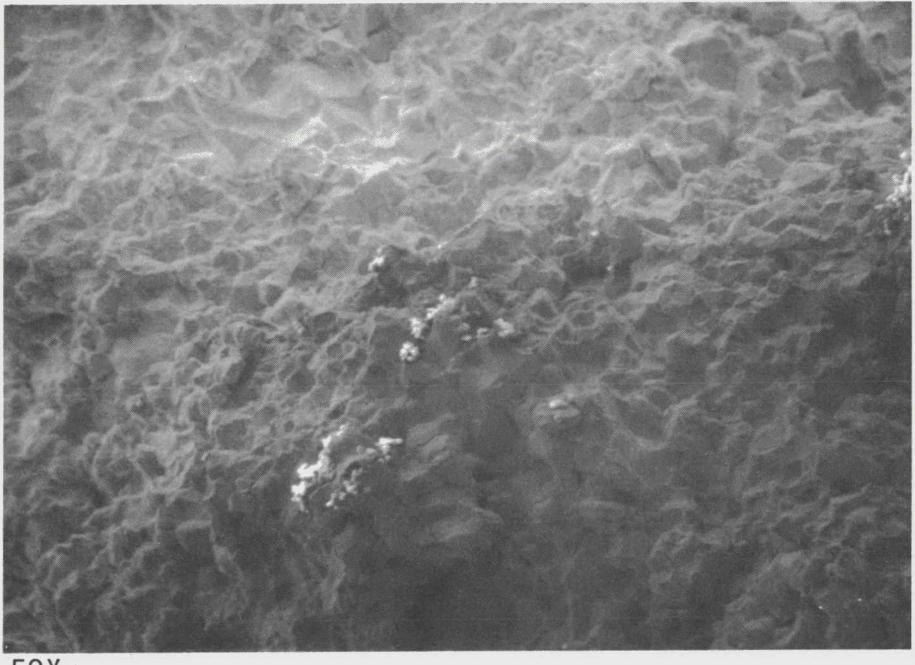
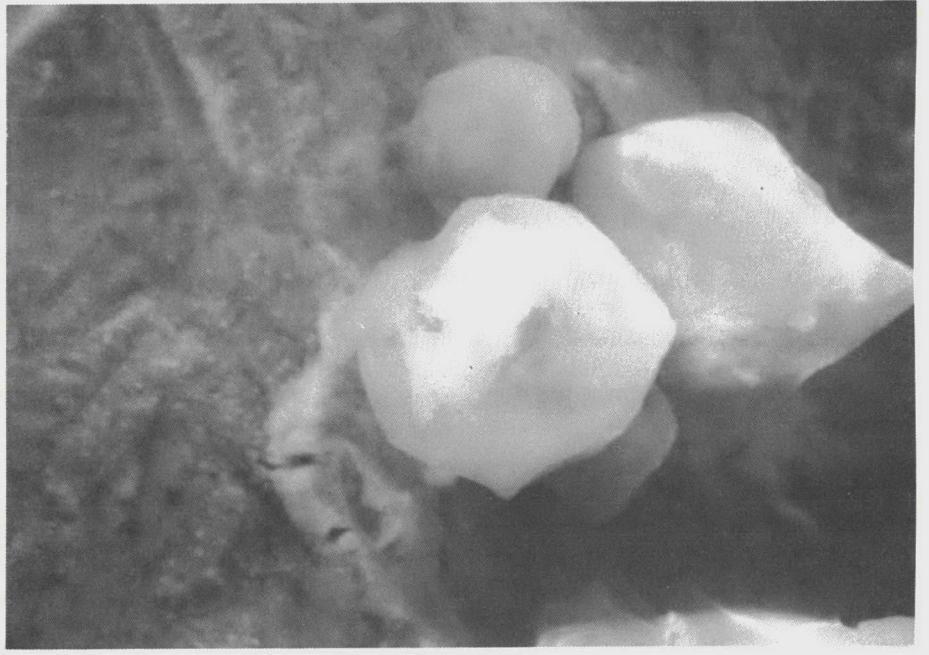
FIGURE 26. SEM FRACTOGRAPHS OF SAMPLE 5 NEAR CRACK TIP

(a) Cluster of crystalline material near crack tip.

(b) Crystalline material subject to EDAX spot analysis. Results indicate high sulfur content (>20%).

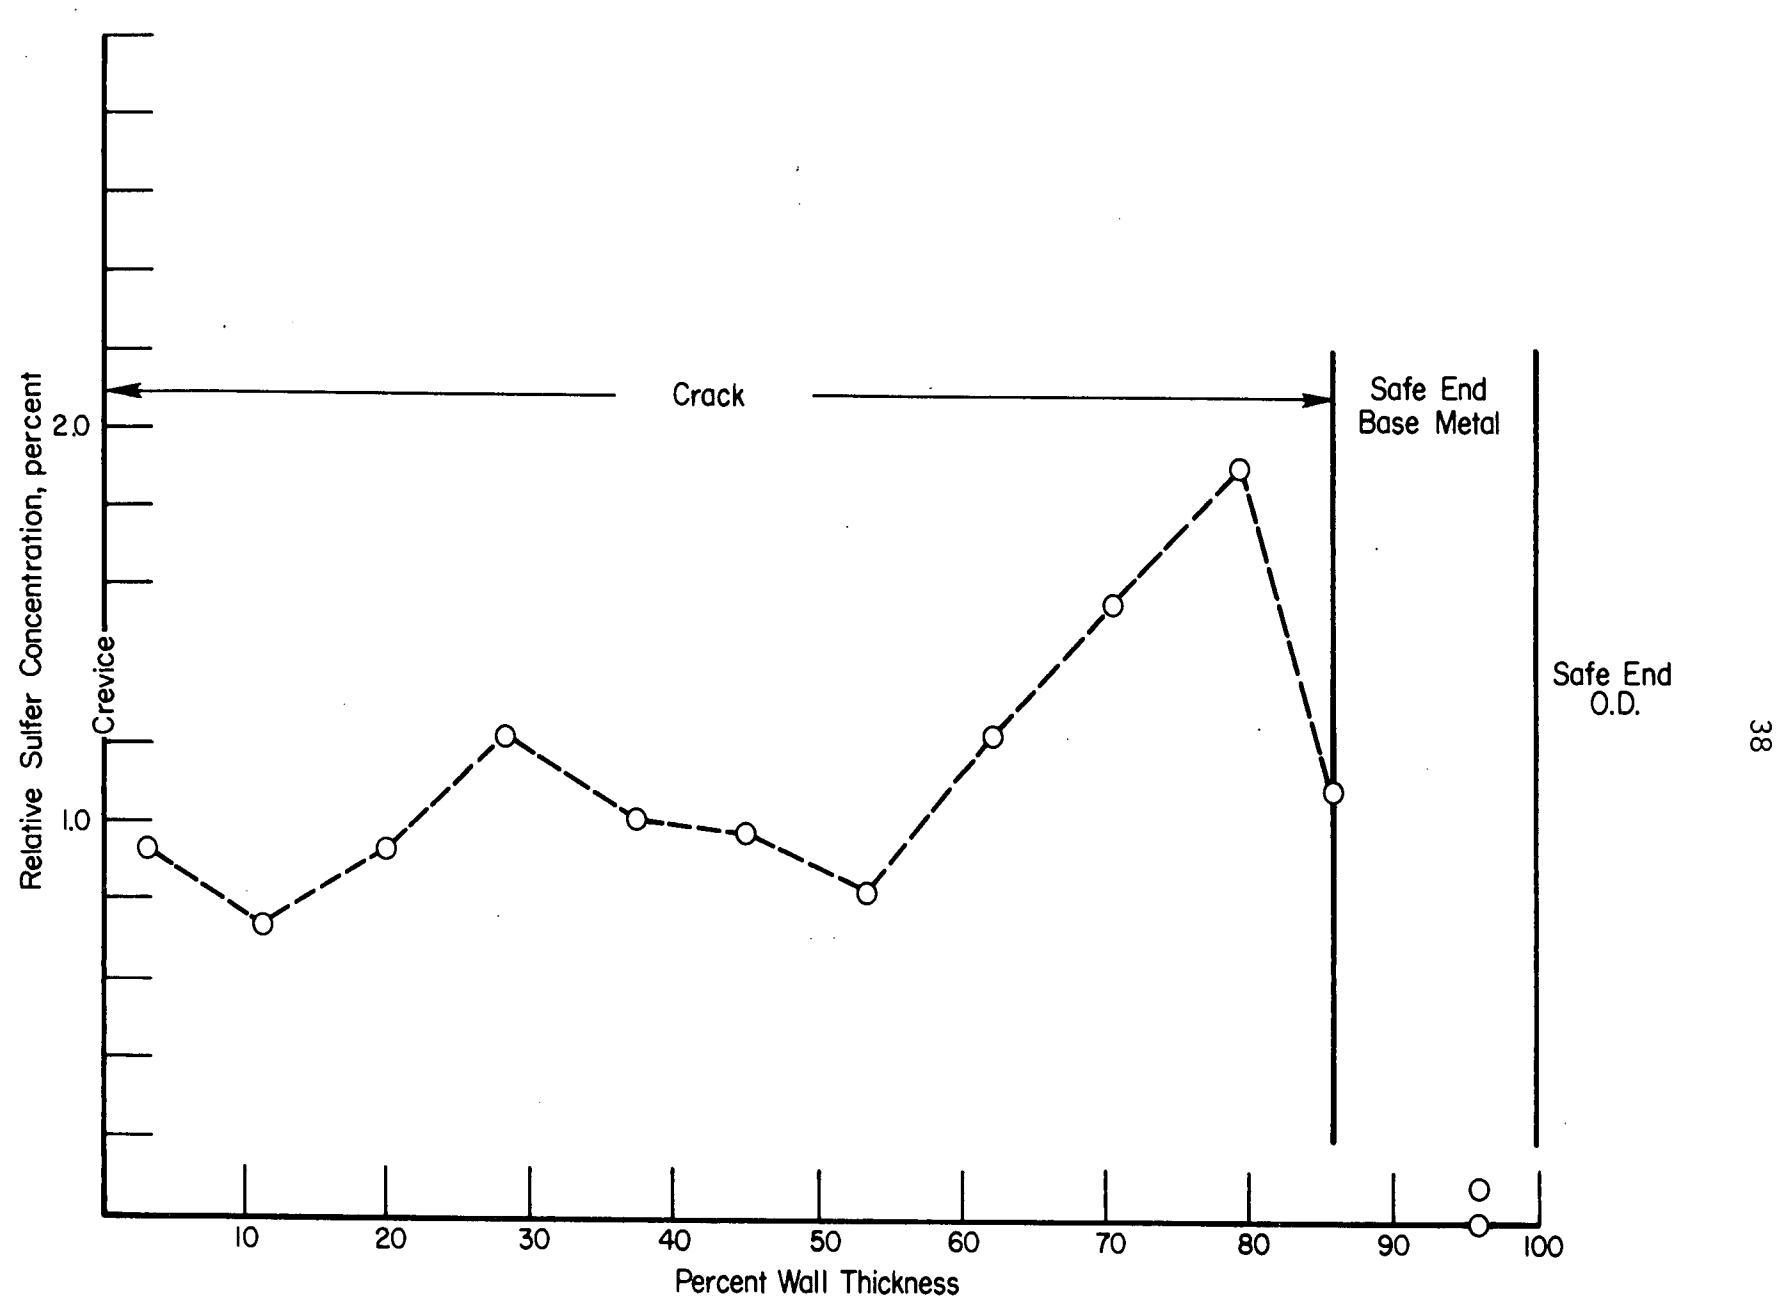
FIGURE 27. DUANE ARNOLD SAFE END SULFUR PROFILE ON FRACTURE SAMPLE No. 1

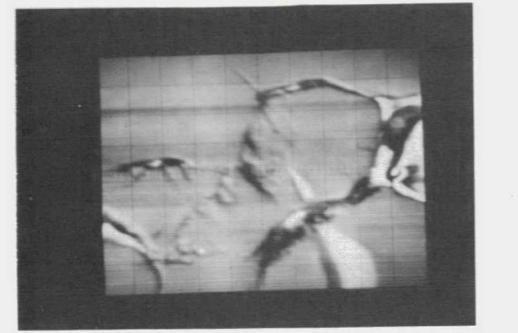
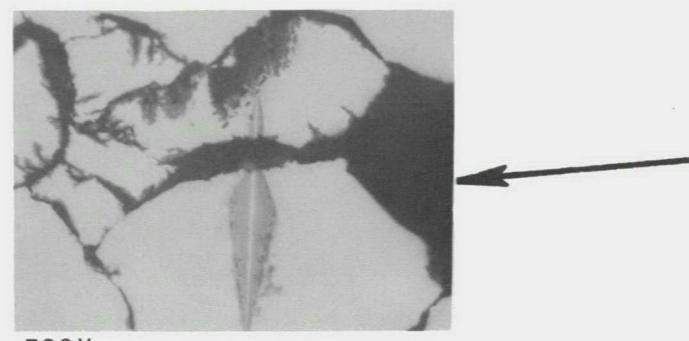
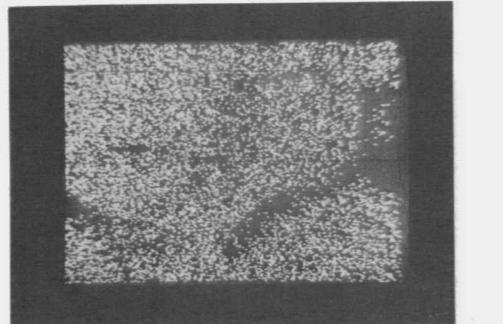
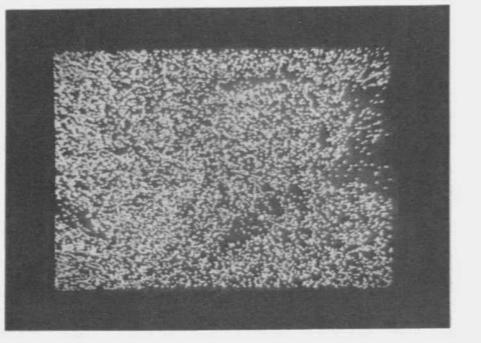
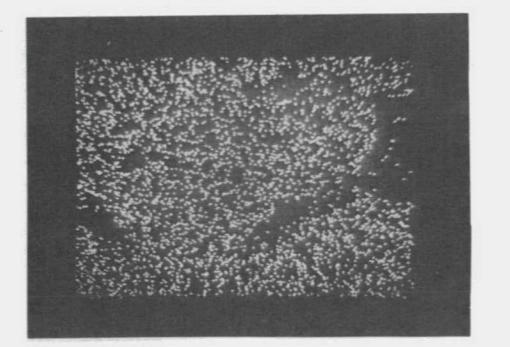
FIGURE 28. SAMPLE #2 - MICROPROBE RESULTS

GREY PHASE
