Iowa Electric Light and Power Company

November 4, 1988 NG-88-3787

Duane Arnold Energy Center Docket No: 50-331 OP License No: DPR-49 LPCI Swing Bus Design Modifications

REVISED DESCRIPTION OF PROPOSED MODIFICATIONS TO THE LPCI SWING BUS DESIGN AT THE DAEC

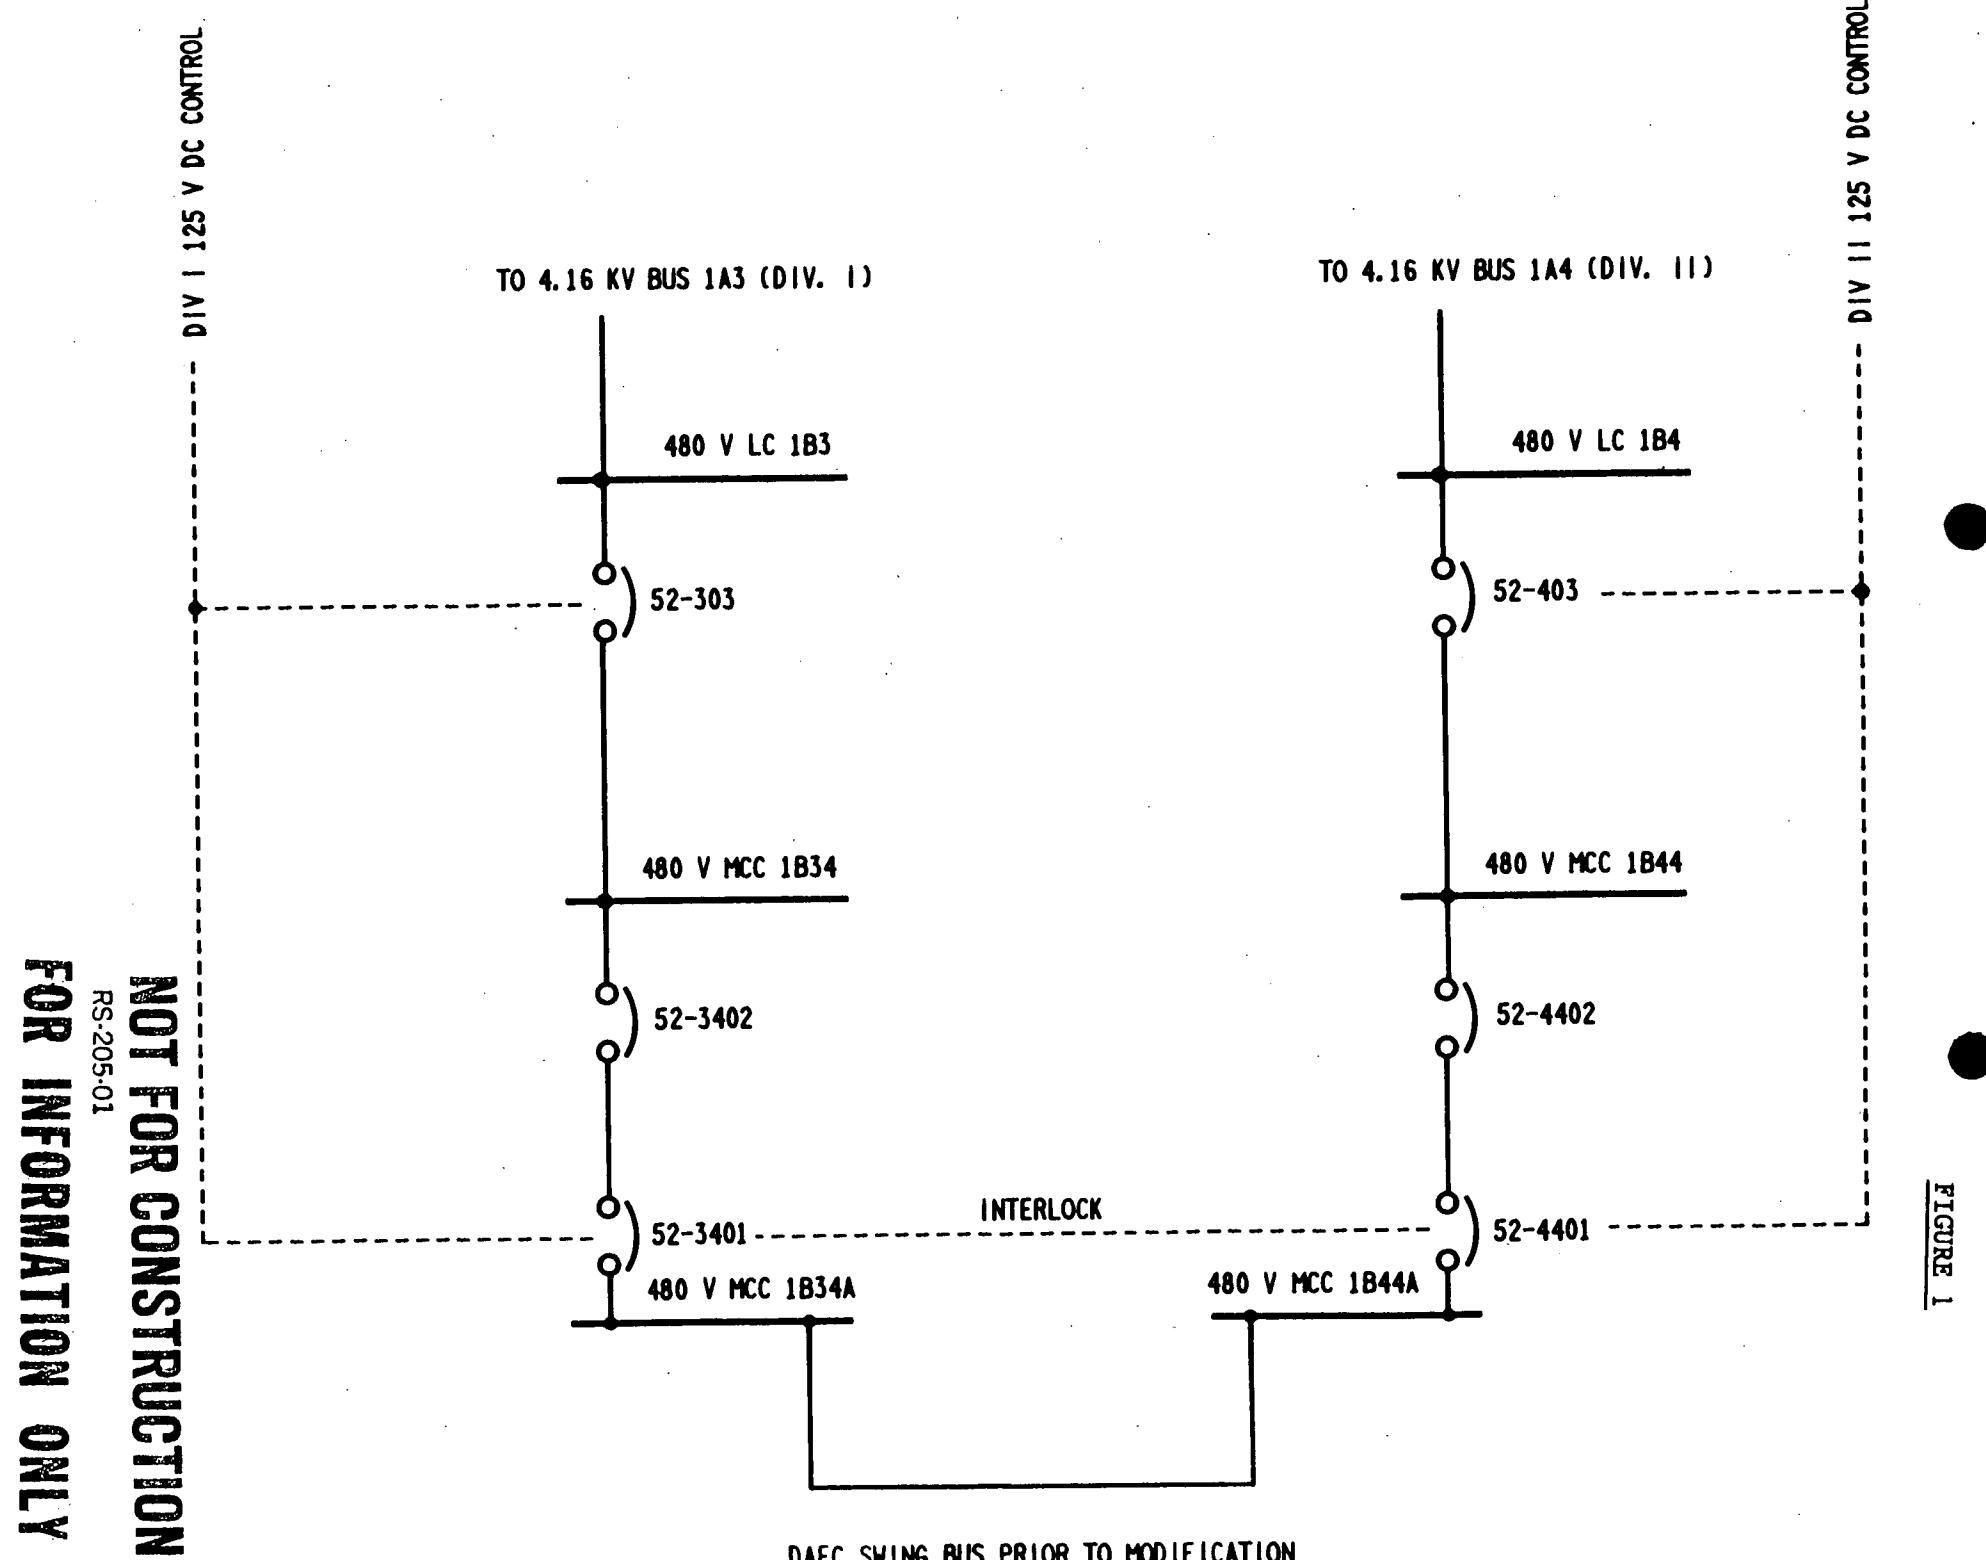
DAEC SWING BUS PRIOR TO MODIFICATION

The existing LPCI swing bus transfer scheme utilizes two (2) electrically interlocked breakers (52-3401 and 52-4401) to accomplish the transfer of electrical power supplying busses 1B34A and 1B44A (see Fig. 1). These two breakers are designed such that busses 1B34A and 1B44A will be powered from the division of the AC distribution system which has power available $(\underline{i.e.}, \text{"power seeking"})$. If both or no divisions are powered, the breakers will remain in their original positions $(\underline{i.e.}, 52-3401 \text{ closed})$ and 52-4401 open). In addition, the interlock feature of these breakers senses the actual breaker position of the corresponding transfer breaker and, therefore paralleling of the two divisions of AC power is not possible ($\underline{i.e.}$, both 52-3401 and 52-4401 cannot be closed simultaneously). Thus, goal 2) is satisfied.

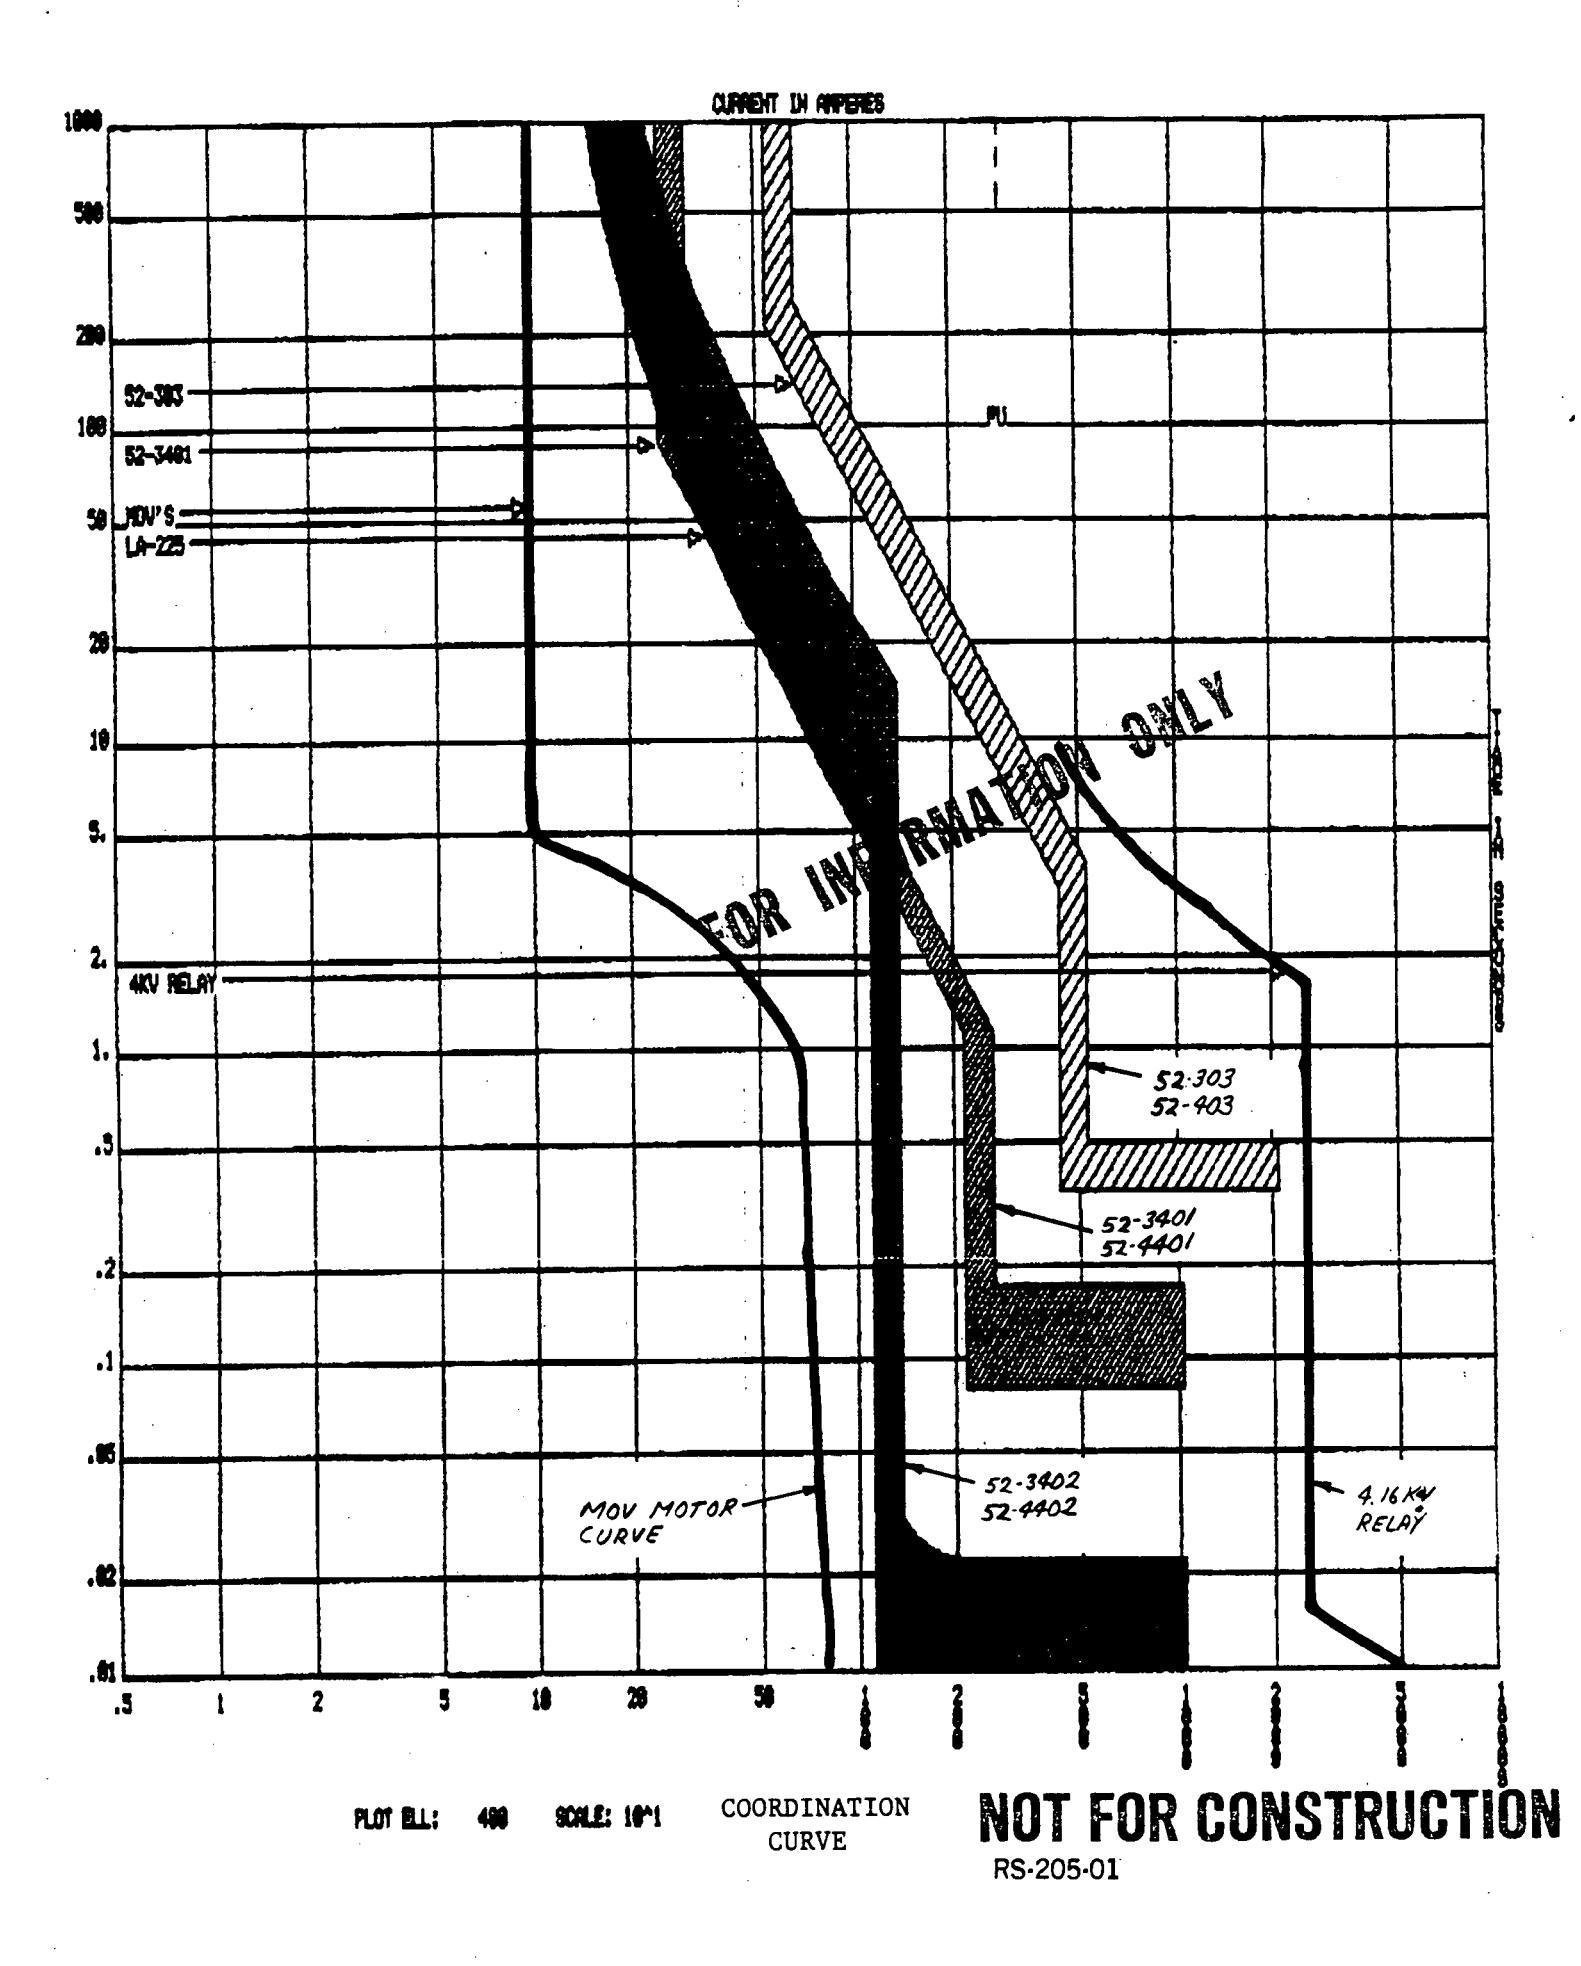
FIGURE 3

The existing maintenance isolation breakers will not coordinate with either the swing bus feeders (52-3401 or 52-4401) or the load center breakers (52-303 or 52-403). Coordination between the maintenance isolation breakers and the load center breakers (52-303 and 52-403) will be achieved by replacing the existing MCBs (52-3402 and 52-4402) with MCBs having a lower rating. It should be noted that the replacement MCBs will not coordinate with ACBs 52-3401 or 52-4401. Efforts are continuing to locate a breaker which will provide improved coordination. However, as of this date, a suitable nuclear-qualified breaker has not been located. The attached coordination plot indicates the coordination available with this revised design. The coordination plot also indicates that the lower rated MCBs will not trip in the event of multiple valve operations, which are required in the event of a Design Basis Accident (DBA). The swing bus loads, consisting of both "A" and "B" loop Reactor Recirculation System isolation valves and two LPCI inject valves, were modeled on the coordination plot as a single curve, which is identified as "MOVs".
