Characterization of Flaws in U.S. Reactor Pressure Vessels

Validation of Flaw Density and Distribution in the Weld Metal of the PVRUF Vessel

Pacific Northwest National Laboratory

NUREG/CR-6471, Vol. 2 PNNL-11143B

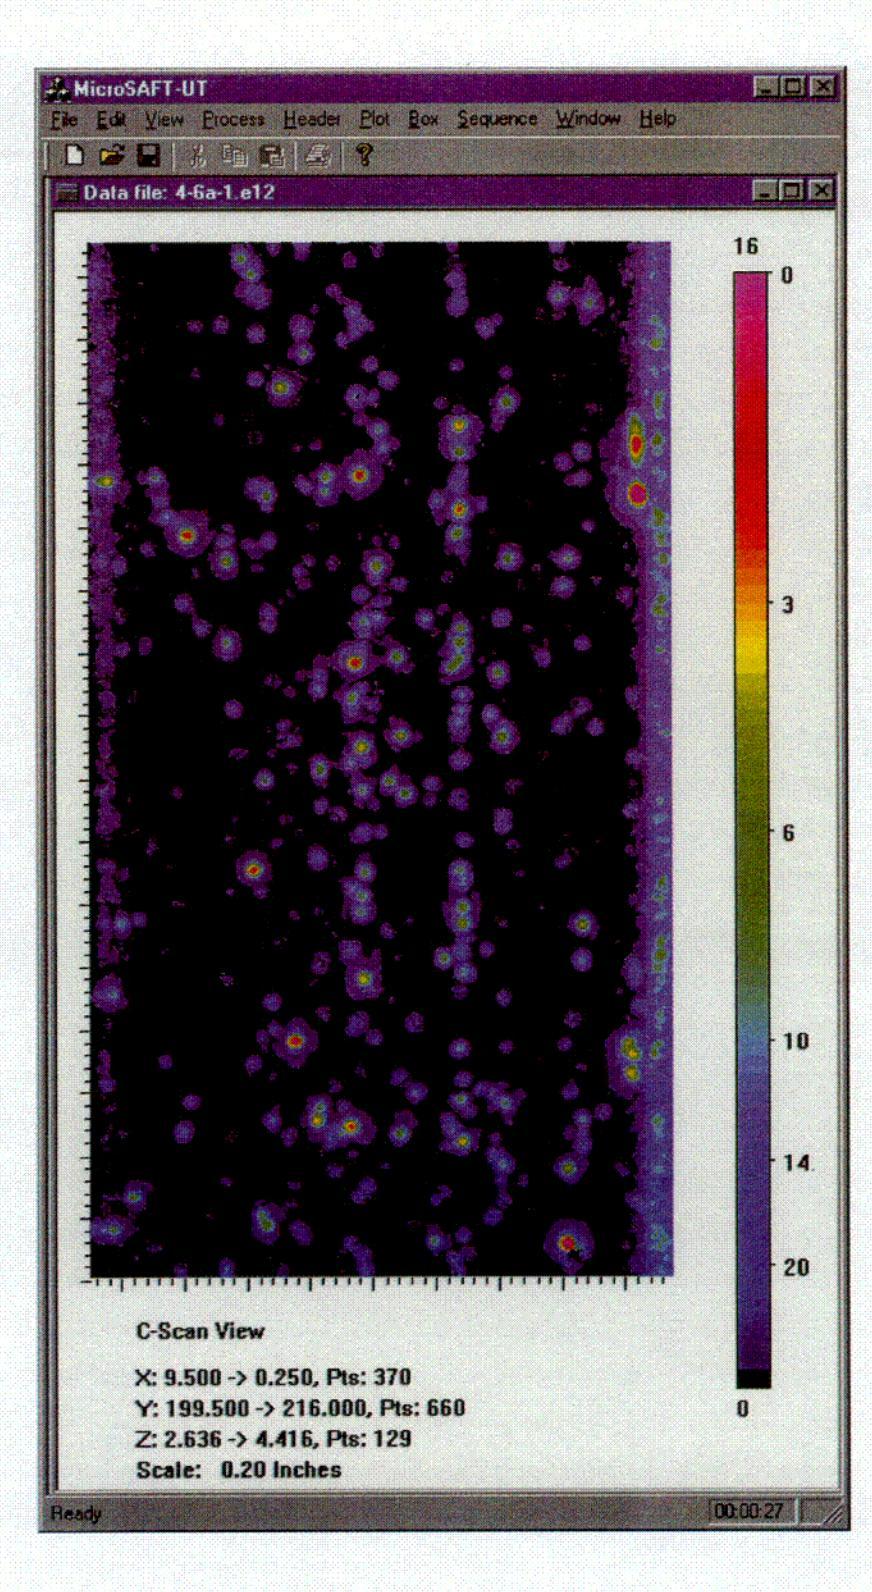
Figure 3.2 C-scan (top view) Image of Small Flaw Indications on the Weld Fusion Surface, from Weld-Normal UT Inspection

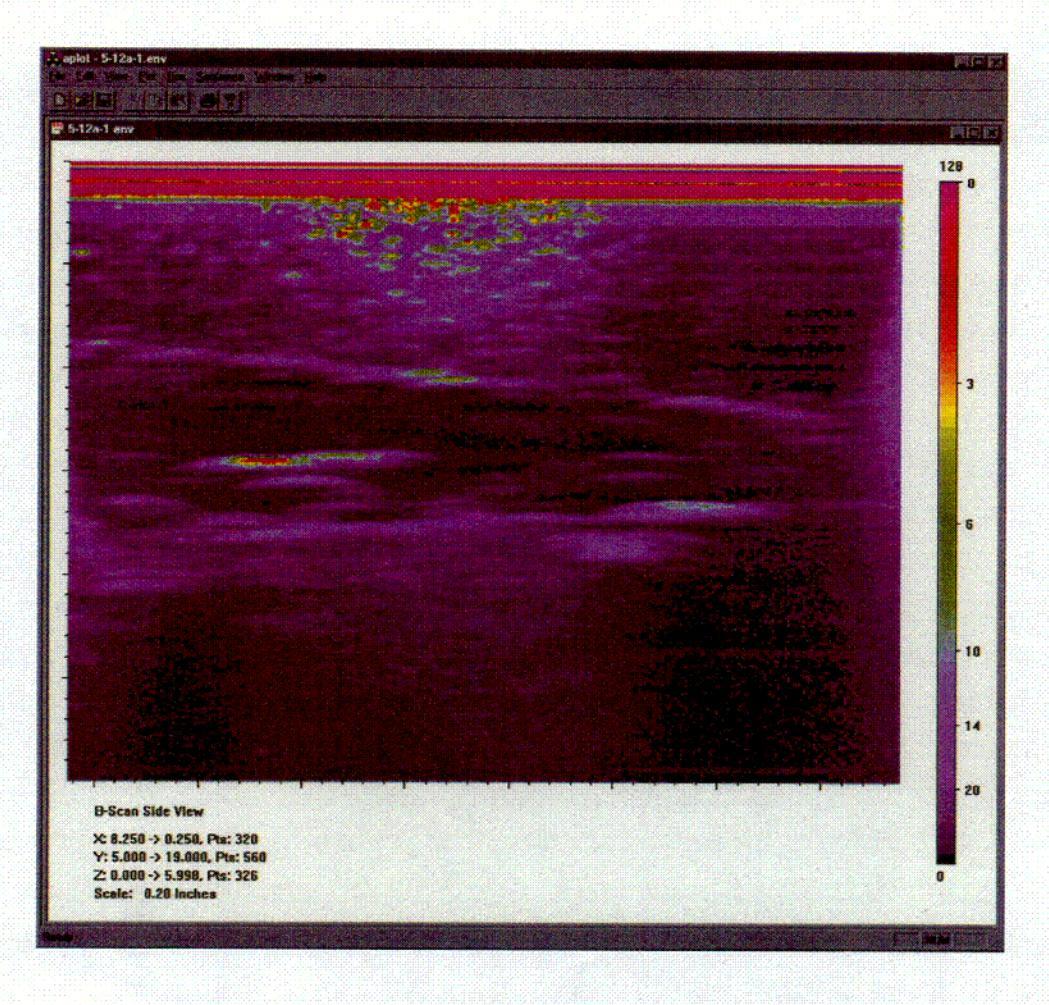
A minor number of flaw indications was found between the weld beads of the machine-made weld metal. Figure 3.3 is similar to Figure 3.1 except that in this case a flaw indication is evident within the weld instead of along the fusion surface.

Figure 3.3 UT Image Showing Weld Profile with Weld Flaw Indication

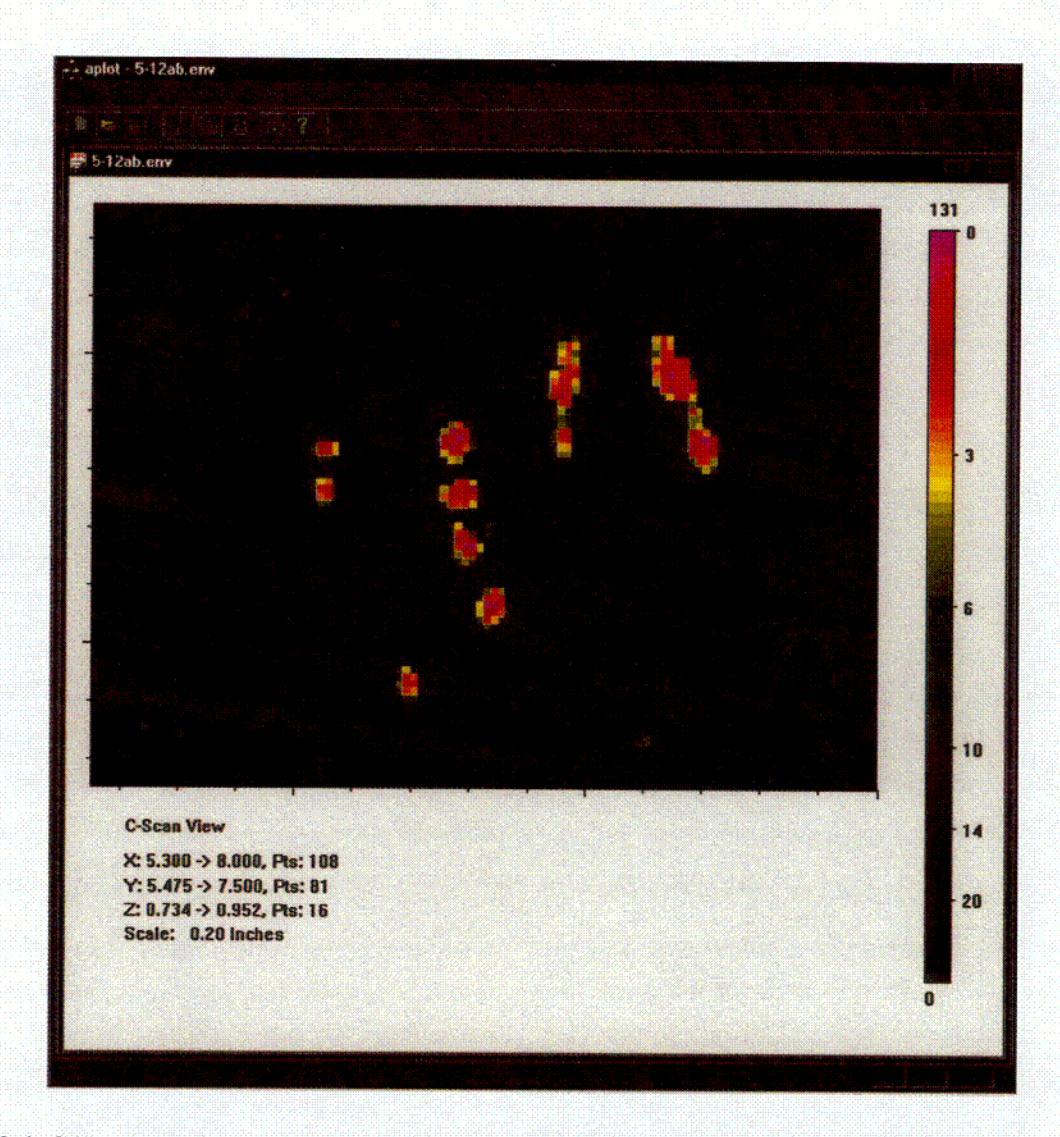
Figure 3.4 SAFT-UT Inspection of a Large Cluster of Weld Flaws in the Mid-Wall Portion of the Vessel Beltline Weld. The through-wall direction, vessel "Z", is on the abscissa and labeled as X: 5.475 -> 8.000 inches in the image. The distance along the beltline weld, vessel "Y", is on the ordinate and labeled as Y: 5.475 -> 7.500 inches.

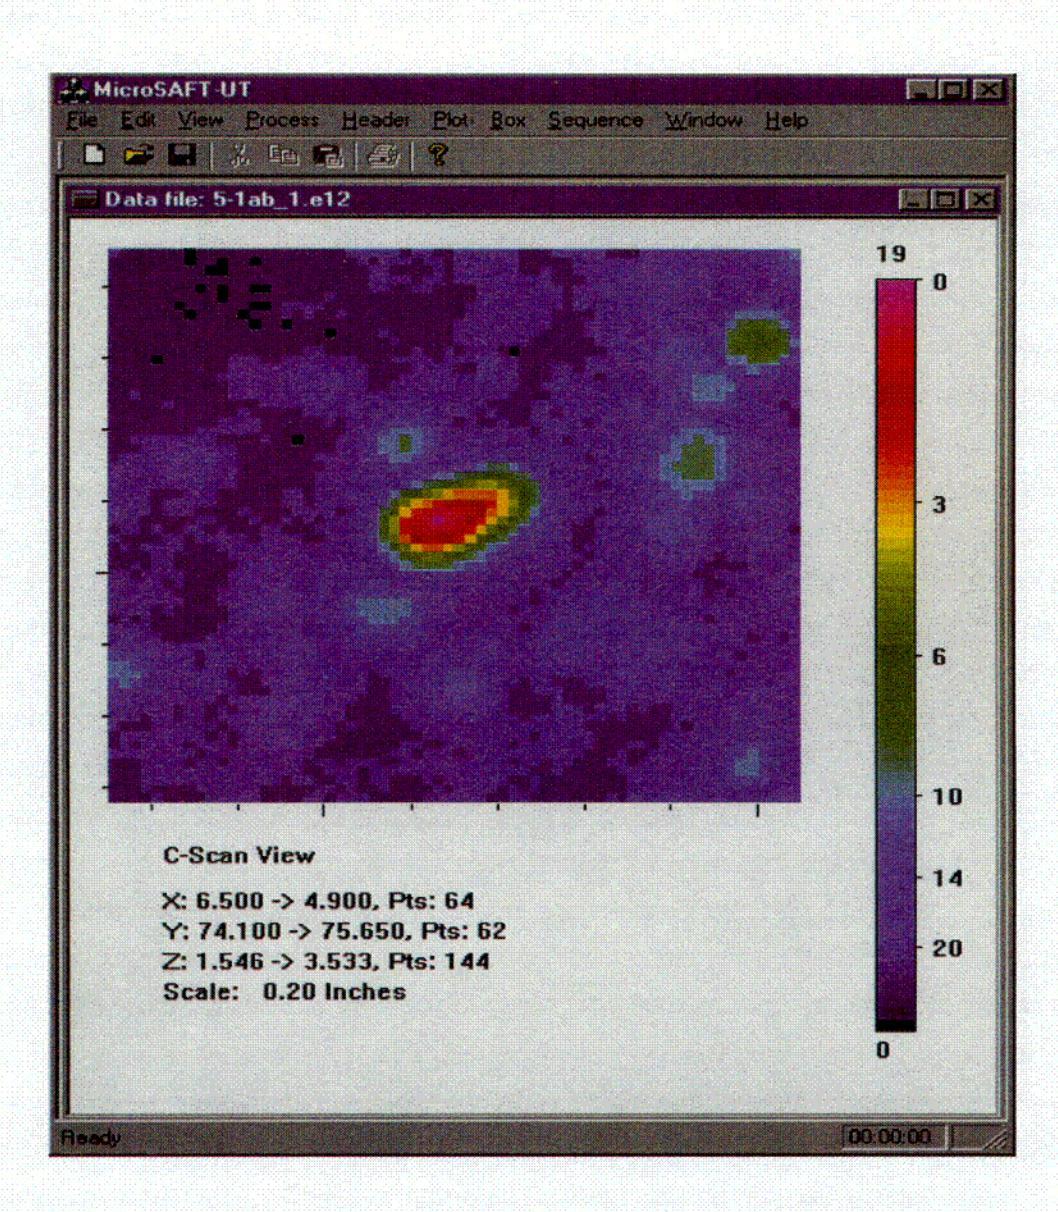
Figure 3.5 Weld-Normal UT Image of Flaw Indication Characterized as Extended Lack of Fusion. Clad is to the right in the figure.

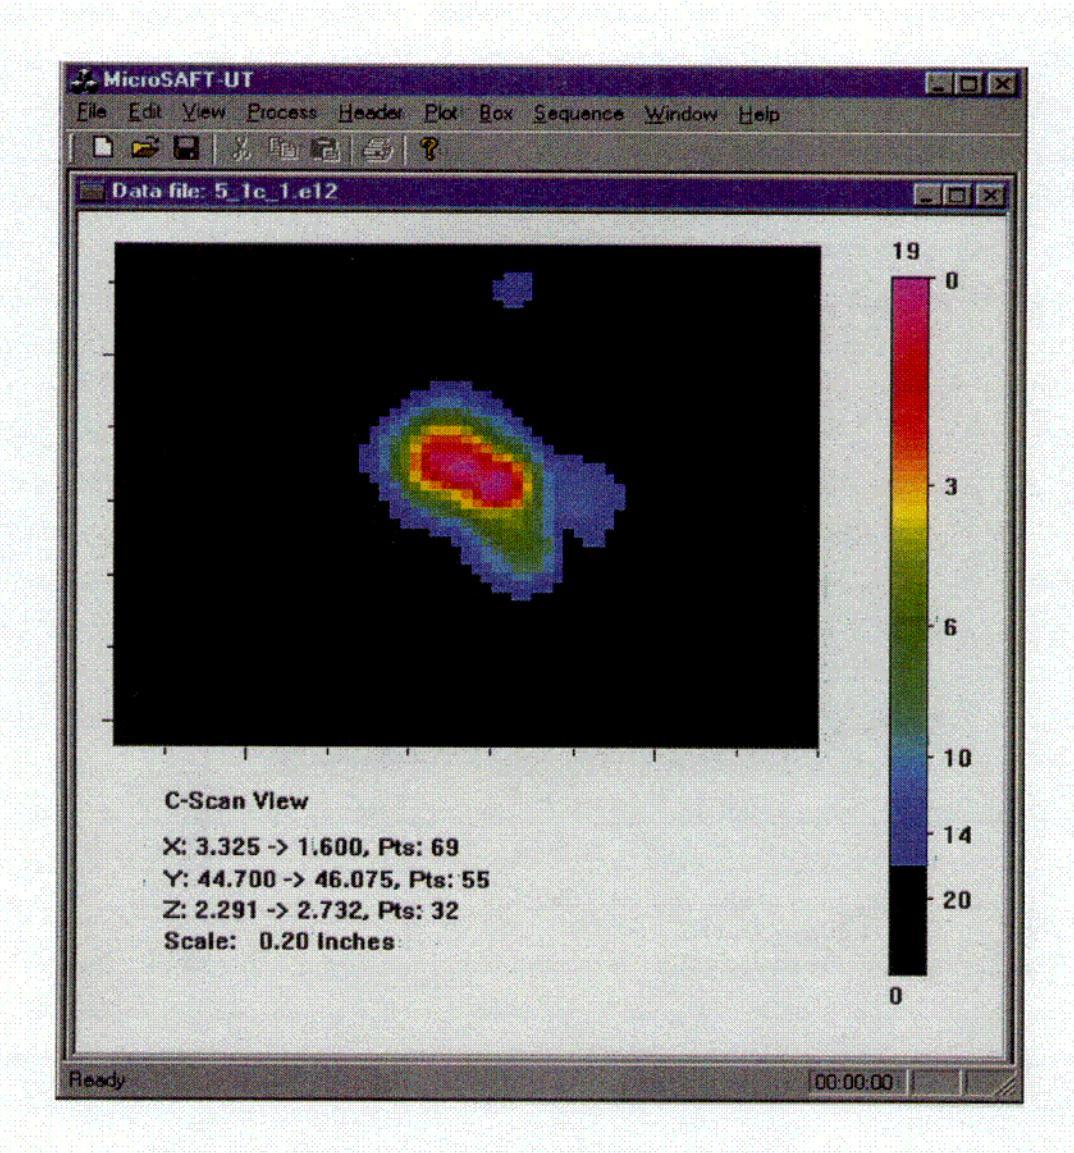
Figure 3.6 Weld-Normal Flaw Indication Characterized as Extended Lack of Fusion. Clad is to the right in the figure.

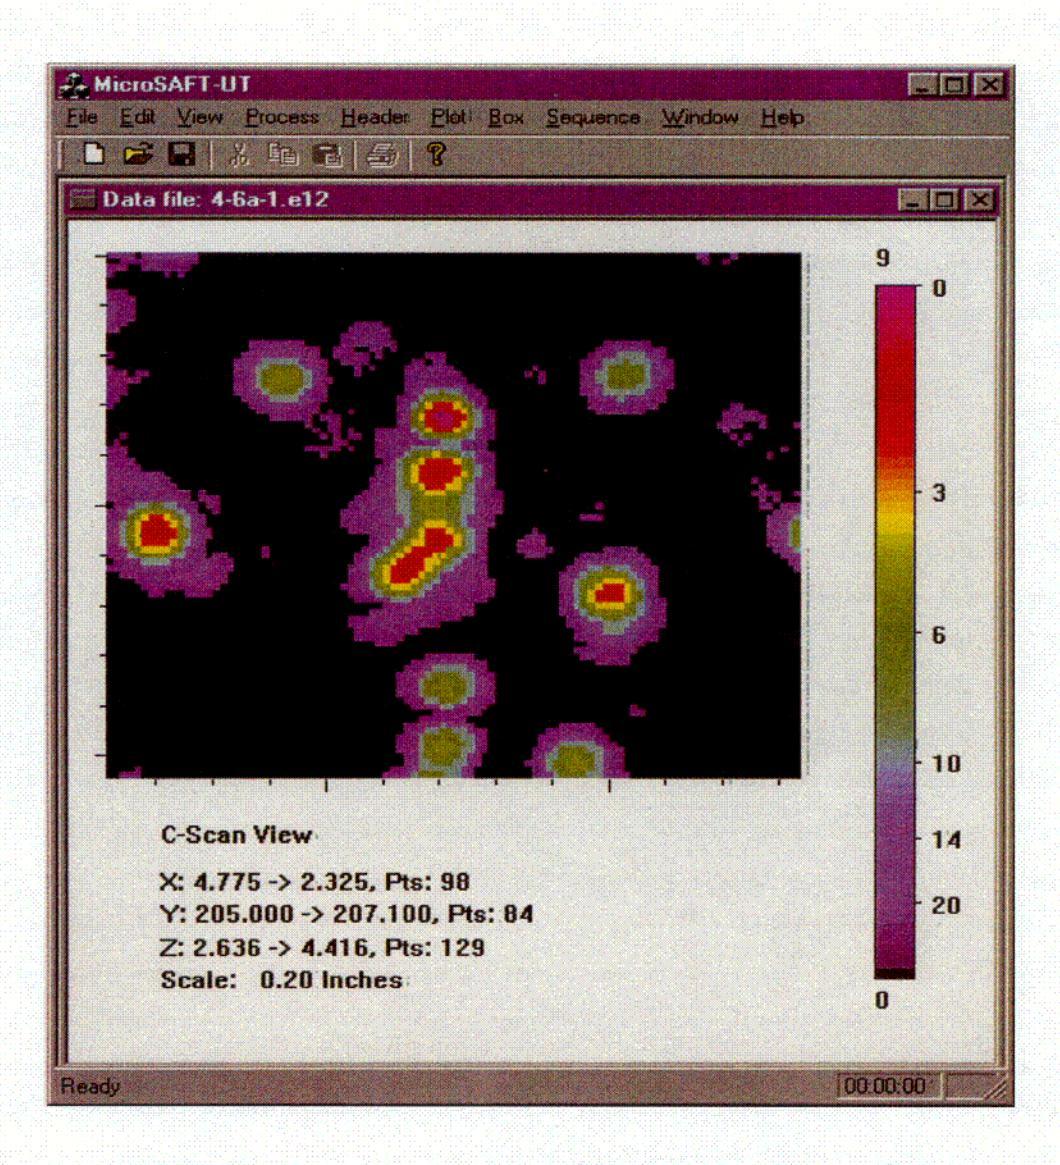
Figure 3.7 Weld-Normal Ultrasonic Testing Flaw Indication Characterized as Long Lack of Fusion. Clad is to the right in the figure.

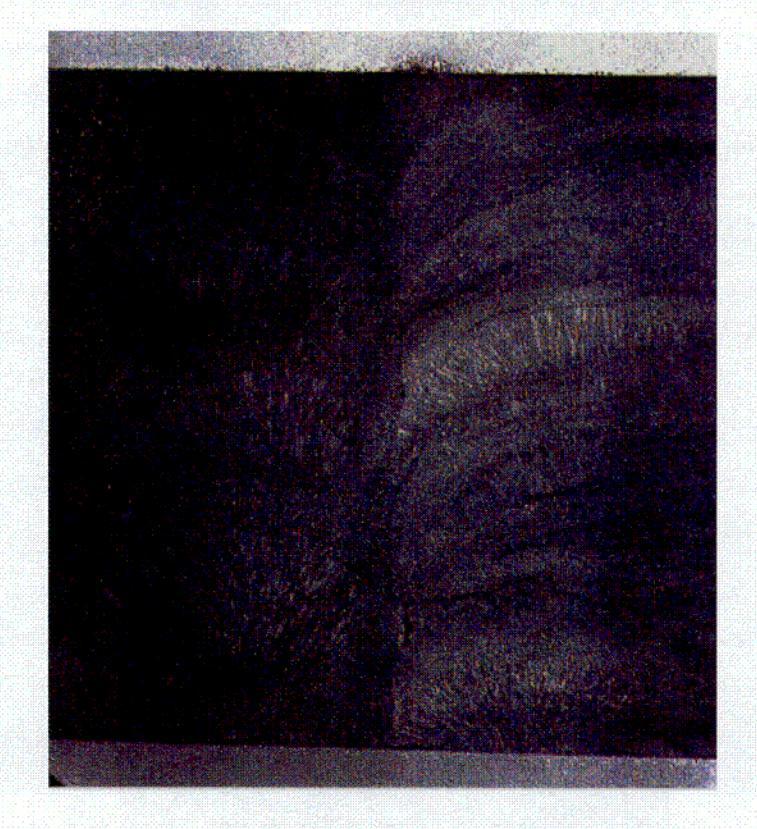
Figure 3.54 Micrograph of 25-mm Cube Showing a Portion of a Large Cluster of Small Weld Flaws. The flaws occur between the weld beads, and the alignment of the flaws follows the alignment of the weld beads.

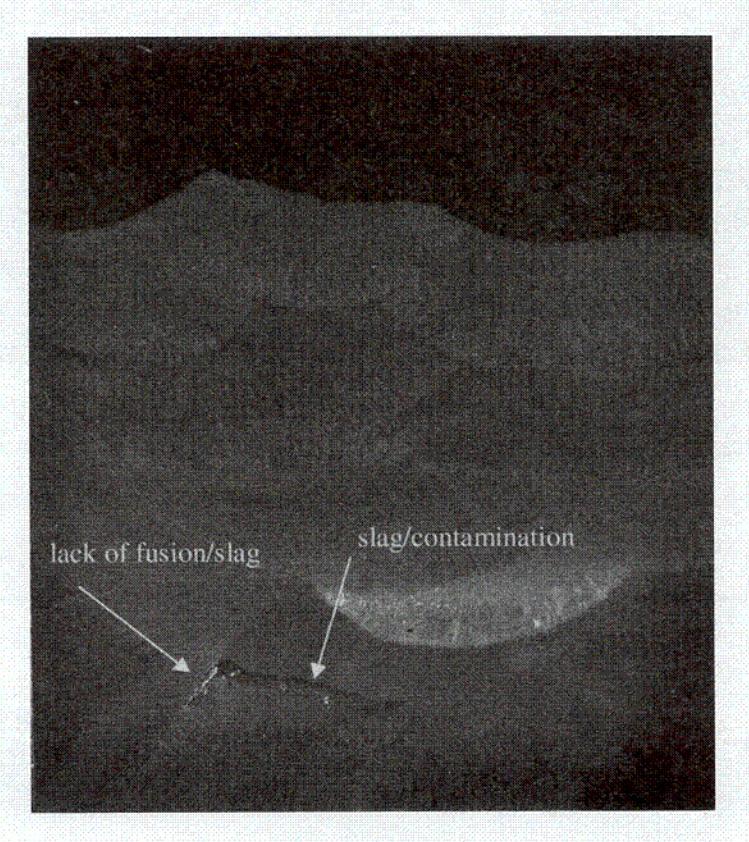
Figure 3.63 Micrograph of Cube 5-10EB1-IIbIIc Showing Complex Flaw Above First Tandem Arc Weld Passes

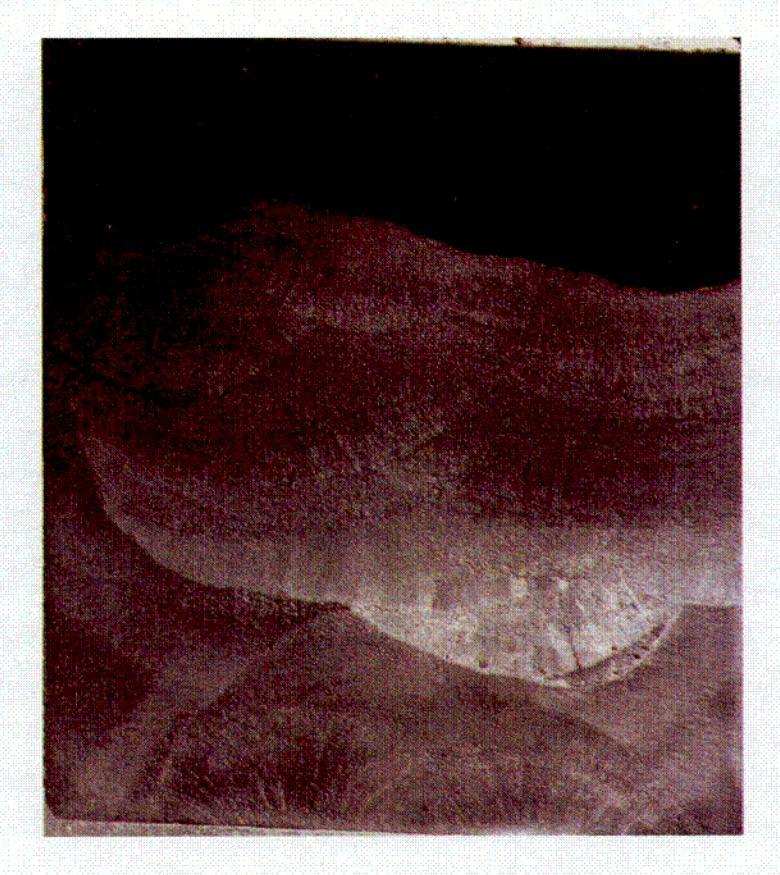
Figure 3.65 Micrograph of Cube Showing Failed Weld Bead

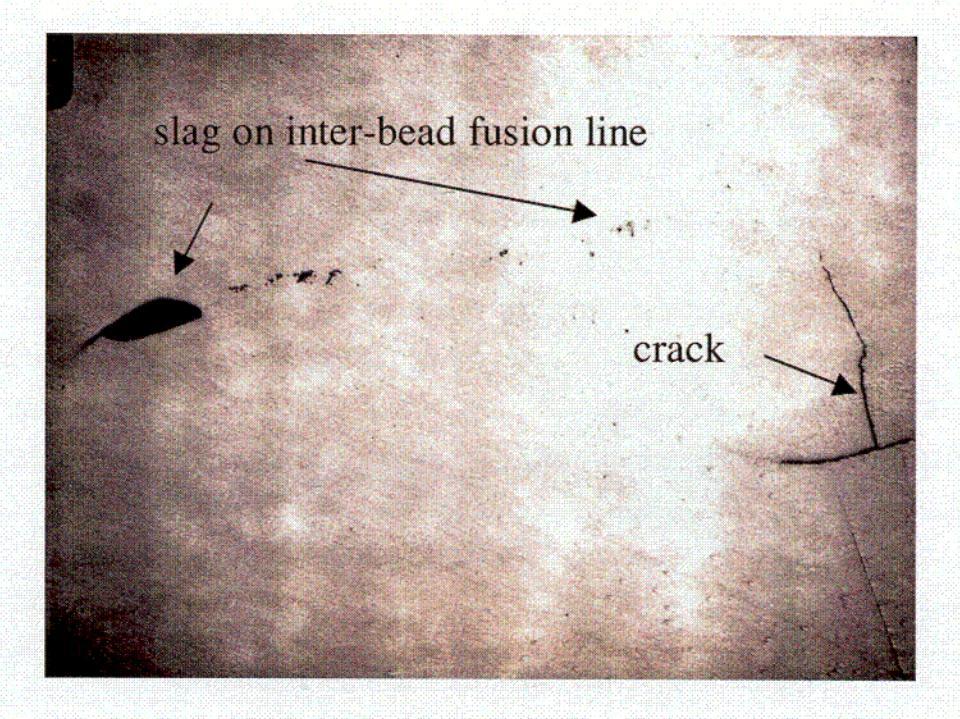
Figure 3.66 Micrograph of Cube 5-10EB1-IIbIIc Showing Flaws in the First Weld Pass of the Back-Fill

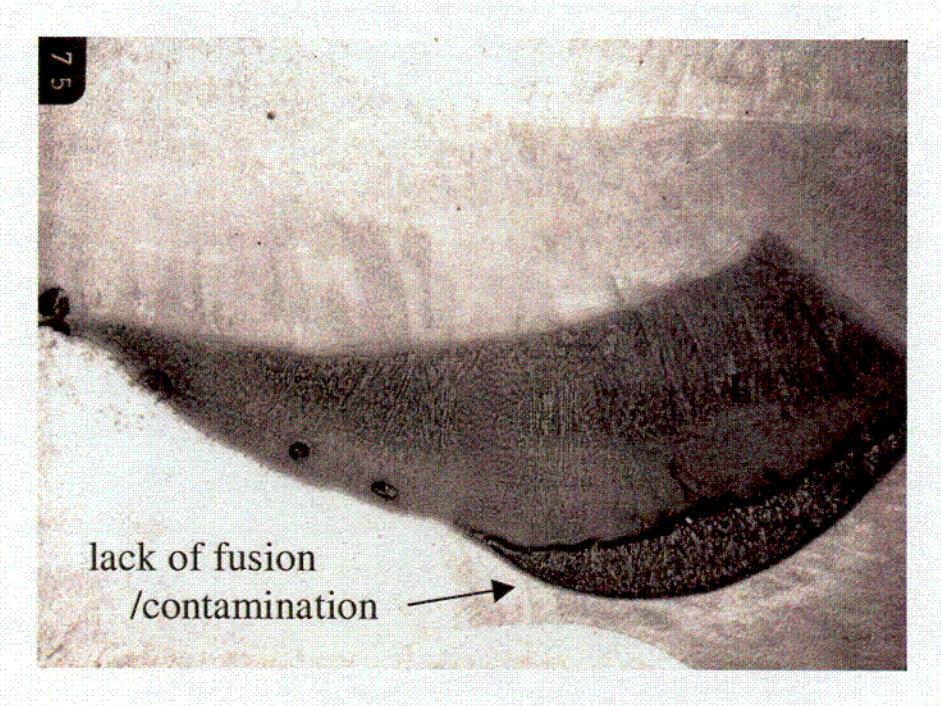
Figure 3.67 Micrograph of Cube 5-10EB1-IIbIIc Showing Contamination of the First Weld Pass of the Back-Fill

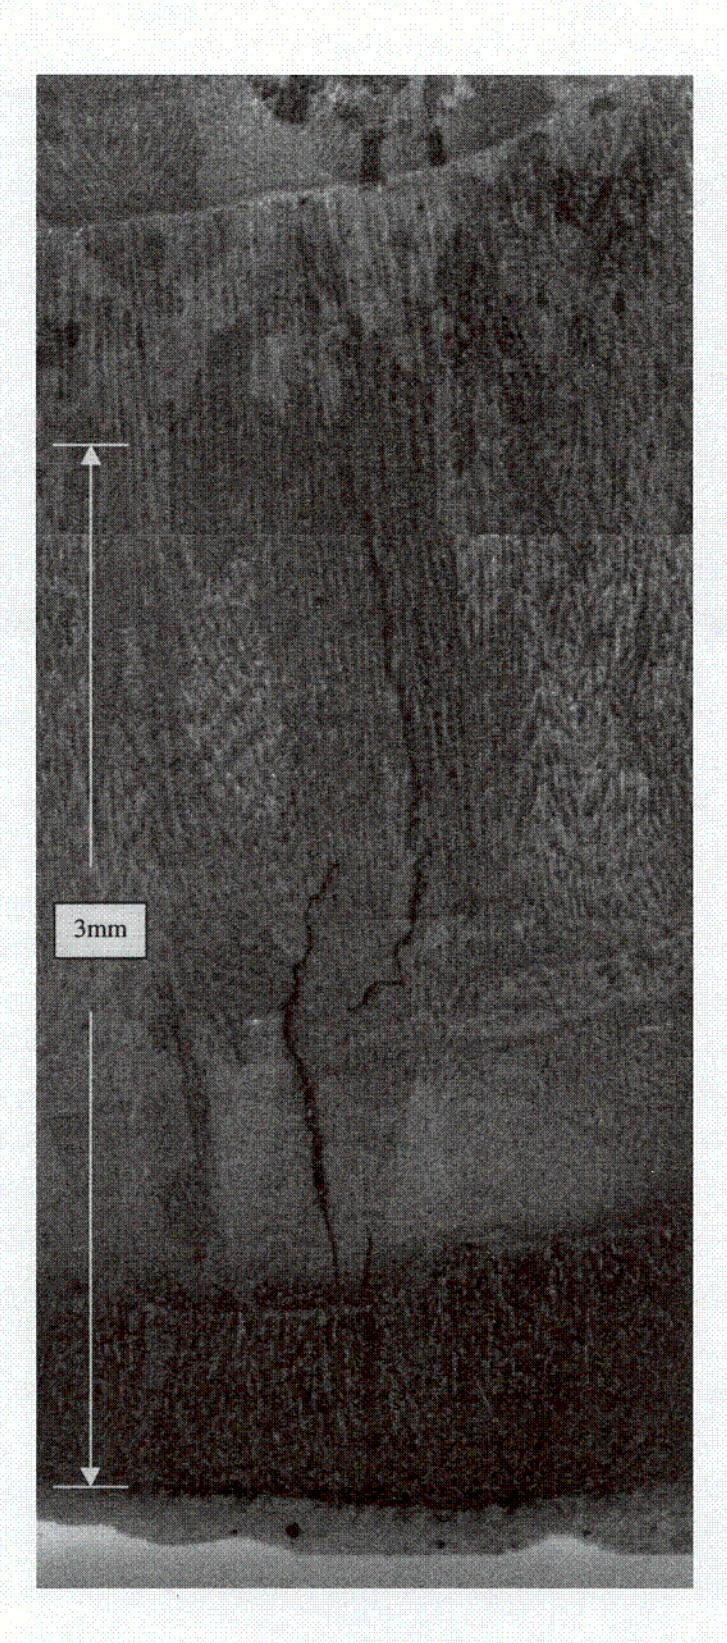
Figure 3.68 Micrograph of Crack in Flawed Weld Bead, Near Surface Zone of PVRUF

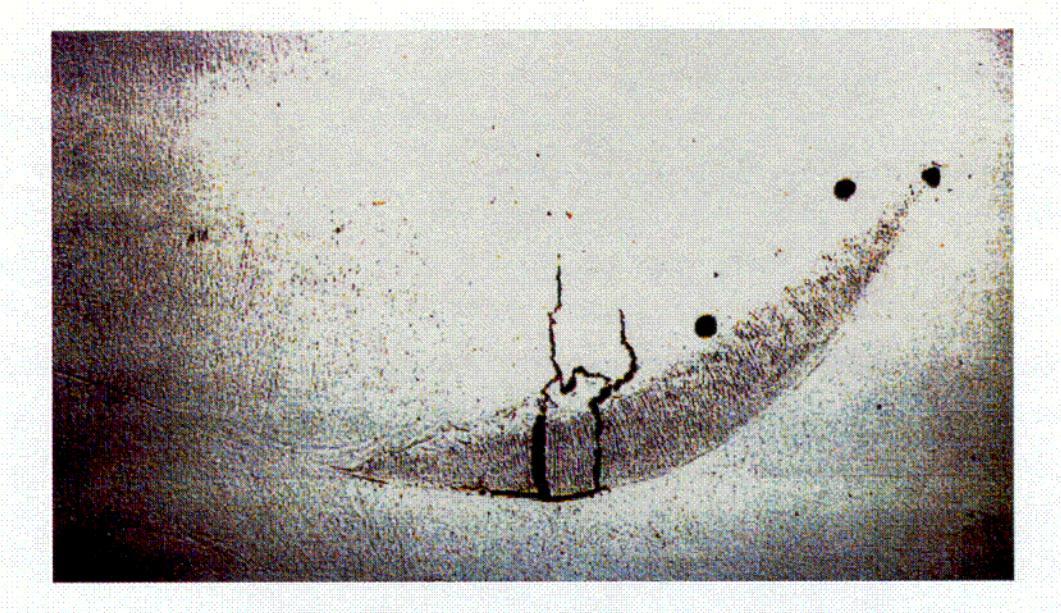
Figure 3.69 Micrograph of Cracked Weld Bead

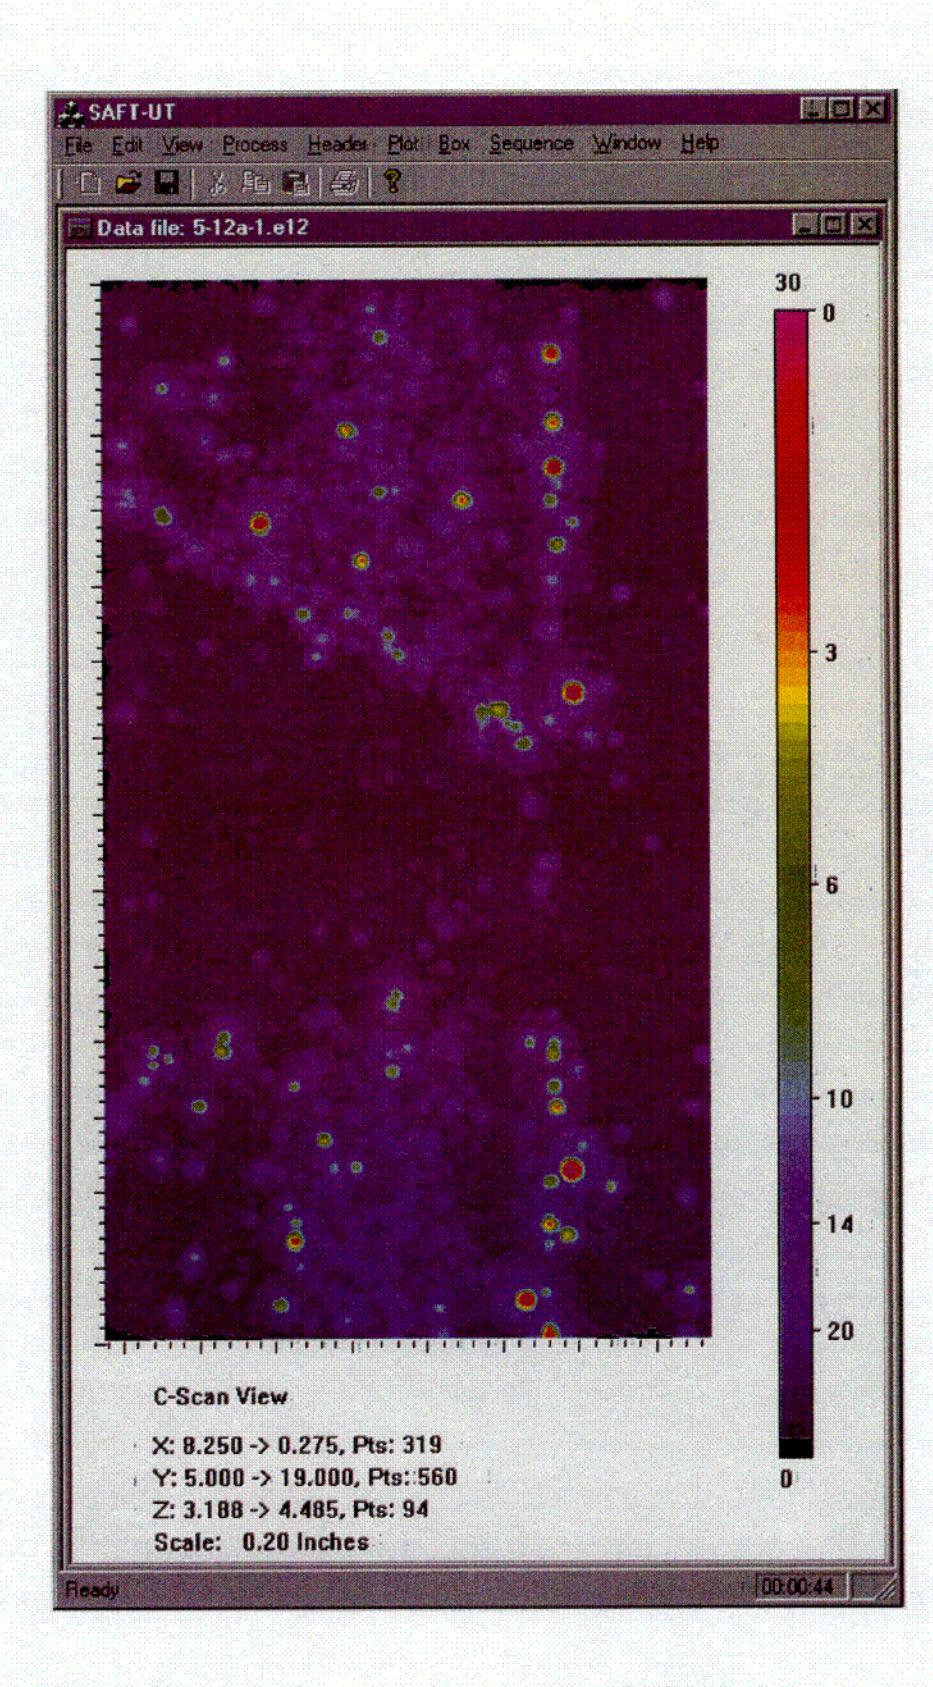
Figure 3.70 Weld-Normal UT C-scan Image of Weld Fusion Surface Showing Profile of Weld Repair's Low Acoustic Energy Signature

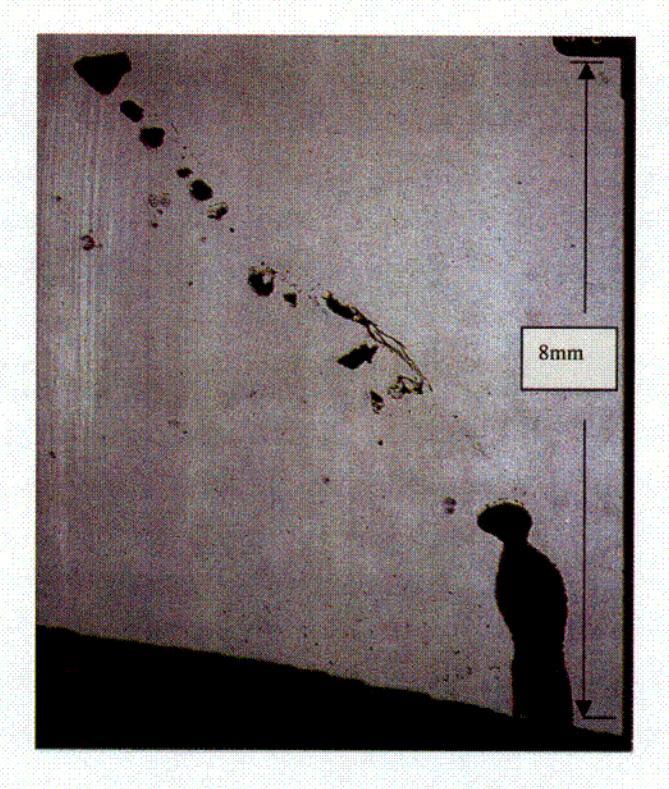
Figure 3.73 Micrograph Showing a Magnified View of a Portion of the 17-mm Flaw. A crack-like portion of the flaw is visible in this figure.

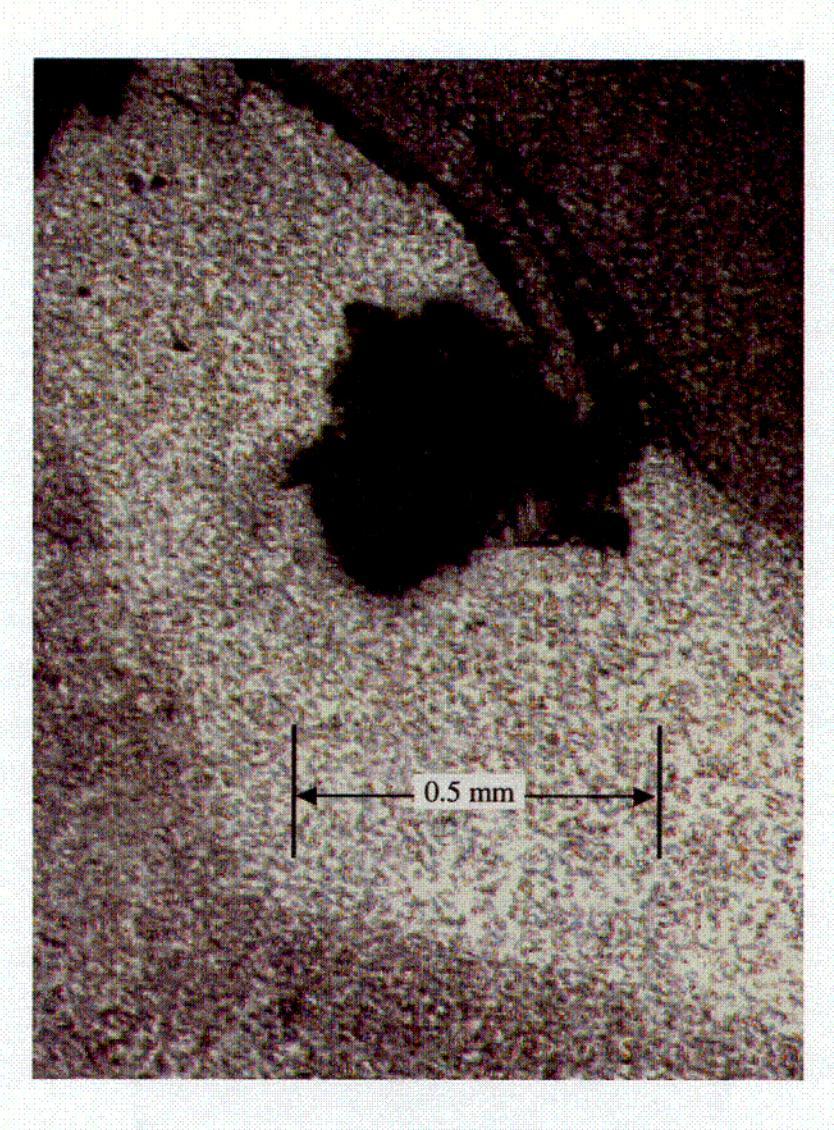
Figure 3.74 Micrograph Showing a Magnified View of the Crack-like Portion of the 17-mm Flaw. The crack originates from a small region between weld beads.

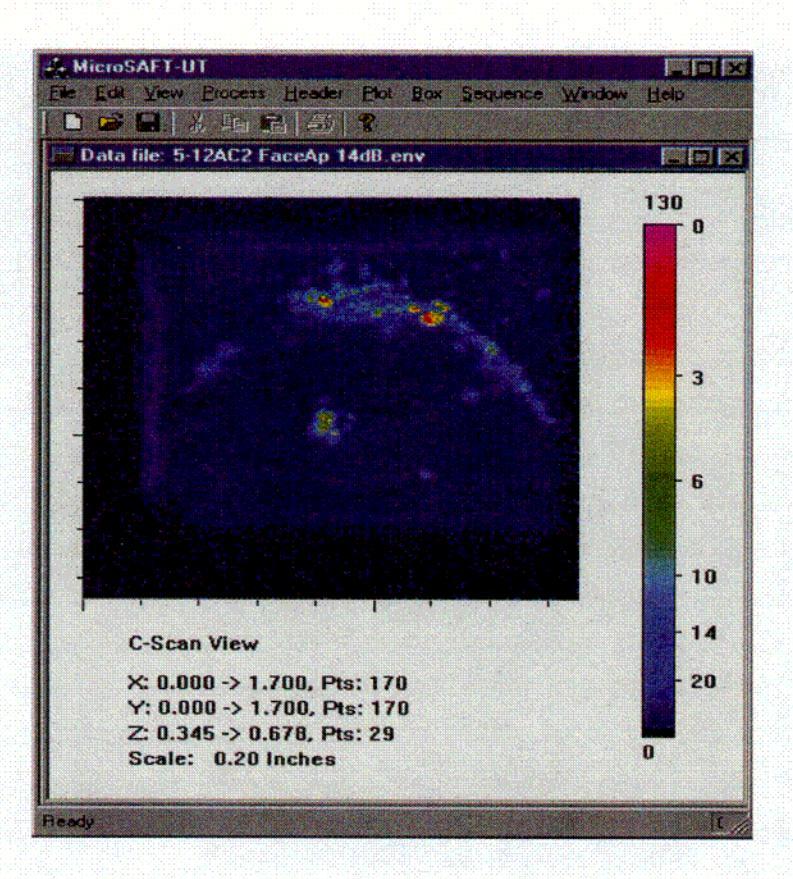
Figure 3.75 Focused Ultrasound (10-MHz Probe) Result Showing Top View of Flaw in 5-12AC2. This is a repair flaw located on the end of the repair. Vessel through-wall direction is into the page. Distance from weld center is on the abscissa. Distance along the beltline weld is on the ordinate. This image shows that the flaw is oriented principally in the axial direction.

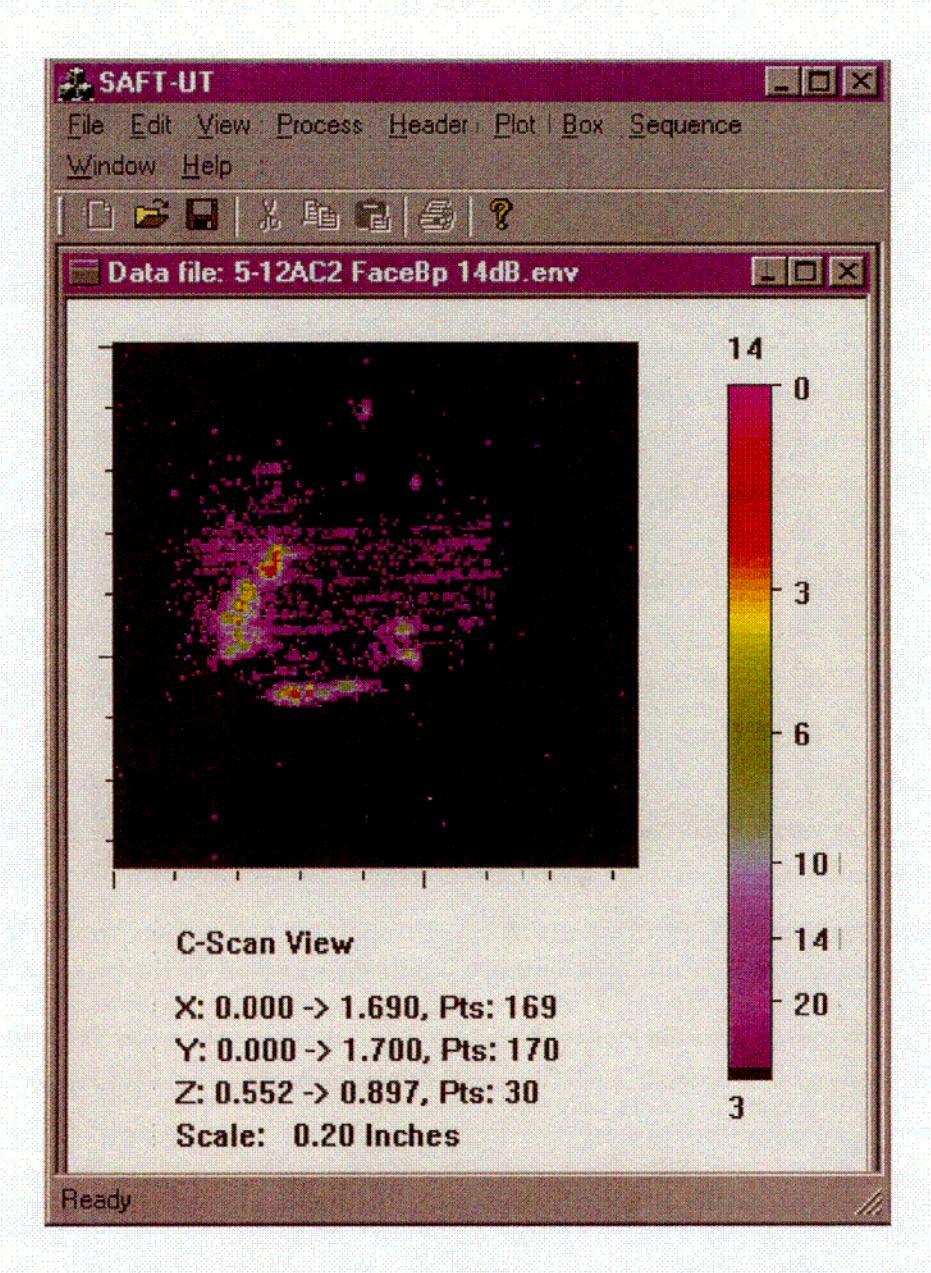
Figure 3.76 Focused Ultrasound (10-MHz probe) Result Showing Side View of Flaw in 5-12AC2. This is a repair flaw located on the end of the repair. Vessel through-wall direction is on the ordinate. Distance from weld center is into the page. Distance along the beltline weld is on the abscissa.

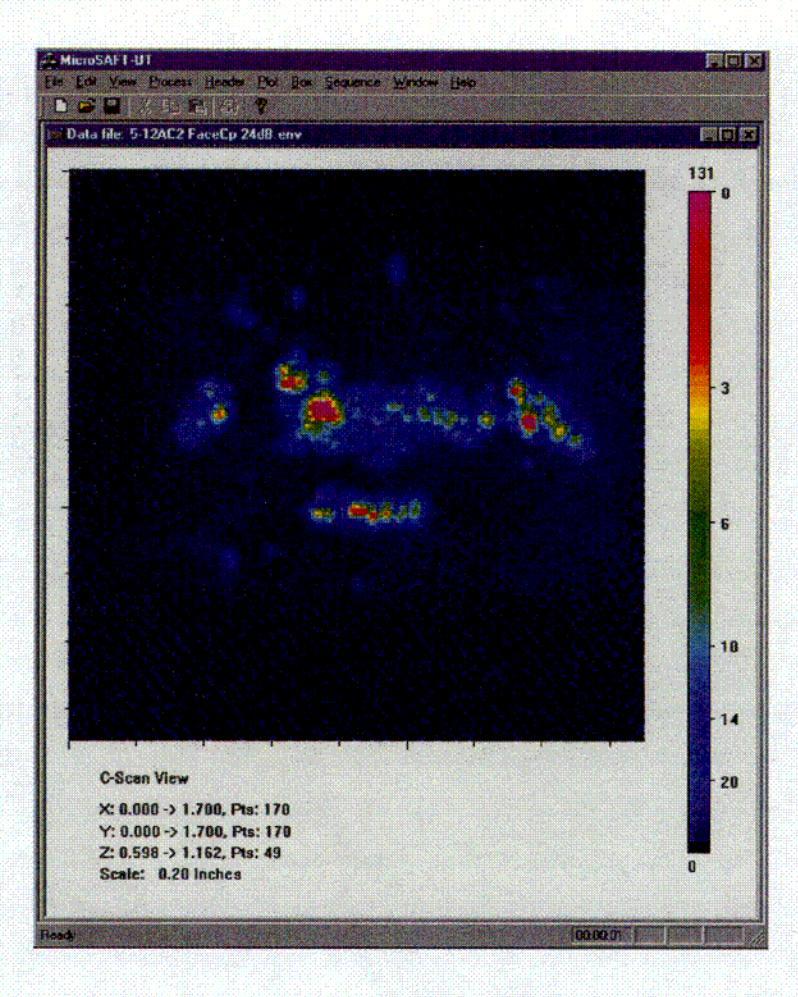
Figure 3.77 Focused Ultrasound (10-MHz probe) Result Showing End View of Flaw in 5-12AC2. This is a repair flaw located on the end of the repair. Vessel through-wall direction is on the ordinate. Distance from weld center is on the abscissa. Distance along the beltline weld is into the page.

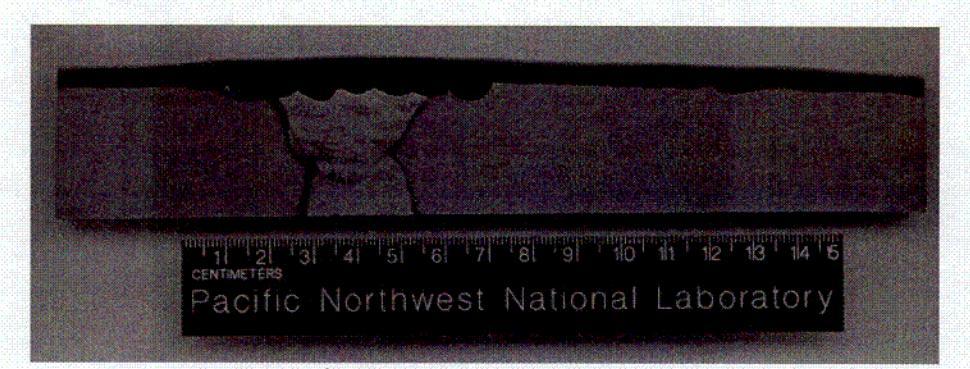
Figure 3.78 Micrograph of Upper Portion of Weld in PVRUF Specimen 5-6Eca. A weld repair, made from inside the vessel, was reported at this location. The repair was not detected.

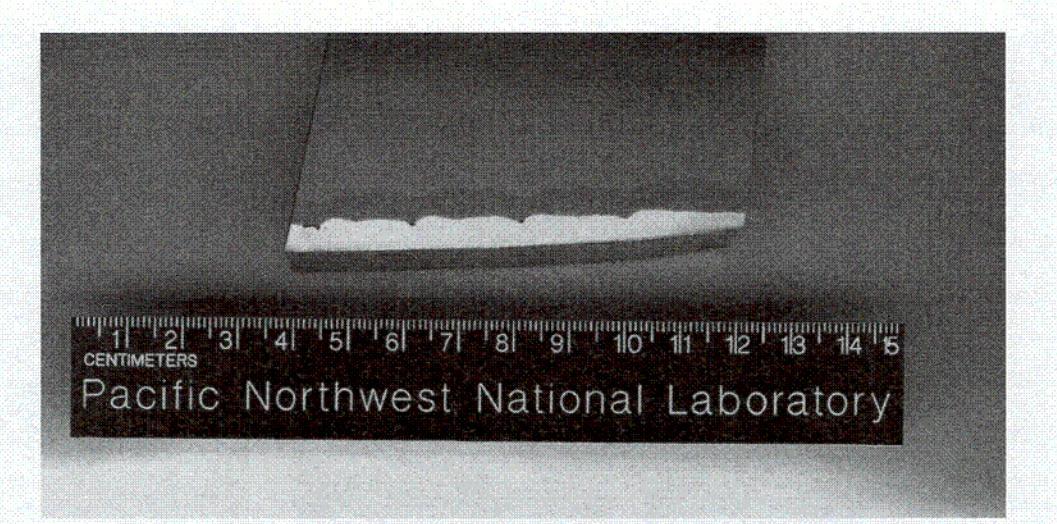
Figure 3.79 Photograph of PVRUF Specimen Showing Small Slag Inclusions at the Clad-to-Base Metal Interface.
