MONTICELLO NUCLEAR GENERATING PLANT Docket No. 50-263 License No. DPR-22

Licensee Event Report to the NRC Crack Indications in Recirculation Bypass Piping

Crack Indications in Recirculation Bypass Piping

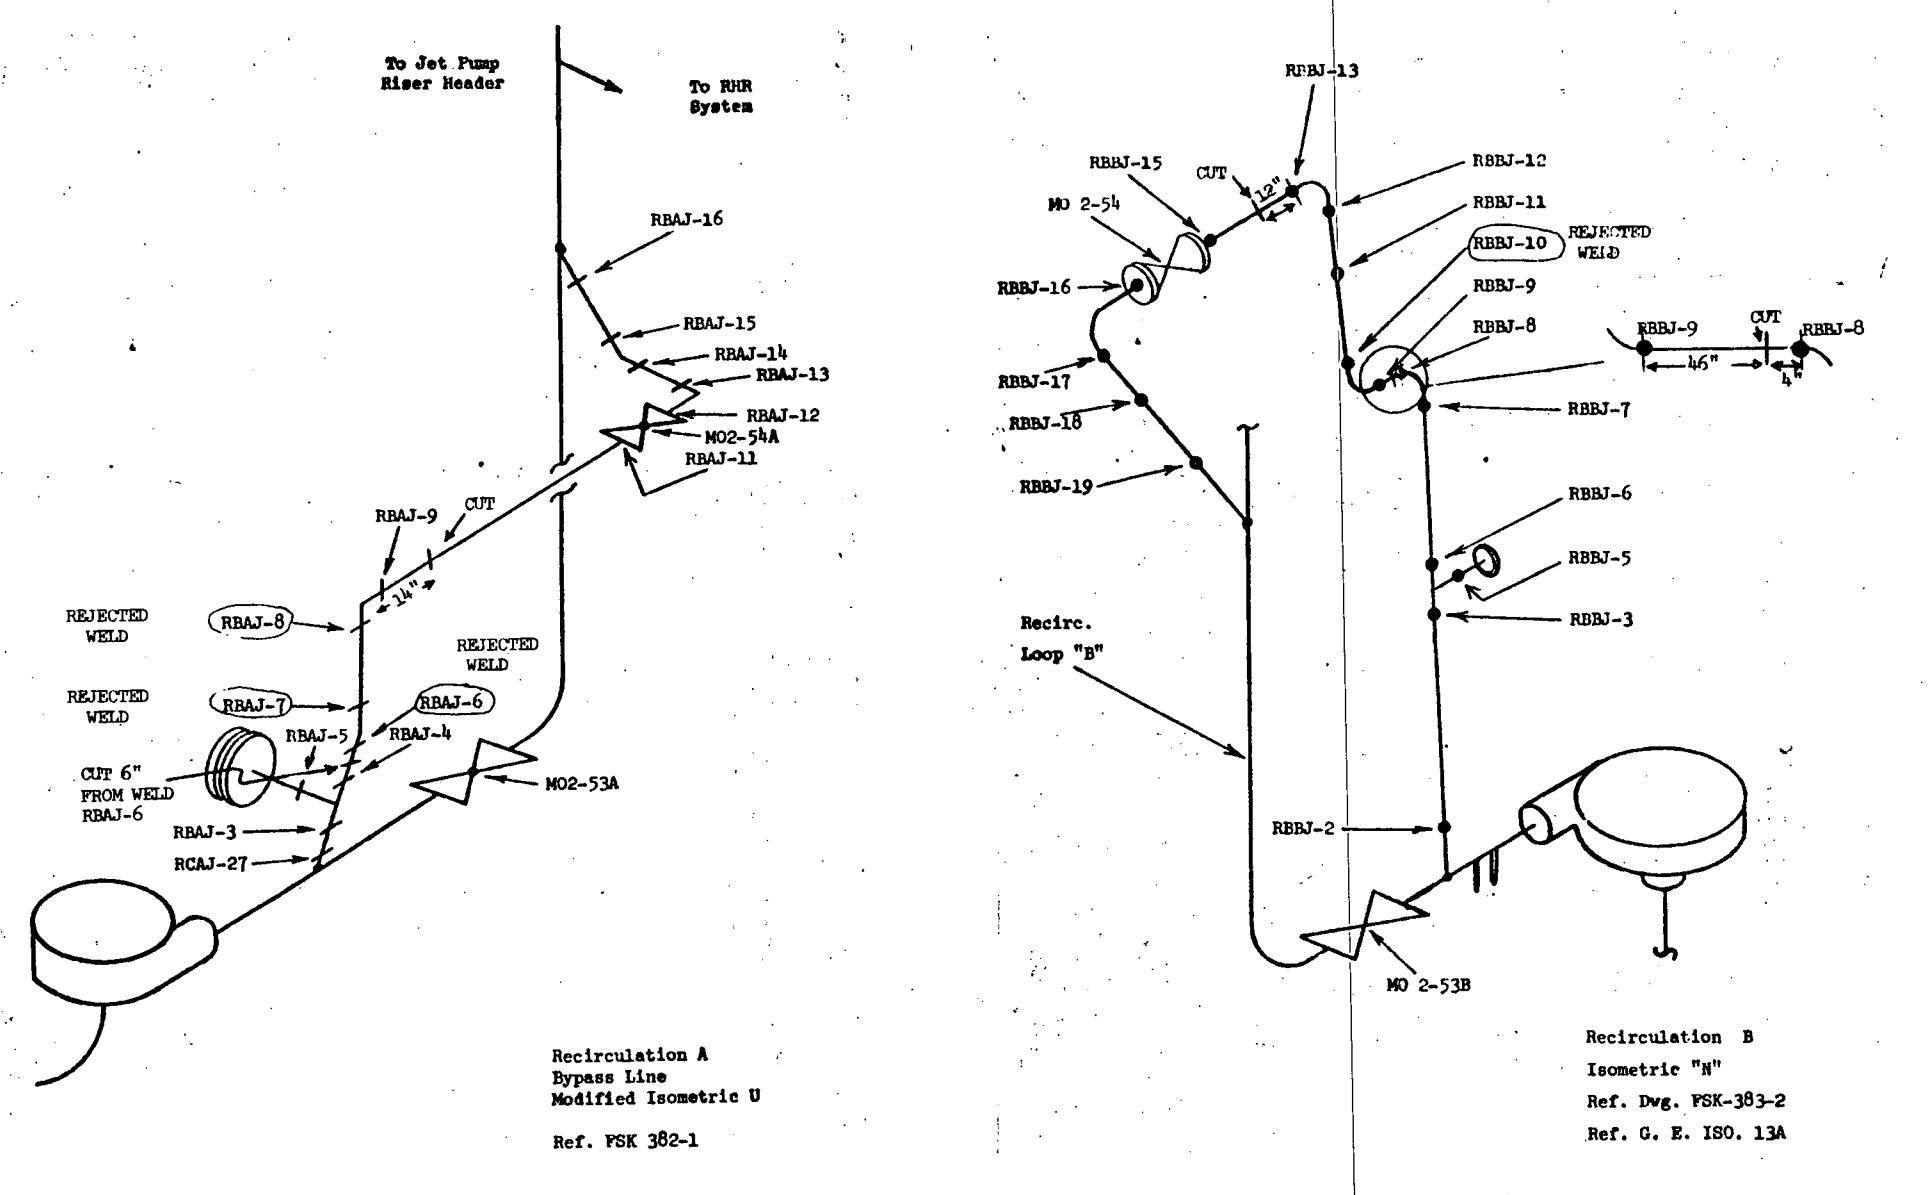
On January 20, 1975, during the inservice inspection of the reactor coolant system, linear indications were detected by ultrasonic examination in two welds in loop A and one weld in loop B of the reactor recirculation system 4-inch diameter bypass lines. Radiographic examination of these three welds definitely verified the presence of a linear indication in one of these welds. The radiograph showed the indication to be located in the weld heat-affected zone.

After a thorough review and study of all of the ultrasonic recordings and comparing inspection results obtained in November, 1974, with the present results, a fourth weld became a suspect. This weld was located in loop A. Although the amplitude of the ultrasonic signal for this weld was relatively low, the signal pattern was similar to the three welds that were rejected; therefore, this weld was also rejected (see attached Figure).

The cause is unknown. It appears to be a generic problem similar to problems experienced at other BWR facilities. Identical inspections performed in November, 1974, revealed no unacceptable indications in these same welds. Indications which were detected in the November inspection were of a magnitude and nature such that they were indiscernible from the weld root I.D.

Segments of both pipe loops which contain the four rejected welds are being removed and replaced. This piping (schedule 80, type 304 stainless steel) will be sent to a laboratory for metallurgical examination.
