NORTHERN STATES POWER COMPANY  
Minneapolis, Minnesota 55401

April 19, 1973

MONTICELLO NUCLEAR GENERATING PLANT  
Docket No. 50-263 License No. DPR-22  
RHR Service Water Pump Seal Problem

RHR SERVICE WATER PUMP  
SEAL WATER ARRANGEMENT

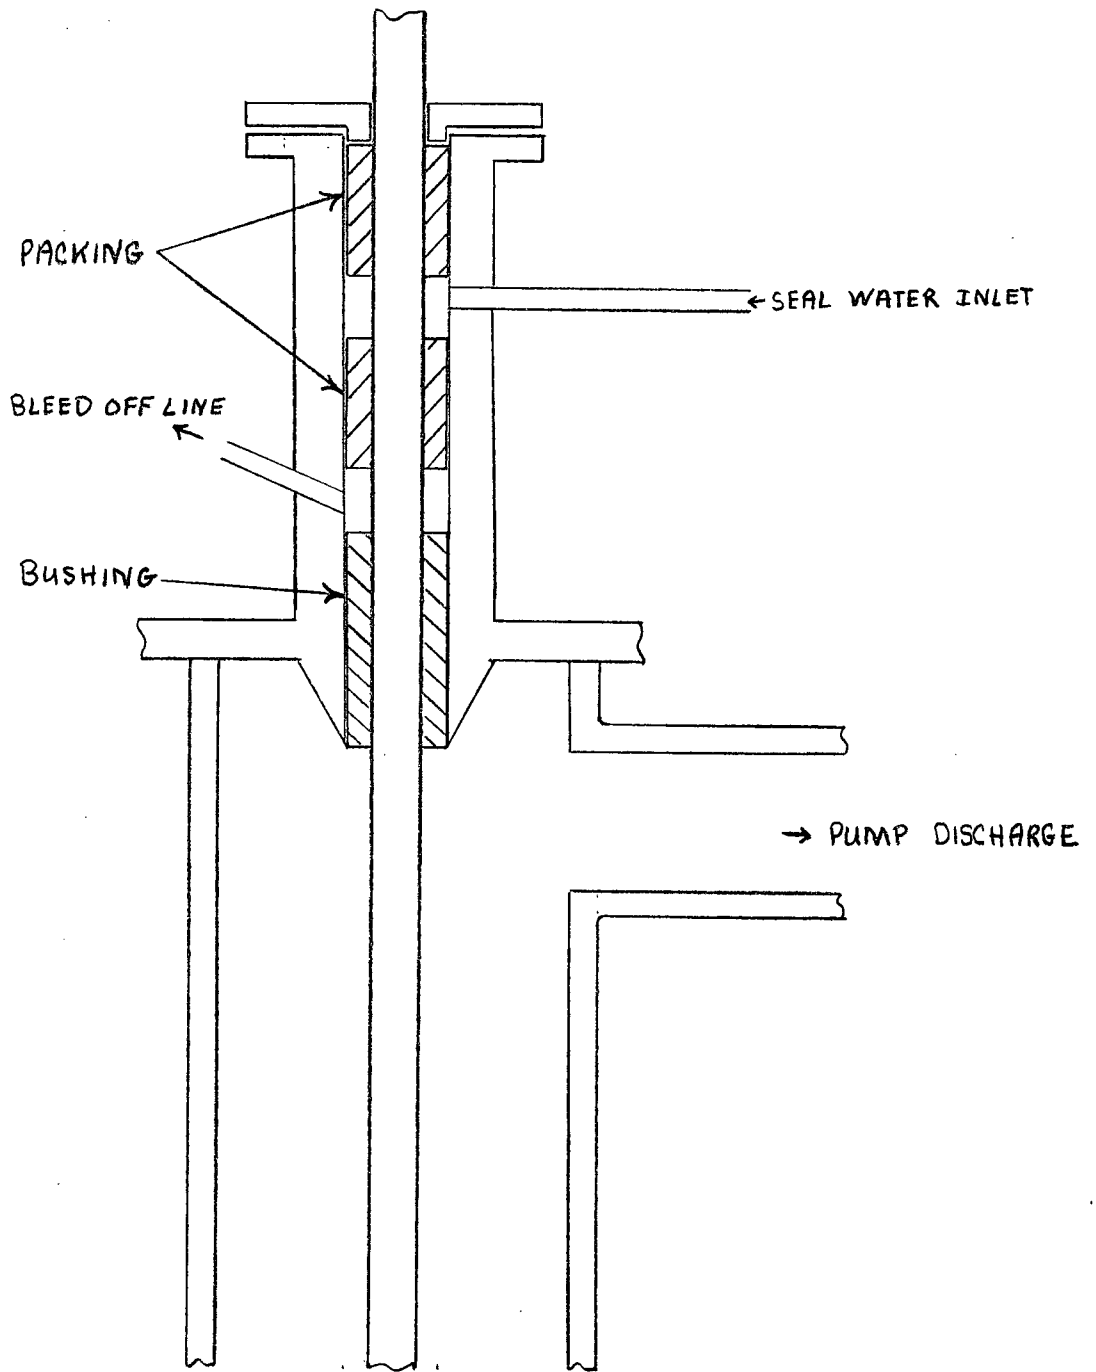
On March 23, 1973, while operating #11 RHR Service Water pump for shutdown cooling, smoke was observed coming from the pump. An investigation of the problem revealed that the upper gland seal packing on the pump had overheated due to dirt in the upper packing (see Figure attached). Cooling water for the bushing is provided by river water from the discharge of the pump. The upper and lower sets of packing are cooled by well water injected at a pressure of approximately 50 psig. When the pump is operated at low flow rates, with corresponding high discharge pressures, unfiltered river water is forced back into the upper seal cavity. Prolonged operation under such conditions resulted in the dirt accumulation.

The upper seal packing was replaced and adjusted. Modifications to eliminate the problem are being evaluated. Operation of RHR service water pumps at low flow rates is not required and will not be conducted until such modifications are implemented.
