Report of Investigation Into Slow CRD Scram Time Test Results Prior to Restart Following Recirculation Piping Replacement

MONTICELLO NUCLEAR GENERATING PLANT SPECIAL ENGINEERING REPORT

SLOW SCRAM TIME DUE TO PLUGGED CRD INNER FILTER

Report Date: May 1, 1985

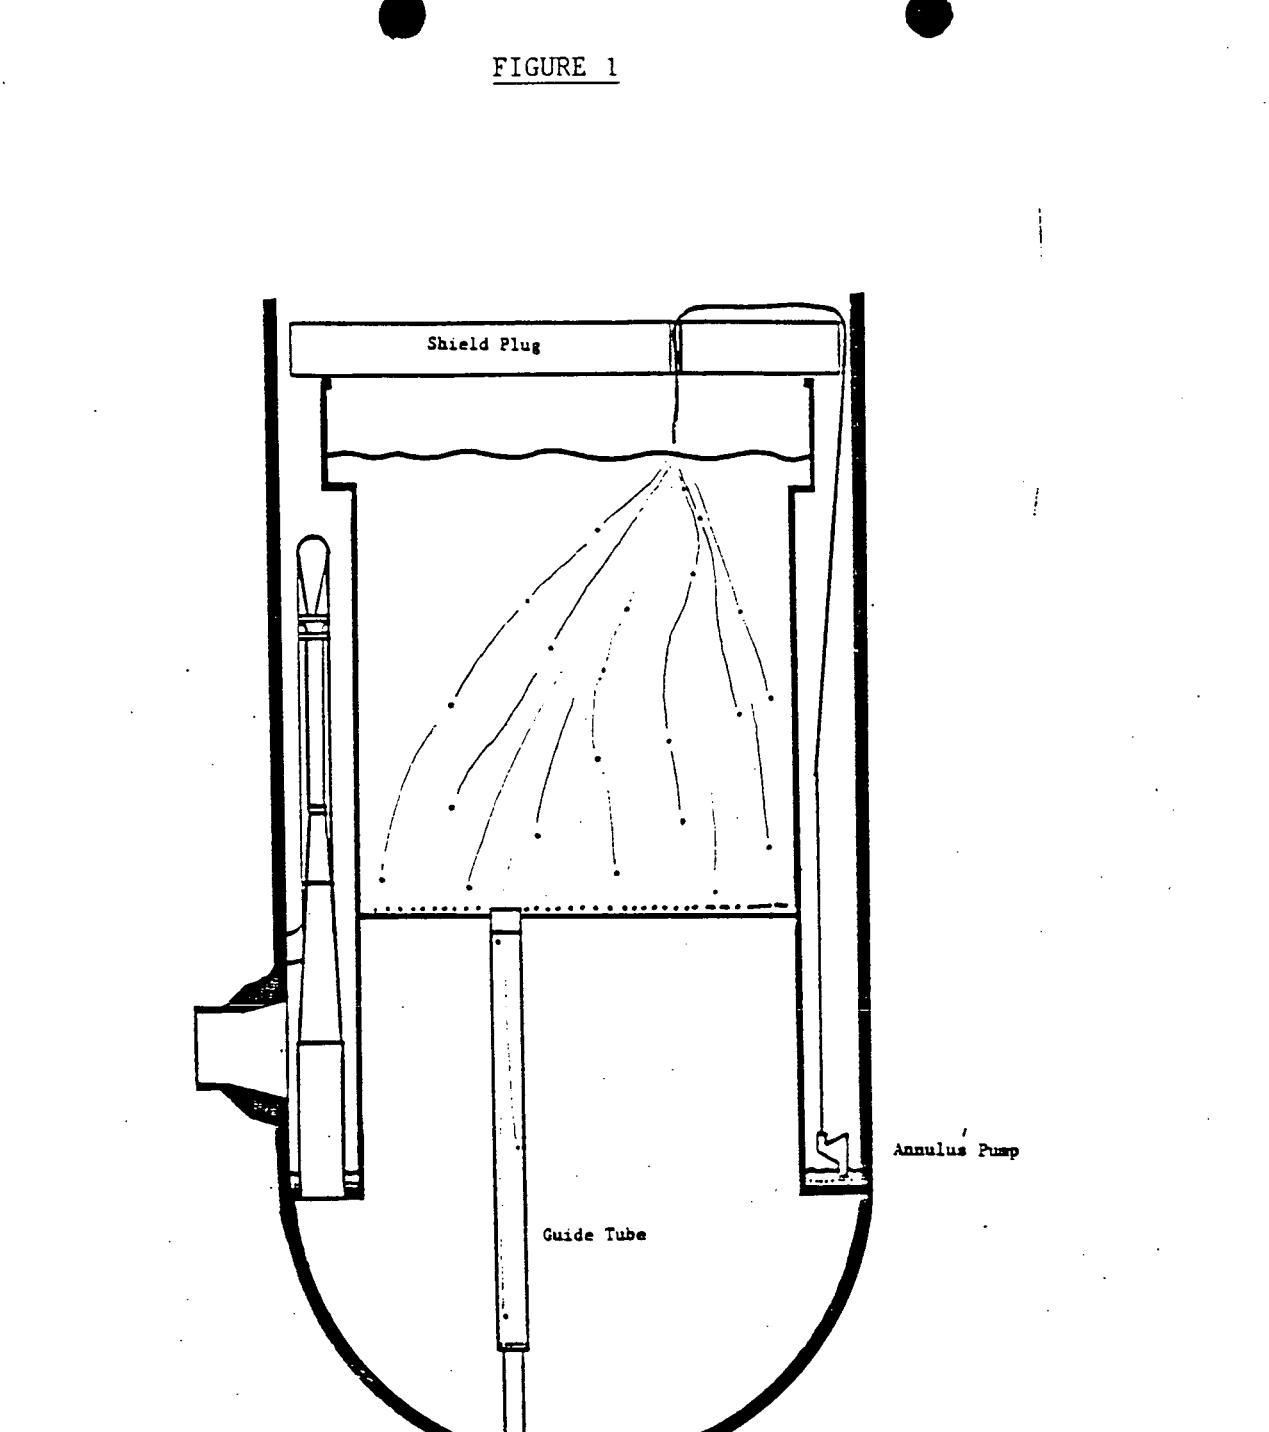
> As illustrated in Figure 1, sediment in the annulus was lifted over the shroud and discharged across the lower core plate. As the annulus sediment settled on the lower core plate, some of the solids fell through the cruciform opening in the fuel support piece castings. Those solids that passed through the fuel support piece casting were deposited at the bottom of the guide tube.

SCHEMATIC OF SEDIMENT AND CRUD MOVEMENT

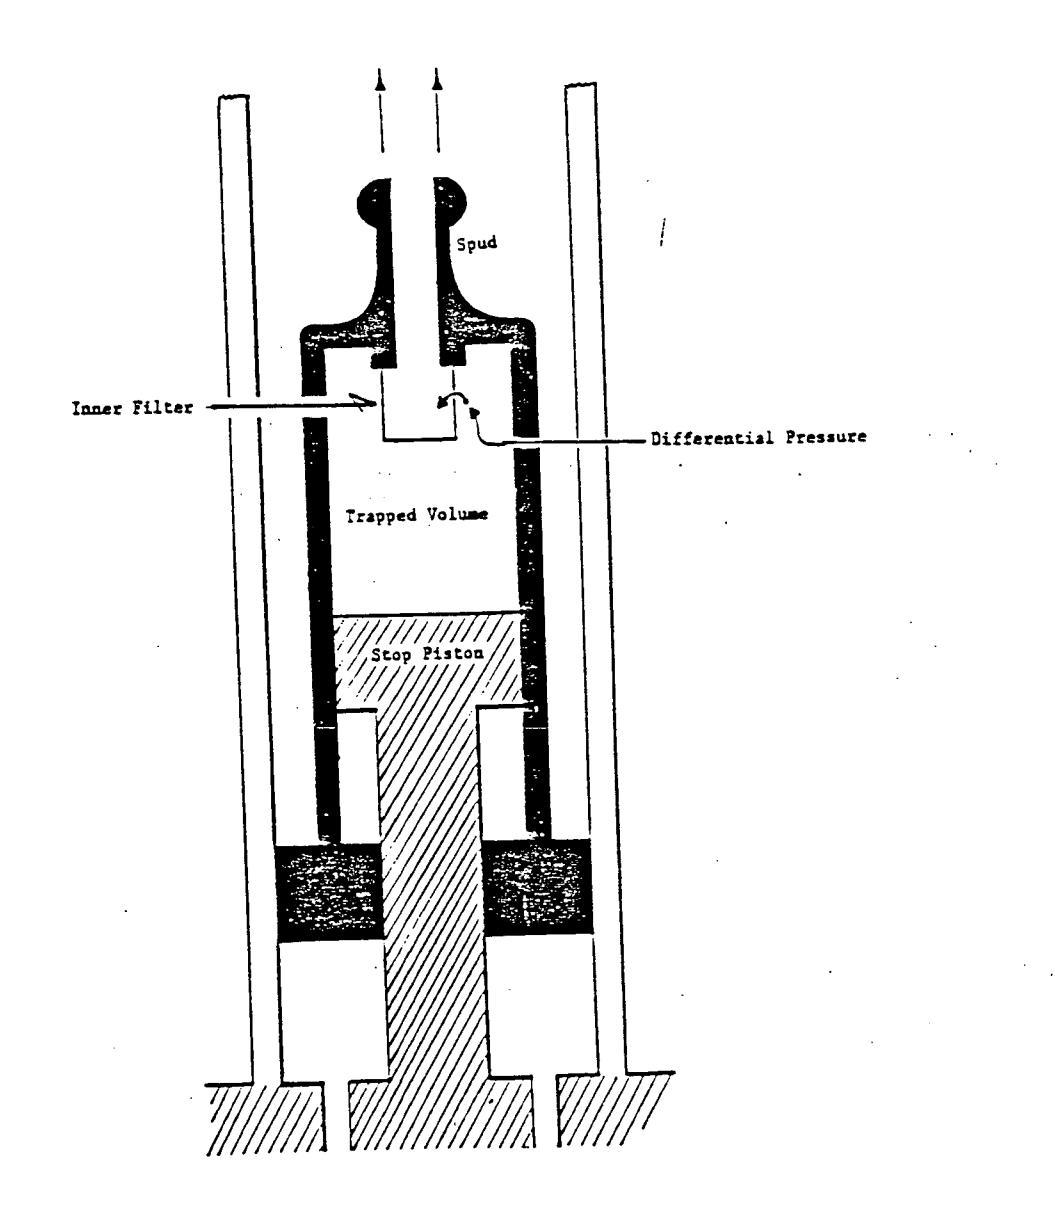
FIGURE 2

The CRD design present during the event provided a spud mounted inner filter which moved with the index tube. As shown in Figure 2, the movement of index tube and filter away from the stop piston produced a increasingly larger swept volume. Accumulated solids and fibers on the filter restricted water flow through the filter into the swept volume. This restriction in water flow generated a differential pressure across the filter which acted to oppose the index tube movement.

General Electric recognized this problem more than a decade prior to this event and developed a modified inner filter which is fixed to the stop piston and thus cannot develop the differential pressure as the original design could. This improvement was marketed by G.E. in SIL 52 as an improvement to reduce wear in an unrelated piecepart of the CRD. Based upon the marketing information provided, NSP chose to retain the original design spud mounted filters which later experienced fouling problems.

SCHEMATIC OF CRD WITH SPUD MOUNTED INNER FILTER

Investigation into the inner filter plugging identified a CRD modification which reduces the possibility of plugging the inner filter and eliminates the symptom of slow scrammming should the filter become plugged. That modification provides for relocating the original spud mounted inner filter to the preferred stop piston location. Measures were taken to modify as many drives as possible in a minimum of time. When the filter changeout was complete, sixty-four drives had the modified design and fifty-seven had the original design.
