INTERIM REPORT ON THERMOSTATIC VALVE FAILURE ON PALO VERDE EDG

10CFR21 REPORTING OF DEFECTS AND NON-COMPLIANCE

COMPONENT: Amot thermostatic valve element P/N: 9760X

Report No.
 10CFR21-0098

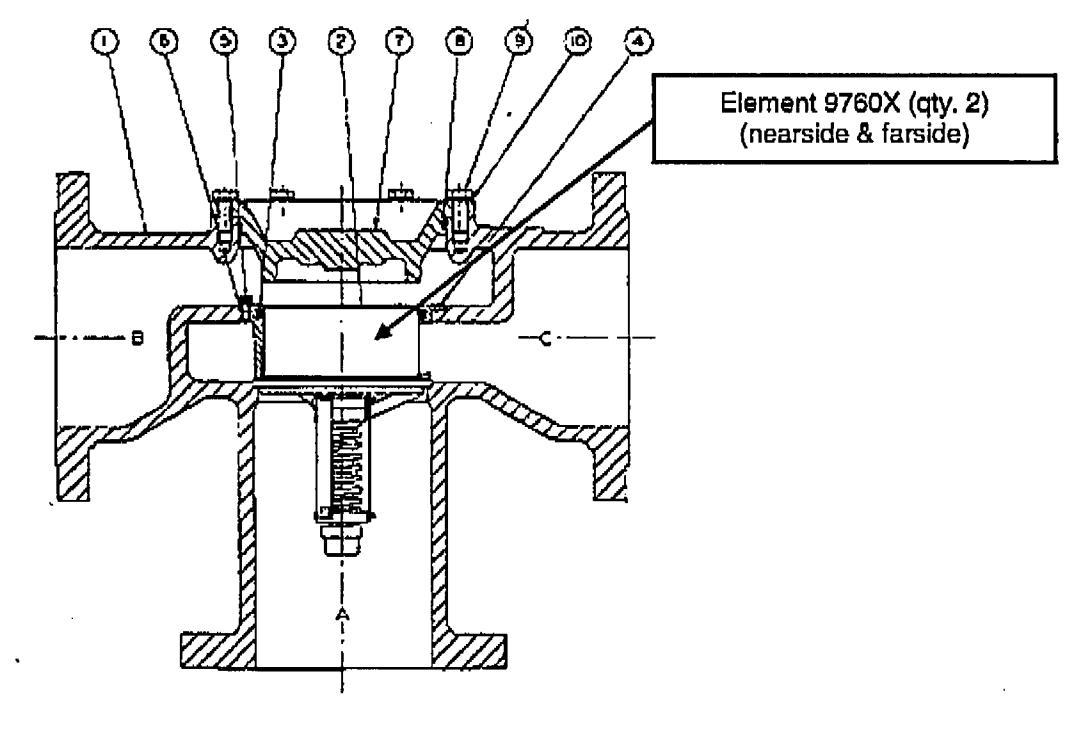
Each valve uses 2 thermostatic elements, Amot type 9760X (Figure 1). The elements investigated for the Palo Verde and STP applications have a nominal temperature setting of 160°F and therefore the element part number is 9760X-160.

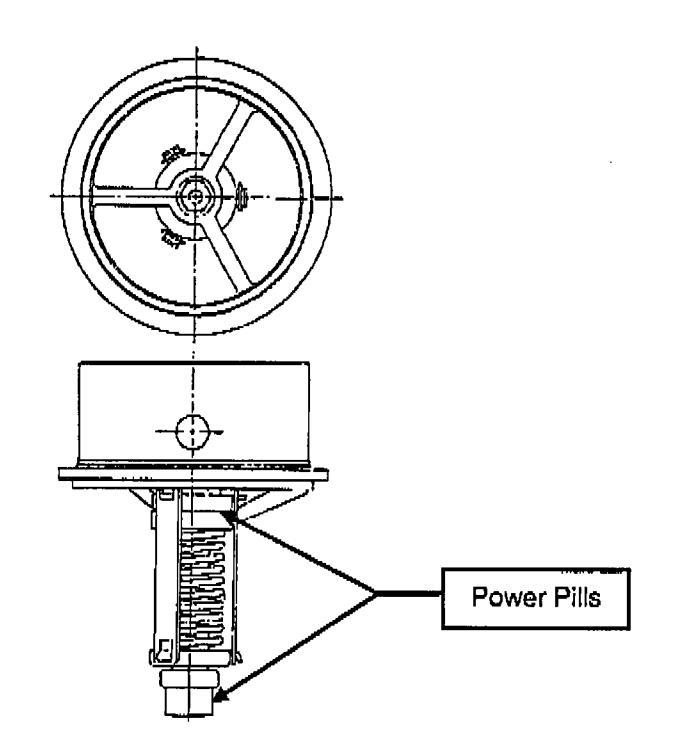
FIGURE 2: VALVE ELEMENT 9760X

- Brass machining debris was found within in the piston guide and on the rubber plug of the failed pill.
- Brass machining debris was also observed within the other three power pills to varying degrees; all of these pills continued to function properly. None of the stems of these pills displayed evidence of gouging or binding.

- The element failure was attributed to wax leakage past the diaphragm seal on one of two power pills within the element. Evidence of mechanical binding of the piston is believed to have caused the wax leakage. If the piston was jammed, the expanding wax could have over-pressurized the diaphragm seal leading to wax leakage.

The 9760X element contains two power pills (Figure 2). The power pills contain a temperature sensitive wax that expands with increasing temperature and provides the motive force to lift the element off of its seat.

Users should return any 9760X elements in their inventory to ESI for inspection of machining debris. *Note: Elements shipped after March 16, 2011 by ESI are not suspect because additional inspection procedures were implemented at that time.*

Users with installed 9760X elements should continue to trend their EDG lube oil and/or cooling water system temperatures and monitor for any indication of thermostatic element problems. The thermostatic elements should be replaced at the first sign of increasing temperature trends.
