Enclosure 2  
Meeting Summary Handouts  
of the January 19, 2012  
ROP Public Meeting

## Reactor Oversight Process Task Force FAQ Log

**Tentative NRC Response to  
FAQ 11-12, FitzPatrick Downpowers**

**Plant:** James A. FitzPatrick Nuclear Power Plant  
**Date of Event:** June 7, 2011 & June 9, 2011  
**Submittal Date:** Introduced October 26, 2011  
**Licensee Contact:** Gene Dorman 315-349-6810 / [gdorman@entergy.com](mailto:gdorman@entergy.com)  
**NRC Contact:** Ed Knutson 315-349-6667 / [edward.knutson@nrc.gov](mailto:edward.knutson@nrc.gov)  
**Performance Indicator:** Unplanned Power Changes per 7,000 Critical Hours  
**Site-Specific FAQ (Appendix D):**  YES /  NO  
**FAQ requested to become effective when approved or \_\_\_\_\_.**

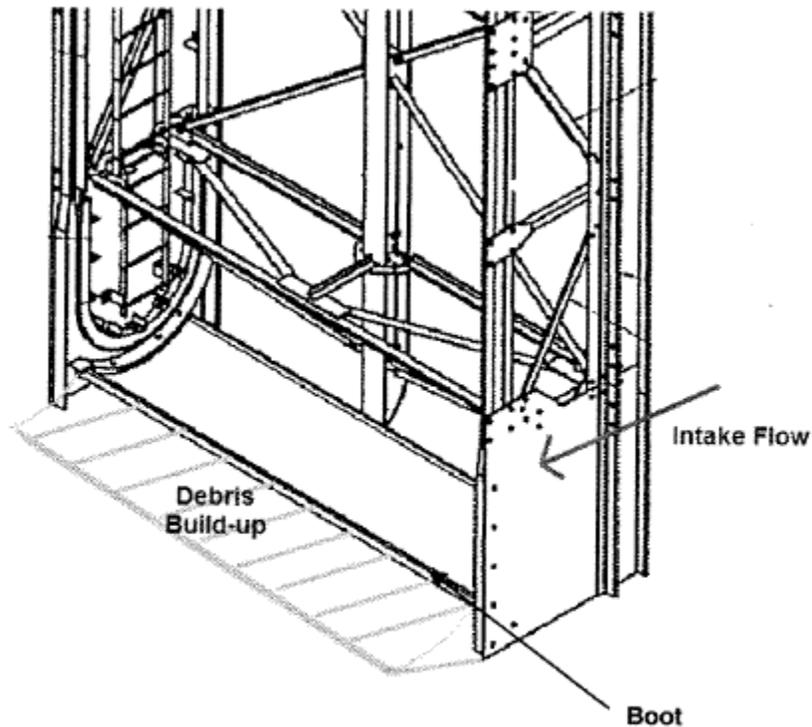
Diagram 1: Low flow area with debris build-up behind Boot

The travelling water screens have a cement filled boot below the screens that runs down to the intake bay (see Diagram 1 below). Due to this design, the annual PM now includes a boot inspection. It was to support this inspection that the gates were inserted.

Based on the need to downpower the unit JAF performed an apparent cause evaluation and determined that the fouling observed was from a previously unidentified source. Based on the design of the boot and the cement, it appears that a low flow area may be forming just past the

boot. There is a possibility for small debris such as silt, sand, and broken zebra mussel shells to settle in this area south of the screens (pump suction side). In this area, the silt may settle out past the boots and build up to a level to meet up with the process flow. This condition would only take a short period of time to build-up and then would remain in the condition until cleaning could remove the debris.

During normal operation, this debris build-up is not a significant threat to fouling because the debris is settled. However, this area becomes vulnerable when the gates are installed because of the change in flow patterns and increased velocity.

During the maintenance activities beginning on 6/6/2011, the south gate was inserted to provide protection for the divers. The installation of the gate caused an increase in flow, which apparently caused the settled debris in the vicinity of the gate to be picked up by localized turbulence, resulting in fouling of the condenser. The apparent cause evaluation postulated

that the turbulence could be reduced by inserting the gate north of the travelling water screens prior to installing the gate south of the travelling water screens.

Based on the apparent cause evaluation corrective actions have been proposed to  
1) incorporate additional guidance in OP-4, Circulating Water System regarding the sequence for installing gates; and 2) to evaluate the PM task for scheduling optimization.

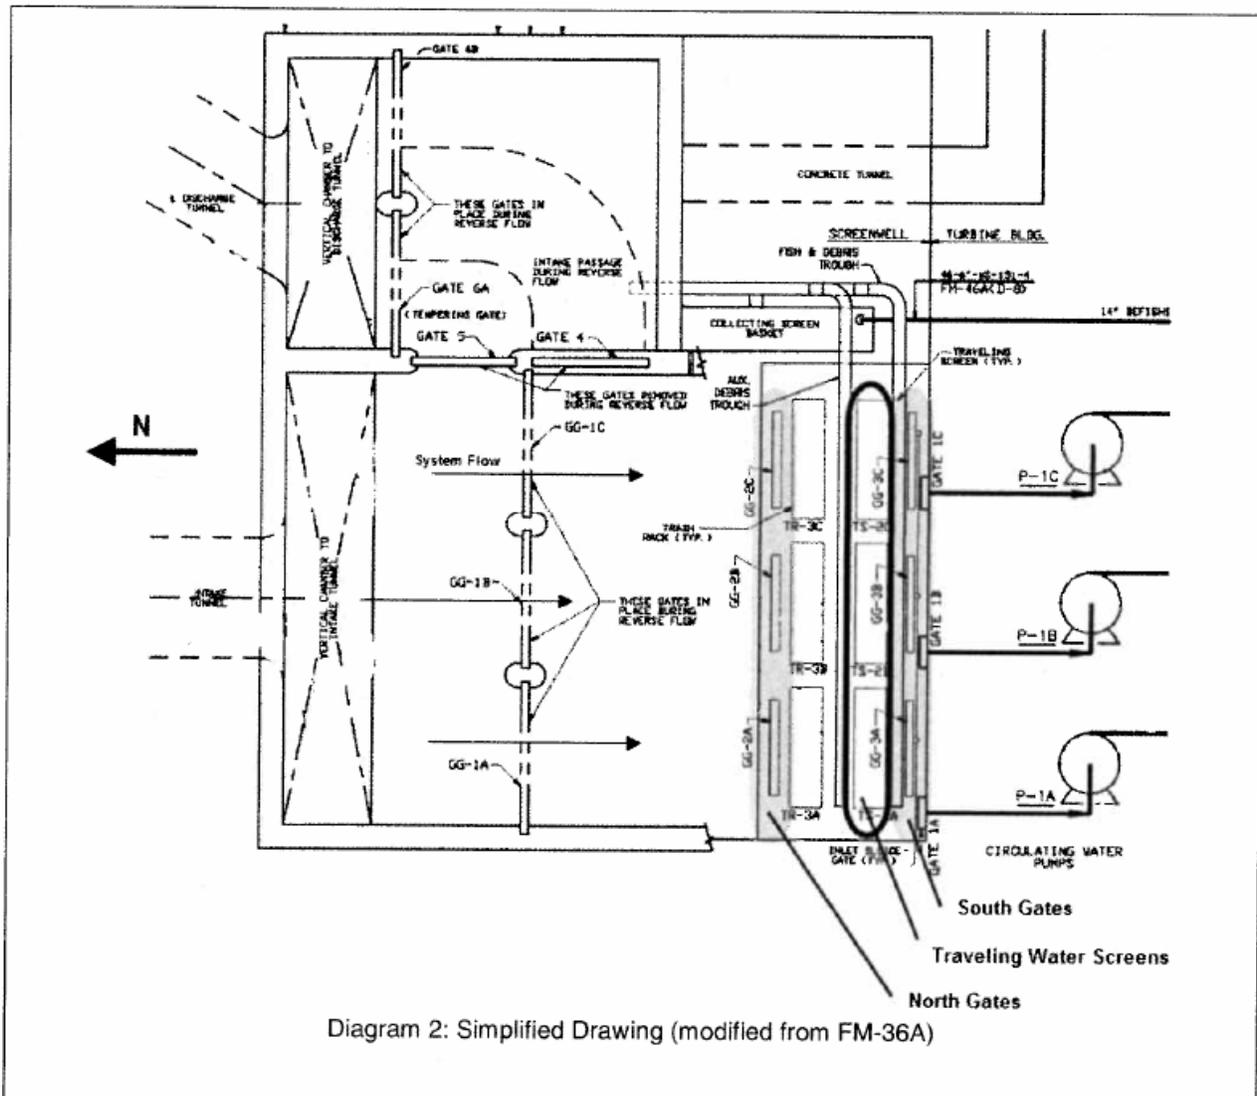
As noted above to minimize the impact of the marine debris buildup in the forebay, the annual cleaning and inspection of the intake canals was performed the week prior to the annual PM to inspect the travelling water screen boot. The cleaning included the areas of the forebay from the tempering gate to the trash racks and the area between the trash racks and the screens. However, due to the configuration of the traveling screens, pump bays, and isolation gates (see Diagram 2 below), the area south of the screens was not cleaned because it is not accessible during operation.
