# **Boric Acid Corrosion Testing Program Overview**

**NRC/EPRI MRP Meeting  
Rockville, MD  
February 29, 2012**

**Rick Reid  
EPRI**

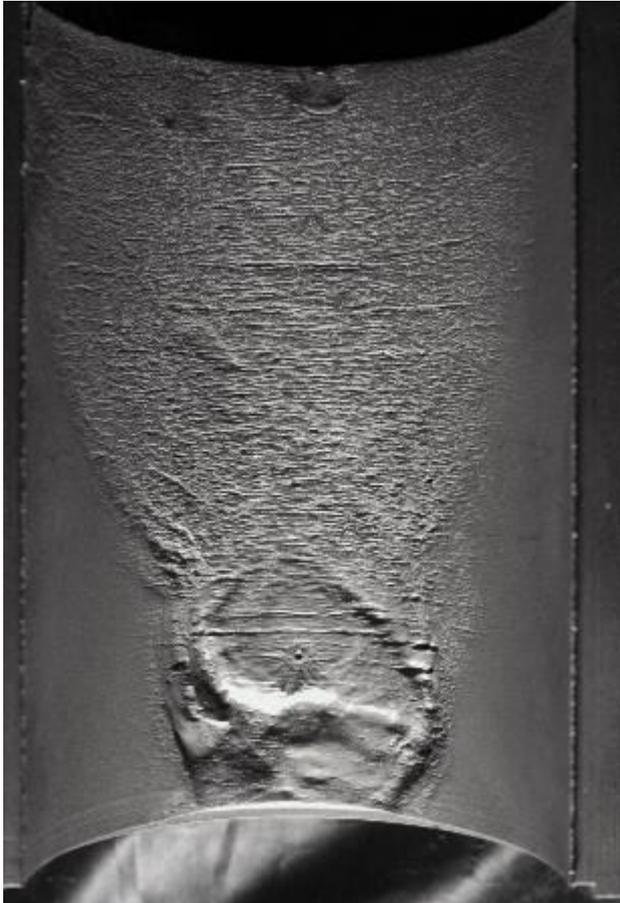
#4

0.1 gpm, 10 mil  
Wastage – 4.1 in<sup>3</sup>/yr

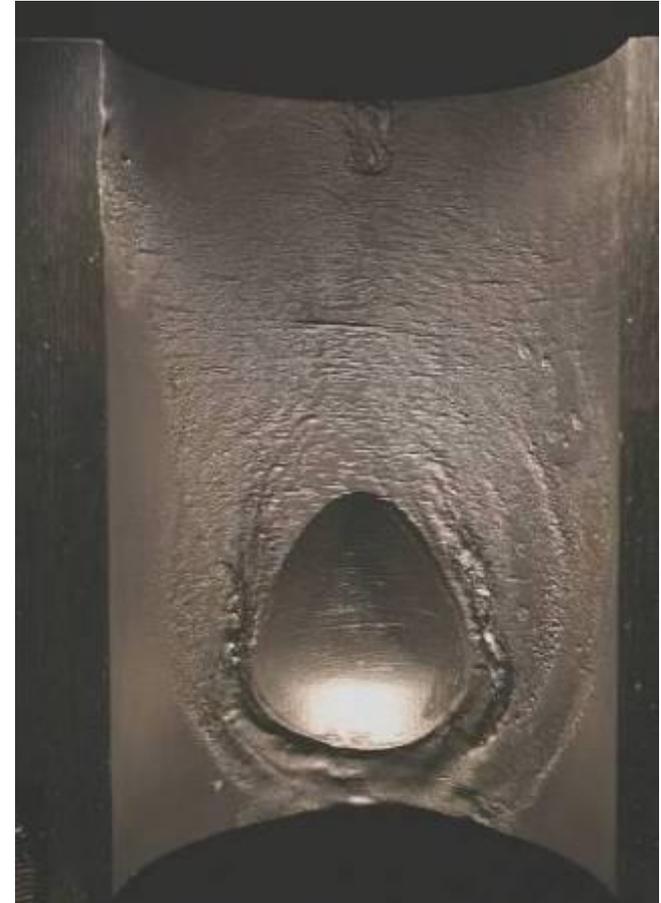
#7a

0.1 gpm, 10 mil  
Wastage – 14.86 in<sup>3</sup>/yr

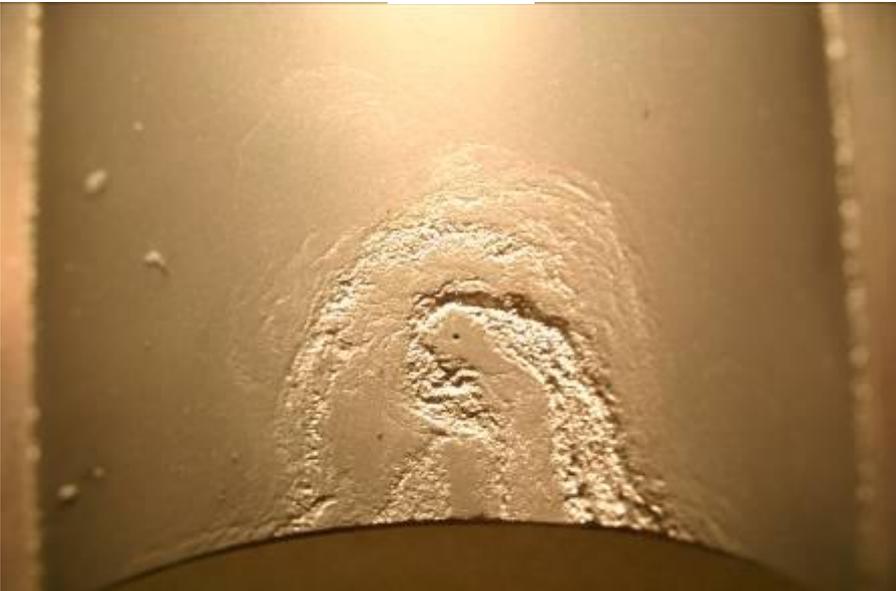
#8a

0.01 gpm, 10 mil  
Wastage – 0.90 in<sup>3</sup>/yr

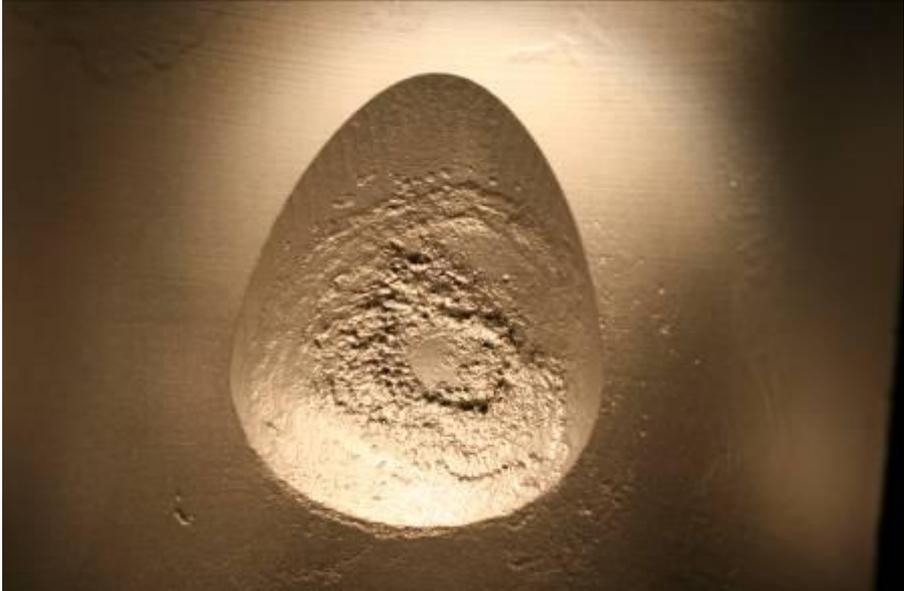
#6a

0.01 gpm, 10 mil  
Wastage – 0.93 in<sup>3</sup>/yr

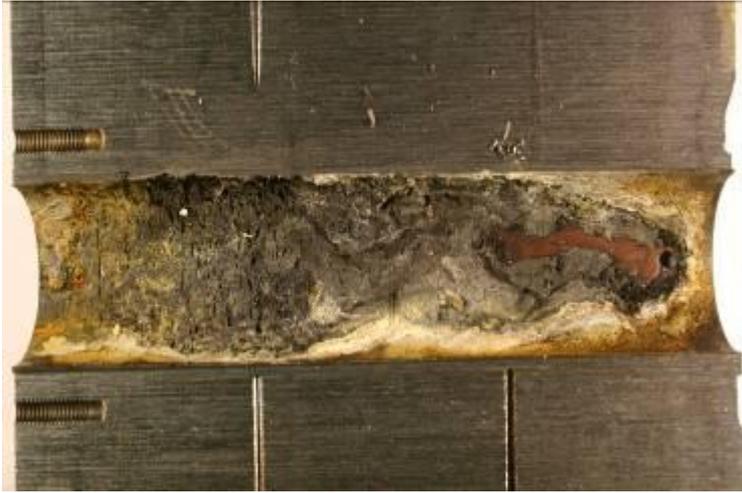
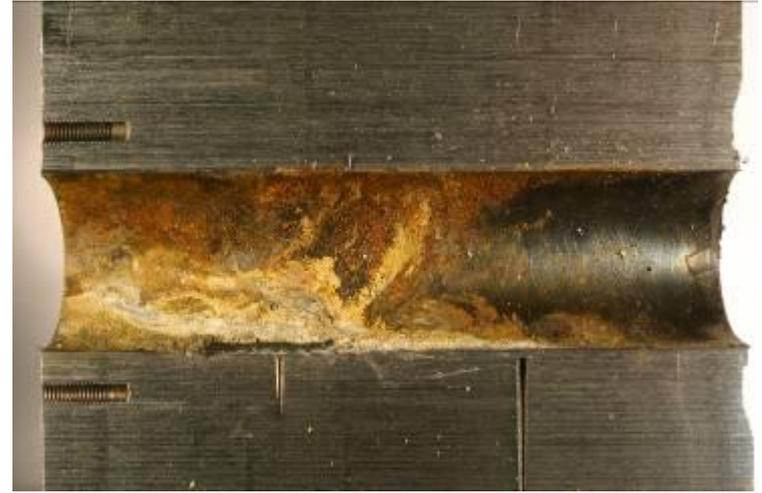
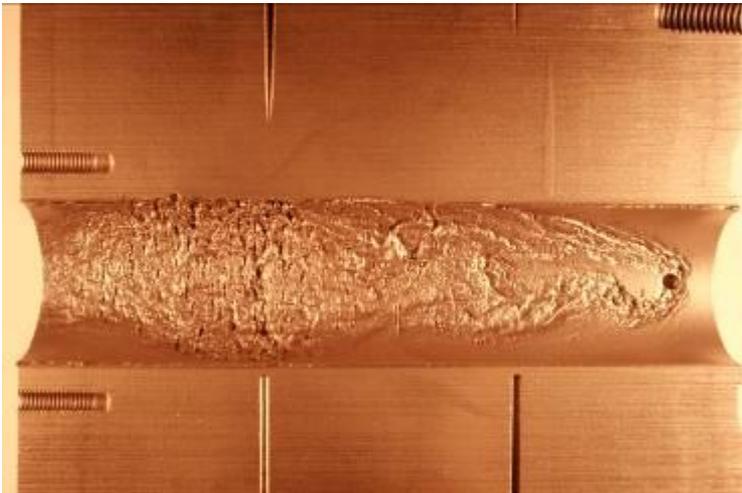
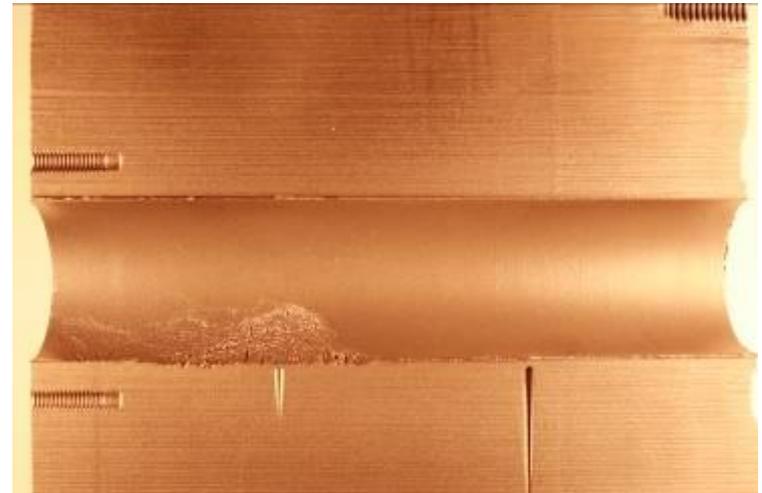
# BMN Test 1 Cross Section

Test No.	Ave. Flow Rate [gpm]	Gap [mil]	Total Material Wastage [in <sup>3</sup> /yr]	Area-Avg Wastage Rate [in/yr]	General Observations	Photo of Post-Test Annulus	Back of Annulus or Exit Plane Photo (if needed)
1	0.0099	10	2.26	0.383	<ul style="list-style-type: none"> <li>(-) Notable impingement damage with small plaeau</li> <li>(-) Flow path restricted to front of annulus</li> <li>(-) Wastage is distributed axially with increased wastage closer to annulus exit</li> </ul>

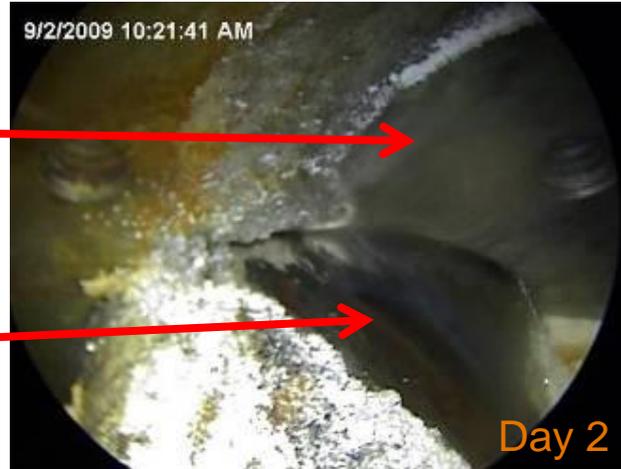
Deposits clearly visible after two days

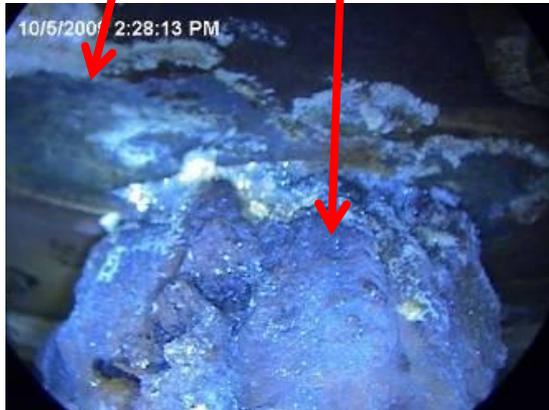
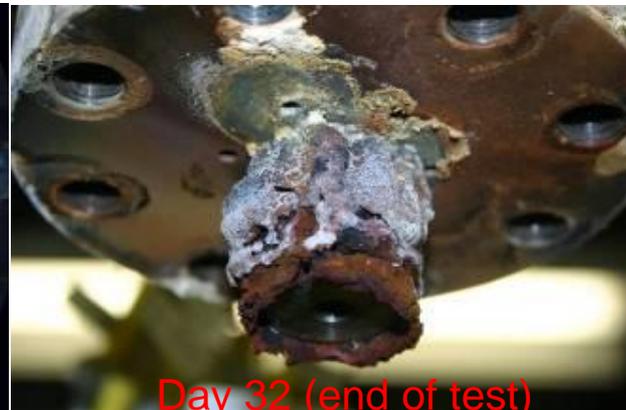
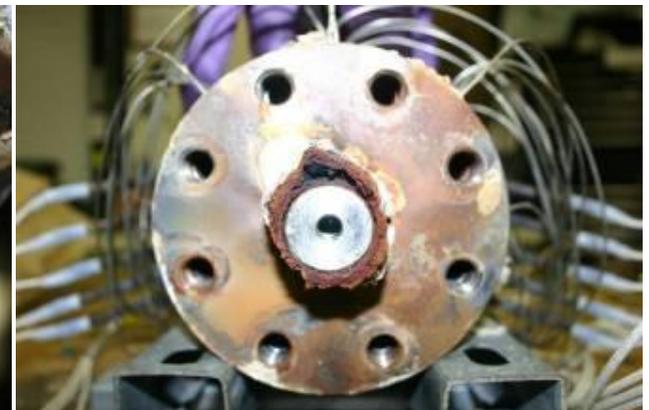
Very heavy deposits after ~one month

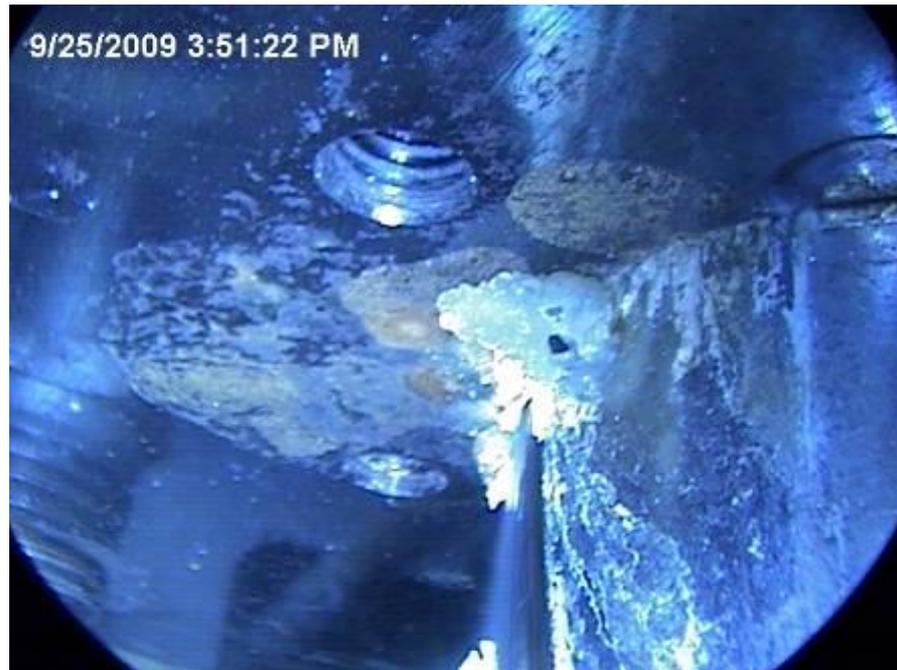
# BMN Test 5

- Long-term test (164 days)
  - 0.006 gpm leakage rate; 1-mil annulus gap
  - Boric acid deposits visible after just one day
