**INSPECTION CHECKLIST**

ENTERGY	ENGINEERING STANDARD	EN-EP-S-002-MULTI	REV. 0
	Buried Piping and Tanks General Visual Inspection	PAGE 12 OF 12

Sheet 2 of 2					
Piping / Tank	IP3 6-inch Fire Protection Line (N/S) at N/W corner of the WHUT Pit		INSPECTION DATE:	8/1	
ELEVATION: <u>EI. 48'-0"</u>	LOCATION DWG:	9321-F-41823	INSPECTOR:	J. Peterson	
1. ANY BLISTERING (COATING)?		YES	NO 🛛	NOTE

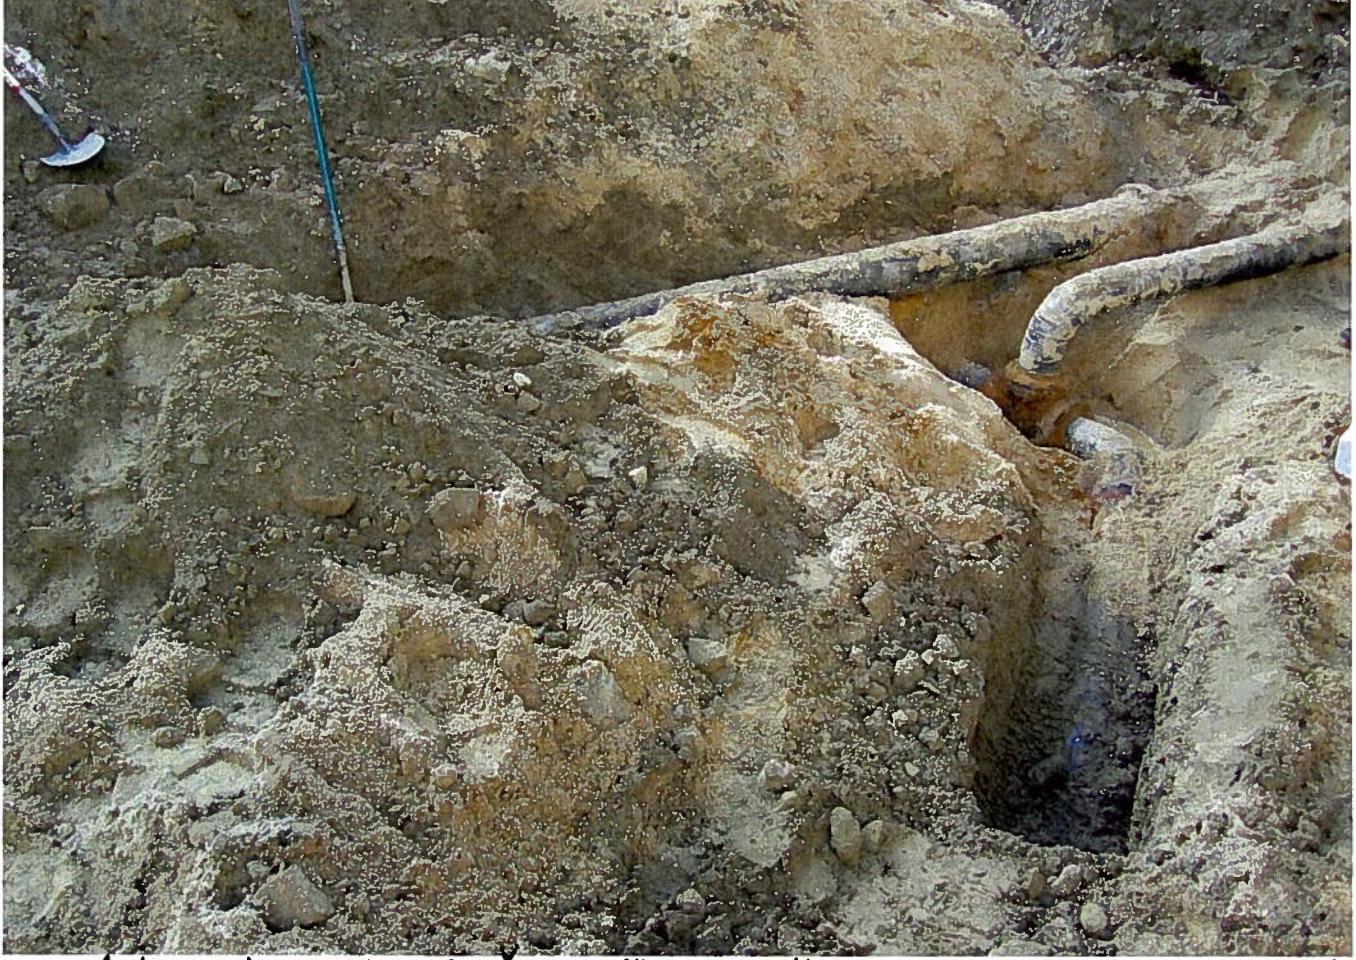
+ MID to NORTH END OF EXCONTION; 8" FP LINE, 6" FP LINE TO PAB, BRANCHING OFF 6" FP HDR.

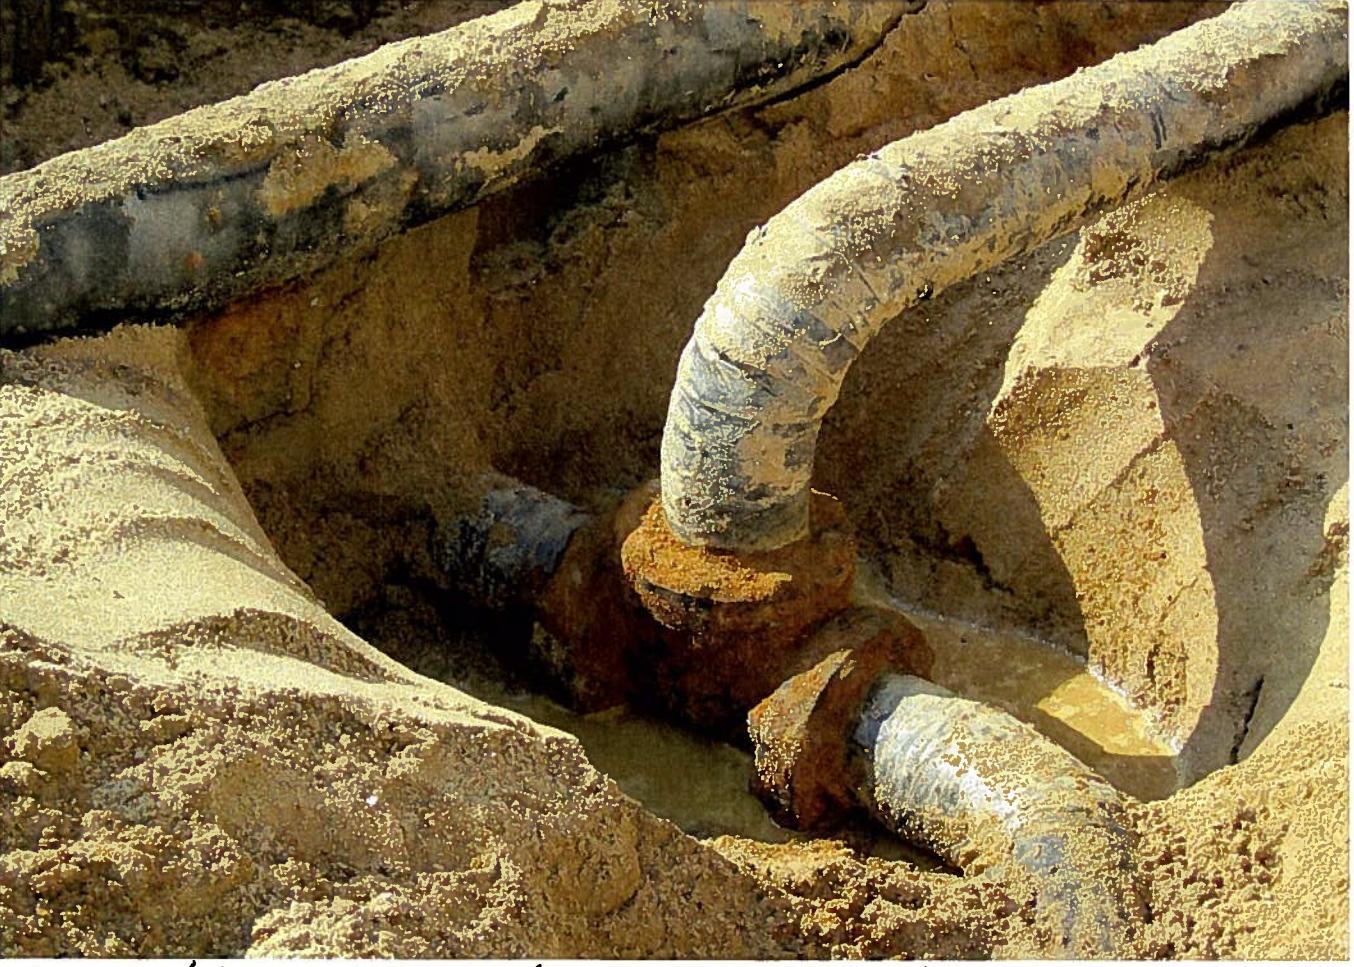
6" BRANCH TO PAB (TO RIGHT) OFF 6" FP HEADER.

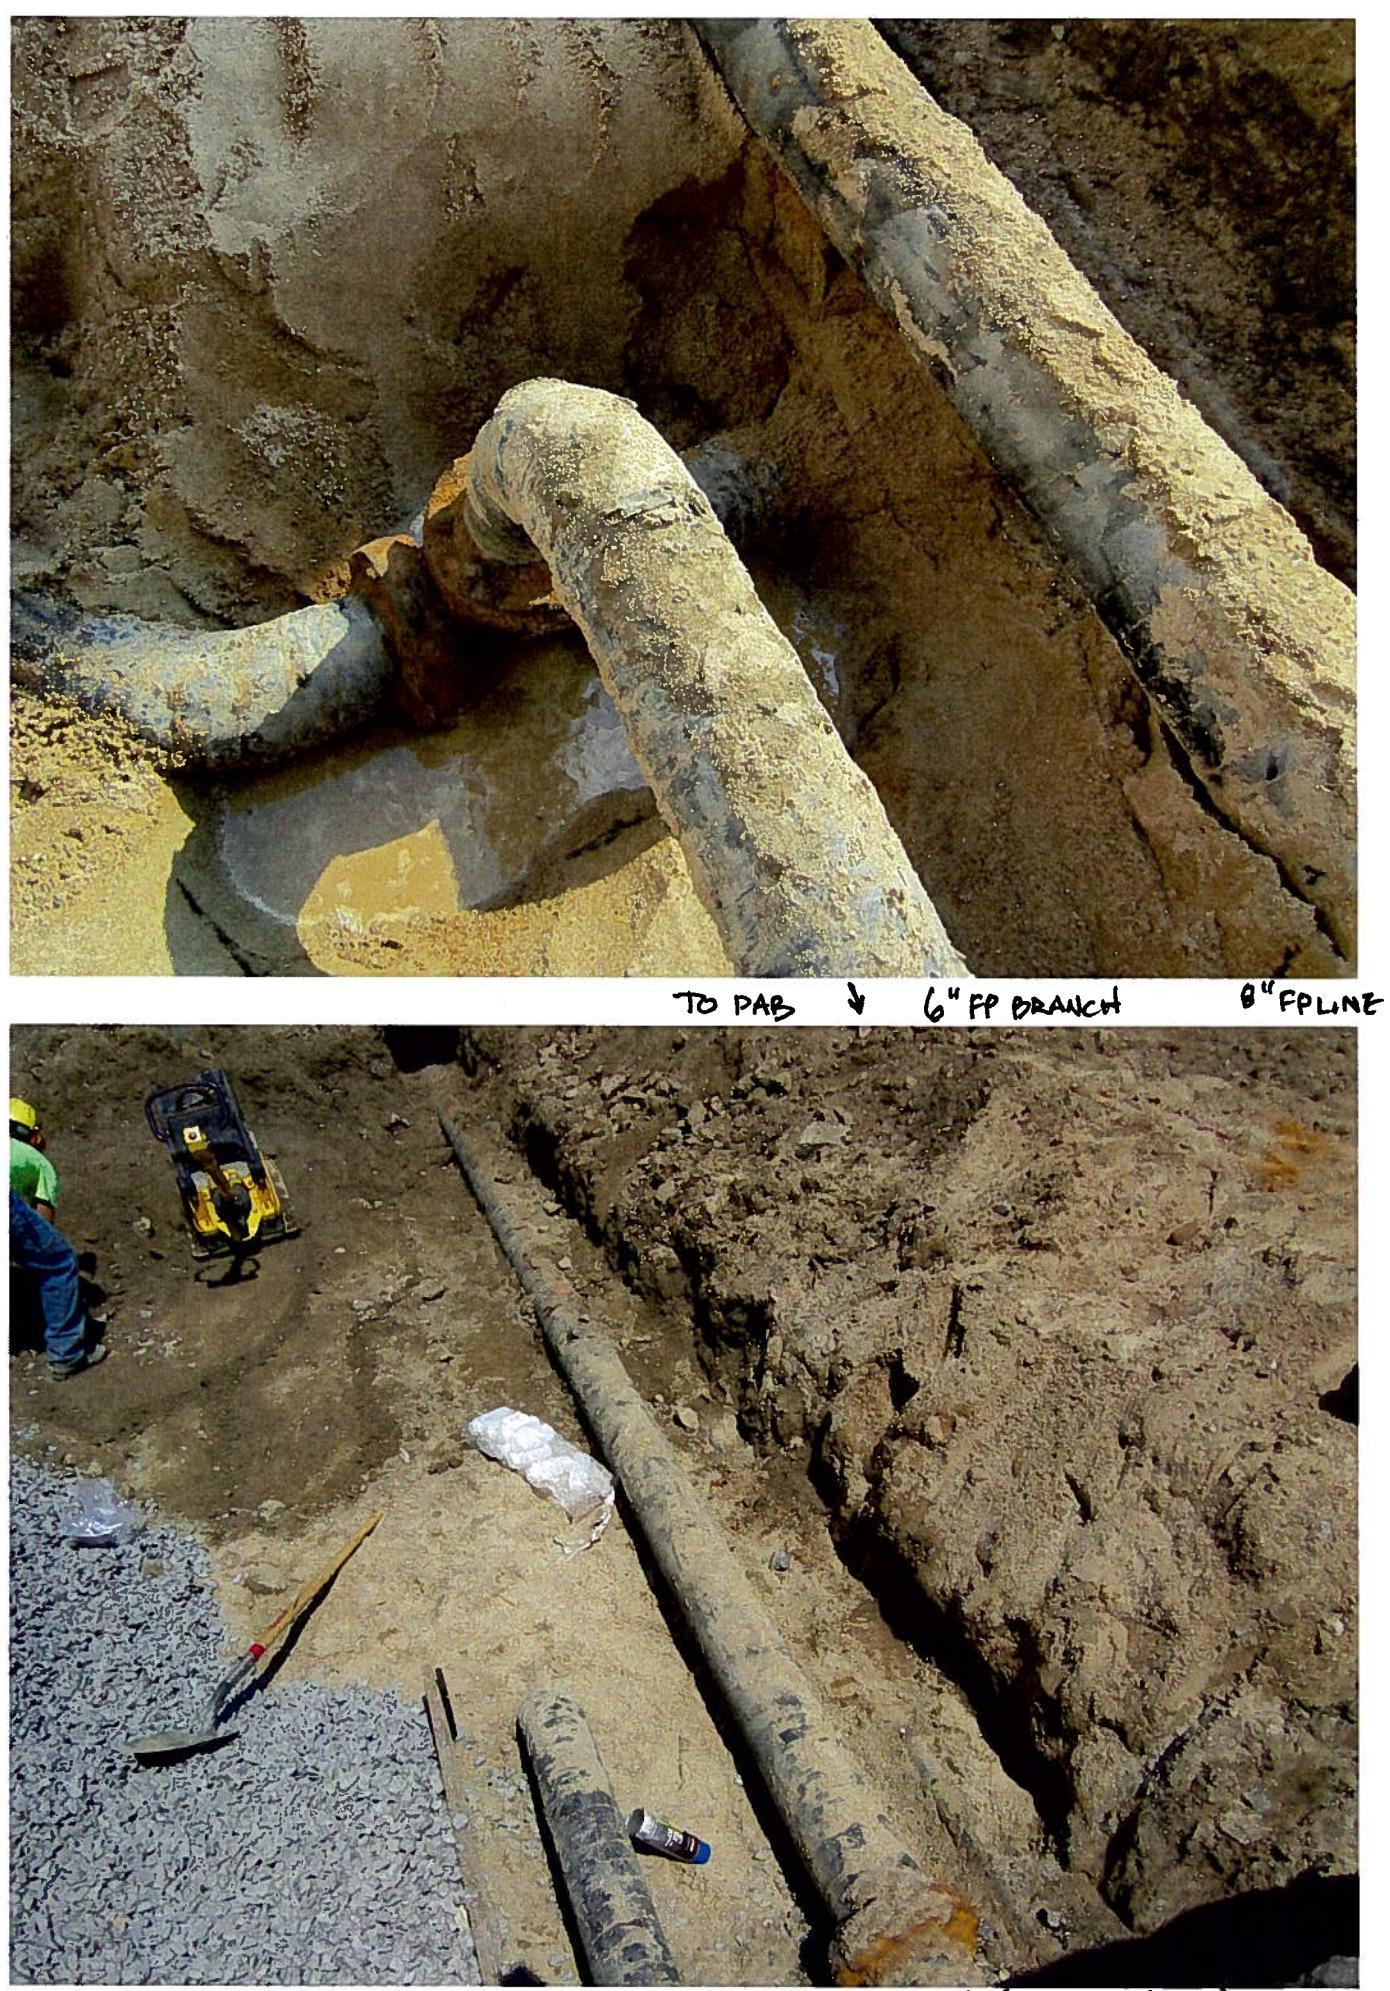
AREA BACKFILLED TO COVER 6" TEE CONNECTION (LOOKING NORTH)

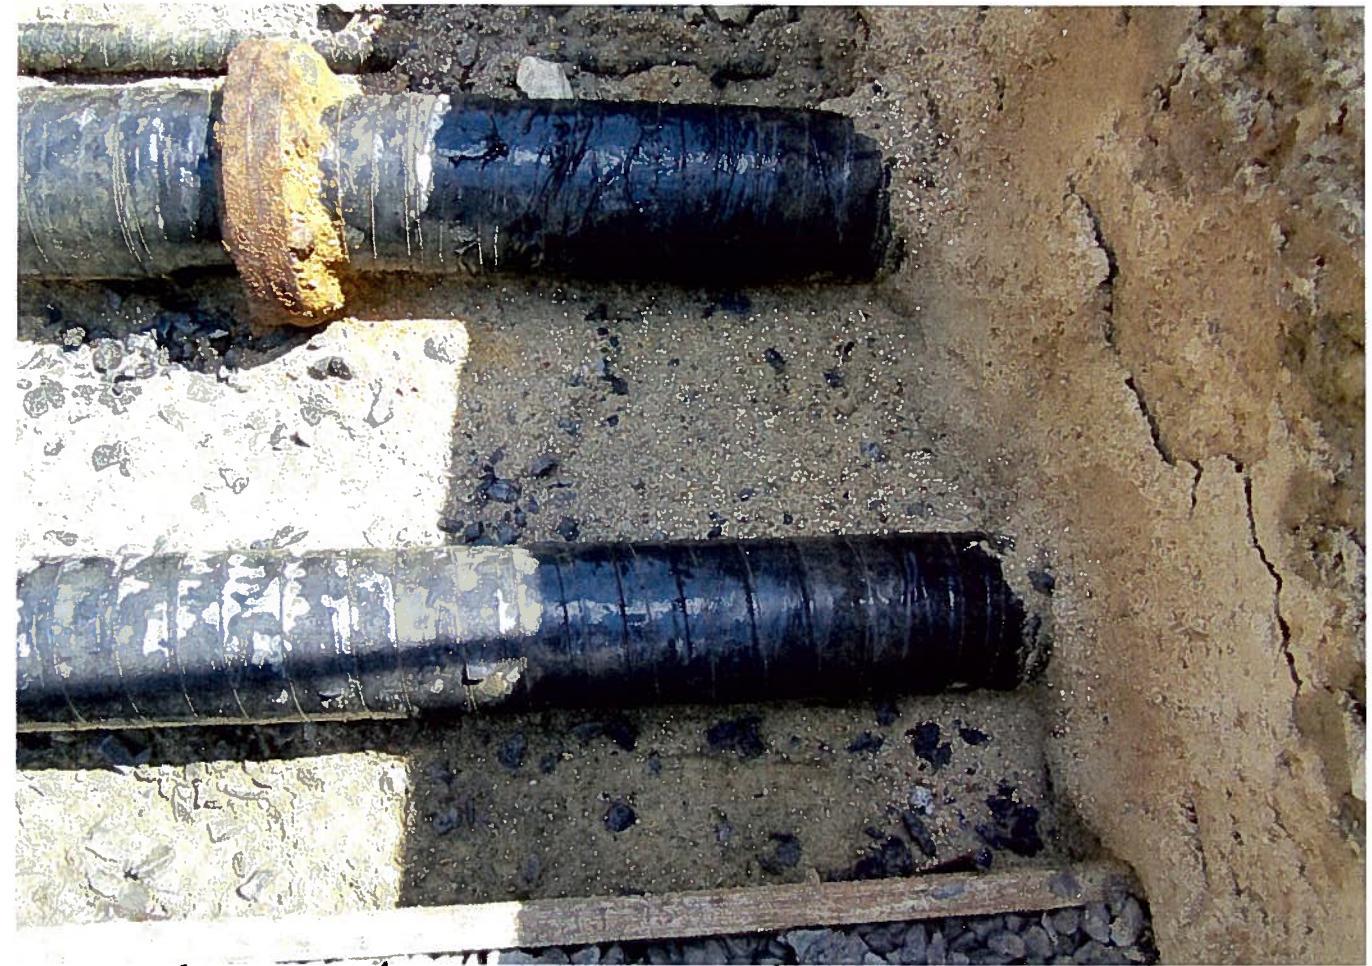
S" FP LINE (TOP) 6' PP BRANCH (BOTTOM)

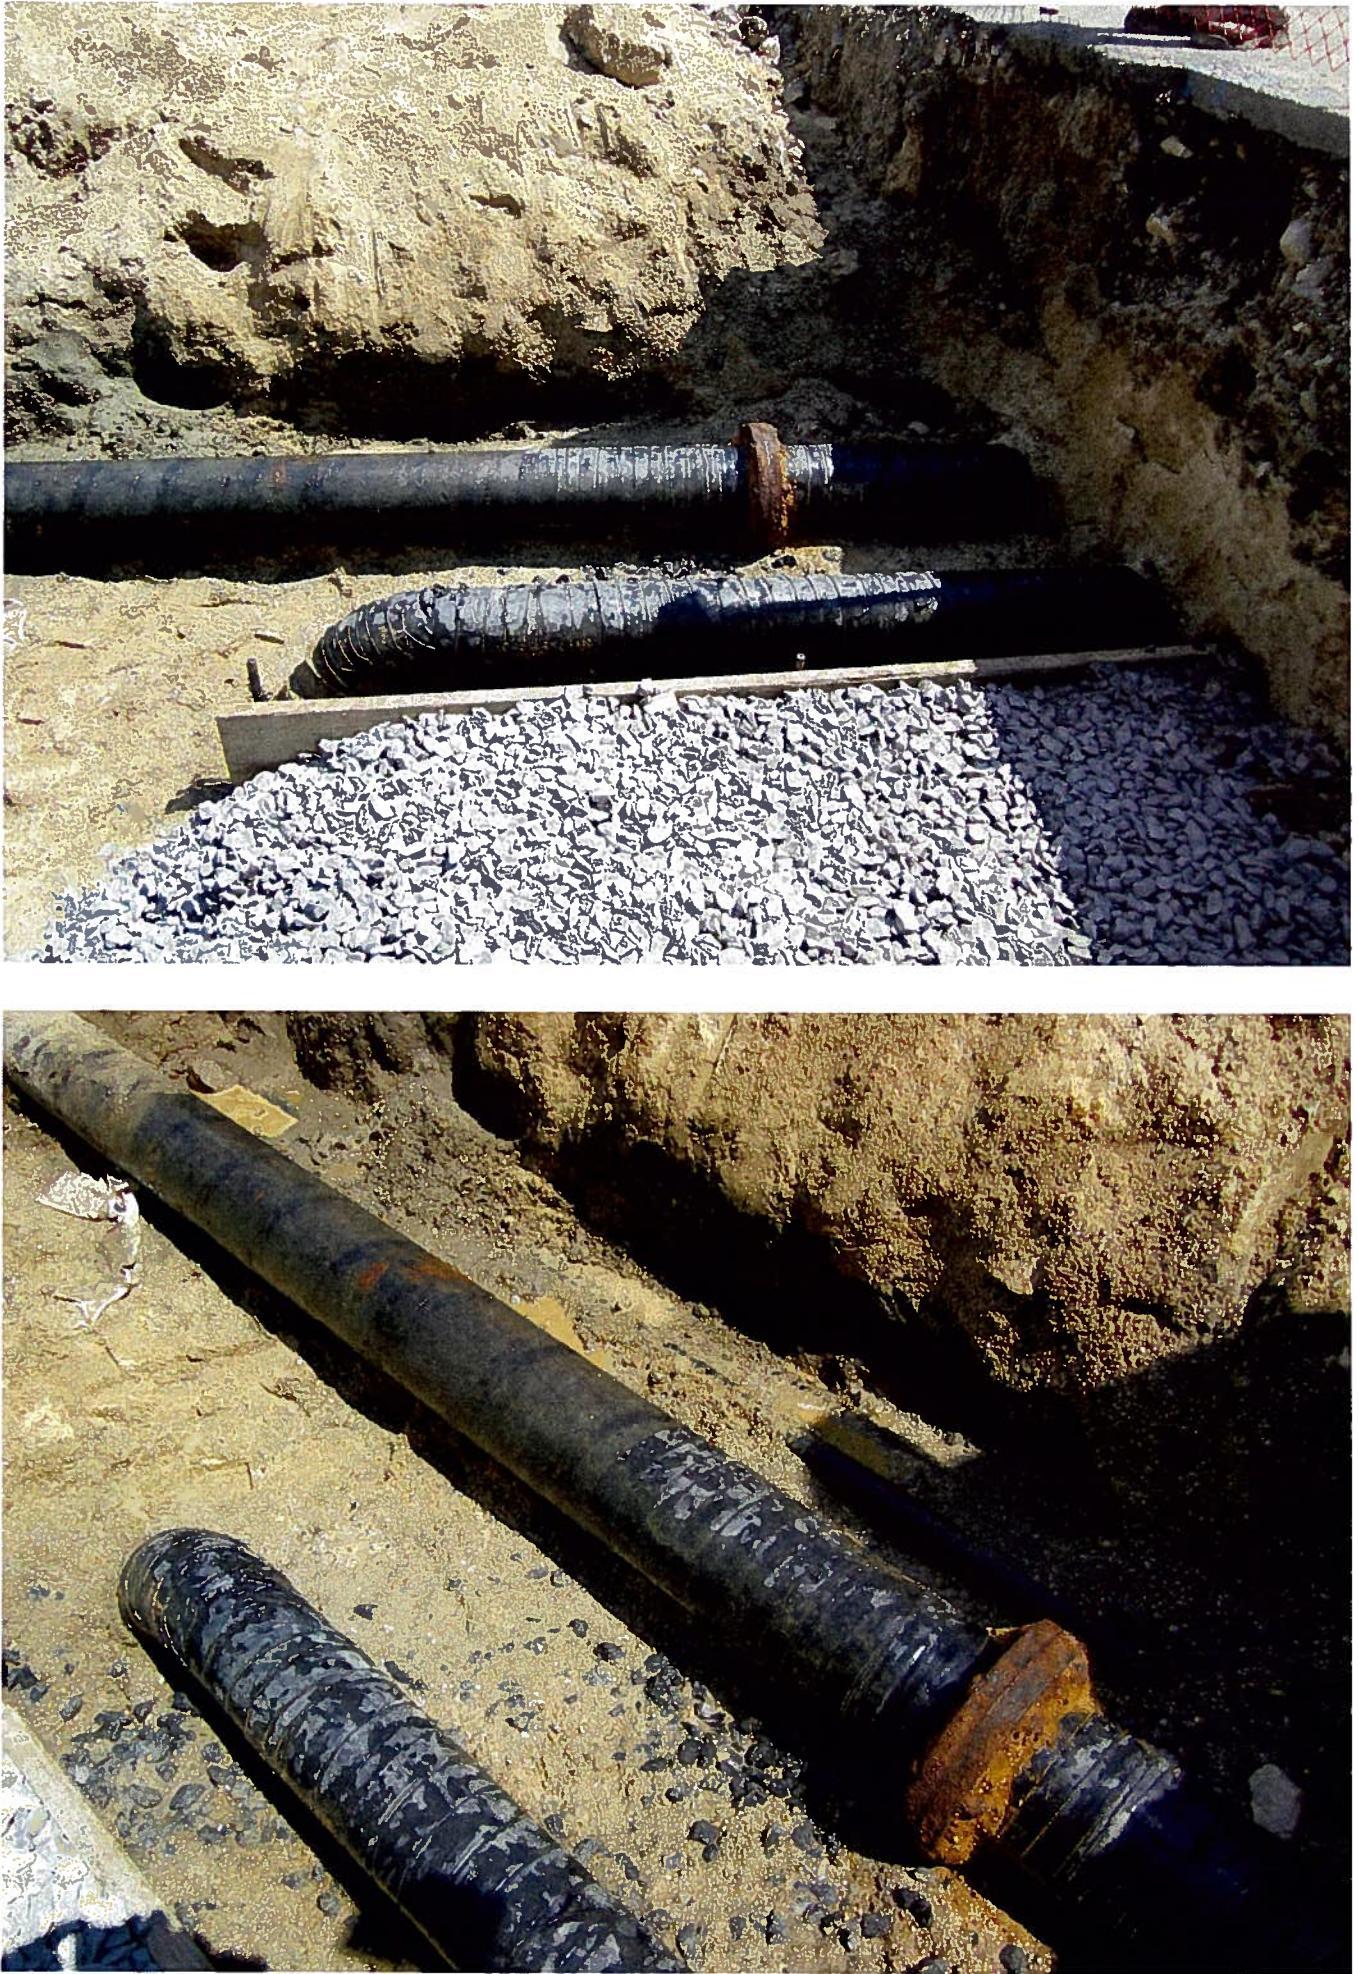
MINOR RUGT DISCOLORATION ON 8" FP LINE; NO TEAR OR DISCONTINUITY IN TAPE WRAP NOTED.
