SEABROOK STATION UNIT 1: DAMAGE TO GENERATOR STEP-UP TRANSFORMER IDENTIFIED 10 NOVEMBER 1998 IMMEDIATELY FOLLOWING GEOMAGNETIC STORM SHOCKS OF NOVEMBER 7-9, 1998

SEABROOK STATION UNIT 1 DAMAGE TO GENERATOR STEP-UP TRANSFORMER IDENTIFIED 10 NOVEMBER 1998 IMMEDIATELY FOLLOWING GEOMAGNETIC STORM SHOCKS OF NOVEMBER 7-9, 1998

Comments of the Foundation for Resilient Societies, prepared by William R. Harris January 19, 2012

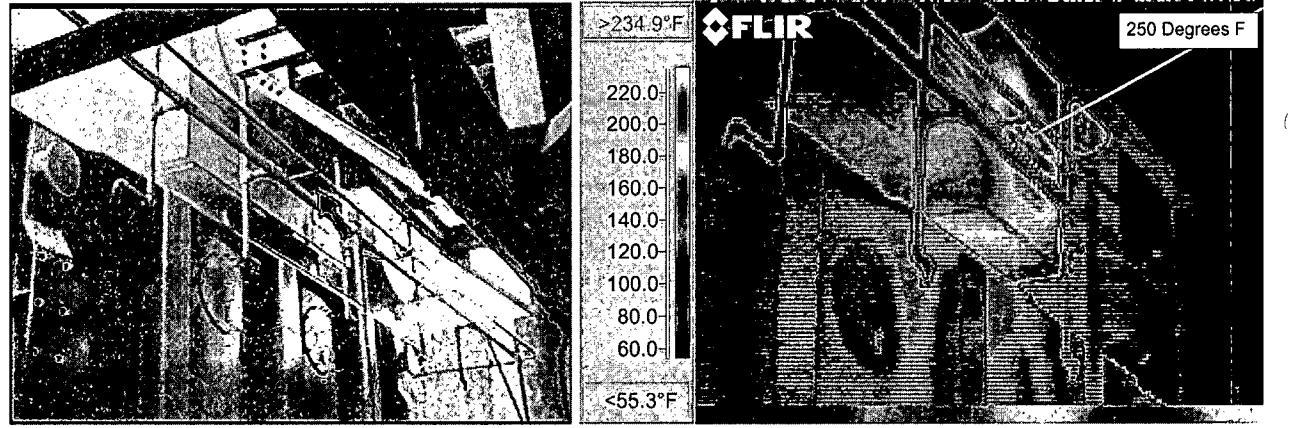
Fig.1 is a visual image of the "A" Phase Generator Step-Up Transformer, Low Side Bushing Compartment. Fig.2 is the corresponding thermal image. The 250°F temperature measured on the surface of the bushing compartment exists because of heat being generated inside the compartment. The source of the heat was suspected to be a high resistance connection between the low side bushing and the isophase. Recognizing that a significant heat source would be needed to raise the surface temperature of the compartment to 250°F, it was suspected that there was potential for a catastrophic transformer failure.

Figure 1 Visual image of the "A" phase generator step-up transformer

Figure 2 Corresponding thermal image of the transformer

Remove the unit from service. Inspect the low side transformer bushing and all other associated components. Make repairs as necessary.

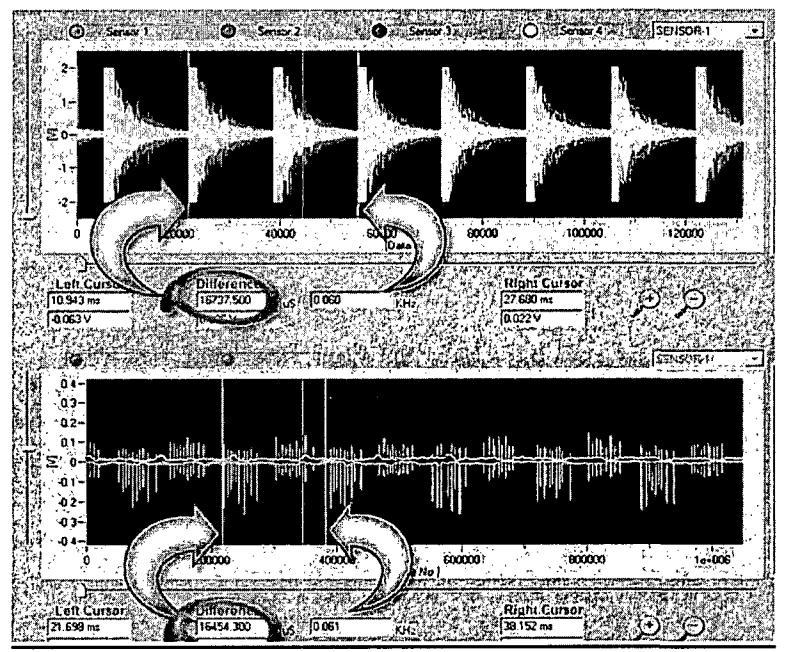
This is classic partial discharge (PD) in a power transformer. Partial Discharge is unwanted electrical activity which is present is approximately 80% of oil filled power transformers. Low level PD activity may continue for the entire life of the transformer. It is when this insulation breakdown gets to a point that threatens the life of the transformer that we are interested in. PD is similar to corona activity and occurs at the high voltage peaks. Most low level PD activity is load dependent. As the load increases the voltage decreases. When the voltage decreases the PD will decrease or disappear completely then return when the voltage returns to full value.

Figure 1: Transformer acoustic (top) and electrical activity on the same time line.

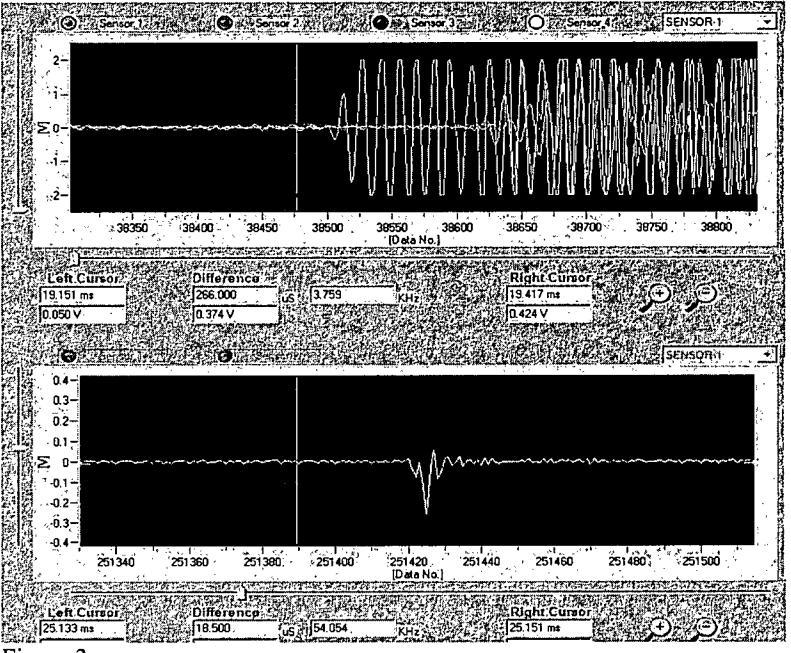
Figure 3:

Trending the deterioration process aids the asset manager in the deciding when to take action. Asset managers need to know what to do and when to do it to be able to avoid the up-coming failure. The acoustic and electrical are measured for amplitude and duration as shown in Figure 3. This is easily trended by comparing subsequent test results under similar conditions. The top screen shows the AE bursts with sensor #3 (blue) being closet to the source. The bottom screen shows the electrical burst captured from the case ground lead using the HFCT.

The burst captured by the HFCT (bottom screen of figure 3) was obtained by expanding one spike shown in the bottom screen for figure 1. This is the classic shape of PD activity.

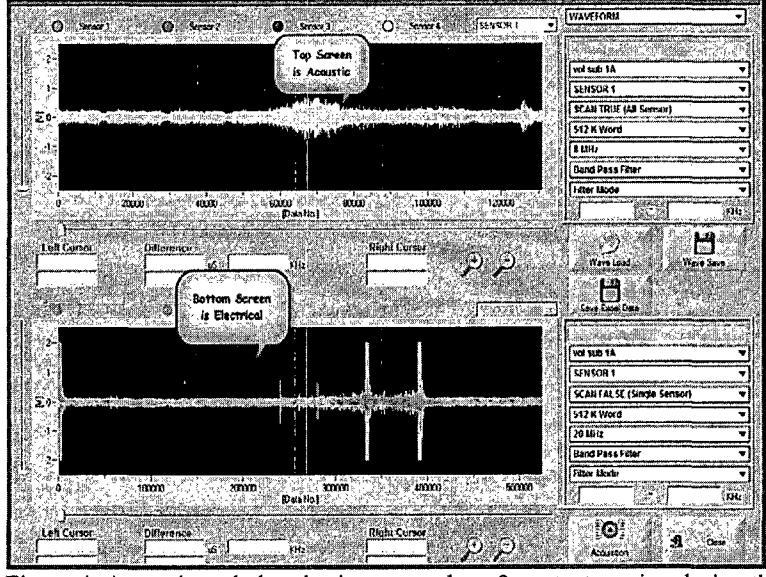
Figure 4 shows acoustic and electric signatures of a vacuum type LTC. The trace on the bottom screen indicates a problem with B phase of this transformer. The timing is off (not equidistant between contact operation) and also the activity just before and after the center burst indicates some electrical activity associated with poor contact quality.

Figure 4: Acoustic and electric signatures show 3 contacts arcing during the operation of a vacuum type LTC.

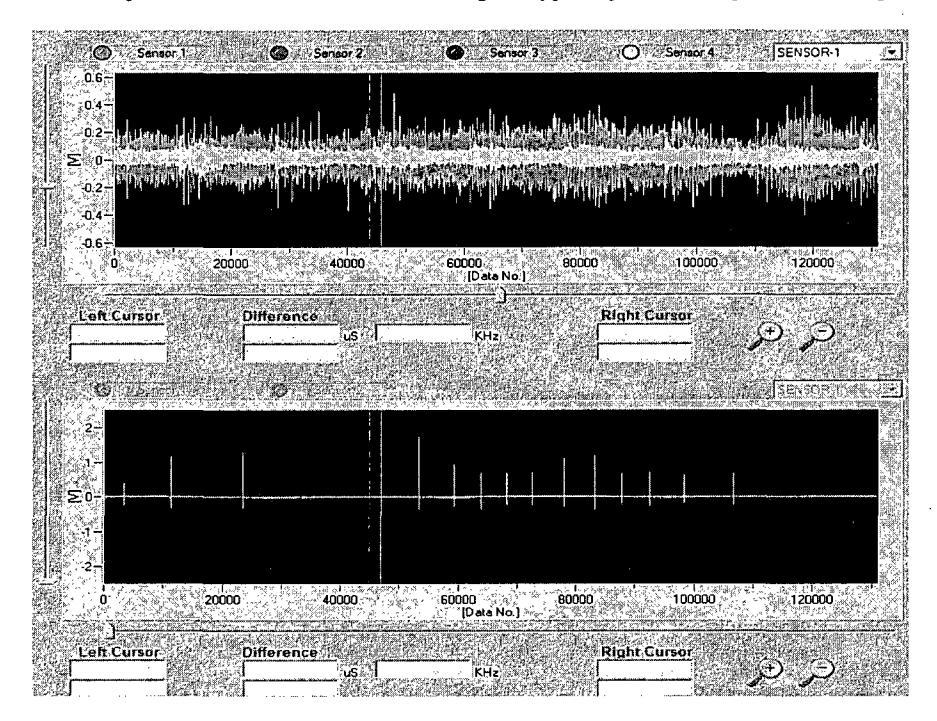
Figure 5 indicates a problem with this 500 kV lightning arrestor. The middle screen is showing activity from the arrestor and there should be none. The HFCT is on the arrestor ground lead above the strike counter. The acoustic activity on the top screen is from normal transformer noise. The bottom screen is a time expanded view of an electrical spike on the middle screen, showing the typical pattern of a problematic lightning arrestor.

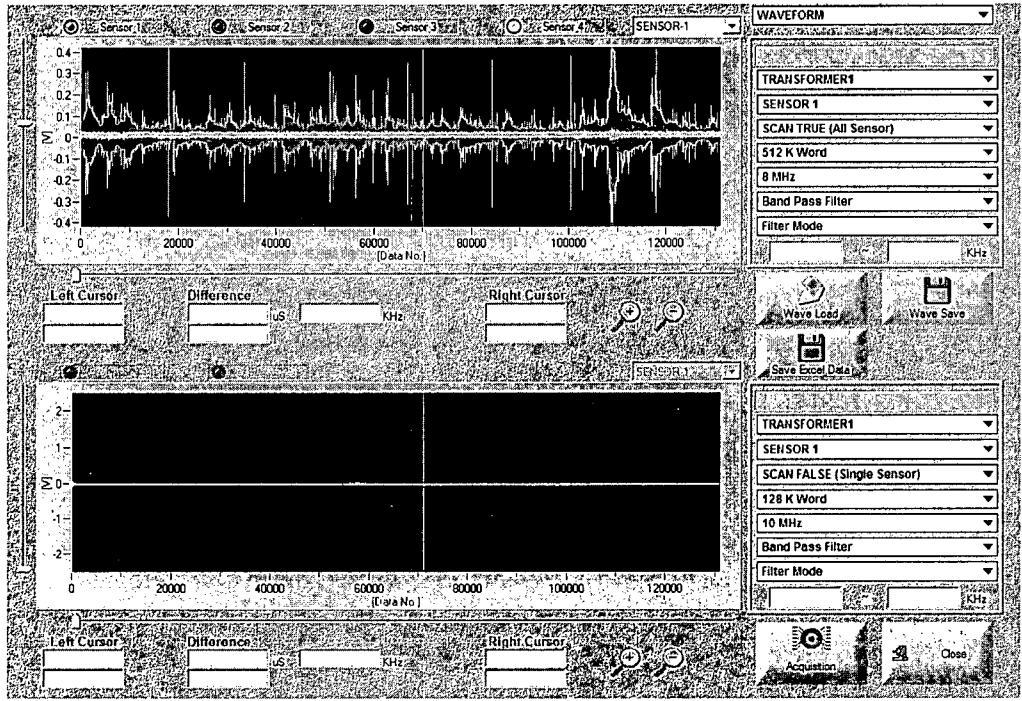
Figure 6 indicates a normal pump/motor. Figure 7 is from a pump/motor combination that has a rubbing problem in the impeller, which may circulate small metal particles into the transformer. No anomalies appear in the electric signal, but the acoustic signal has periodic noise on it.

Figure 7: Acoustic (top) and electric signature of a problematic transformer oil circulating pump/motor combination.

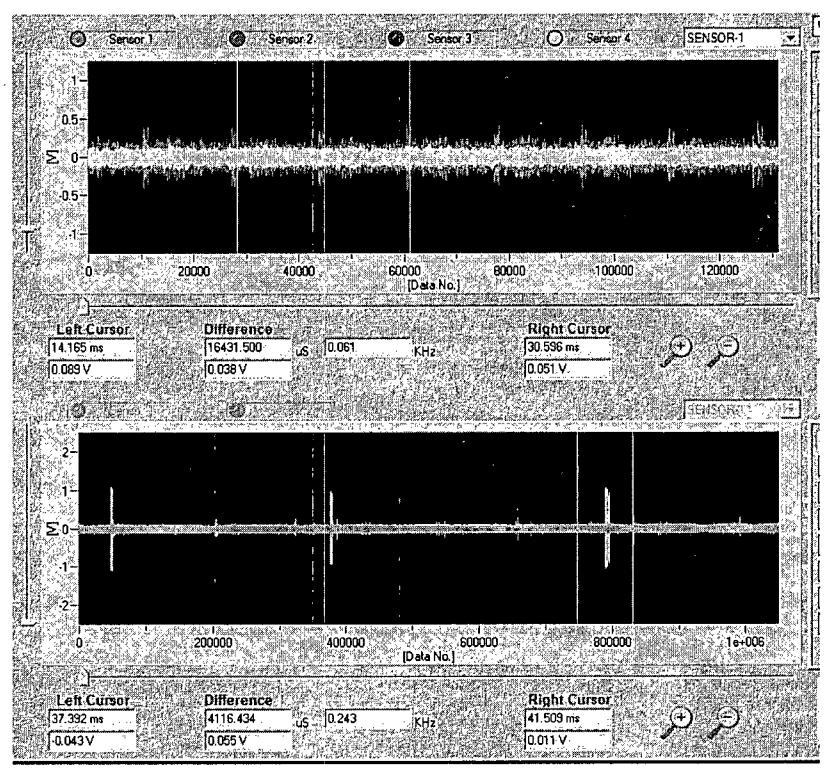
Figure 8 indicates arcing inside the main tank of an oil filled power transformer. A slight indication of PD is present in the top screen, sensor #2 (red). The cursor measures one full sign wave.

Figure 8: Acoustic (top) and electric signatures of a transformer with internal arcing in the main tank.

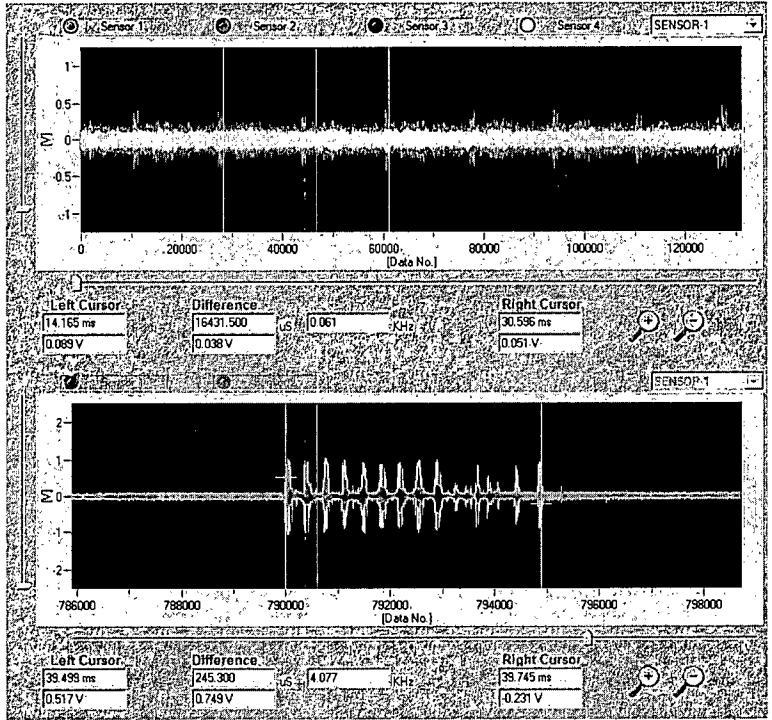
Figure 9: Time-zoomed view of a spike shown in figure 8 showing it is really a series of short bursts lasting 245 uS; this is an arc.

Figure 9 shows the expanded burst from fig. 8. The duration of this arc is 245 micro-seconds. Notice that the single burst in fig. 8 is really a series of bursts.

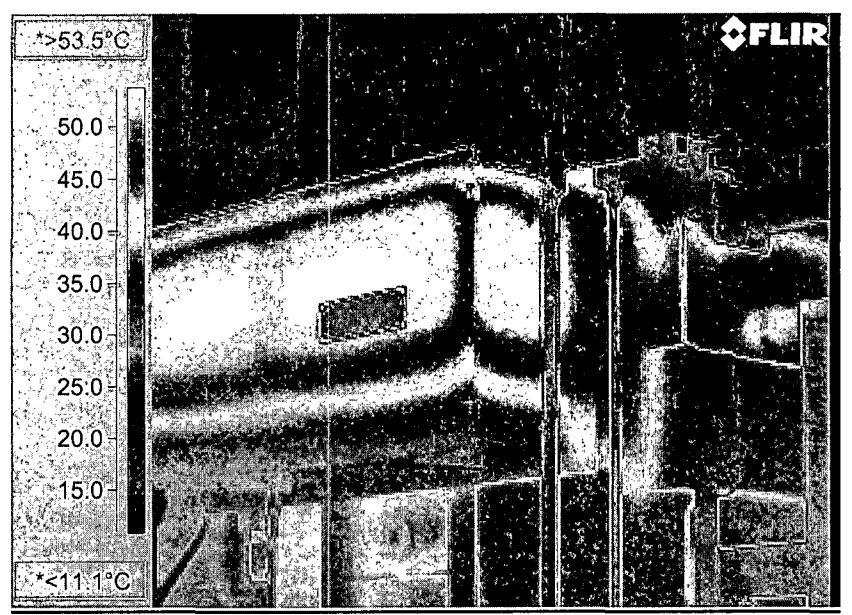
Figure 10: IR Image of a FAILING Load Tap Changer (LTC)

Load Tap Changers are an electrical device, very similar to a circuit breaker that gets a lot of use. There are contacts inside of tap changers that both wear out and begin to overheat or contacts which begin to overheat due to high resistance and excessive carbon from arcing. LTC's should be 5 to 10 C cooler than the main tank at the same elevation. The profile temperature, top to bottom should not exceed 10C. There are cases where the combination of high ambient temperatures and recent running of the cooling system make the LTC appear hotter than normal. Figure 10 is an IR image of a problematic load tap changer. Performing an off-line evaluation of an LTC requires a good deal of labor and is time consuming. When we find such problems with IR, we usually recommend further diagnostics such as DGA of an oil sample or acoustic/electric testing mentioned above.

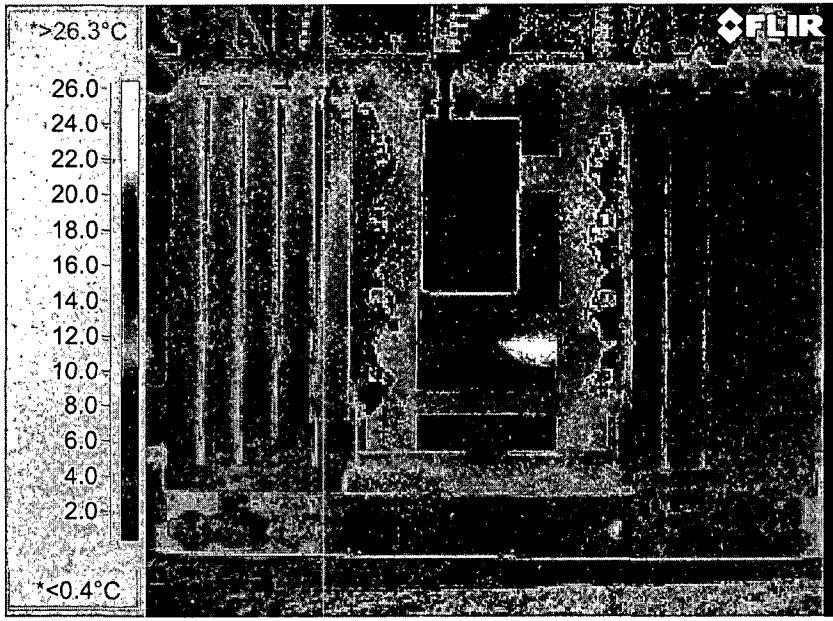
Figure11: IR Image of a FAILING Cooling System

Figure 11 is an IR image of a cooling system that is only working at 50%. A 50% loss of cooling is critical during the summer and in high loading conditions. The cooler on the right is operating normally with some overheating of fan motors. The left side cooler is not working at all. The image indicates no flow thru this cooler. Remember from all training given on the cooling system, the normal flow in a cooler is top to bottom whether pumped or natural flow. The cause of this anomaly was a sheared key on the pump motor shaft. This allowed the shaft to rotate within the impeller. Notice the pump motor on the right is hot compared to the left side. The heating near the bottom of the left side is from back pressure, reverse flow from the other cooler.

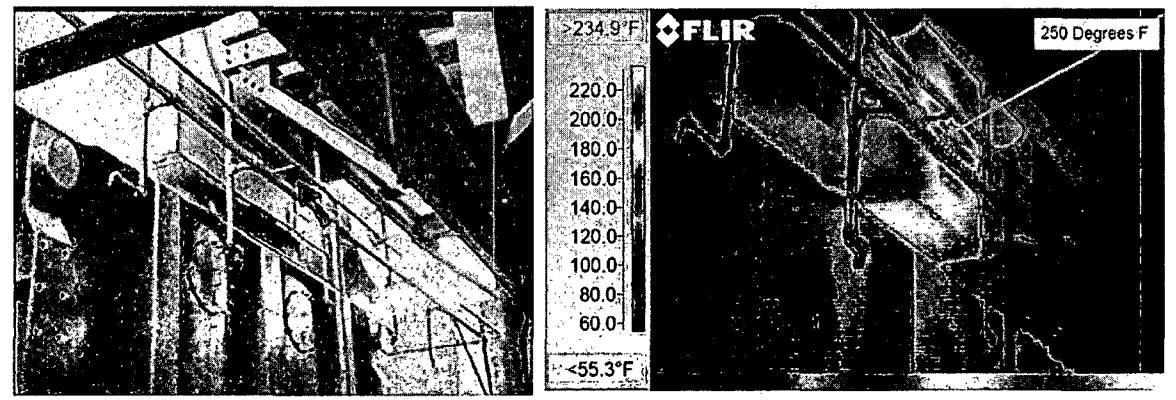
Figure 12 shows a portion of an enclosure on a generator step-up transformer, low voltage side at the Seabrook Nuclear Generating Station [1]. Many times there is heating due to circulating current in this area, but this appeared to be a high resistance connection within the bus; most likely caused by the connection to the low side bushing.

Figure 12. IR Image of a FAILING Indirect Connection. Courtesy R. Bjornson, Seabrook Nuclear Generating Station. Ref 1.

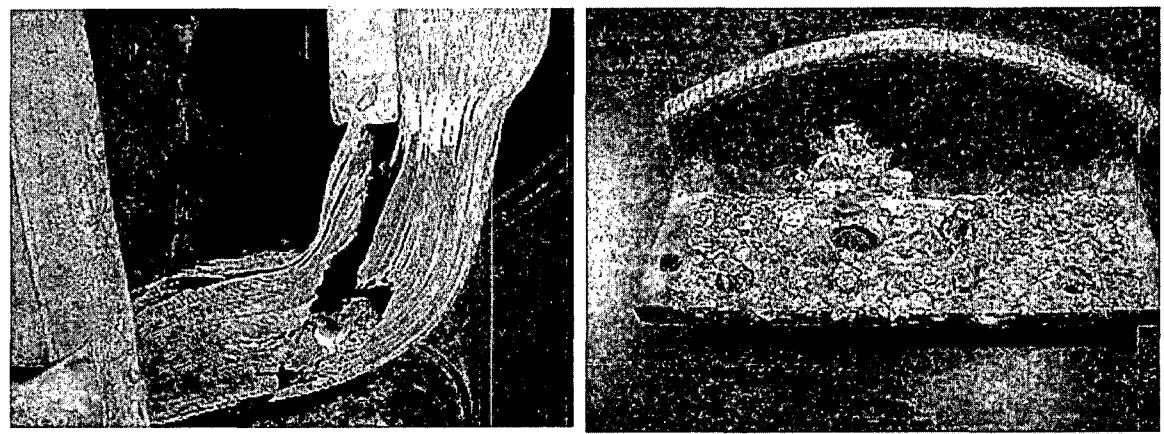
Figure 13 shows some of the internal damage due to an overheating leaf connection between the iso-phase bus and the transformer bushing. The utility estimated a \$30,000,000 cost avoidance for this IR thermography find.

Figure 13. Overheating leaf connection approaches failure. Right hand image shows where heating has caused aluminum to melt. Courtesy R. Bjornson, Seabrook Nuclear Generating Station. Ref 1.

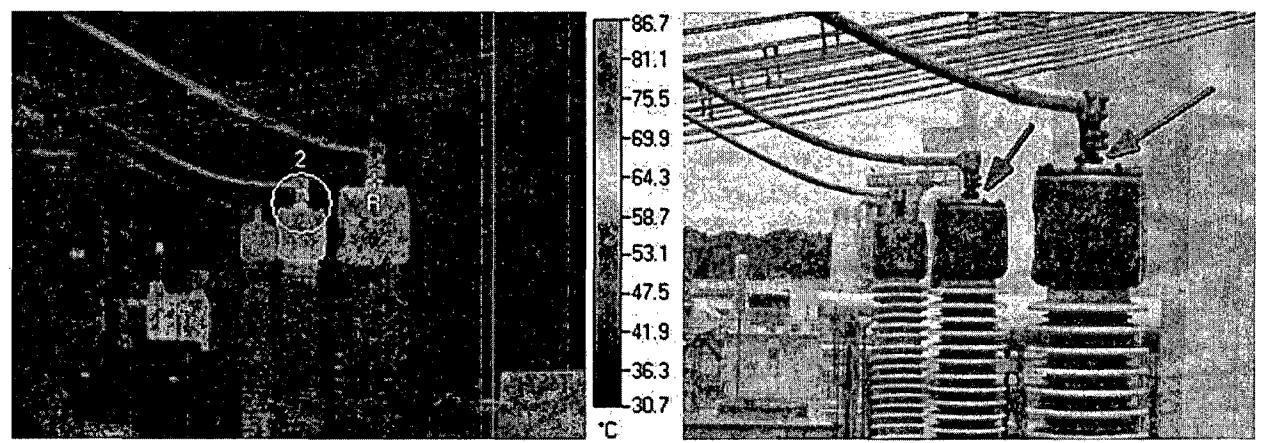
Figure 15 shows a primary termination to a transformer bushing. The image was taken from a man-lift. Getting different angles is very important to making a correct assessment. This is a GE Type "U" bushing, notice the bolting to the cap, similar to the above image. <u>However, this problem is the stud and expansion chamber and not the primary termination.</u>

Figure 15. Primary termination to a transformer bushing showing a severe problem.

This is a 40C temperature rise measured from the initial position standing on the ground. This image from the man-lift indicated a 67C rise. The actual measured temperature at the stud entrance is 125C.

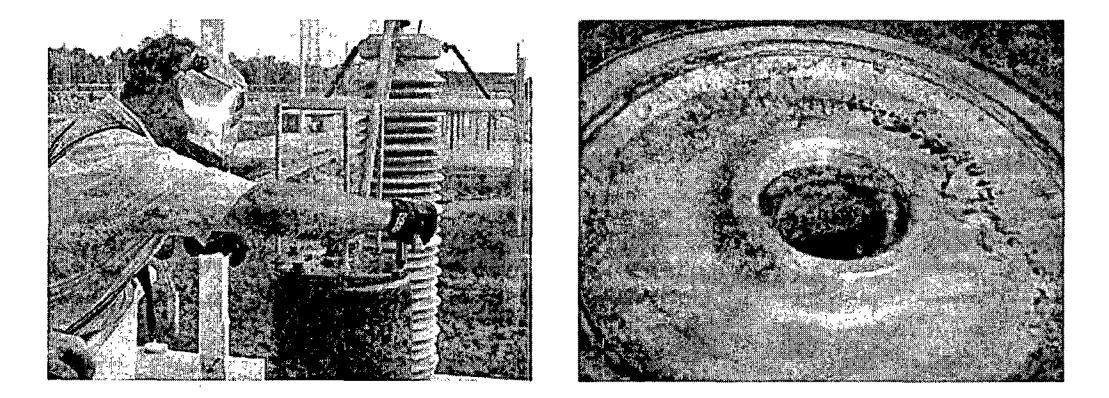
Figure 16. Substation tech dismantling the bushing cap assembly. Right hand photo shows melted threads and baked on oil deposits.

The substation tech was unable to remove the center stud due to melting. The right side image is the under side of the bushing cap showing melted threads and baked on oil deposits. Molten metal had dripped to the bottom of the conductor tube. This was very close to a catastrophic failure. A \$4.5 million dollar cost benefit was assigned to this equipment save by the utility.

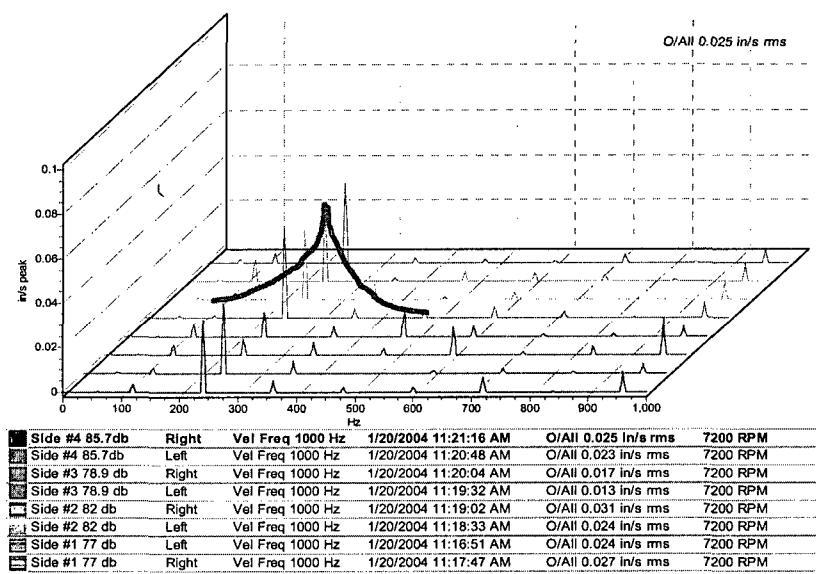
Case study #2 is a 1667 KVA unit (very small) Load at the time of this test was unknown, but average load is 80 to 120 amps. Notice that the 120 Hz has dissipated and the energy in the spectrum has shifted to the right to 240 Hz. This gives an abnormal slope shown by the hand drawn red line in the plot of Figure 18 and indicates looseness. Average sound level during this test is 81db. The sound level on this unit was 8 to 12 db higher than

on similar units at the same load. This condition occurs in approximately 2% of all transformers. An SFRA test was done on this unit which indicated some abnormalities.

Figure 18. Case study #2 waterfall vibration plot. Energy is shifted to higher frequencies in this core form transformer. The red line is hand drawn to show abnormal slope due to energy shift of a loose transformer.

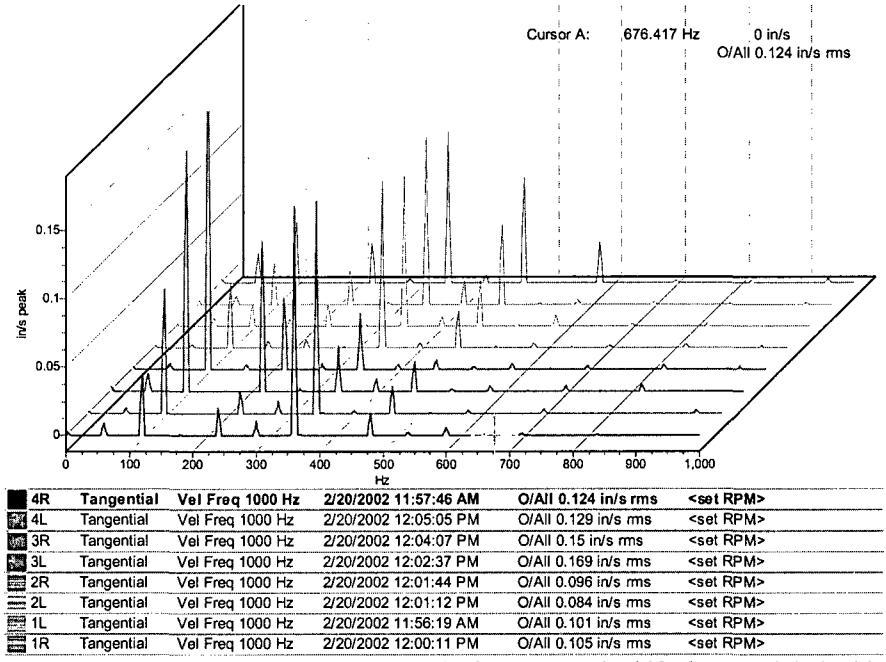
Case study #3 shown whose vibration waterfall plot is shown in Figure 19 is a 100 MVA unit loaded at 6 MW. The energy shift has moved to 360 Hz with some 480 Hz starting to show up. Notice that where the most of the energy is at 120 Hz the 360 is lower. The average sound level on this unit was 92 db, which brought on many complaints from homeowners in the surrounding area. Due to the noise related complaints this transformer was inspected using vibration and sound level. The combination of sound level and the energy shift made this an easy candidate for inspection. This unit was shipped offsite for inspection and tightening. The report from the factory indicated many loose clamping bolts.

Figure 19. Case study #3 vibration waterfall plot. Energy is shifted to the right in this core form transformer.

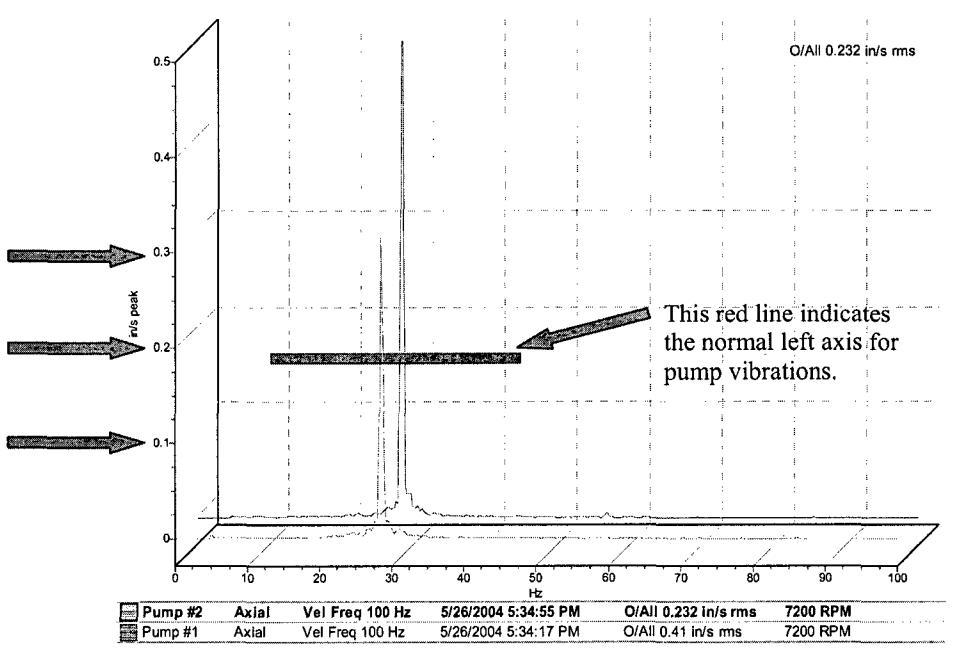
Figure 22. Waterfall vibration plot of abnormally operating cooling oil circulating pumps.

The arrows at the left indicate the three alarm levels used in axial pump vibration. Notice that pump #1 in Figure 22 has exceeded all three levels, while pump #2 is approaching the highest severity level. This condition is unacceptable and should be addressed.
