# A Review of Criticality Accidents

2000 Revision

LA-13638 Issued: May 2000

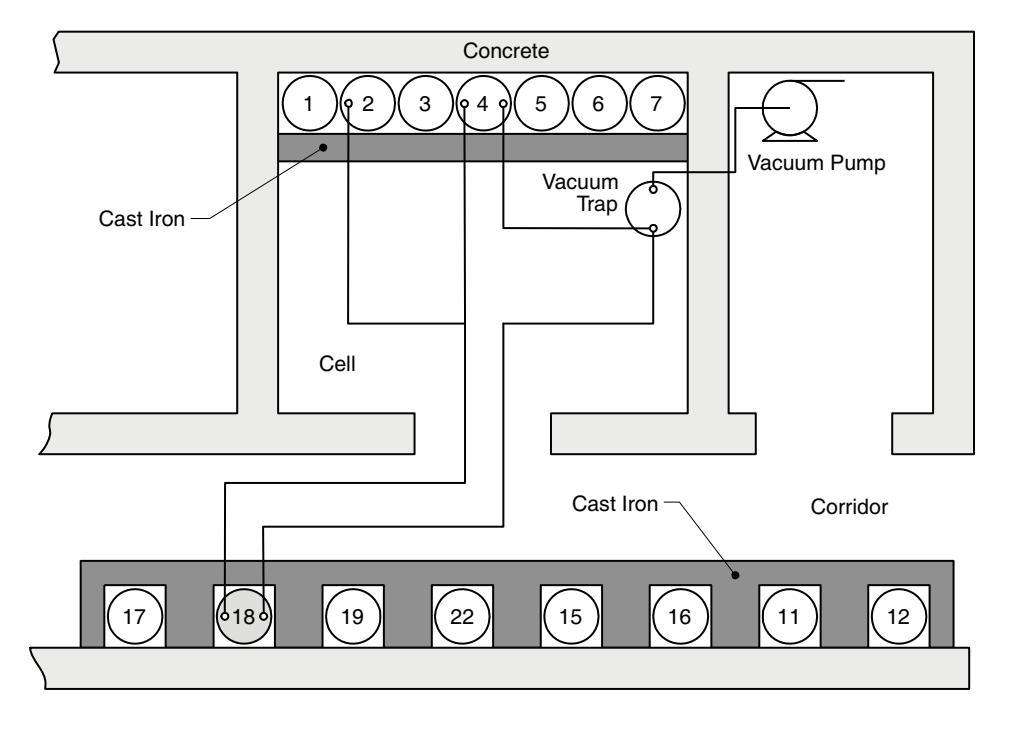
Figure 6. Layout of vessels and equipment in the staging area.

On Sunday, 15 March 1953, the written instructions alerted shift personnel that two transfers of plutonium solution were scheduled to arrive at the vessels in the concrete cell. Table 1 shows the contents of the seven vessels as recorded in the operational log before the accident. It should be noted that in violation of procedures, vessels 2 and 4 were in use, and the 500 gram mass limit was being ignored. A plan was prepared to receive the first transfer of plutonium solution. The plan specified that the contents of vessels 2 and 4 were to be transferred to vessel 18, which was located in the second array. The operational log showed vessel 18 was empty. Based on the values in Table 1 and the assumption that vessel 18 was empty, this transfer would result in vessel 18 having the solution volume and plutonium mass given in Table 2.

Two operators performed the transfer of solution from vessels 2 and 4 to vessel 18. One operator was positioned next to vessel 18 and the other was in the cell near vessels 2 and 4. Following completion of the transfers, the operator next to vessel 18 disconnected the hose. Immediately after disconnecting the hose, the operator noticed foaming and violent gas release from the vessel. With his hands the operator also observed that the vessel temperature was elevated well above room temperature. The operator in the cell noticed that solution had accumulated in the glass vacuum trap. The operator in the corridor immediately reconnected the transfer hose to vessel 18. Both operators then decided to transfer the contents of vessel 18 back to vessel 4. The loss to the vacuum trap during the excursion explains why criticality did not re-occur during this transfer. Water and nitric acid were then added to vessel 4 to dilute and cool the contents. The operators then split the contents of vessel 4 by transferring it to vessels 22 and 12 located in the corridor.

As part of the investigation, both experiments and calculations were performed to estimate the conditions for criticality in vessel 18. The results determined that 30  $\ell$  of solution containing 825 g of plutonium (27.5 g/ $\ell$ ) would be required for criticality. These values agree closely with the best estimate of the contents of vessel 18 at the time of the accident, 31  $\ell$  of solution with 848 ± 45 g of plutonium (27.4 g/ $\ell$ ). One contributing cause of the accident was the unrecorded transfer of 5  $\ell$  of solution from vessel 1 to vessel 18.

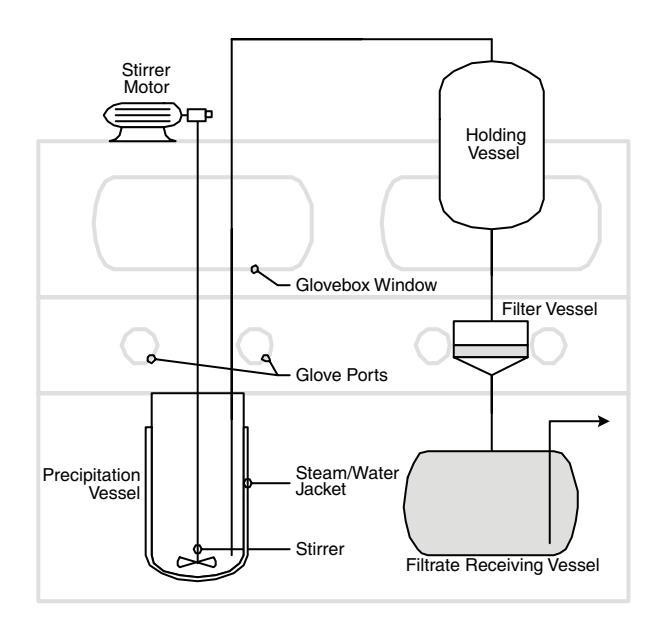
Figure 7. Equipment layout for the oxalate precipitation and filtration process.

- While not known for sure, it was suspected that minor defects in the filter fabric might also have contributed to an increased rate of precipitate accumulation in the filtrate vessel. Procedures called for the filter fabric to be replaced based on either visual evidence of defects or unusually high flow rates through the filter.

The criticality accident occurred during what was thought to be routine vacuum filtration of a batch of uranyl oxalate trihydrate precipitate slurry. Looking though the glovebox window, the operator observed the filter vessel fabric bulge upward, followed by a violent release of gas and ejection of some of the precipitate out of the filter vessel and onto the glovebox floor. The operator instinctively gathered up the precipitate by hand and put it back into the filter vessel. Immediately after (seconds, not minutes), the operator began to feel ill. The release of gas or vapor continued for about 10 minutes, at which time sufficient solution had been ejected from the filtrate receiving vessel into the vacuum trap of an adjacent glovebox to cause the excursion to stop.

After dismantling the glovebox and cleaning the various pieces of equipment, a total of 3.06 kg of <sup>235</sup>U was discovered in the filtrate receiving vessel. This material was primarily in two forms: a thin, hard crust, due to long-term buildup, and a flocculent precipitate, the concentration of which decreased with height in the vessel. The accident caused no mechanical damage to this vessel, and the room was not contaminated. The glovebox was taken apart, cleaned, and reassembled with essentially the original equipment. The operation was resumed after just a few days. During the down-time, a radiation meter was installed on the glovebox, operating instructions were revised, and enhanced operator training was implemented.

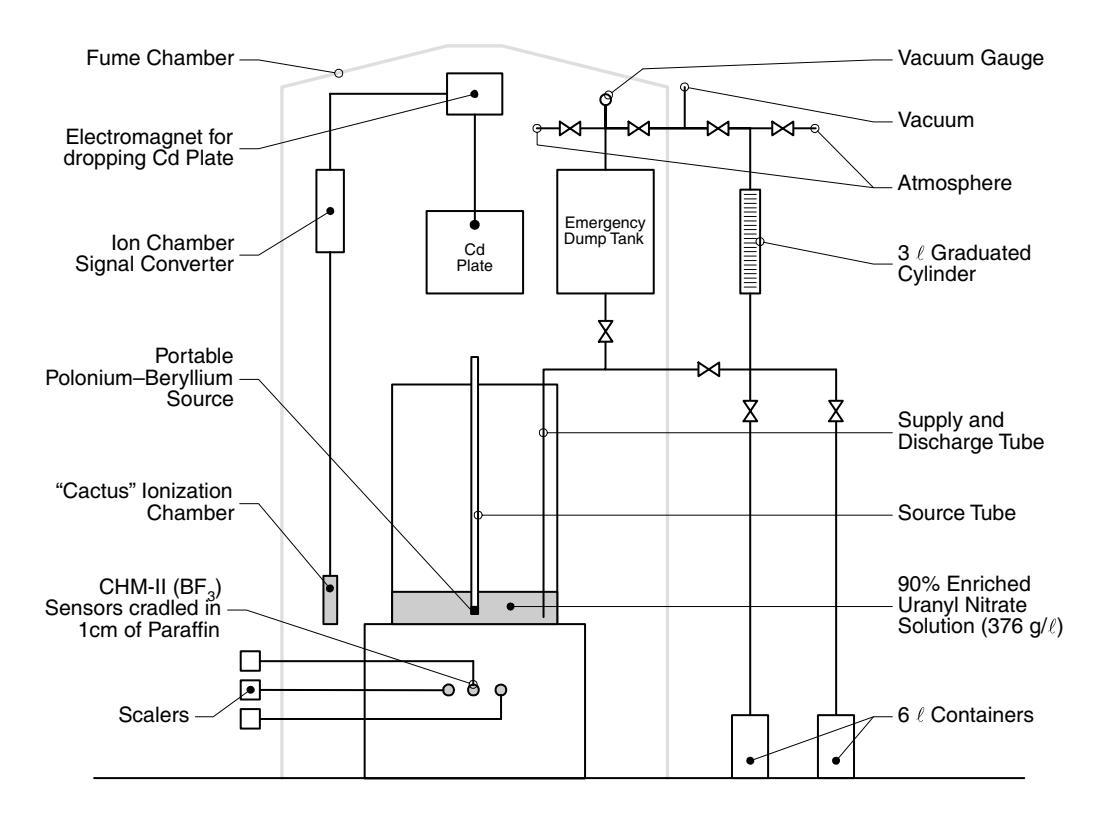
Figure 8. Layout of the experimental equipment.

They immediately noticed a flash (due to Cherenkov radiation), and simultaneously, fissile solution was violently ejected, reaching the ceiling about 5 m above. The three experimenters dropped the vessel and, along with a fourth experimenter who was located about 2.5 m away from the excursion, went immediately to the change room, showered, and were transported to the hospital. The combination of additional reflection from the three experimenters and the change in the geometry of the solution volume was sufficient to cause the system to exceed prompt critical. The small neutron background, estimated at only 100 neutrons per second, apparently also contributed to delayed initiation and thus to increased excursion energetics.

- Violation of the procedure that stipulated the complete draining of the experiment solution into 6 liter bottles.
- Unbolting and removing the experiment vessel when it contained solution. This was not specifically permitted in the operating procedure.
- The design of the experiment stand that made it relatively easy to unbolt and remove the experiment vessel.
- The additional reflection provided by the operators and by lowering it closer to the floor.
- The lack of knowledge and awareness of the operators as to the large reactivity changes that can occur with shape changes of solutions having H/D << 1.

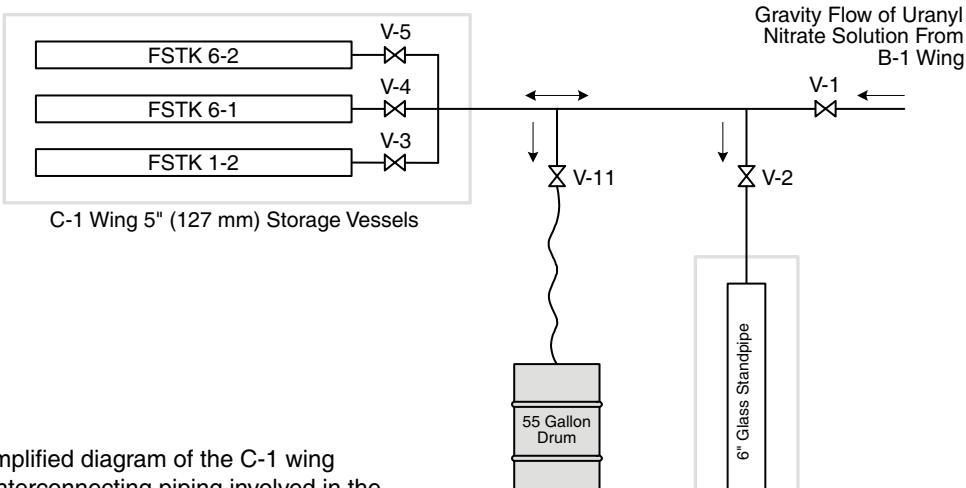
Figure 9 is a simplified diagram of the C-1 Wing vessels and equipment involved in the accident. The inventory required the disassembly and cleaning of the three, 5 inch (127 mm) diameter vessels\* (FSTK 1-2, FSTK 6-1, FSTK 6-2) used to store uranyl nitrate solution. Before resumption of operations, it was necessary to reassemble and to leak test the vessels. This entire process usually required several, 8–hour shifts to complete.

Unknown to anyone at the time, uranyl nitrate had been leaking from the B-1 Wing through valve V-1 from the early hours of the previous shift until about 13:30, when one of the operators checked it (and by applying pressure completely closed the valve), as instructed by the supervisor. Before this, the uranyl nitrate had been collecting in vessel FSTK 1-2, because valve V-3 had also been open.

Figure 9. Simplified diagram of the C-1 wing vessels and interconnecting piping involved in the accident.

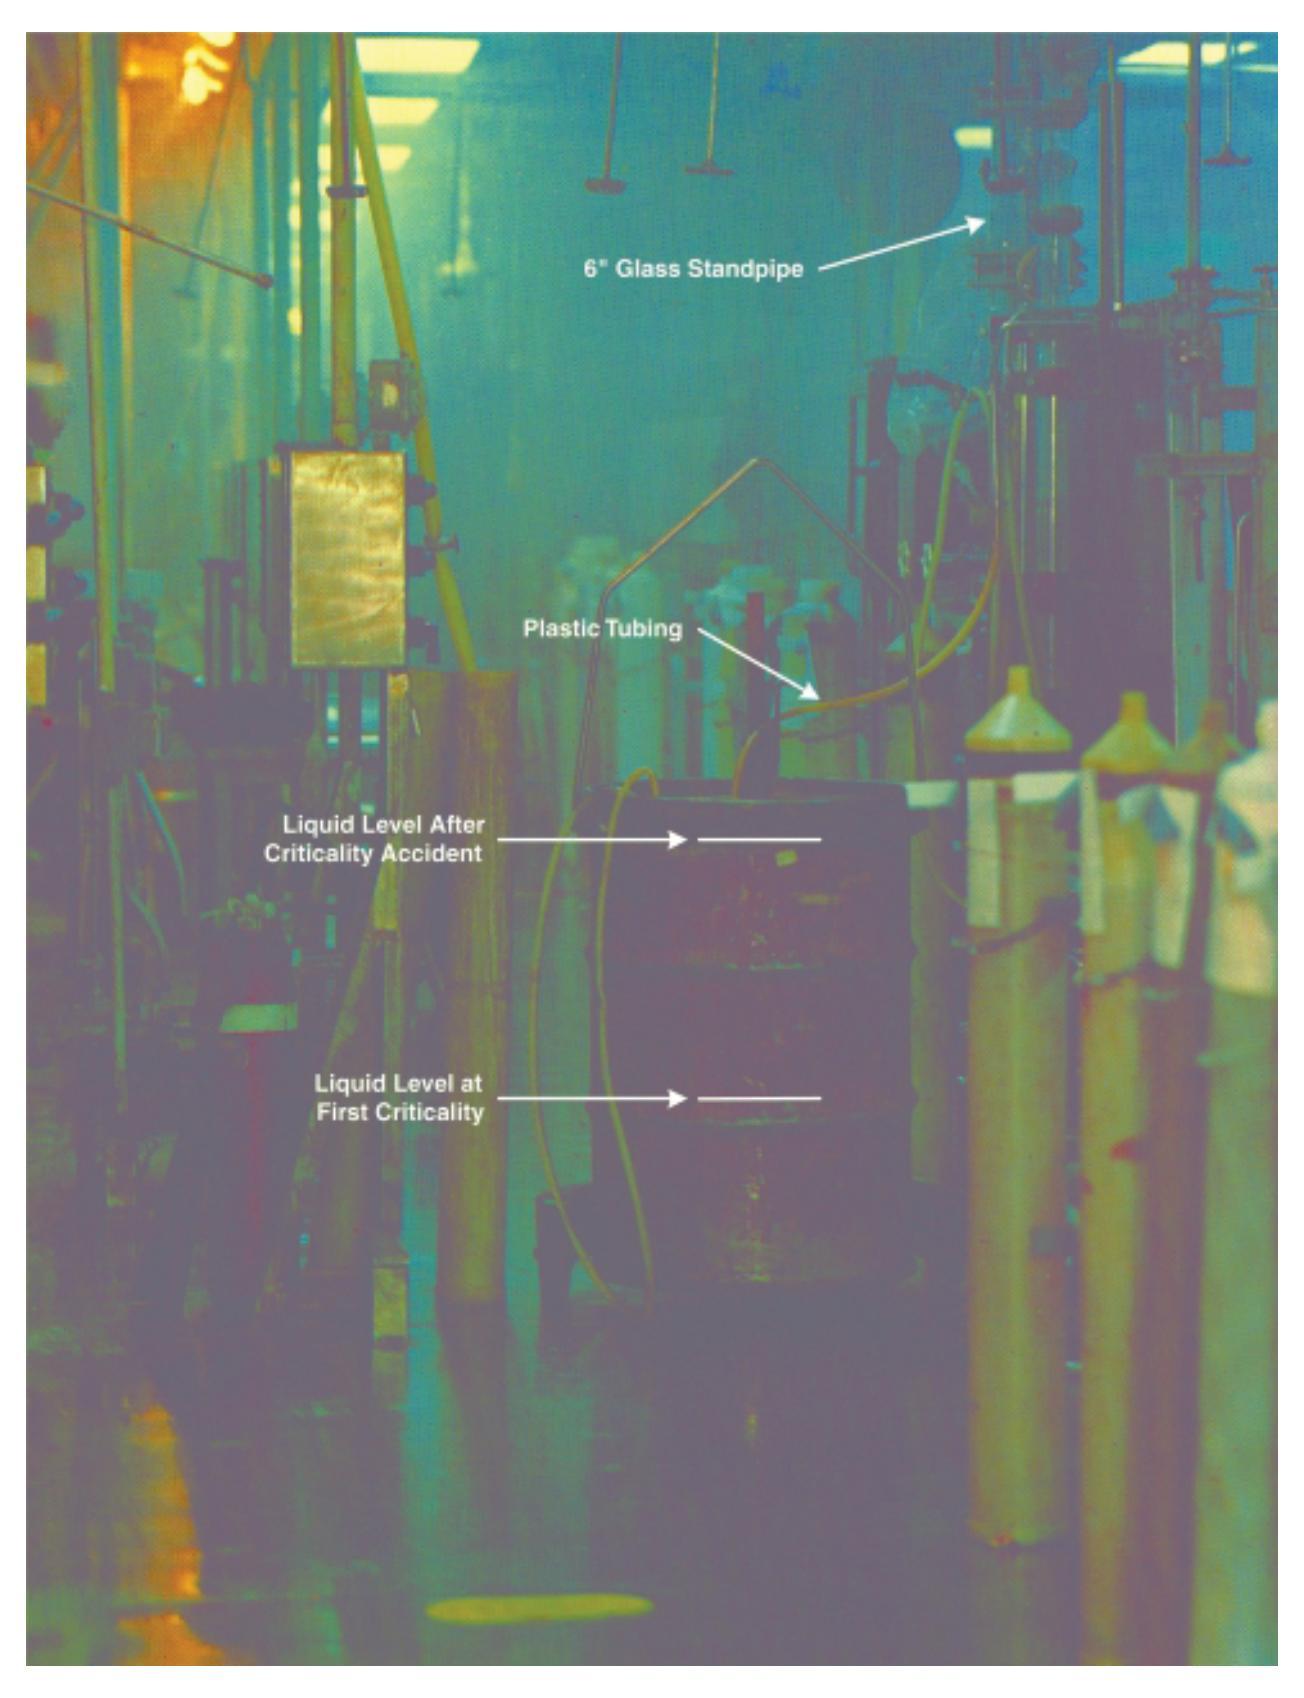
The trace suggests that most of the fissions occurred in the first 2.8 minutes, in which case the average power required to account for the observed yield is about 220 kW. After this, the system probably started to boil, causing a sharp decrease in density and reactivity and reducing the power to a low value for the final 18 minutes.

Figure 10. Drum in which the 1958 Y-12 process criticality accident occurred.

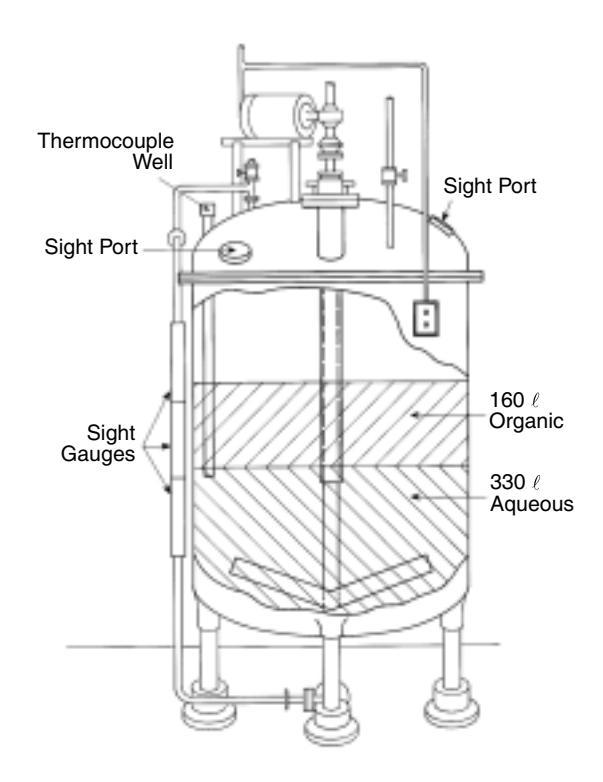
Figure 11. Configuration of solutions (aqueous and organic) in the vessel before the accident.

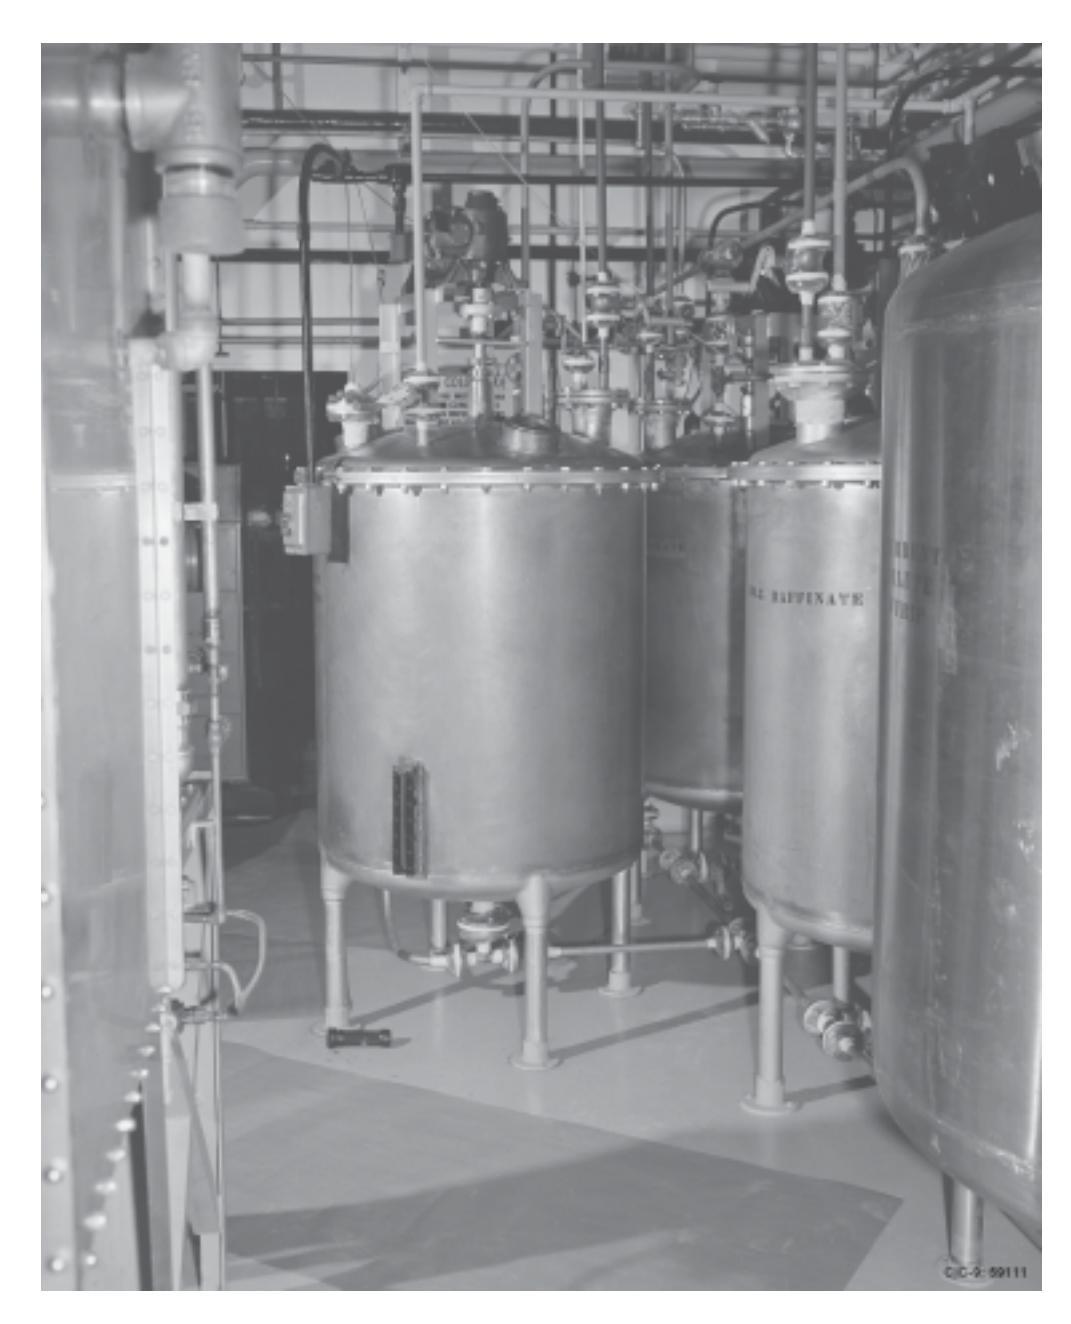
The accident resulted in the death, 36 hours later, of the operator who was looking into a sight glass when the motor was turned on. The dose to his upper torso was estimated to have been  $12,000 \pm 50\%$  rem. Two other persons apparently suffered no ill effects after receiving radiation doses of 134 and 53 rem. No equipment was contaminated or damaged even though the shock associated with off-axis bubble generation displaced the tank about 10 mm at its supports.

Figure 12. Vessel in which the 1958 Los Alamos process criticality accident occurred.

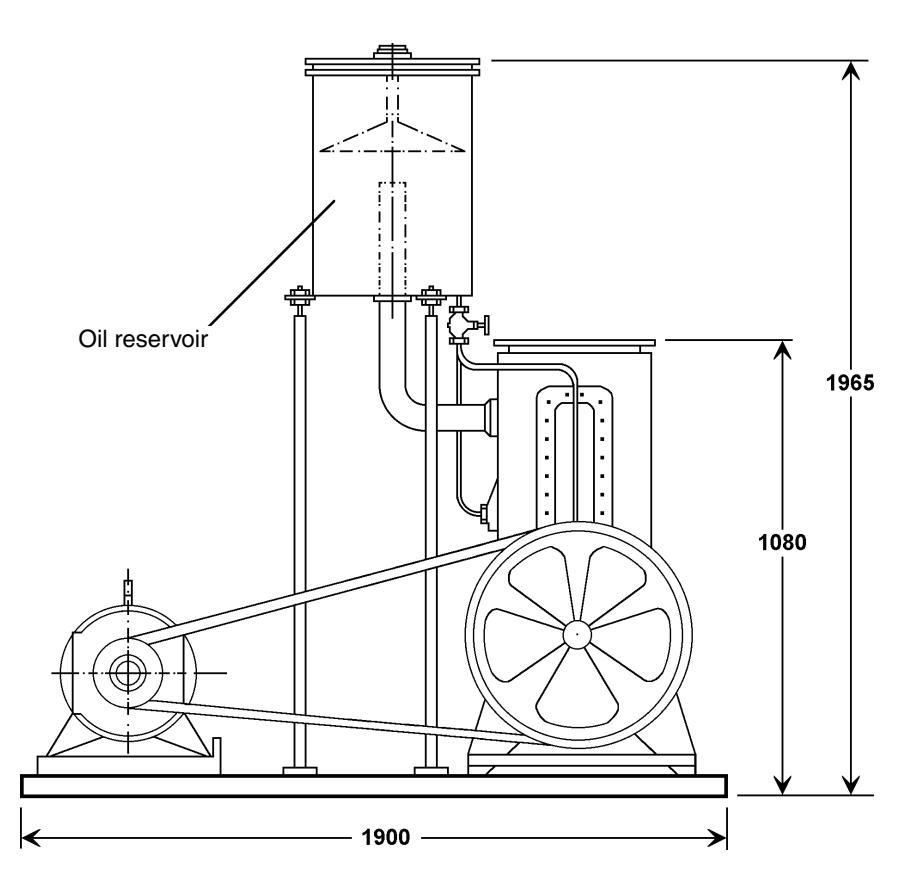
Figure 15. Vacuum pump diagram showing oil reservoir (Dimensions are in mm).

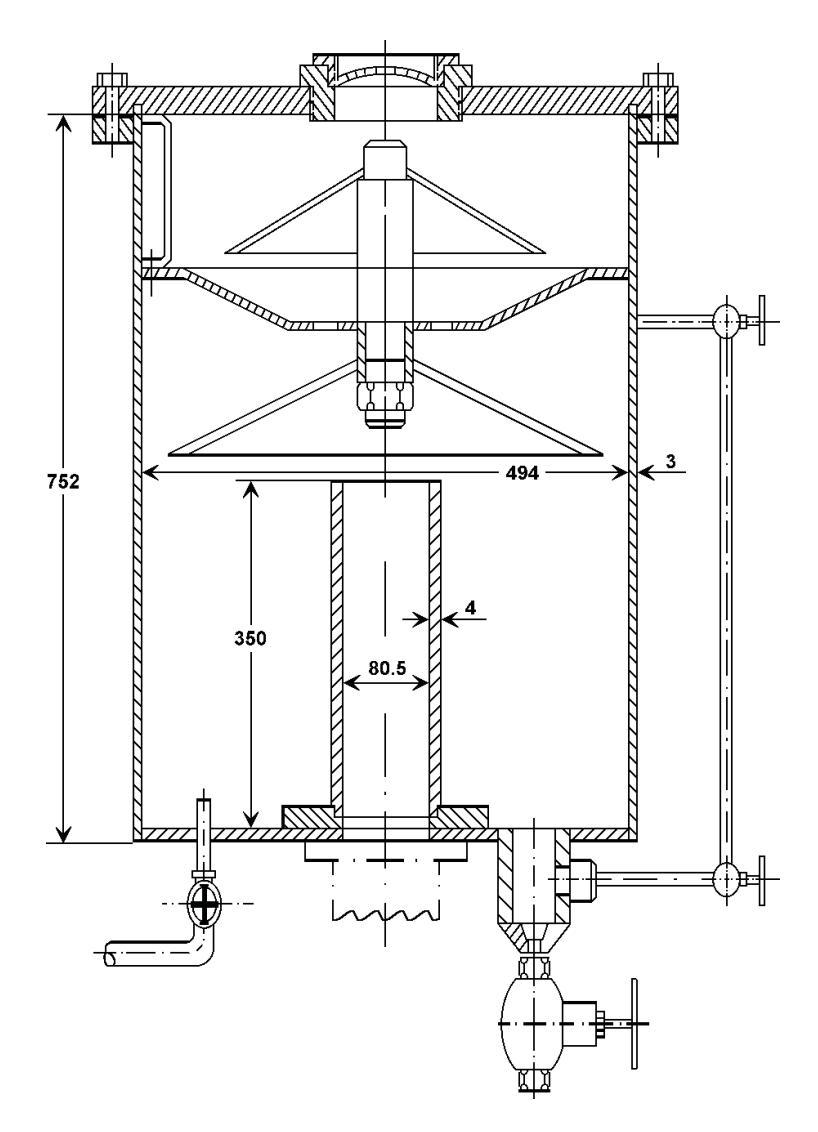
When the pump was turned on at 07:30, the oil in the pump's cavities was forced out into the central pipe of the oil reservoir. This sudden injection of oil containing uranium led to the second and much larger excursion. The shutdown of this excursion was due to a combination of temperature rise and radiolytic gas generation, which caused ejection of the oil from this central pipe back into the pump's cavities and the gas purification equipment. As with the first excursion, the

Figure 16. Oil reservoir (Dimensions are in mm).

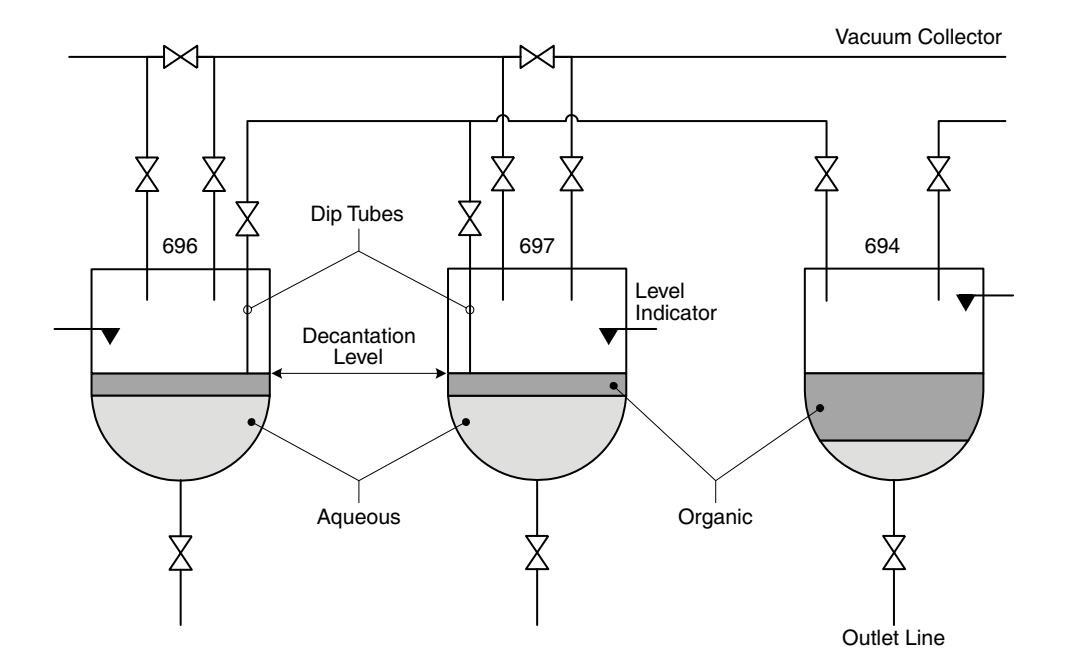
During typical operations, sufficient quantities of aqueous solutions would accumulate in vessels 696 and 697, causing the automatic decanting to occur up to four times per day. The elevation difference between the level indicator and the dip tube was slight, thus causing only 1 or 2  $\ell$  to be transferred at a time.

Figure 19. Schematic of vessels showing organic and aqueous solutions (not intended to imply the exact conditions at the time of the accident).

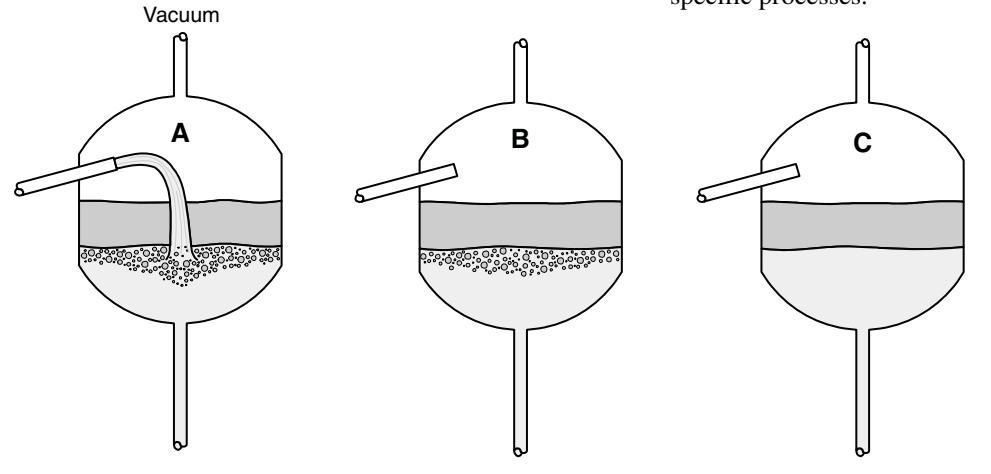
This excursion illustrates the subtle ways in which accidents can occur during solution processing. Although the deep trap was considered a safety feature for the control of contamination, it contributed directly to the criticality accident. The difficulty of understanding what had happened, even after it was known in which vessel the excursion occurred, is an excellent example of the impracticability inherent in attempting to calculate criticality accident probabilities for specific processes.

Figure 26. Solution transfer as reconstructed from the transparent plastic mockup of the transfer vessel. Configuration (B) is the postulated state at the time of the accident.

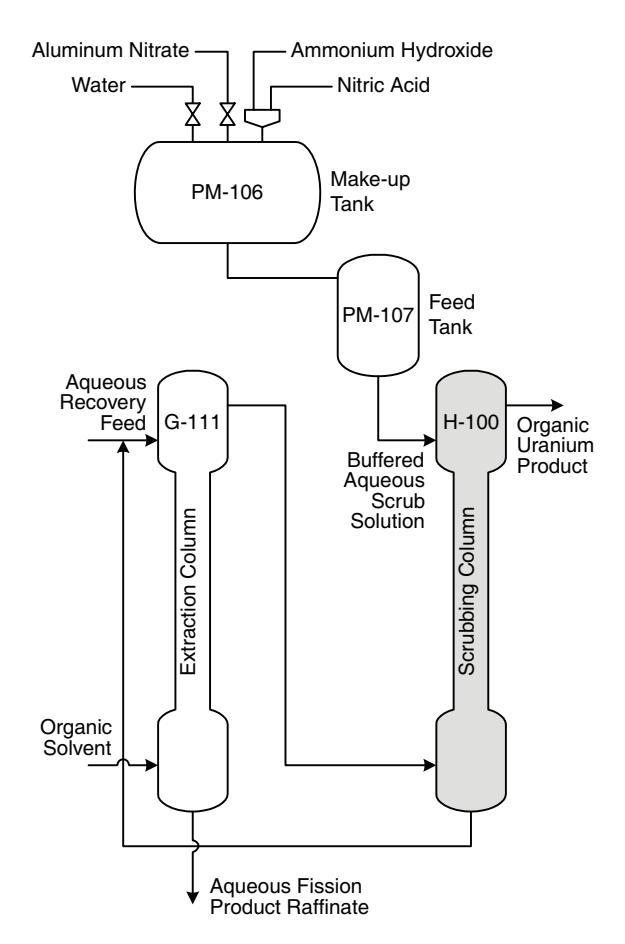
for the scrubbing column, H-100, had been leaking for about a month prior to the accident. Over time, this leak caused a dilution of the feed solution from 0.75 M to 0.08 M. The 13.400  $\ell$  make-up tank was equipped with a density alarm that would have indicated the discrepancy, but the alarm was inoperable. A density alarm was scheduled to be installed on the 3,000  $\ell$ process feed tank (PM-107) that was filled, as necessary, from the make-up tank, but this had not been done. The make-up tank was instrumented with a strip-chart recorder showing the solution level in the tank. However, the leak into the tank was so slow that the change in level would have not have been discernible unless several days worth of the chart was analyzed. To complicate matters, the chart recorder had run out of paper on 29 September and it was not replaced until after the accident. Furthermore, procedures that required the taking of samples from the feed tank, PM-107, to confirm the density, were not being followed.

Figure 27. First cycle extraction line equipment. The accident occurred in the lower disengagement section of the H-100 column.

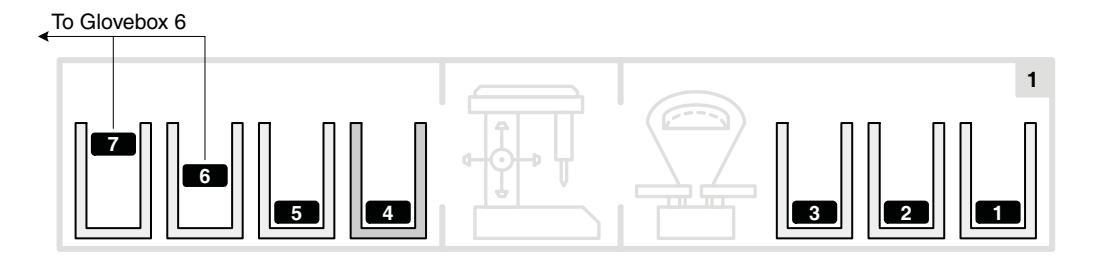
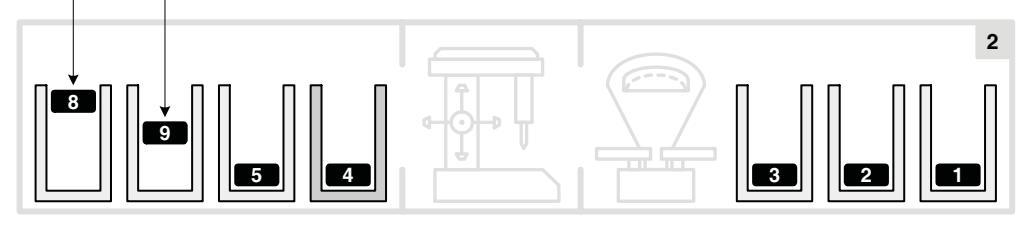
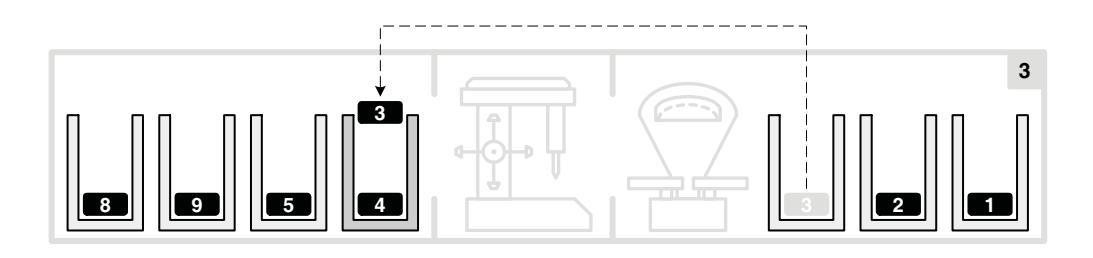
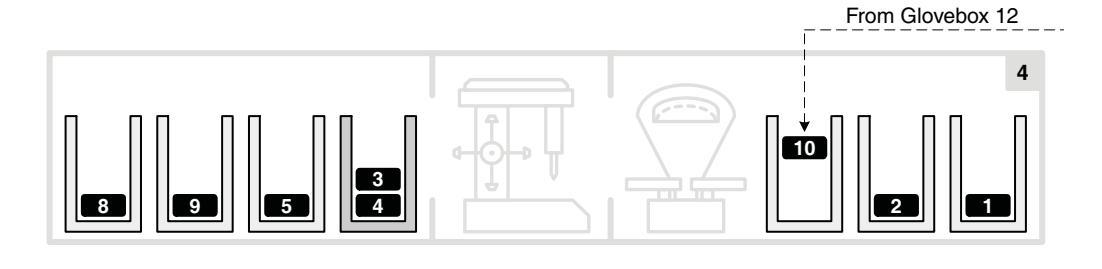
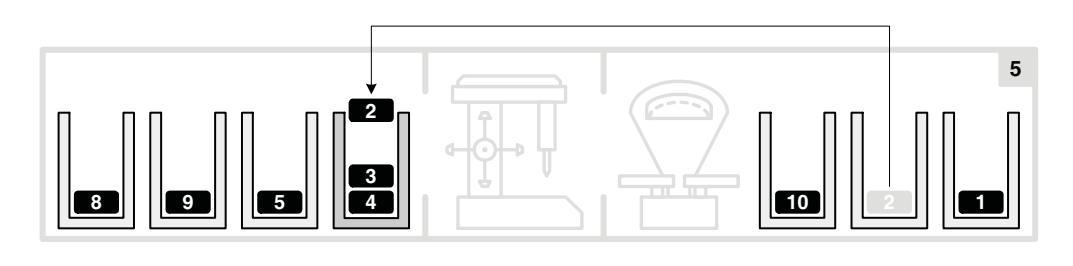
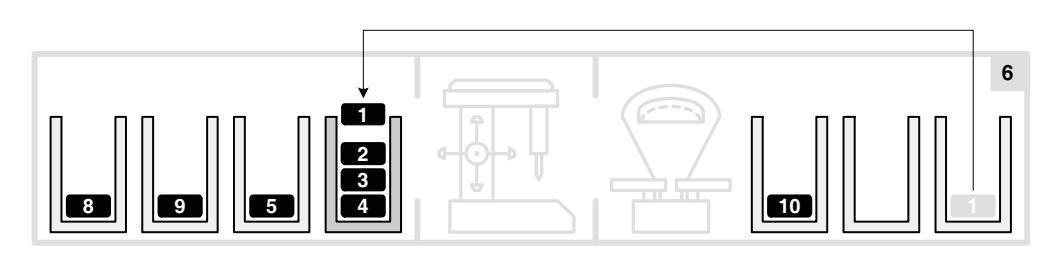
Figure 31. Actual order of ingot transfers from and to Glovebox 13. The solid lines represent the actions of operator A and the dotted lines the actions of operator B.

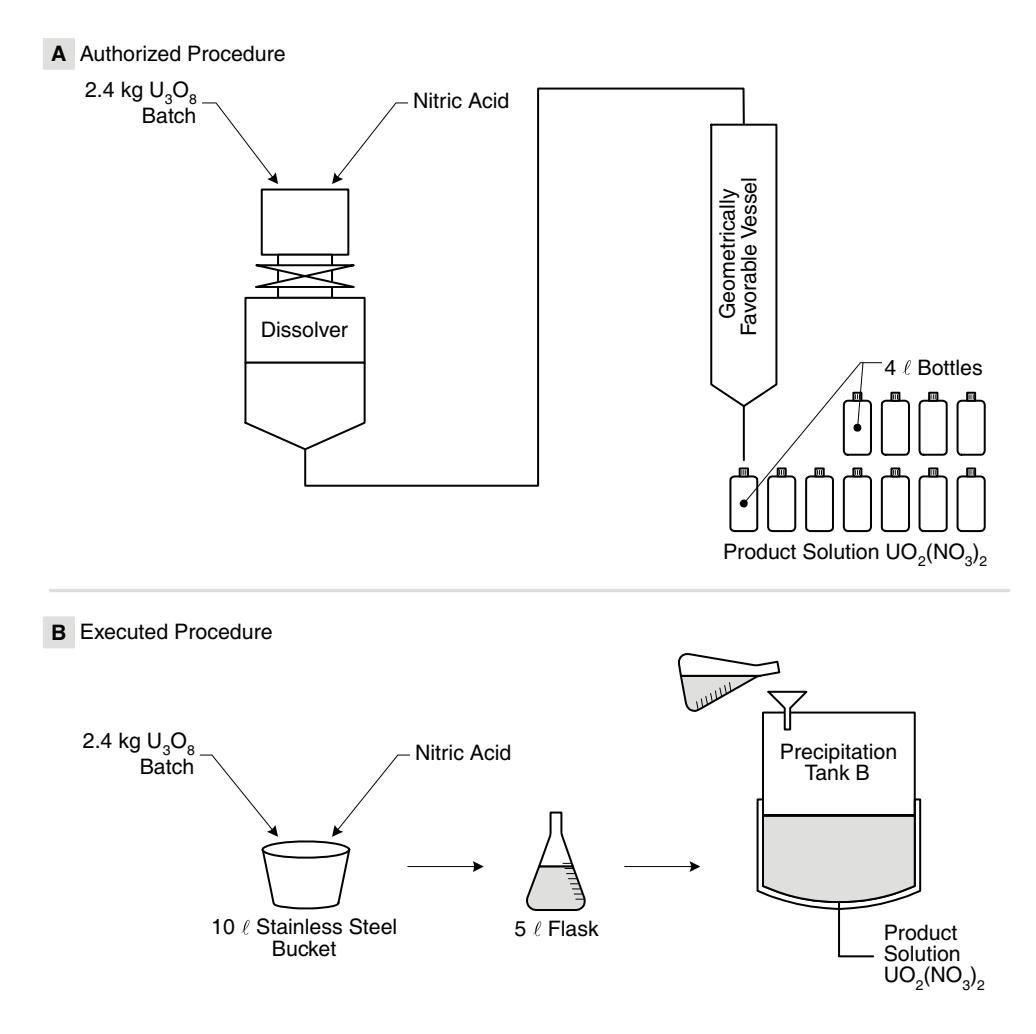
On 29 September the operators completed the dissolution of four, 2.4 kg batches. The solution was first transferred to a five liter flask and then hand poured through a funnel into the precipitation vessel. The precipitation vessel was 450 mm diameter by 610 mm high with a capacity of about 100 liters. Figure 35 is a photograph of the actual precipitation vessel, interconnected piping, ports through which materials could be added, and the stairs on which one

Figure 34. Authorized and executed procedures.

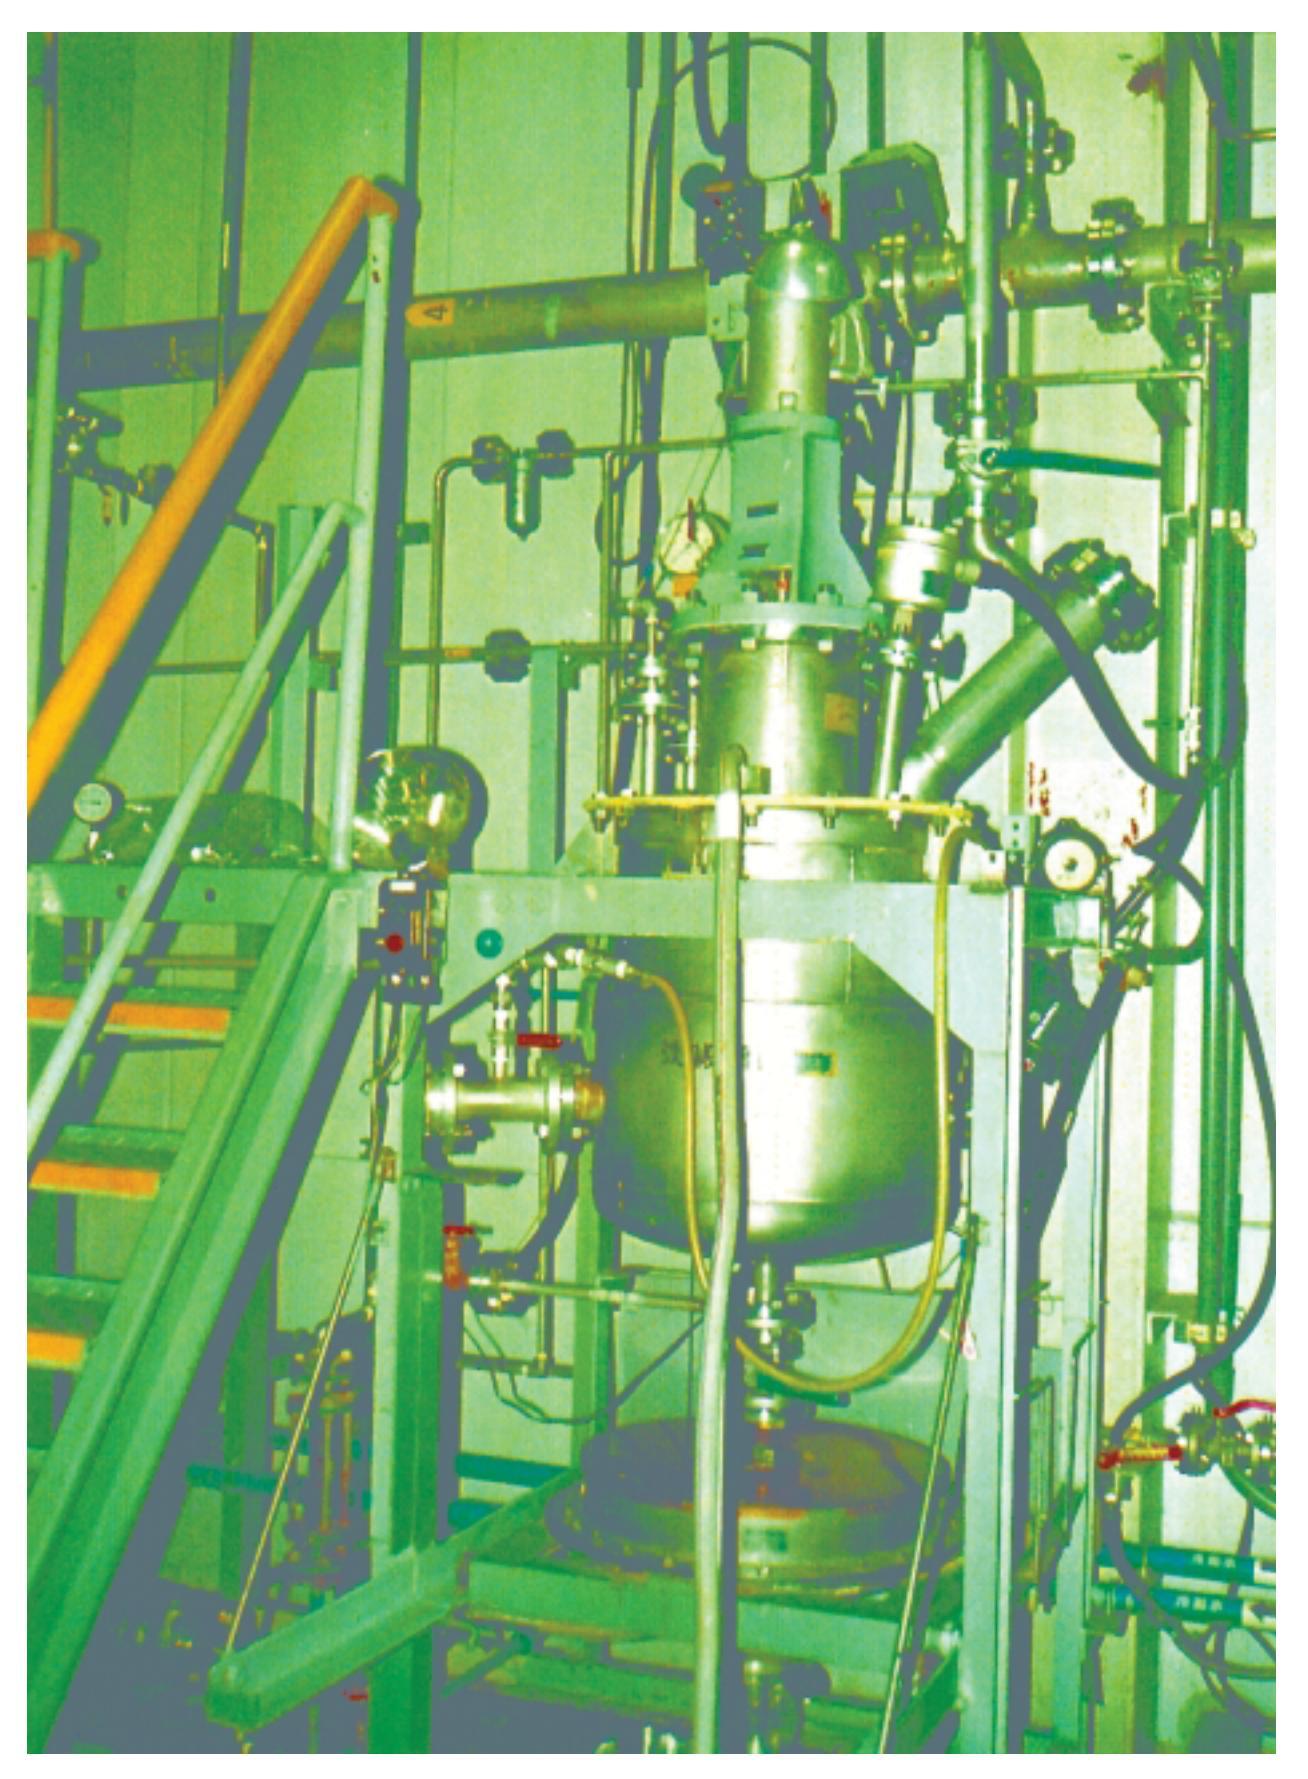
Figure 35. The precipitation vessel in which the process criticality accident occurred.
