Shield Building Crack Investigation and Root Cause Presentation

Davis-Besse Nuclear Power Station

August 9, 2012

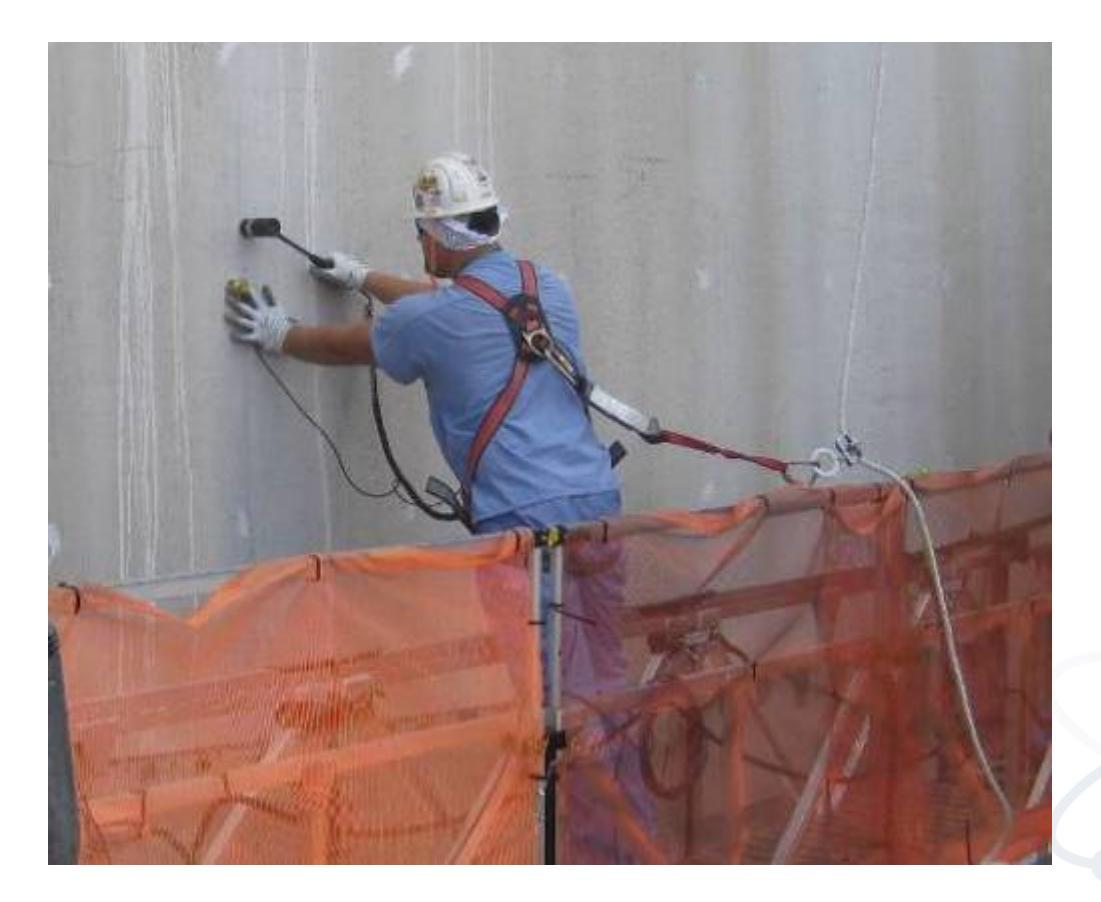
Investigation

Impulse Response (IR) testing methodology used to investigate extent of crack

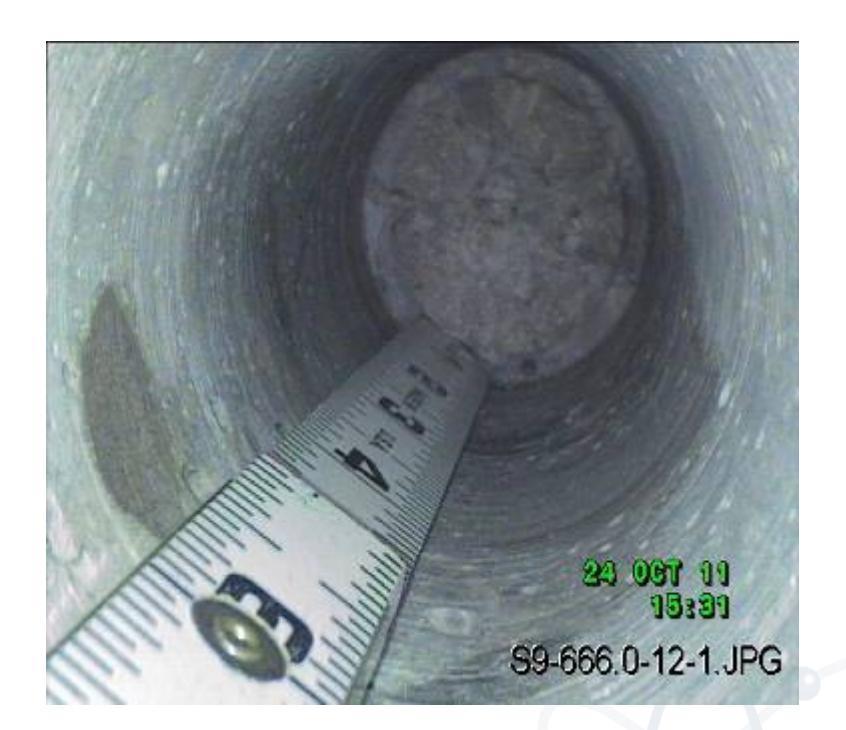
Investigation, continued

- Core bores taken to validate IR testing results, to determine crack depth and to determine crack width
- Investigation results were documented in the corrective action process, and the NRC was promptly notified of findings

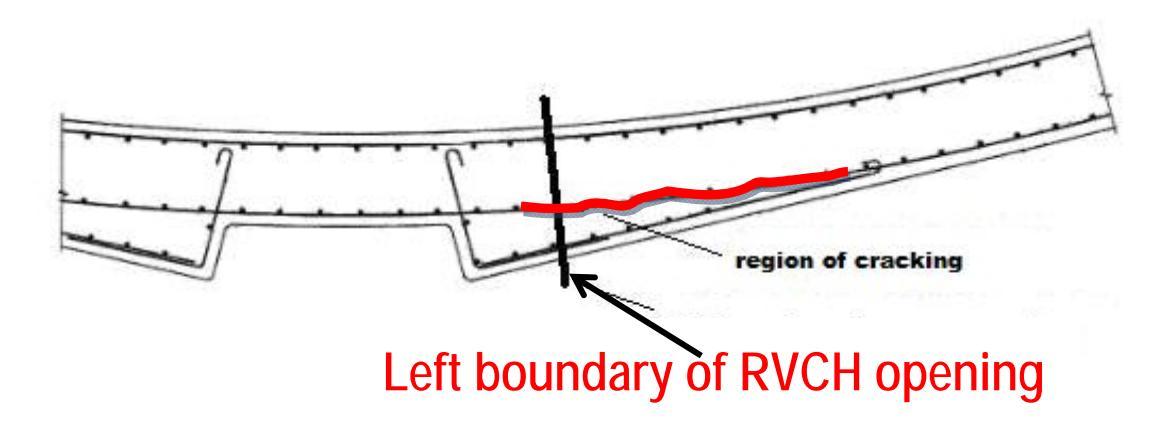
Summary of Shield Building Condition

- Cracking is generic to flute shoulder regions and can be assumed to be present at any elevation in the flutes shoulders; cracking was observed to be more prevalent on the south side of the building
- Cracks are located near the outer reinforcing mat; no cracking observed in interior reinforcing mat

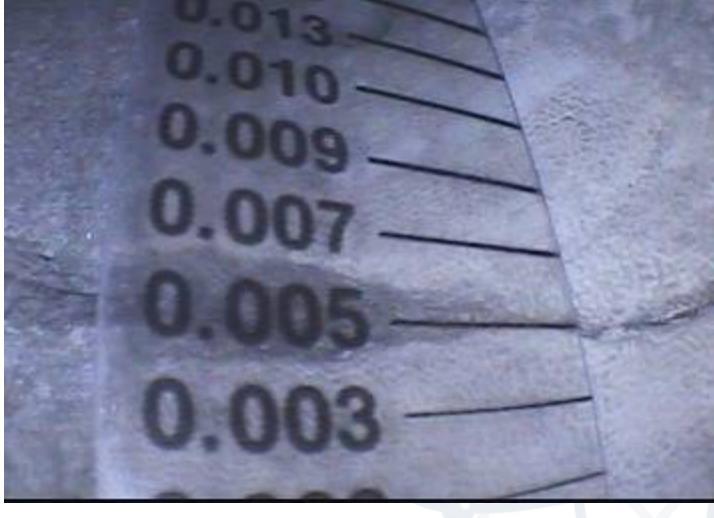
Summary of Shield Building Condition, *continued*

- Cracking exists at the top 20 feet of the Shield Building wall outside the flute shoulder region
- Two small regions adjacent to the Main Steam Line penetration have similar cracks
 - The extent of these regions is localized and unique to these particular penetrations
- Cracks are very tight

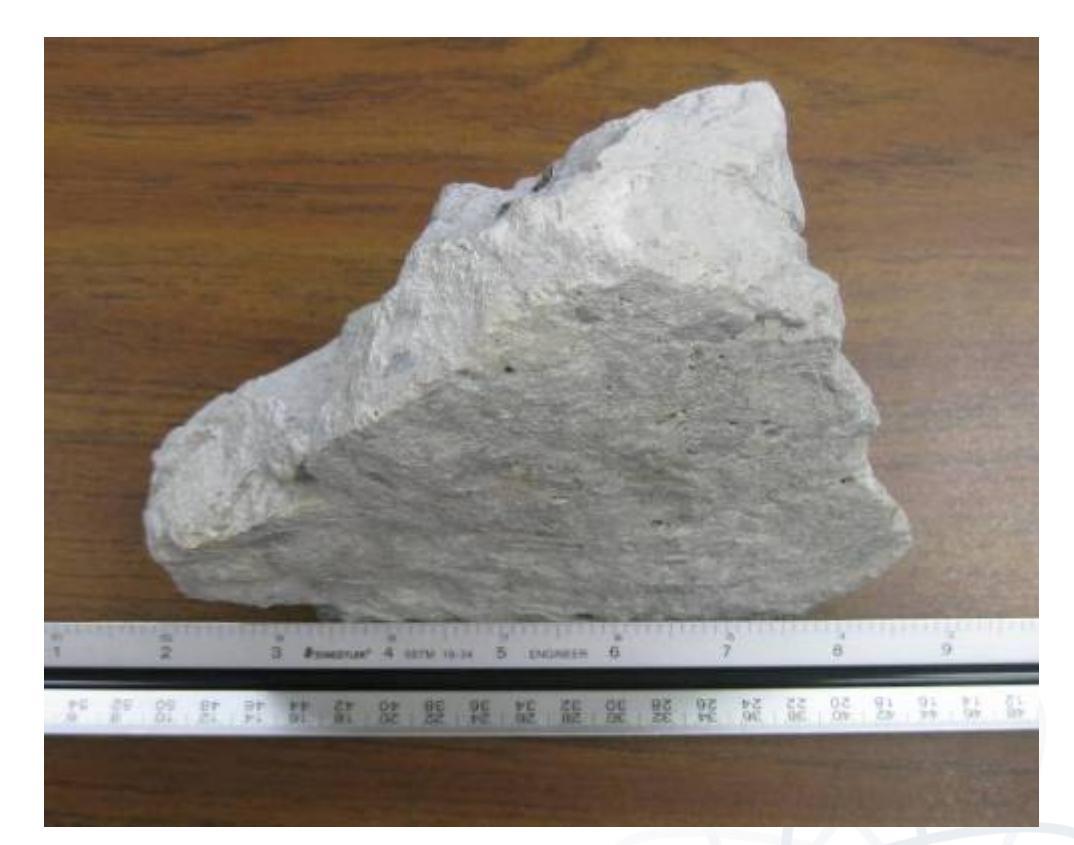
Shield Building Concrete, continued

- Typical concrete sample showing the laminar crack sheared the coarse aggregate
- Therefore, laminar crack occurred after the concrete achieved it strength

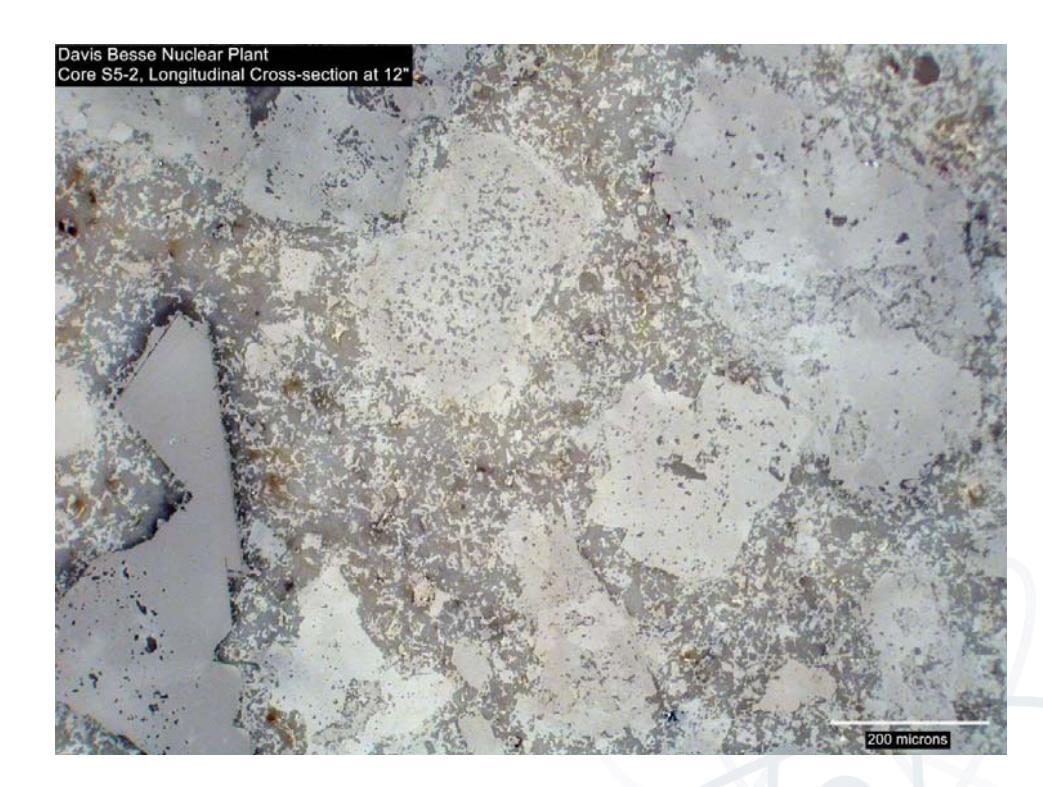
Magnification at 100 Times

- No evidence of micro cracks
- No signs of cyclic load mechanism
- No cyclic freeze-thaw mechanism
- No indication of fatigue or age related events

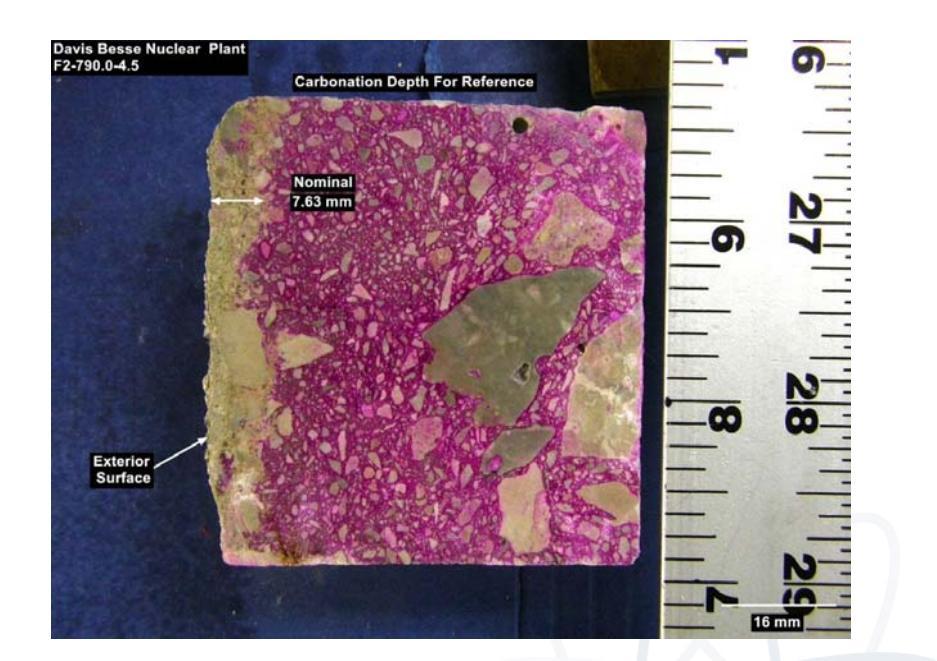
16 samples were tested for carbonation

- Average depth of carbonation is 8.57 mm (0.337 inches)
- Maximum average
 11.7 mm (0.46 inches)
- Typical for concrete
 40 years old

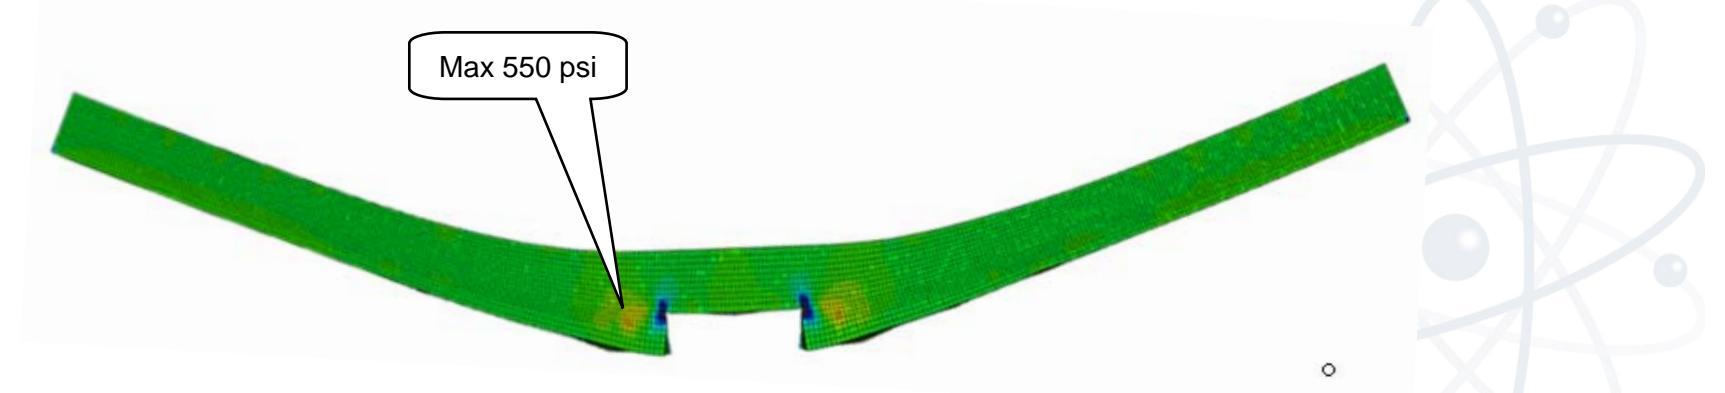
- A complex computer model of the Shield Building was developed
- Concrete properties from the concrete core tests were used
- Laboratory tests showed moisture infiltration up to four inches
- Maximum radial stress in the shoulder area were approximately the tensile capacity of the concrete
- High stresses were located in areas of observed cracking

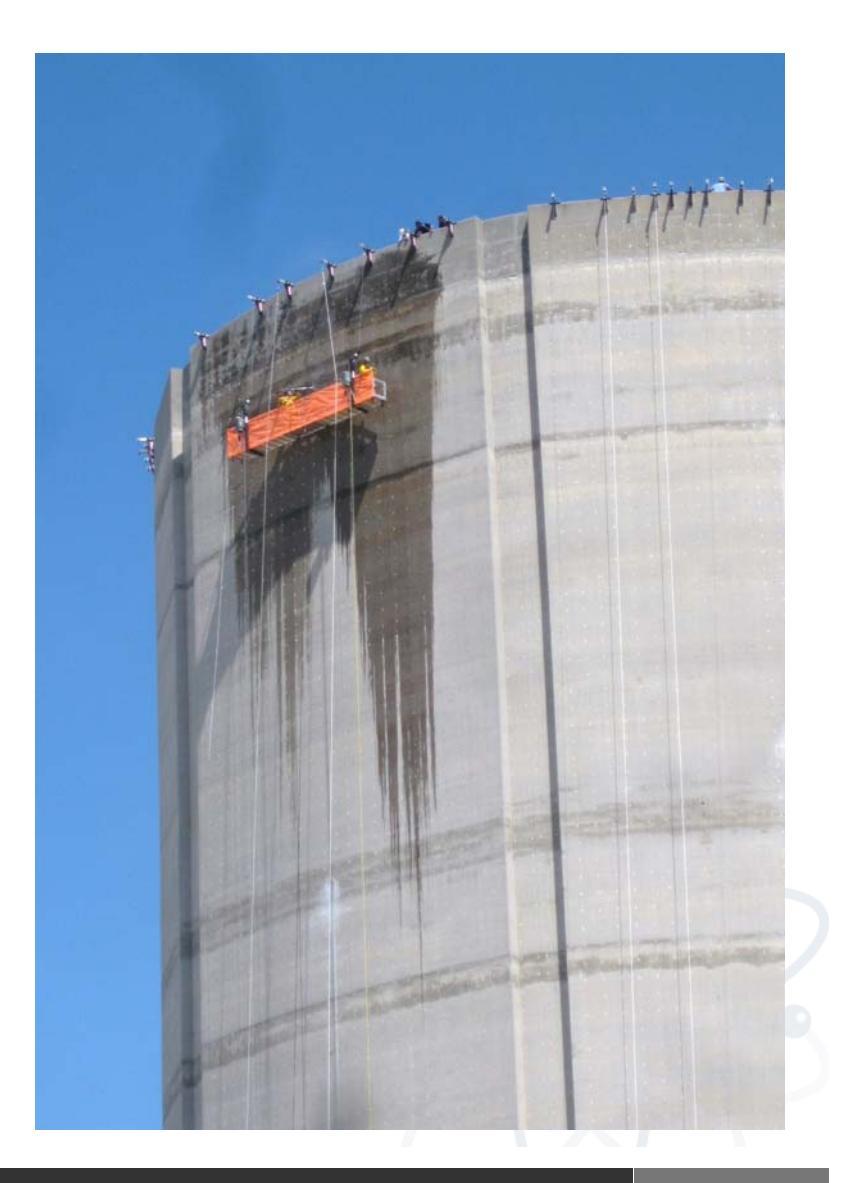
Root Cause

- Lack of concrete sealant

Preventative Action to Prevent Recurrence

- The exposed exterior surfaces of the Shield Building will be sealed
- Contractor has started and is expected to be completed by the end of September of this year

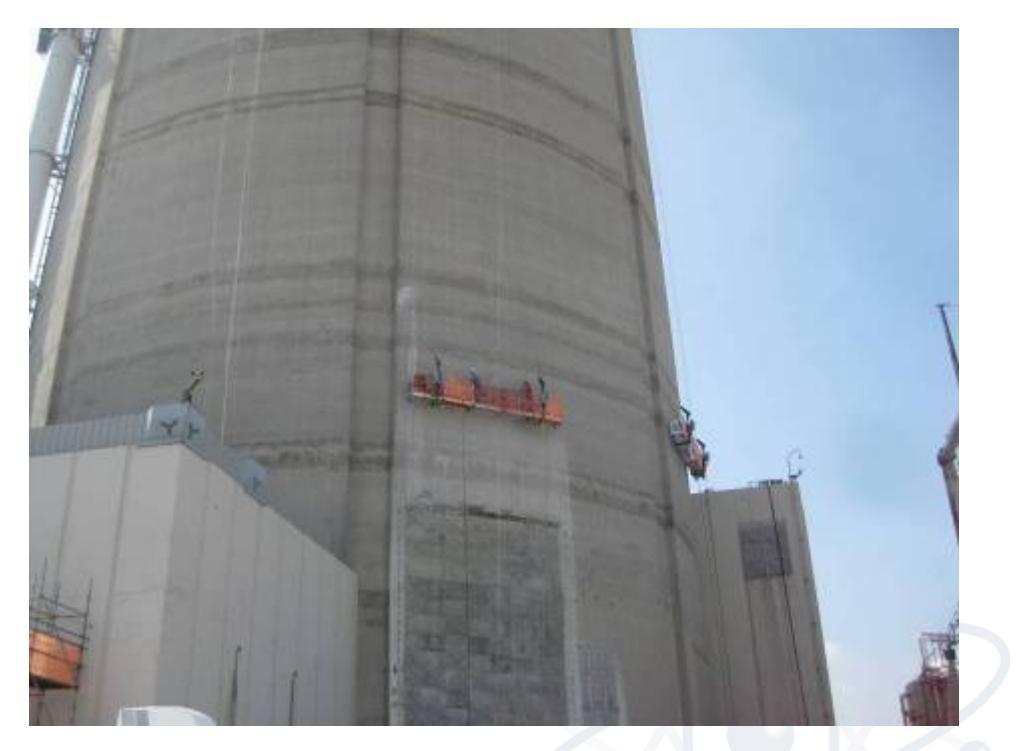
Additional Actions - IR Mapping

Complete IR examinations on the Shield Building wall and an independent structure

- All accessible areas of the Shield Building wall were mapped
- Over 60,000 individual readings were obtained to fully characterize the condition of the building

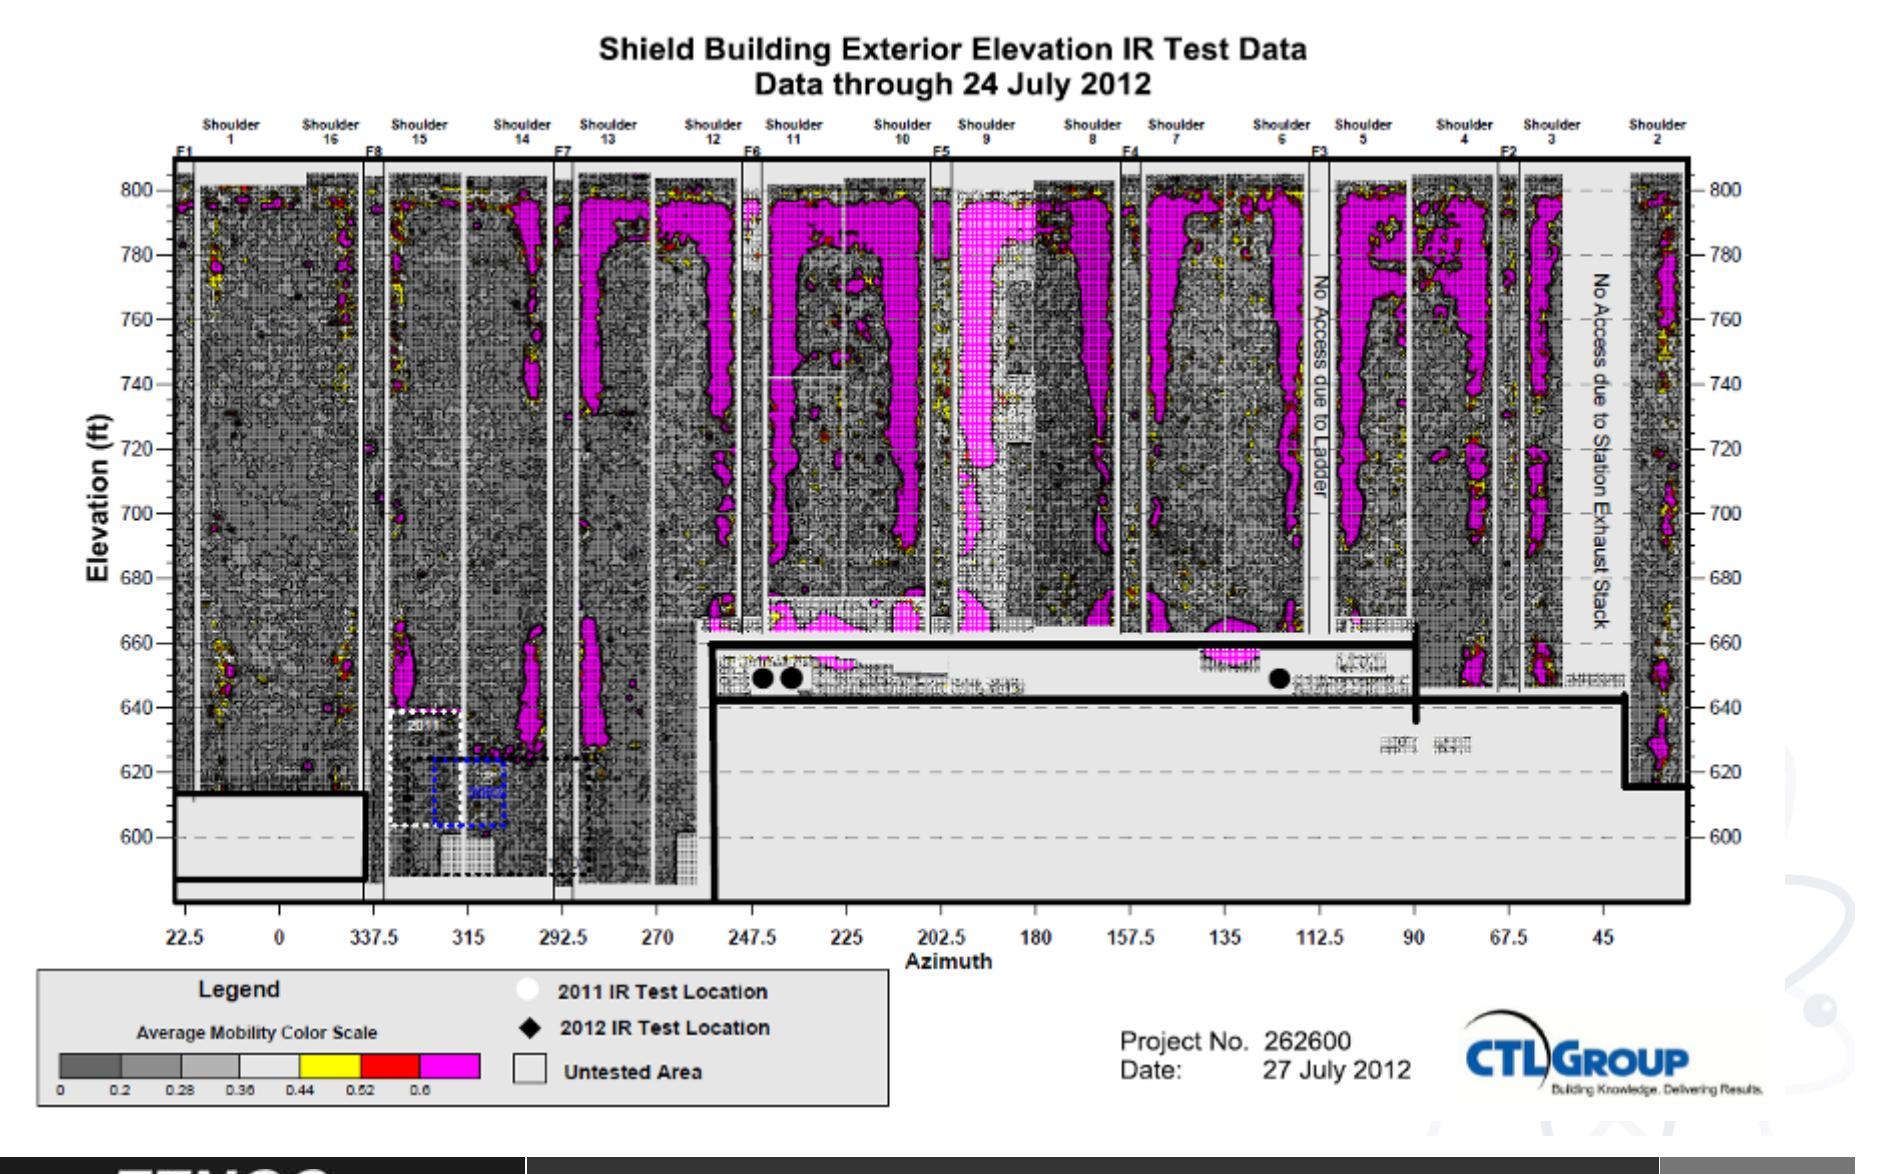
Additional Actions - IR Mapping, continued

- The IR validated our original assessment that the laminar cracks are generally confined to:
 - The shoulder areas
 - Top of the Shield Building
 - Near one corner of the Main Steam Line penetration
- Impulse Response reading on an independent structure validated that laminar cracks are not present
