Official Transcript of Proceedings  
NUCLEAR REGULATORY COMMISSION

Title: Advisory Committee on Reactor Safeguards  
Plant License Renewal Subcommittee

# Davis-Besse Nuclear Power Station License Renewal Application

Advisory Committee on Reactor Safeguards  
License Renewal Subcommittee Meeting  
September 19, 2012

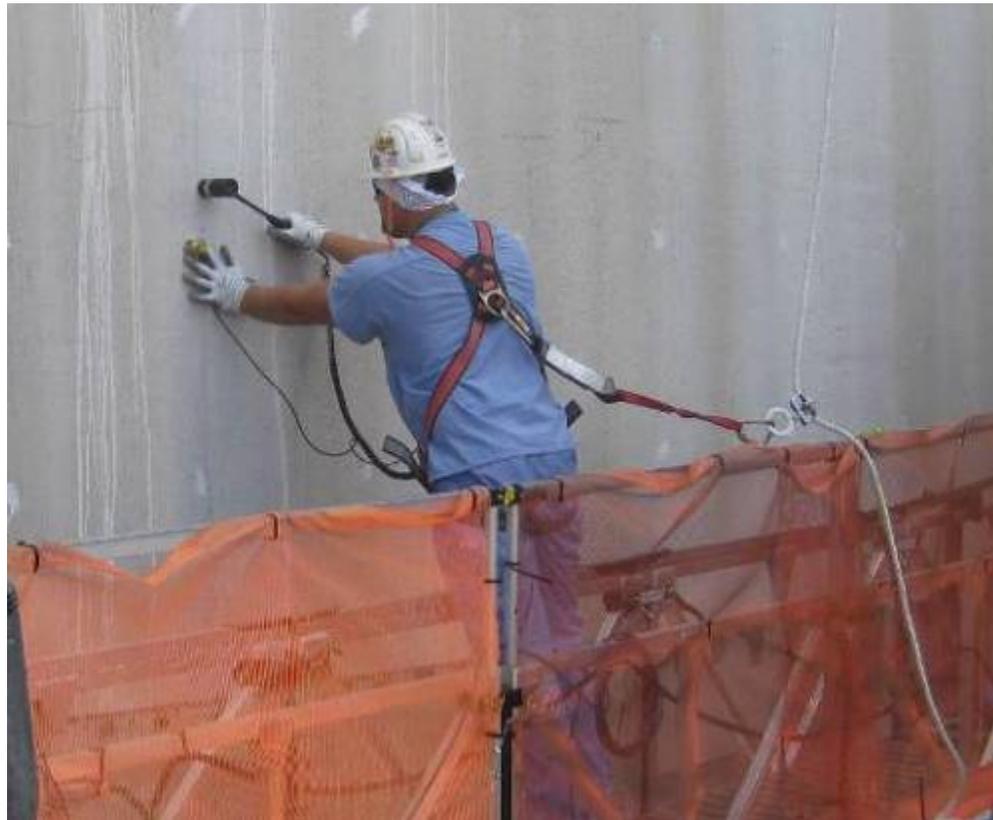
- **Impulse Response (IR) testing methodology used to investigate extent of crack**

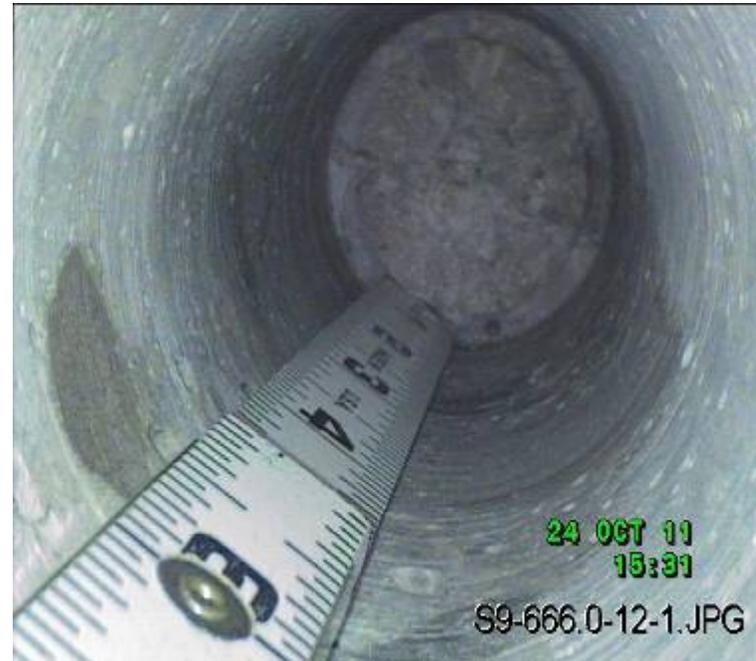
- **Core bores taken to validate IR testing results, to determine crack depth and to determine crack width**
- **Investigation results were documented in the corrective action process, and the NRC was promptly notified of findings**

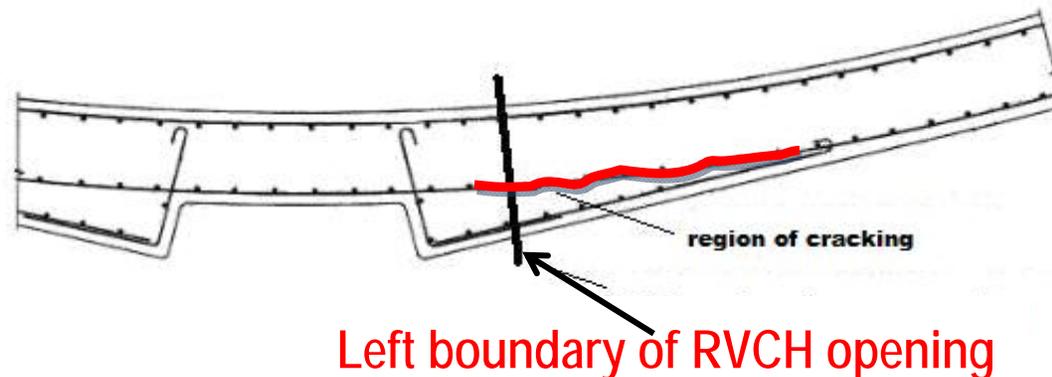
- Cracking is generic to flute shoulder regions and can be assumed to be present at any elevation in the flutes shoulders; cracking was observed to be more prevalent on the south side of the building
- Cracks are located near the outer reinforcing mat; no cracking observed in interior reinforcing mat

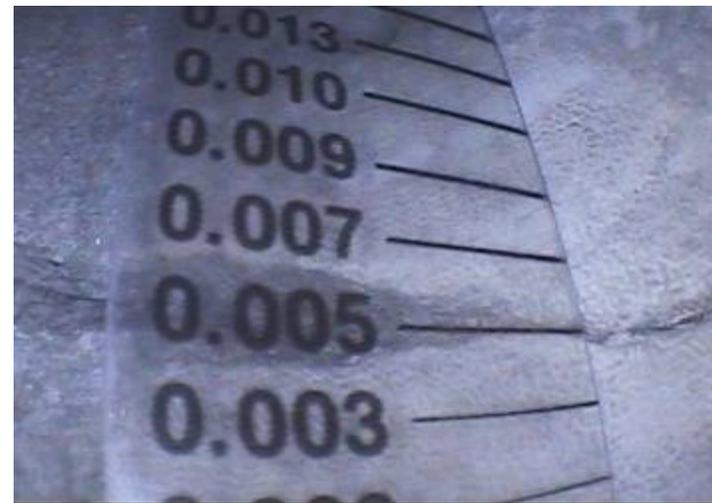
- **Cracking exists at the top 20 feet of the Shield Building wall outside the flute shoulder region**
- **Two small regions adjacent to the Main Steam Line penetration have similar cracks**
  - The extent of these regions is localized and unique to these particular penetrations
- **Cracks are very tight**

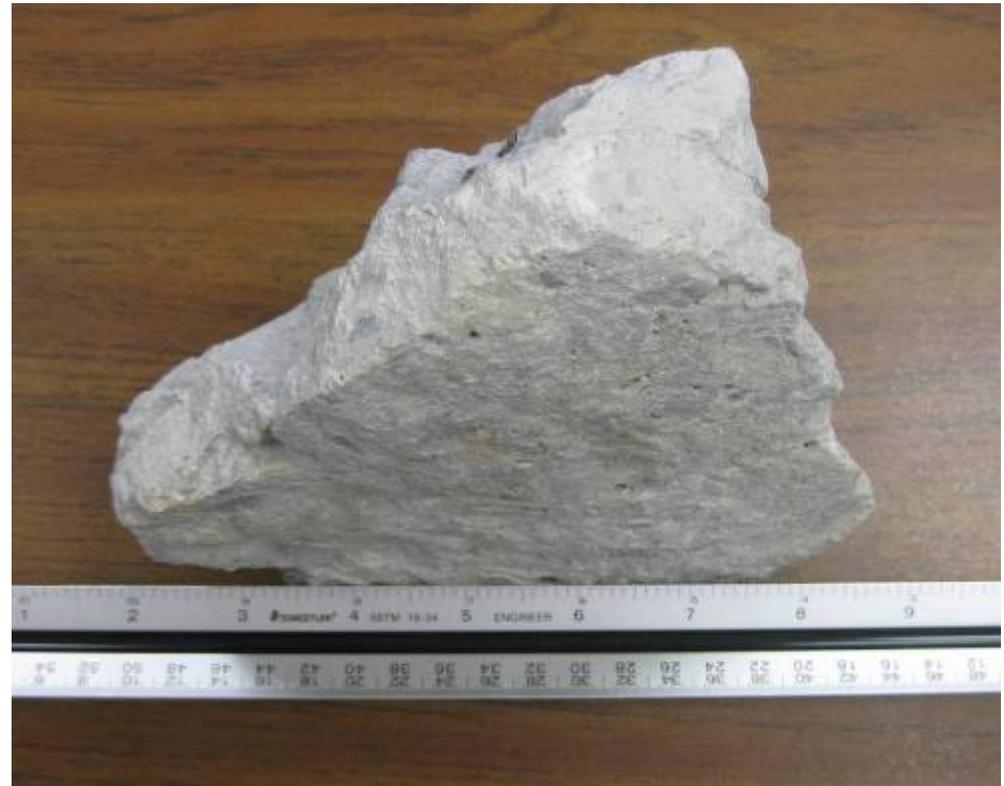
- **Typical concrete sample showing the laminar crack sheared the coarse aggregate**
- **Therefore, laminar crack occurred after the concrete achieved its strength**

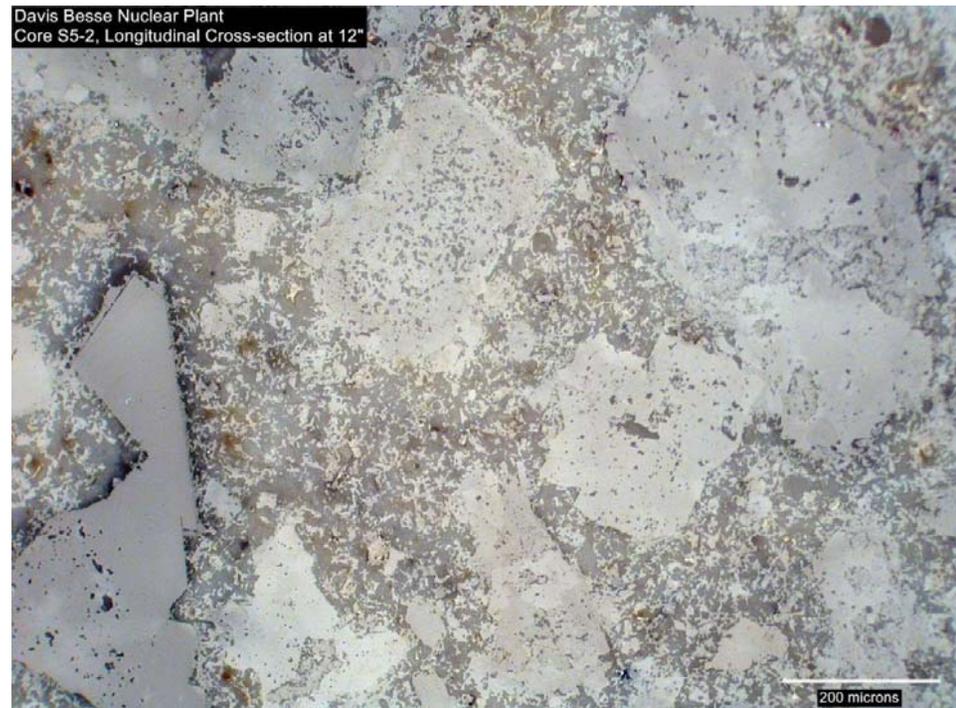
Magnification at 100 Times

- **No evidence of micro cracks**
- **No signs of cyclic load mechanism**
- **No cyclic freeze-thaw mechanism**
- **No indication of fatigue or age related events**

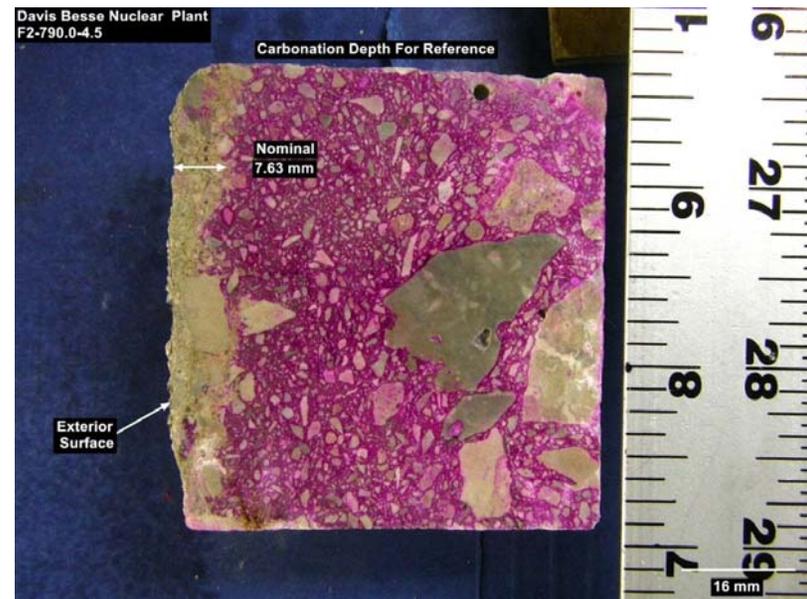
- **16 samples were tested for carbonation**
  - Average depth of carbonation is 8.57 mm (0.337 inches)
  - Maximum average 11.7 mm ( 0.46 inches)
  - Typical for concrete 40 years old

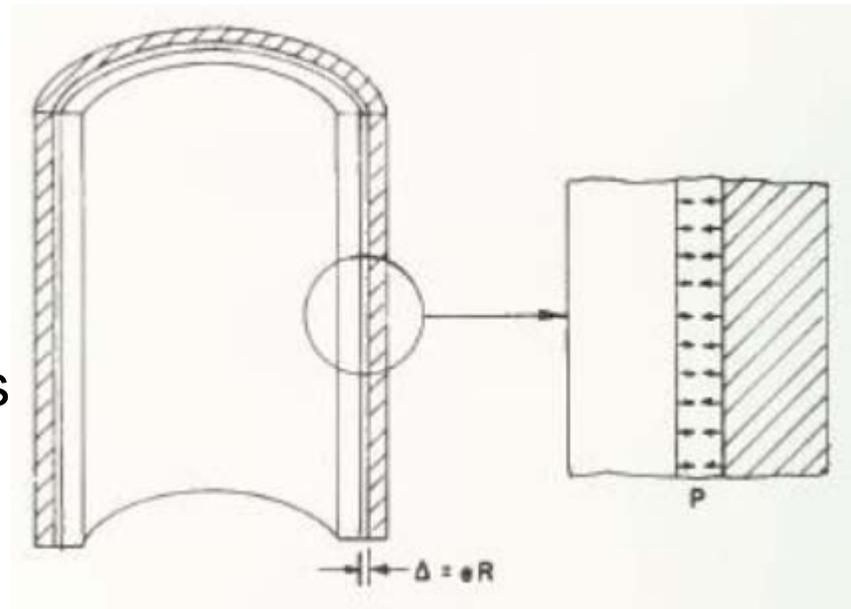
- **Water migrated into the concrete from the inside**

- Inner layer of the wall freezes and expands
- Outer layer of wall contracts
- Creates high radial stress
- Results in laminar cracking

- **Conclusion: Laminar cracking as a result of water freezing is a real potential**

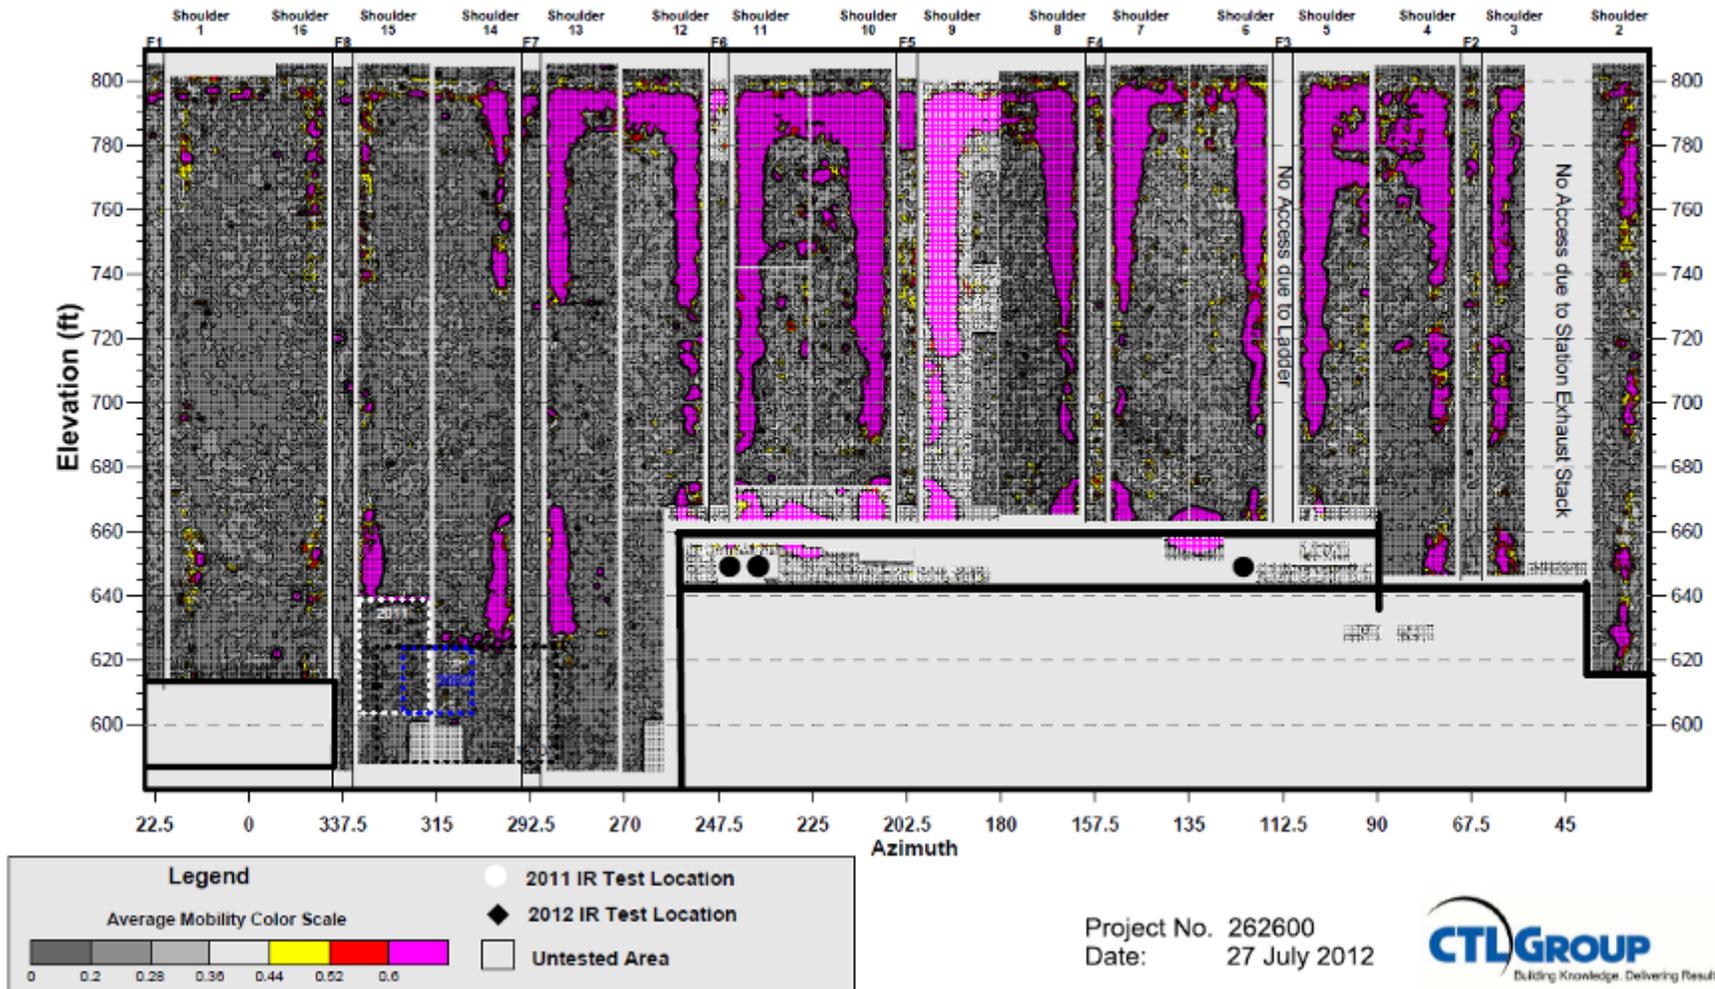
Shield Building Exterior Elevation IR Test Data  
Data through 24 July 2012

- **The IR validated our original assessment that the laminar cracks are generally confined to:**
  - The shoulder areas
  - Top of the Shield Building
  - Near one corner of the Main Steam Line penetration
  - Southern exposure
- **Impulse Response reading on an independent site structure validated that laminar cracks are not present**
