Official Transcript of Proceedings
NUCLEAR REGULATORY COMMISSION

Title: Advisory Committee on Reactor Safeguards
Plant License Renewal Subcommittee

Davis-Besse Nuclear Power Station License Renewal Application

Advisory Committee on Reactor Safeguards
License Renewal Subcommittee Meeting
September 19, 2012

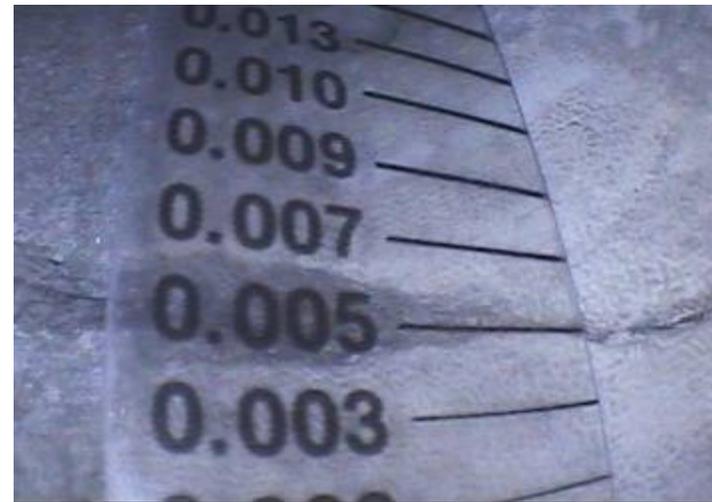
Summary of Shield Building Condition (cont.)

- **Cracking exists at the top 20 feet of the Shield Building wall outside the flute shoulder region**
- **Two small regions adjacent to the Main Steam Line penetration have similar cracks**
 - The extent of these regions is localized and unique to these particular penetrations
- **Cracks are very tight**
