PROGRAM SECTION No. SEP-UIP-IPEC  
Revision No. 0  
Page 1 of 69

INDIAN POINT 2 & 3

UNDERGROUND COMPONENTS INSPECTION PLAN

ENTERGY NUCLEAR ENGINEERING PROGRAMS

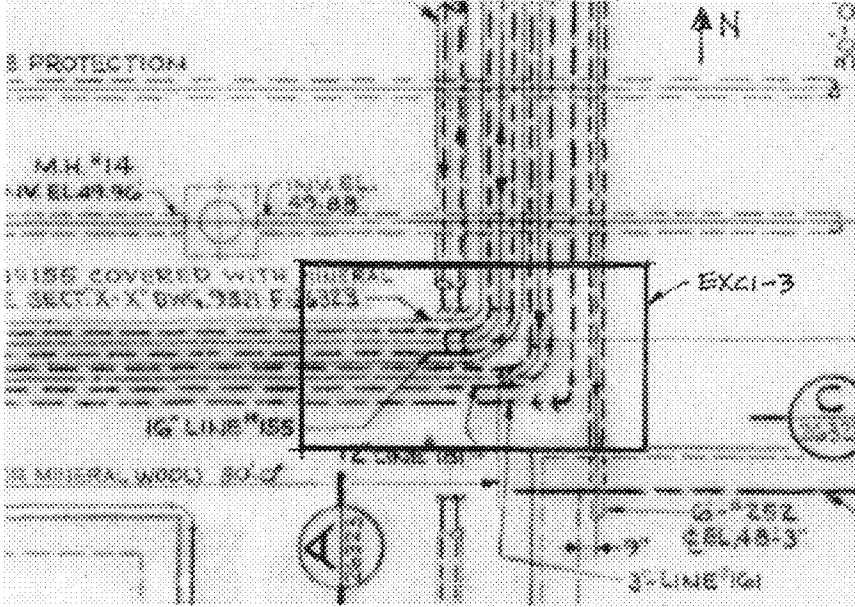
EXC1-3: IP3 @ NW Corner of the WHUT Pit

Reference: drawing 9321-F-26313 from Refueling Water Storage Tank (NORTH)  
 See legend below for line description: (5) (4) (3) (2) (1)

Buried lines continue to the Fuel Storage Building on the Left (WEST). PAB is at lower left

A 15 ft (N-S) x 20 ft (E-W) x 8 ft (deep) excavation (grade is at approx. El. 54 ft) will uncover the following lines:

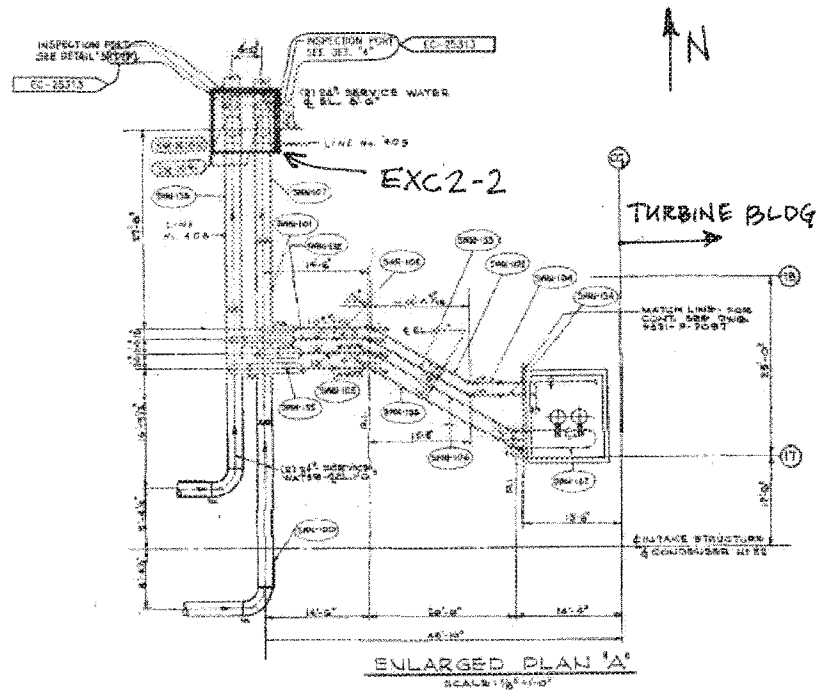
EXC2-2: IP2 West Side of the Turbine Building

Reference: Drawing 9321-2700  
Co-ordinated excavation with installation of EC 25313  
Lines to be inspected 24-inch SW Lines 408 and 409

The excavation to remove the existing 14-inch blind flanged access point on SW Line 409 will be expanded to expose a minimum of 10 feet of length of pipe for both Lines 408 and 409 over their full circumference. At the access point location, the centerline of the 24-inch Line 409 (& Line 408) is at El. 8'-6", and the access point is at 4'-6" downstream of a vertical rise of 7'-6" from El. 1'-0". The excavation will be 10 ft (E-W) x 12 ft (N-S) x 10 ft deep.

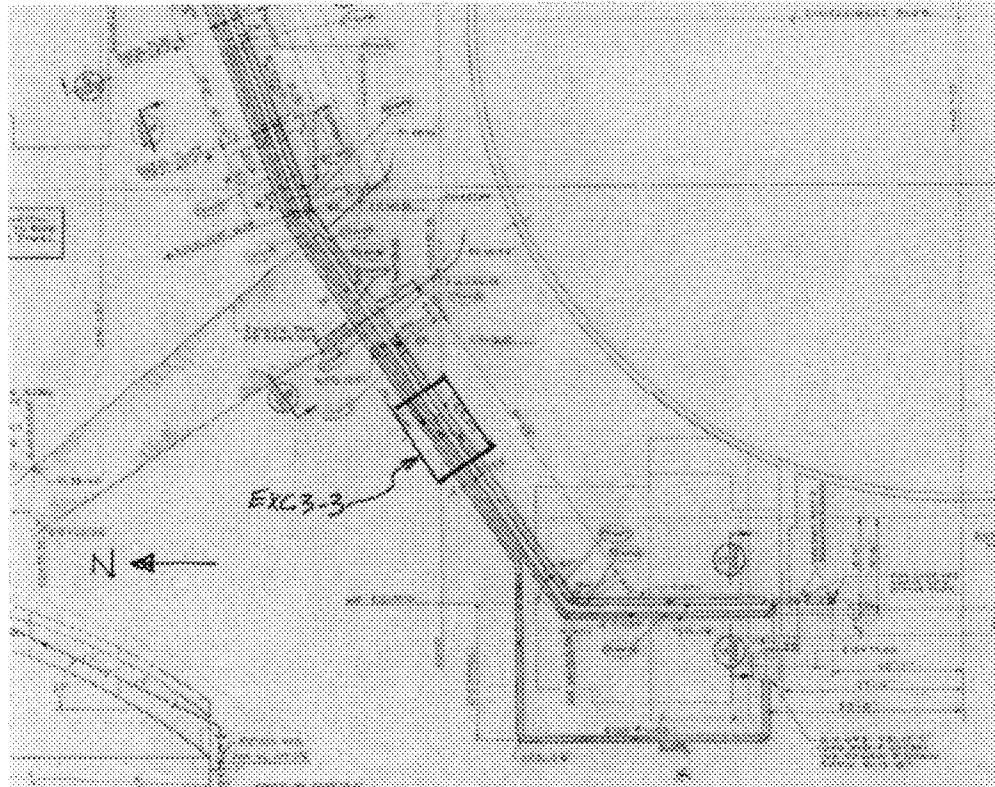
EXC3-3: BURIED LINES FROM THE IP3 CST TO THE AFW PUMP BLDG.

REF: DWG. 9321-F-22873  
LINES TO BE EXCAVATED & INSPECTED:  
(Note: App R DG Fuel Oil & Cooling Water  
Run overhead the perimeter of the  
Area -- see drawing 9321-F-23593)

IP3- YARD AREA  
12" Line 1070 (CST Supply to CST)  
8" Line 1080 (Condensate Return to CST)  
8" Line 1028 (CMP CST Tank Overflow to MH-9)
