Area W	/alk-By Checklist (AWC)	Status: Y N U
Loc	ation (Bldg, Elev, Room/Area): AWC-U3-14	
<b>Instruc</b> This ch space t Additior	tions for Completing Checklist ecklist may be used to document the results of the Area Walk-By near one or more S below each of the following questions may be used to record the results of judgments nal space is provided at the end of this checklist for documenting other comments.	WEL items. The and findings.

Dresden Generating Station Unit 3 12Q0108.30-R-002, Rev. 2 Correspondence No.: RS-12-167 Sheet 2 of 11

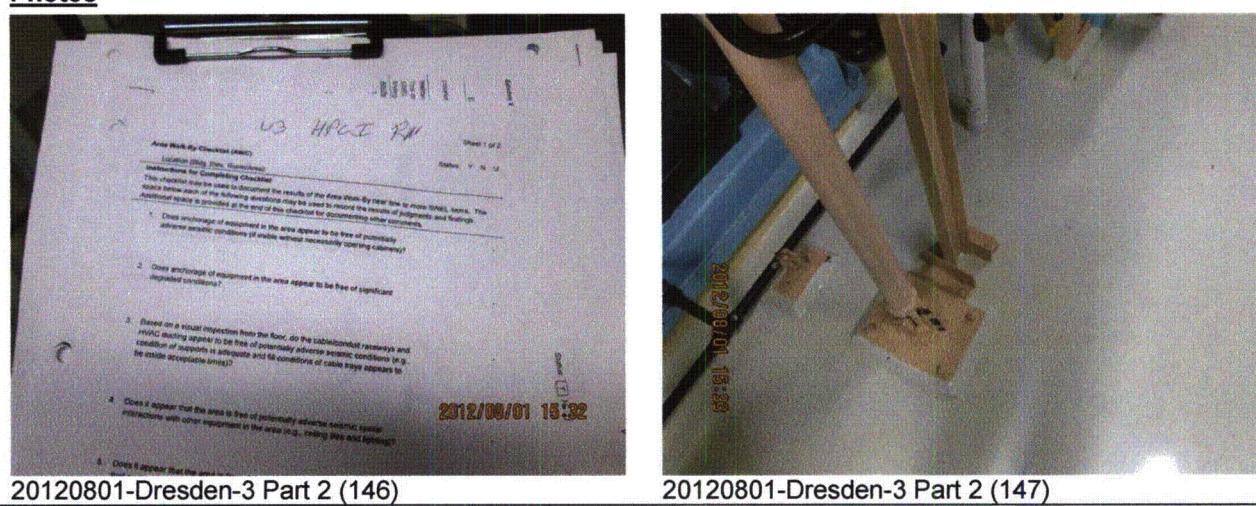
4.	Does it appear that the area is free of potentially adverse seismic spatial interactions with other equipment in the area (e.g., ceiling tiles and lighting)? S-hooks and/or eyehooks in light fixtures need to be more adequately closed. Fixtures might swing down from their non-power cord ends but will not affect soft targets, and therefore are judged to be acceptable.	Yes
	IR 1396017: LIGHT SUPPORT CONNECTION DEFICIENCY

5.	During the Seismic Walkdowns it was identified that there are multiple open S- hook connections between the chain and the support bracket for the lighting fixtures in the U3 HPCI Room. However, each light fixture is hardwired, therefore, they would not fall if the support chains were to hardwired, therefore, they would not fall if the support chains were to come loose. In addition, the equipment within the range that the light fixtures would swing, if they were to come loose, appears to be robust and would not be significantly damaged by engineering judgement. Does it appear that the area is free of potentially adverse seismic interactions that could cause flooding or spray in the area? Threaded fire piping well supported and judged to be acceptable. Welded piping judged to be acceptable.	Yes
	Collection pit below grating at turbine near end of room is full of fluid which appears to be water. Fluid in pit does not pose a flood or spray risk.
