Global Nuclear Fuel

SPM 13-036

July 16, 2013

Subject: Addendum to GNF-A10 CFR 71.95 Report Dated 6/15/12 – UX-30 Certificate Condition Not Followed

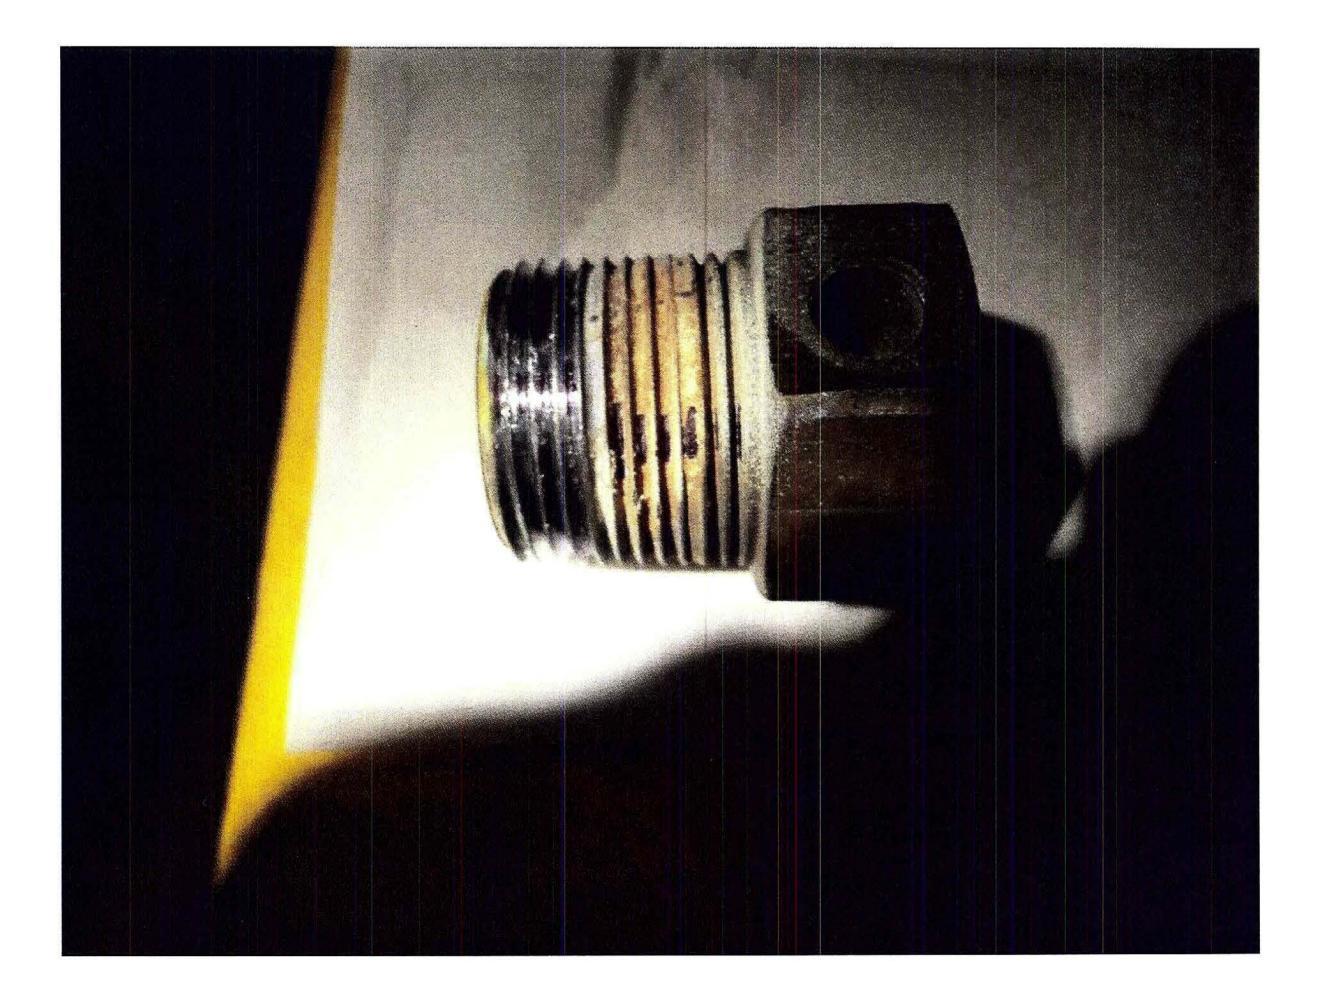
Attachment 2

After UF_6 removal, the cylinder contains approximately 2 kg or less of solid low enriched uranium hexafluoride "heel" material and was last shipped by GNF-A to USEC in 2010 for re-filling. There was no indication of any leakage of UF_6 from this cylinder on receipt. Photographs taken of the removed plug from cylinder GEW357 indicated between 4 and 5 threads had been engaged. The plug had been stamped to indicate it had 10 threads.

According to AREVA NP, the cause has been determined to be a non-conservative plug thread marking process in that the technique used to mark the fifth thread on the plug did not guarantee that five full threads would actually be engaged when the plug was installed in the cylinder.

Removed Plug from GEW357

- 1. Cylinder GEW357 was taken out of service and sent to AREVA NP on February 20, 2013 for recertification.
- 2. GNF-A has opened a condition report (CR) to document further communications needed to the cylinder service provider (AREVA NP) and to document the re-certification of the cylinder.
