TESTS FOR FIRE PROTECTION  
FOR COMPLETE FIRE ENGULFMENT OF CABLE TRAYS  
AND CONDUITS CONTAINING GROUPED ELECTRICAL CONDUCTORS.

TEST REPORT ON KOAWOOL

CHARLES E. CHAILLE

10/24/78

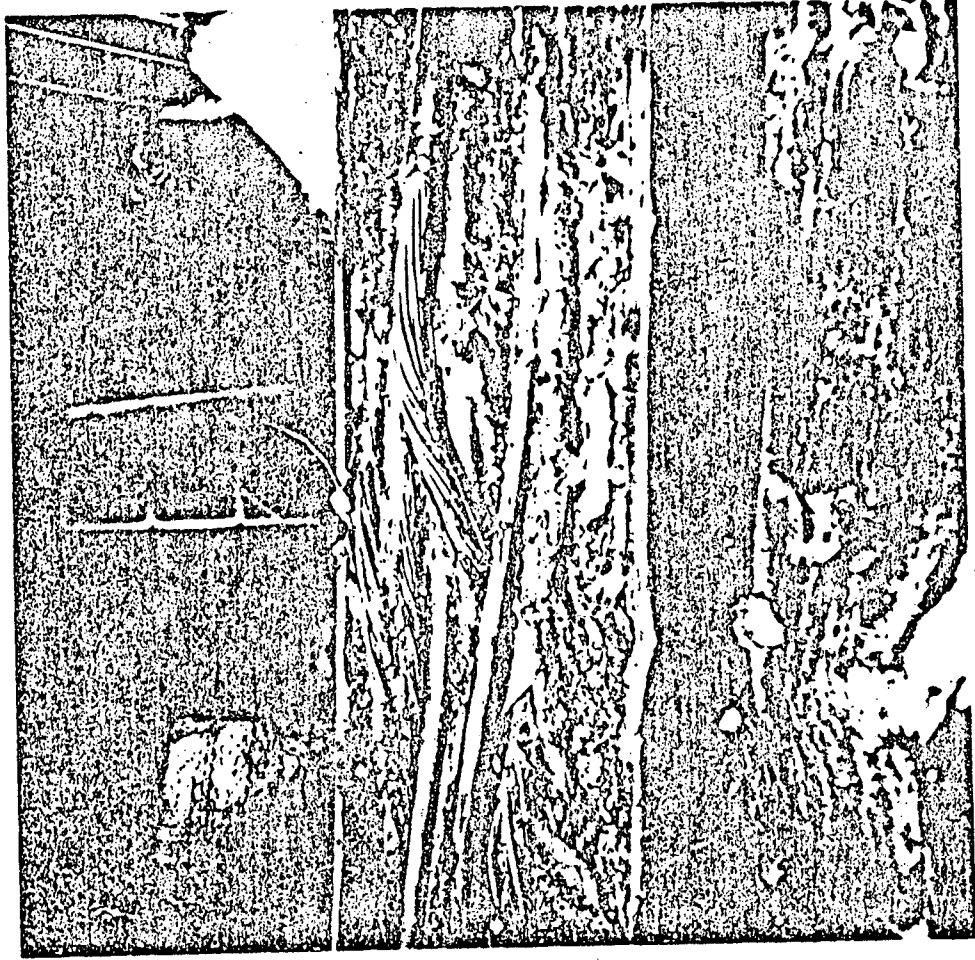
FIGURE 29

APPEARANCE OF CABLES IN CABLE TRAY  
AFTER TEST NO. 2 - WRAPPED WITH 2" OF  
KAOWOOL INSULATION AFTER EXPOSURE TO  
FIRE FOR ONE HOUR AND 17 MINUTES

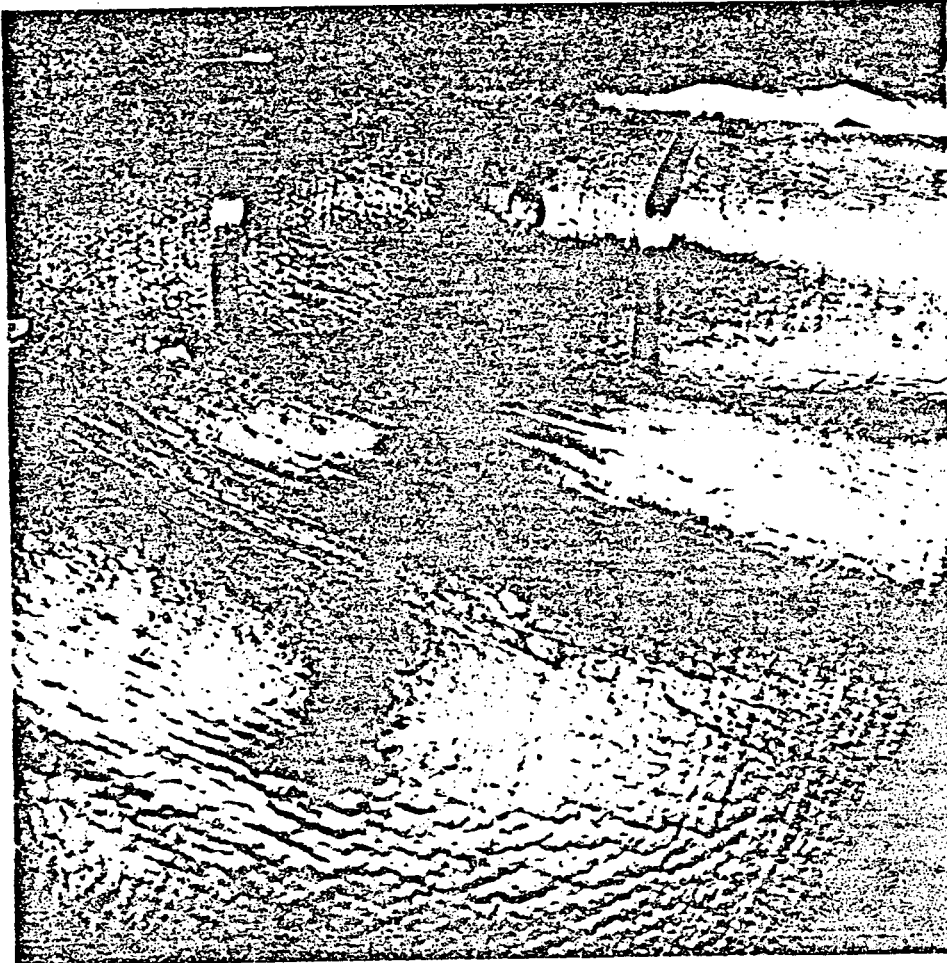
FIGURE 32  
OPEN BUTT JOINT IN INNER KAOWOOL  
BLANKET WRAP AFTER FIRE TEST NO. 3A

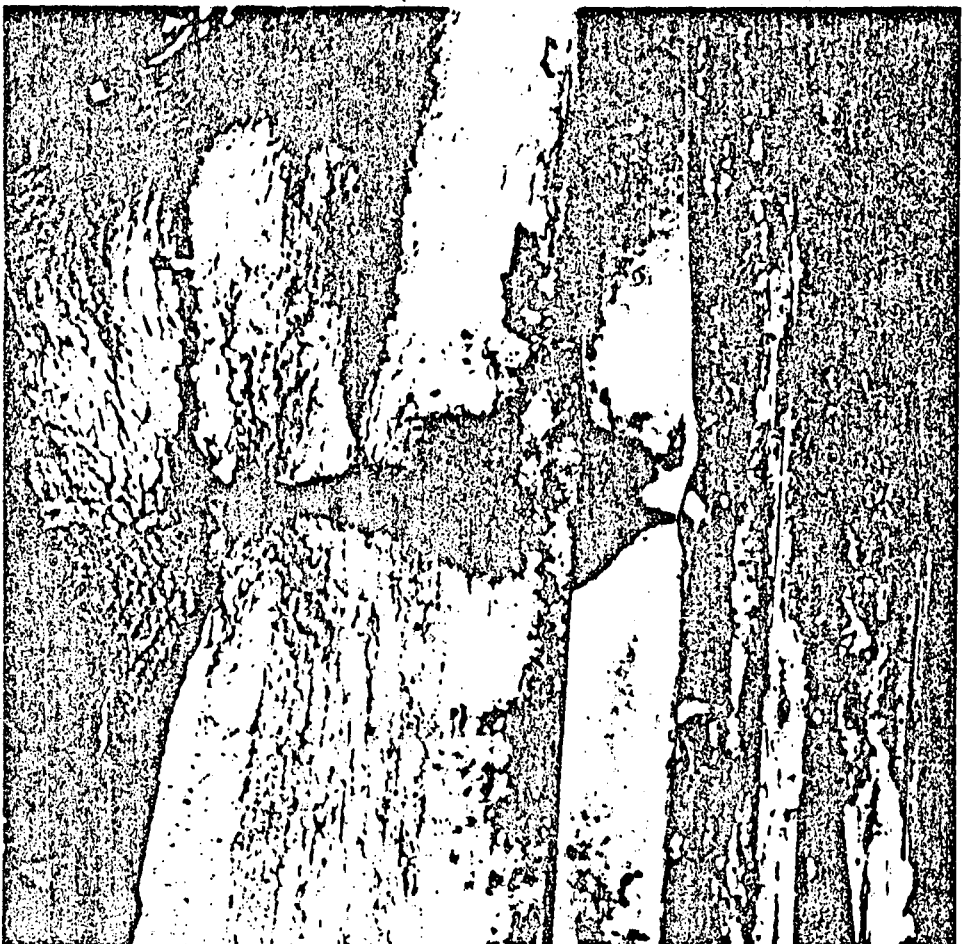
FIGURE 35

APPEARANCE OF CABLE TRAY IN AREA  
OF OPEN BUTT JOINT AFTER FIRE TEST NO. 3A

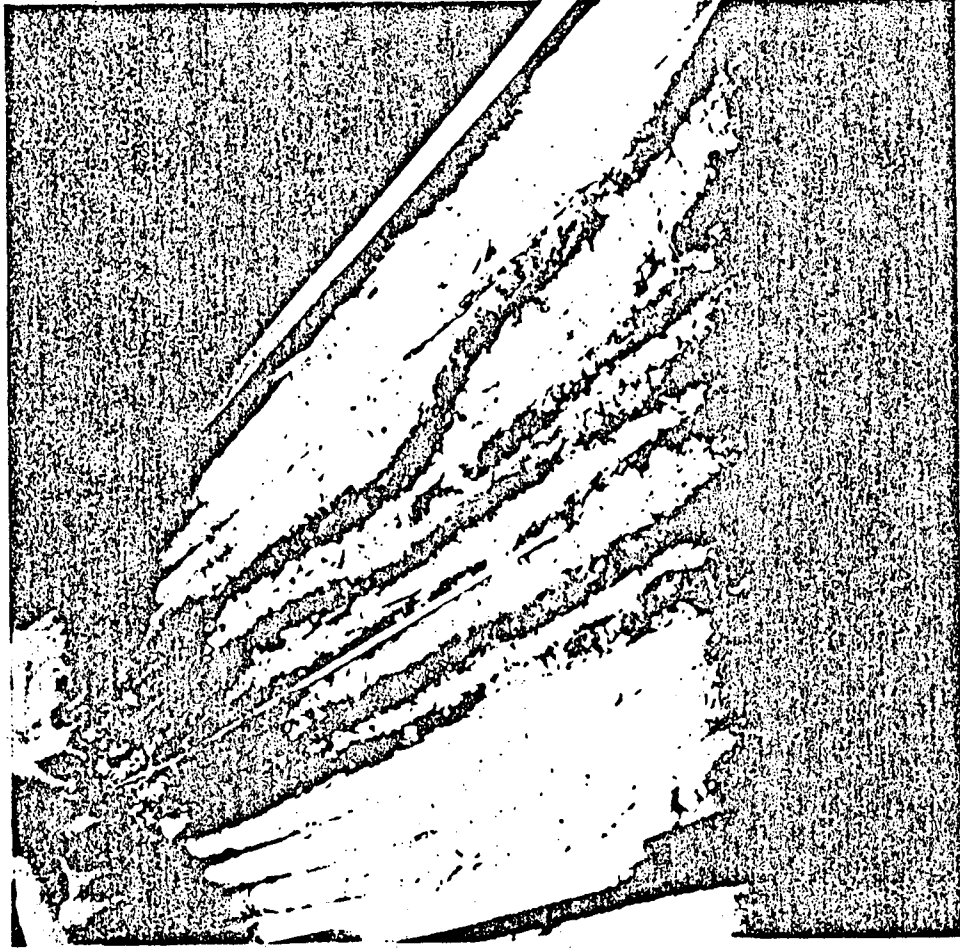
FIGURE 37

The temperature rise in the cable tray is shown in Figure 35. Again the Kaowool blanket retarded the heat transfer into the tray. This resulted in a slow temperature rise in the tray. Thermocouple 5 which was placed against the side of the tray indicated the highest temperature of all of the thermocouples inside the tray. Following the test the cable tray was removed from the furnace and the Kaowool blanket unwrapped. Figure 36 shows the innerwrap of Kaowool blanket at the butt joint. The joint was still tight and there was essentially no residue from the burning of the cables. The condition of the cables in the cable tray after the test is shown in Figure 37. Since the blanket prevented oxygen from reaching the cables they charred rather than burned. The IEEE-383 qualified cables were charred white, the non-qualified cables were charred black.

APPEARANCE OF CABLES IN CABLE  
TRAY AFTER TEST NO. 3B - WRAPPED WITH  
2" OF KAOWOOL BLANKET INSULATION WITH  
TIGHT BUTT JOINTS

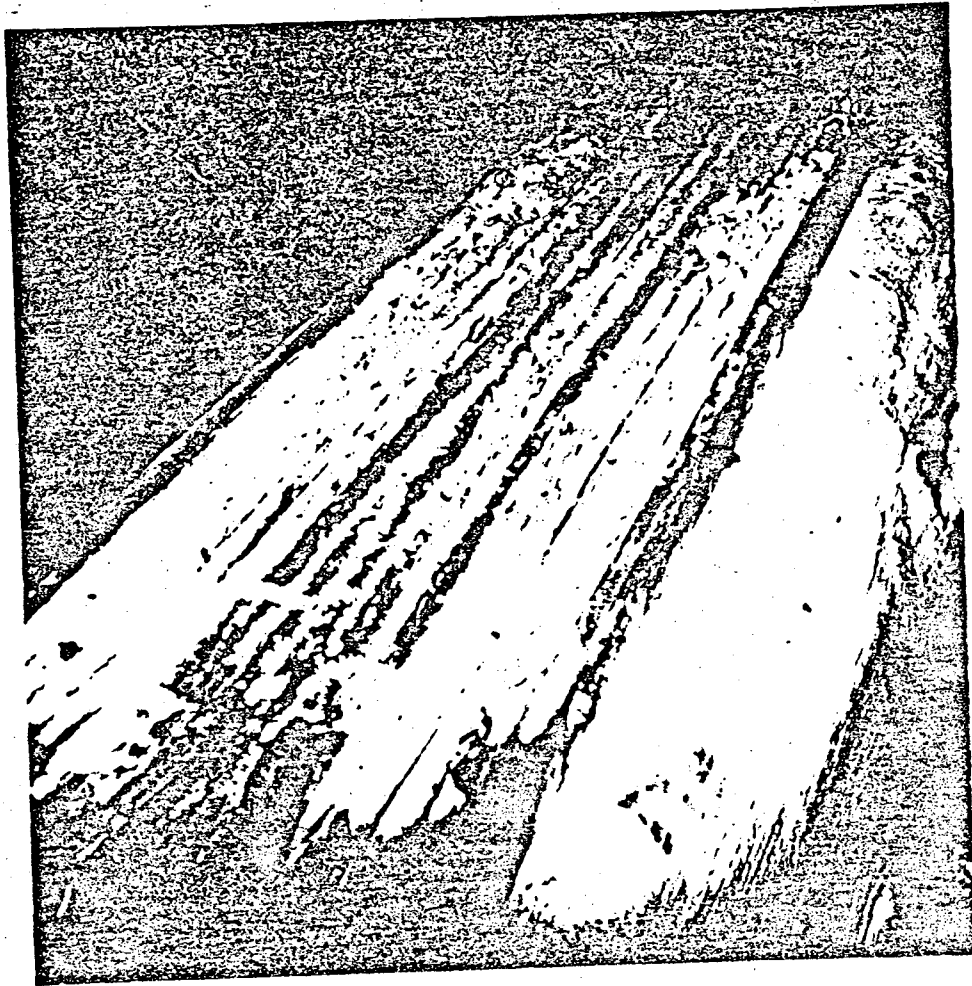
FIGURE 59

APPEARANCE OF CABLES IN CABLE  
TRAY AFTER TEST NO. 4 - WRAPPED  
WITH 1" KAOWOOL BLANKET (4" OVERLAP  
STRIP OVER BUTT JOINTS)
