ROOT CAUSE EVALUATION OF
4KV BREAKER SECONDARY
CONTACT BLOCK FAILURE
RCE 95-010

ATTACHMENT #1

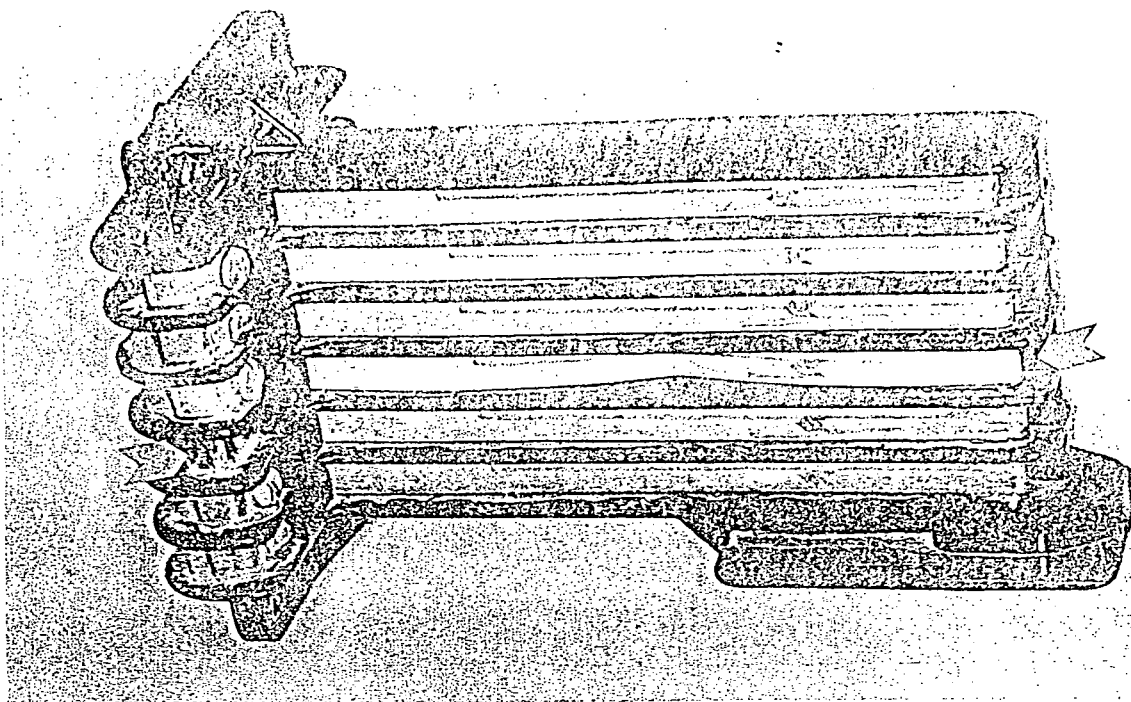
Figure 1: Optical photograph of the failed 3A0605 contact block.
Note the fractured finger at location #4.

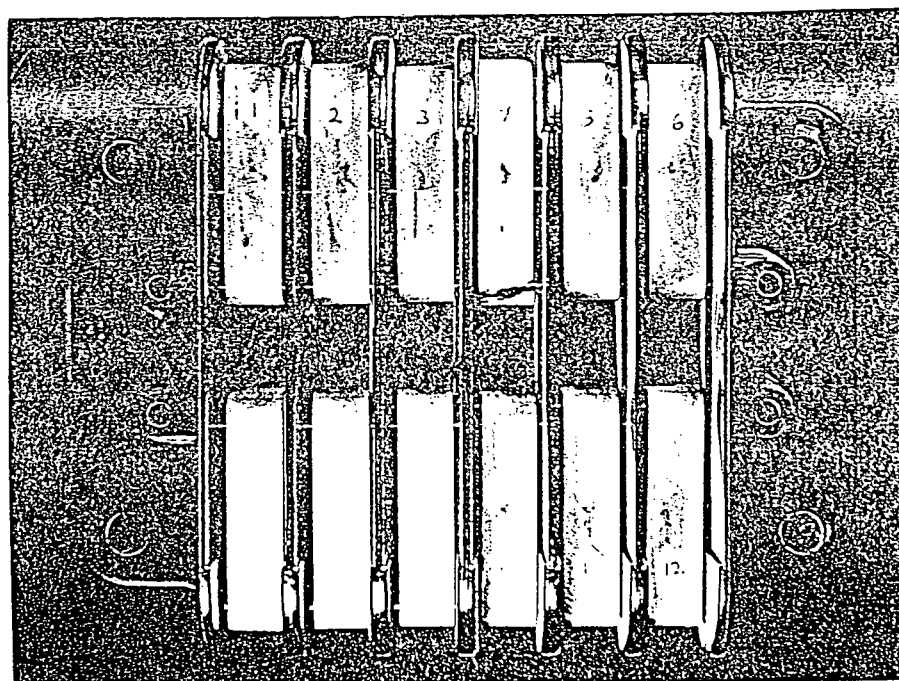
Figure 2: Optical photograph of the back of the 3A0605 contact block showing the fracture at finger #4.

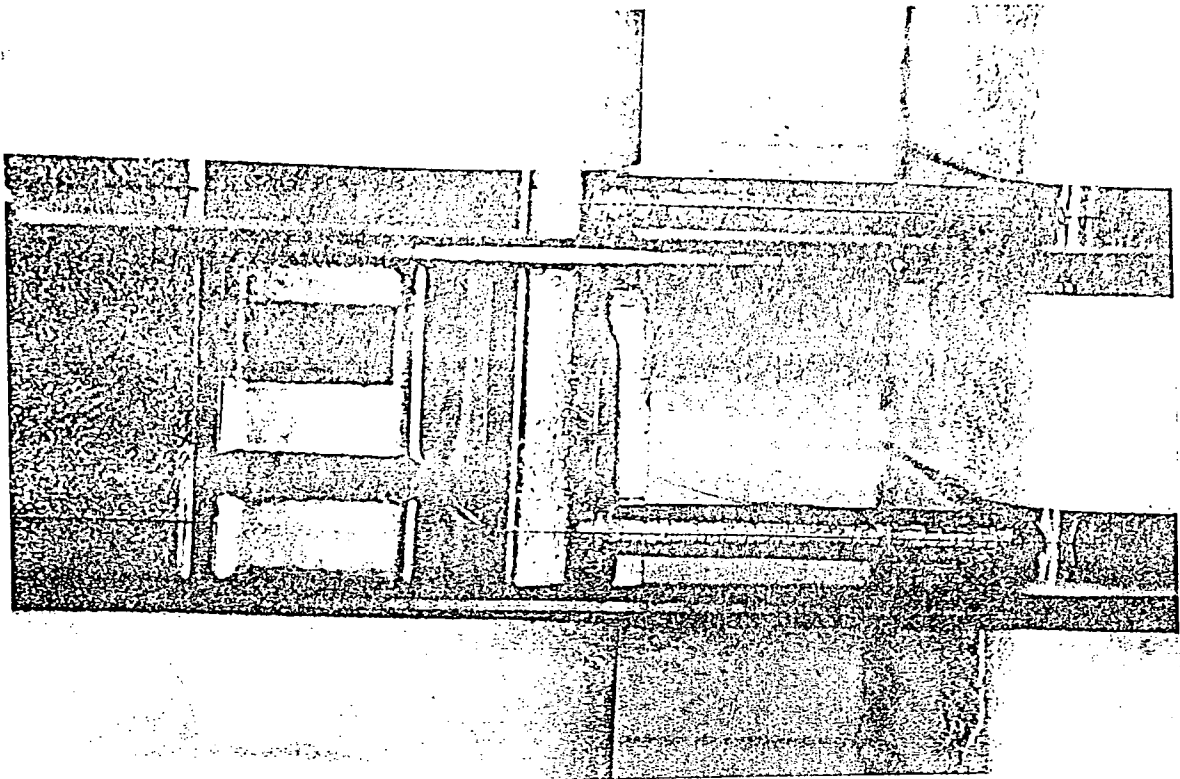
Figure 3: Optical photograph of one end of the fractured finger #4 at bend C. Crack in finger #9 is on lower right.

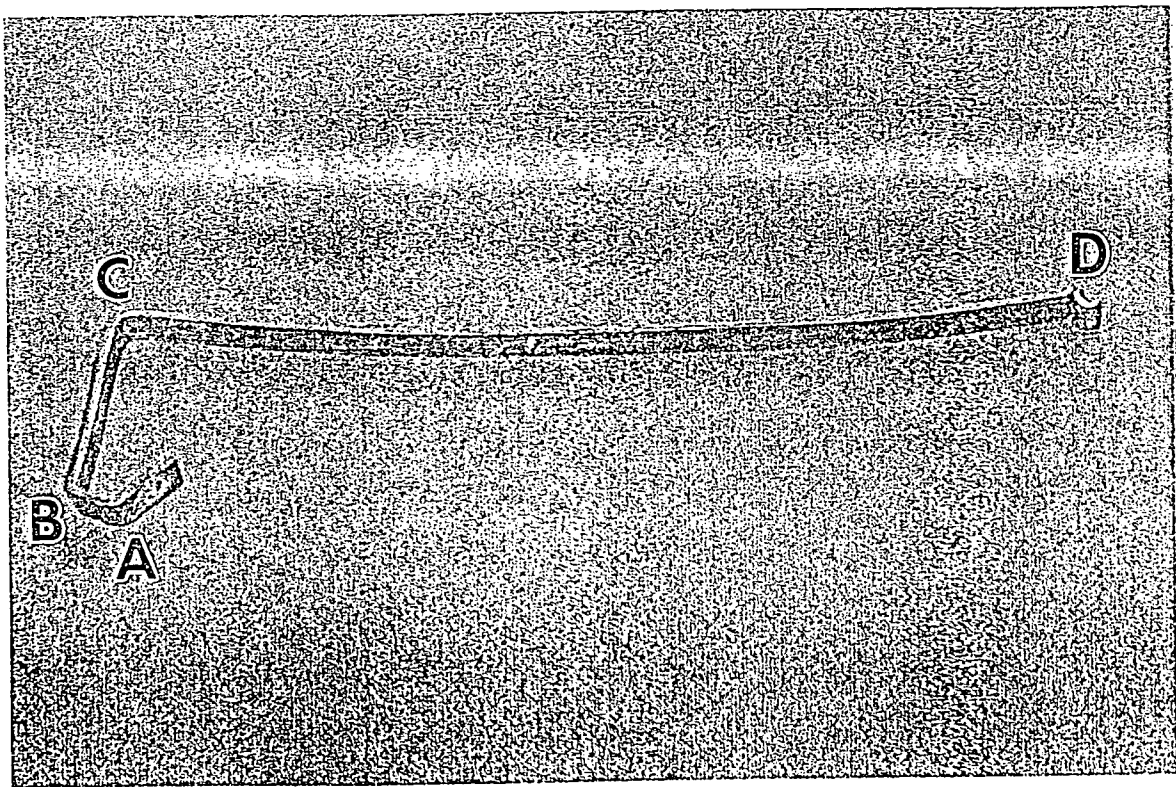
Figure 4: Optical photograph of a finger showing the labeling of the bends. Bend D was fractured during removal.

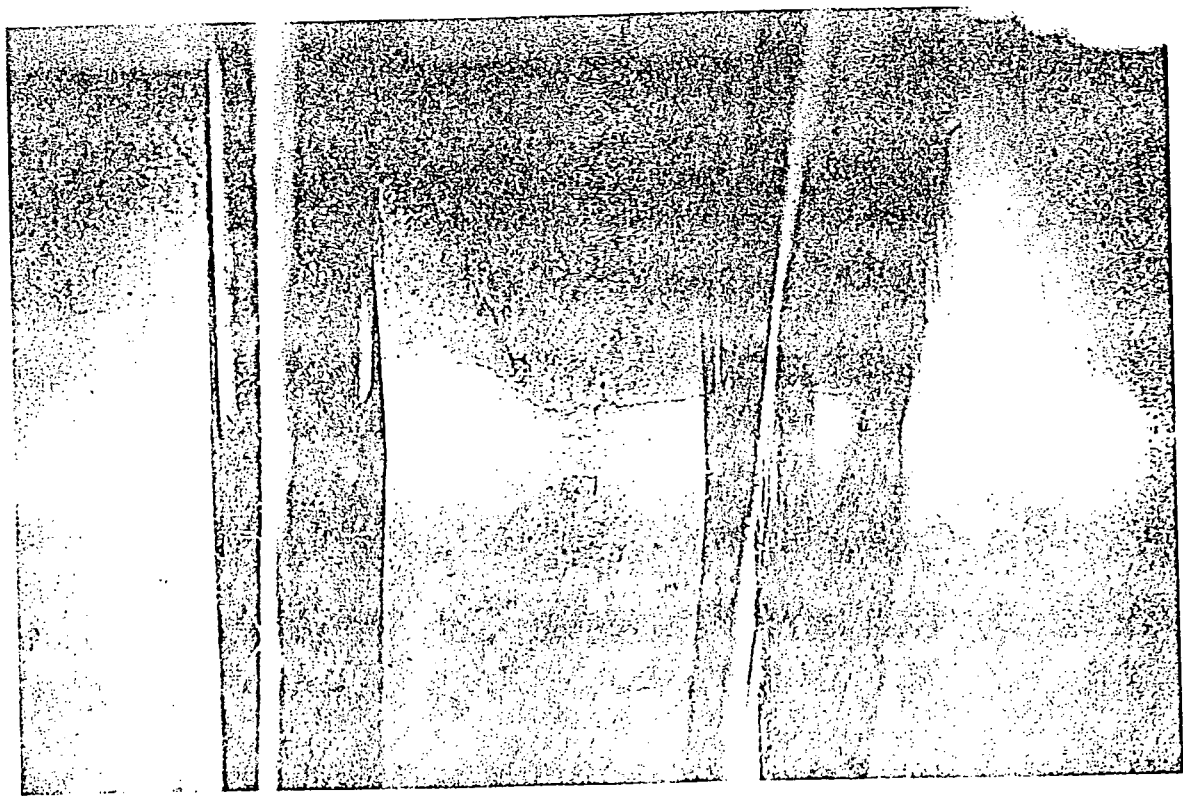
Figure 5: Optical photograph of the crack in finger #9, at bend c, on the 3A0605 contact block.

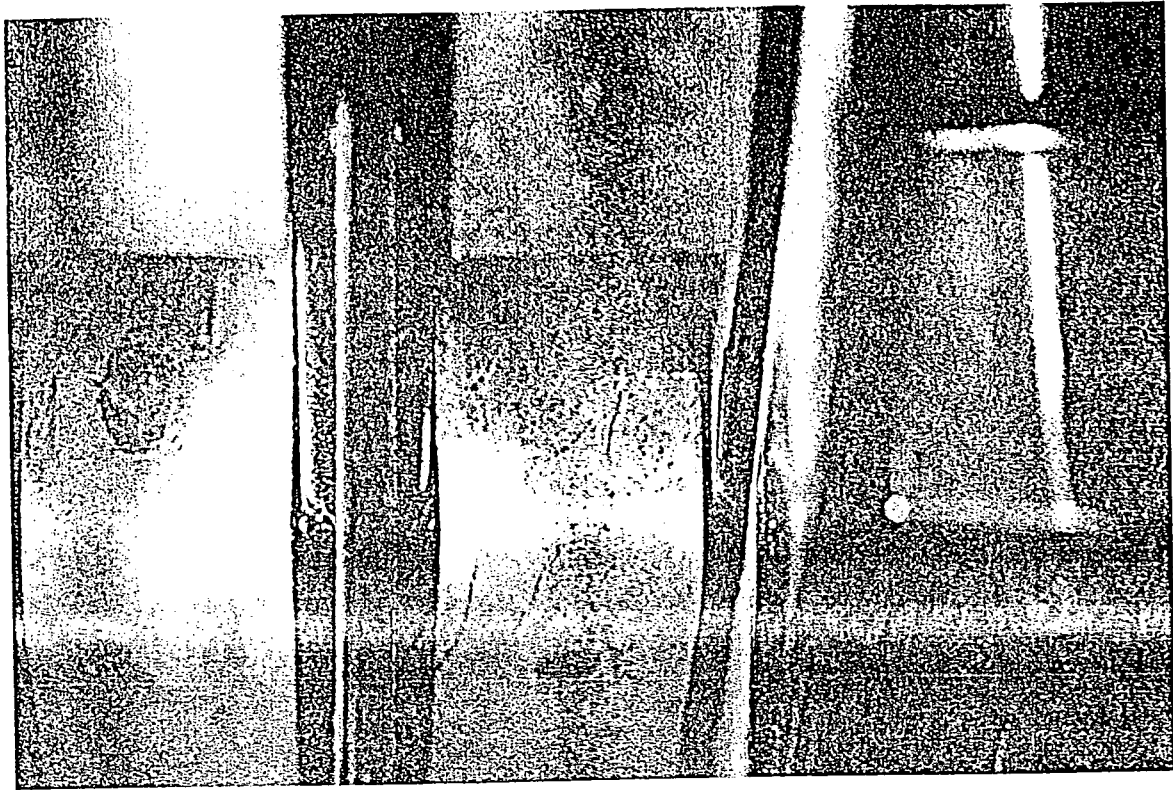
Figure 6: Optical photograph of the crack in finger #12, at bend c, on the 3A0605 contact block.

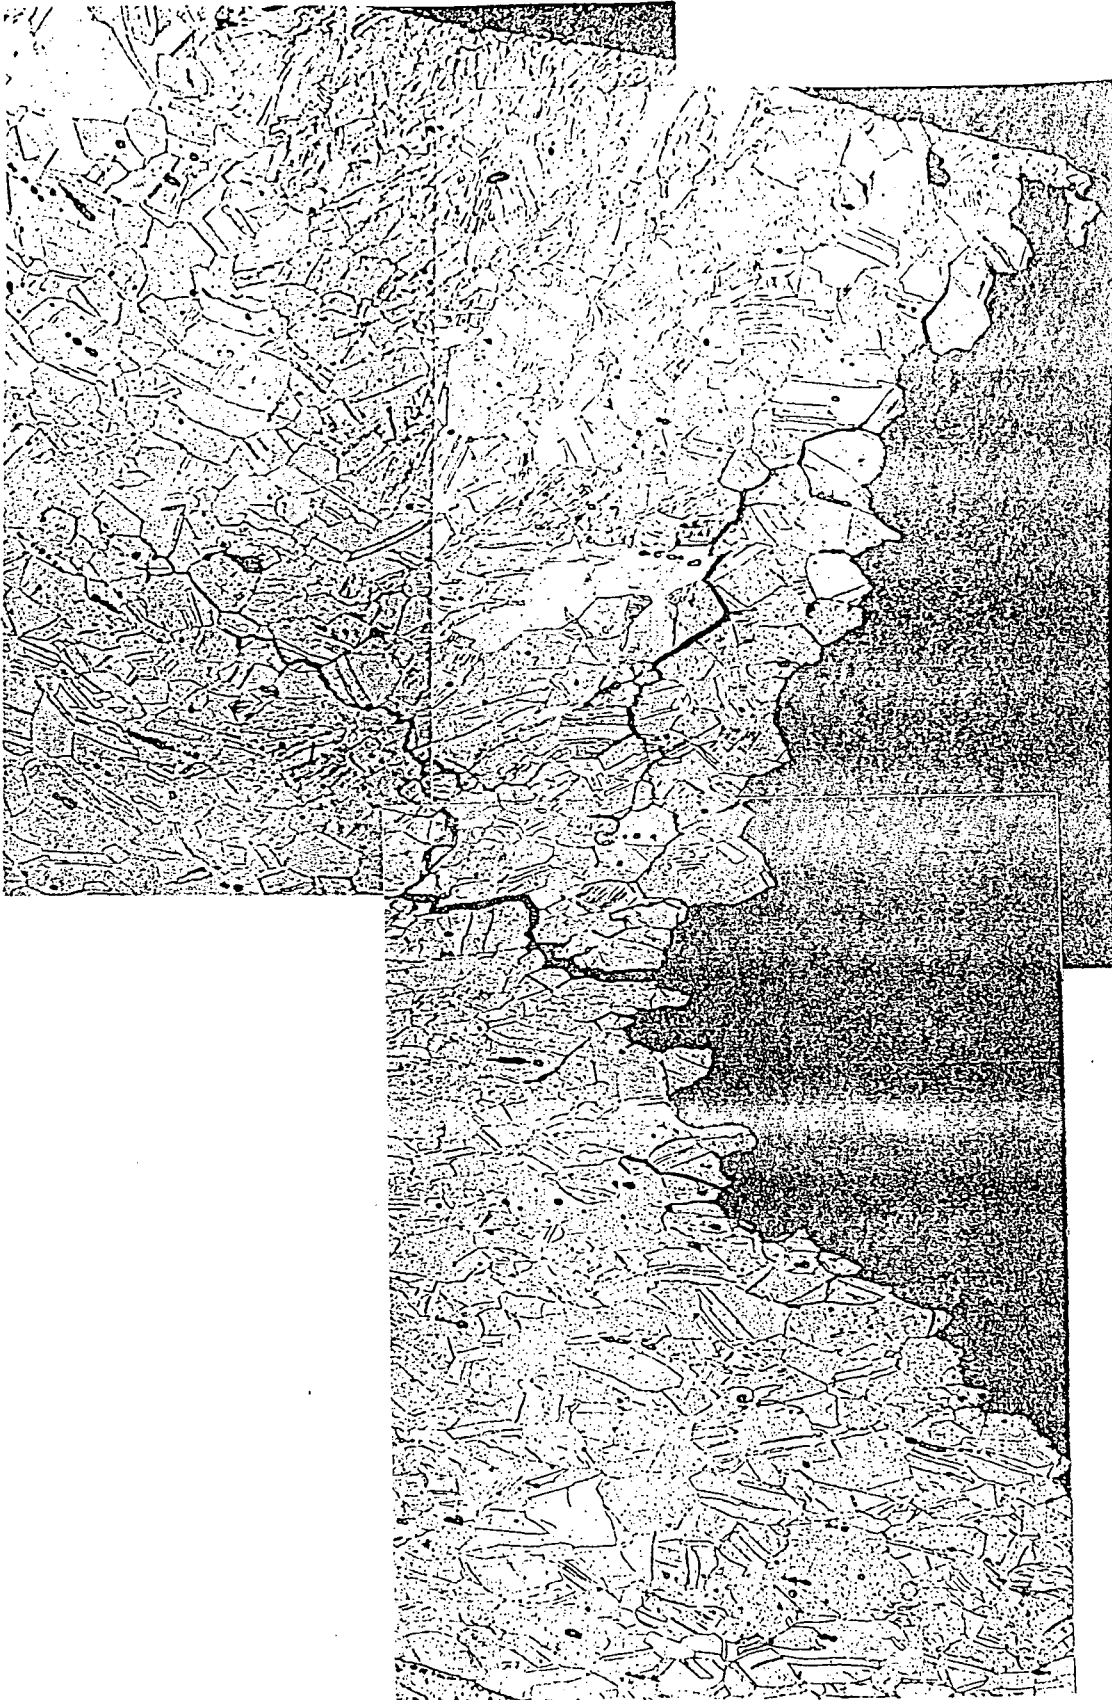
Figure 7: Optical Micrograph of a cross section of one side of the finger #4 fracture showing the intergranular cracks and extra hard temper grain structure. Mag:200X

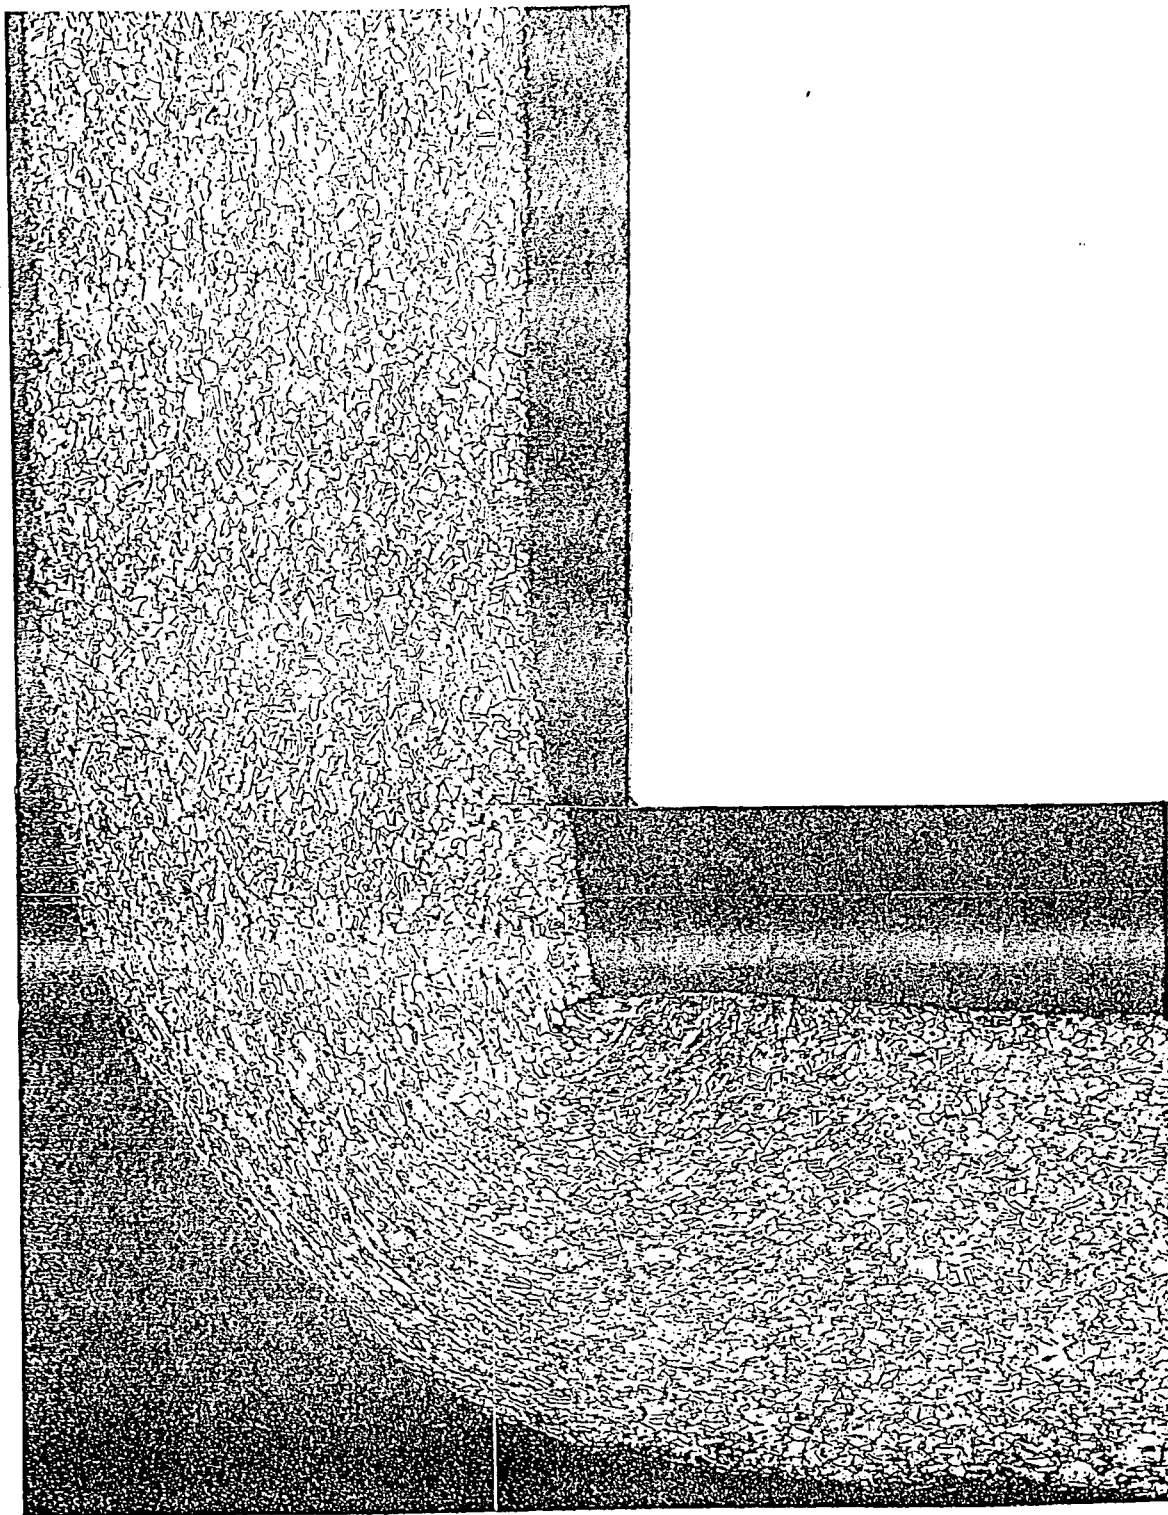
Figure 8: Optical Micrograph of finger #4 cross section at bend B showing a crack at the inner diameter and the extra hard temper grain structure at the bend. Mag:50X

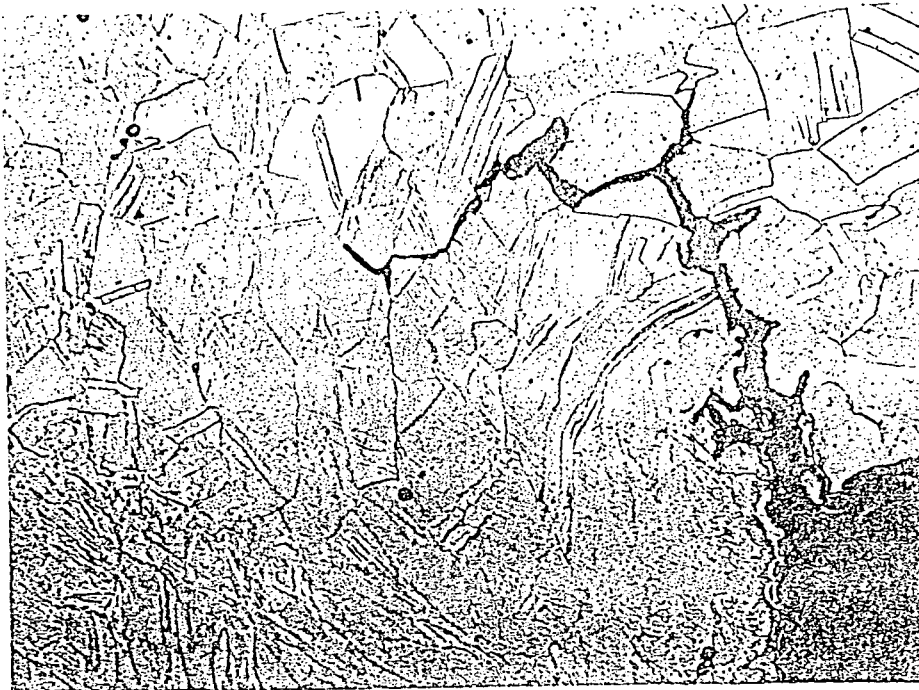
Figure 9: Close-up of the inner diameter crack in finger 4, bend B in Figure 8. Mag:400X

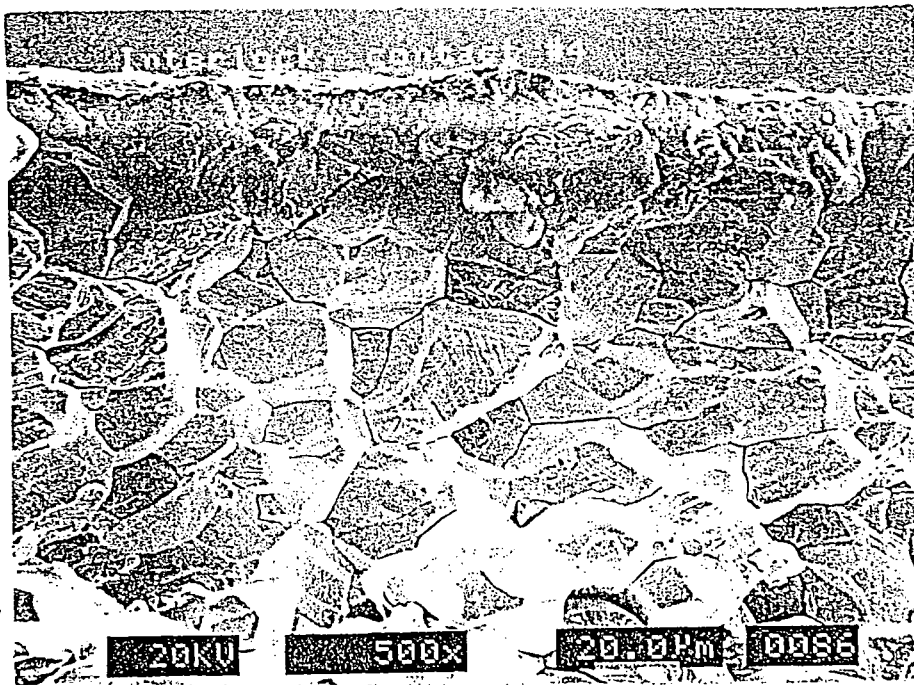
Figure 10: Scanning Electron Microscope (SEM) photograph of the fracture face on finger 4 showing the intergranular structure.

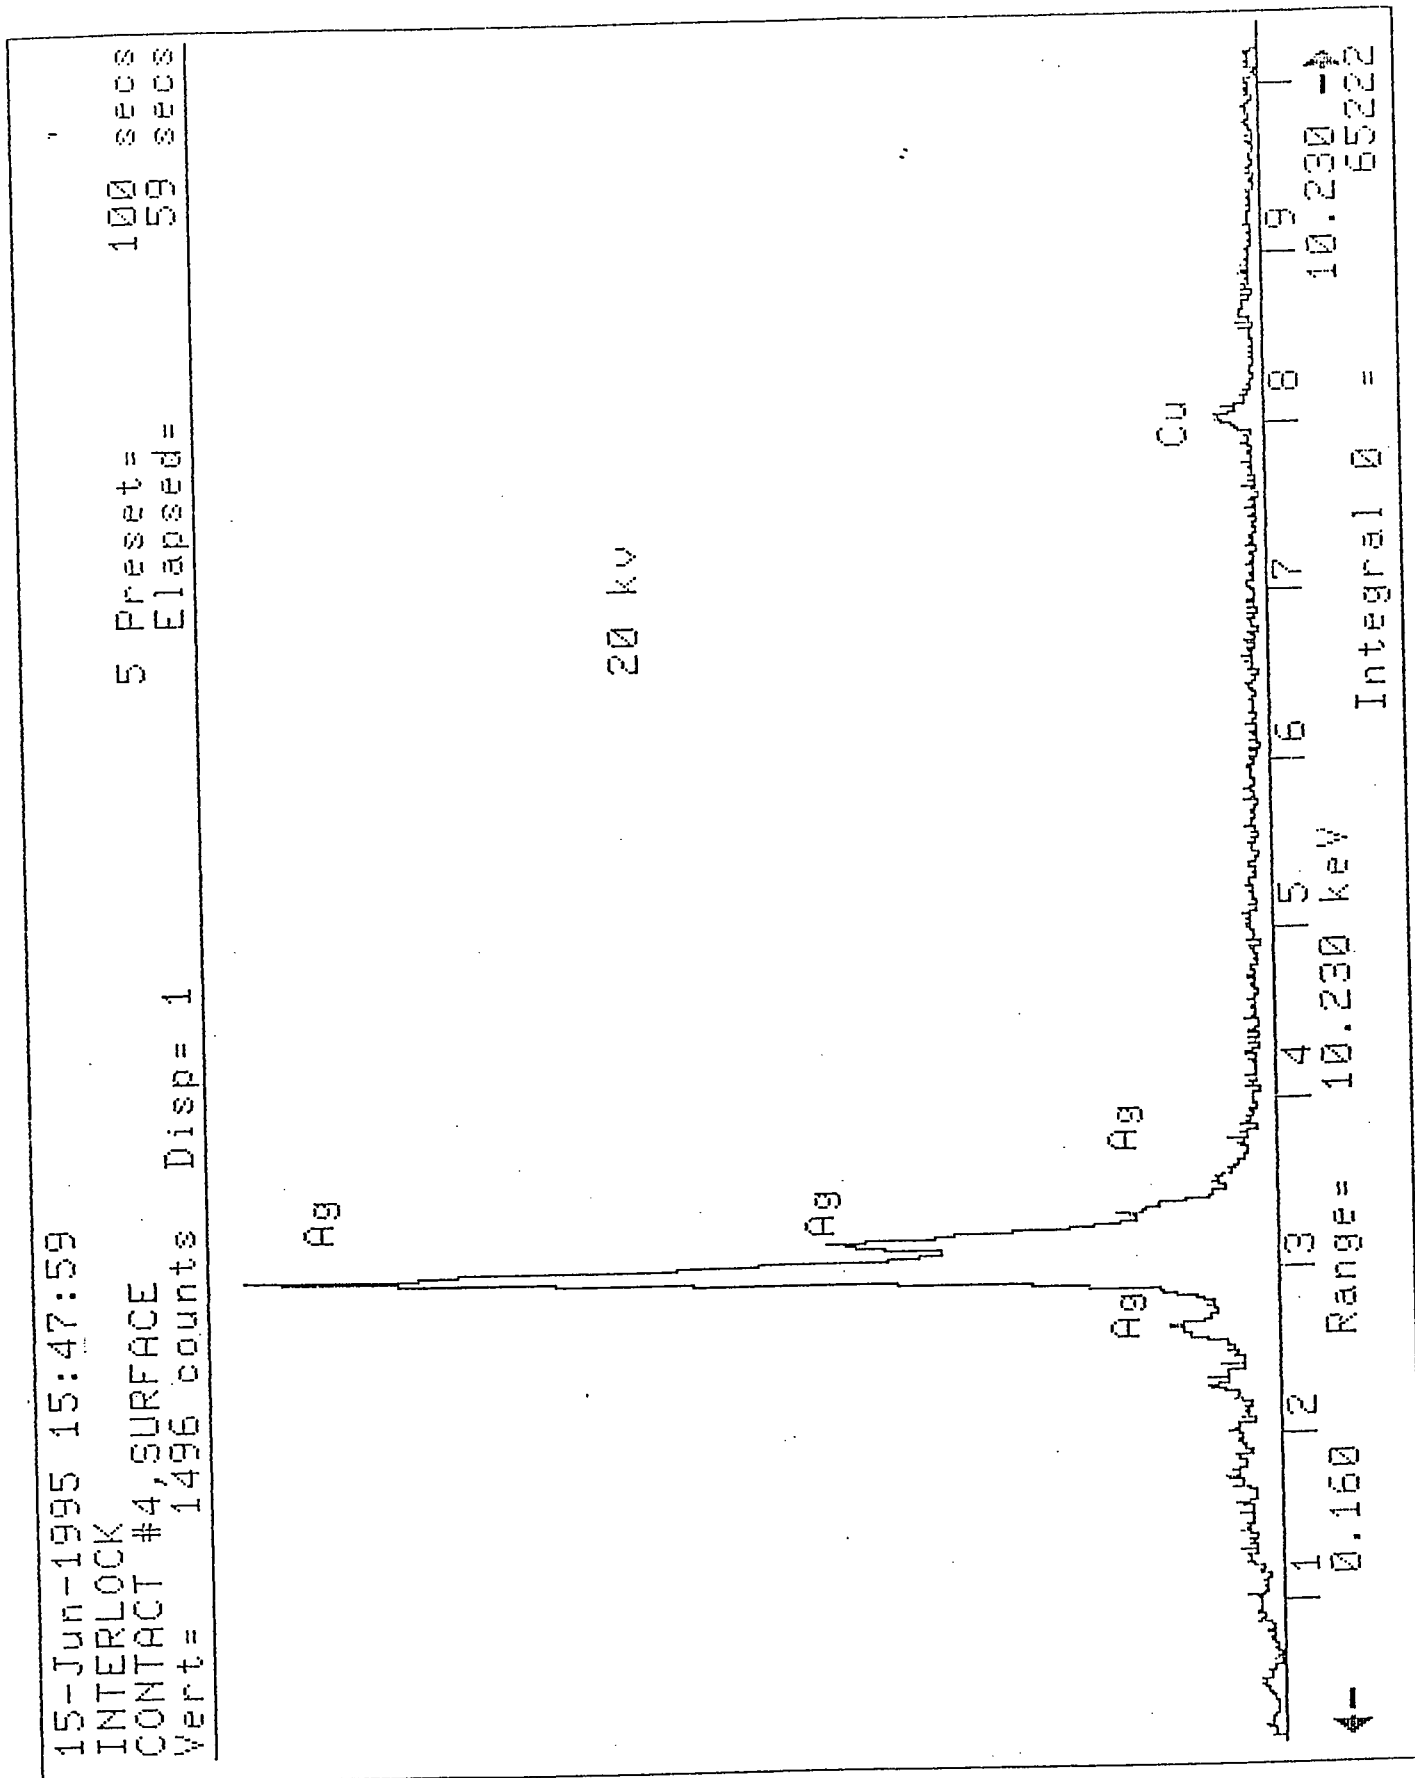
Figure 11: Energy Dispersive spectrum (EDS) showing the elemental composition of the plating on the surface of finger #4, contact block 3A0605.

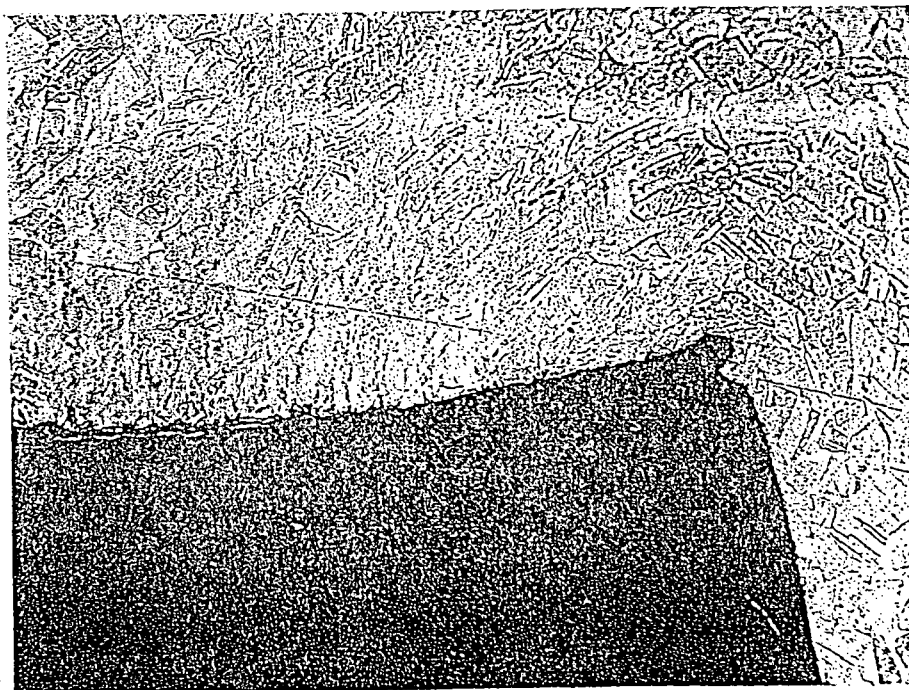
Figure 15: Close-up of the grain structure at the bend area of figure 14. The larger grains are a less hard temper than the cracked fingers. Mag: 200X

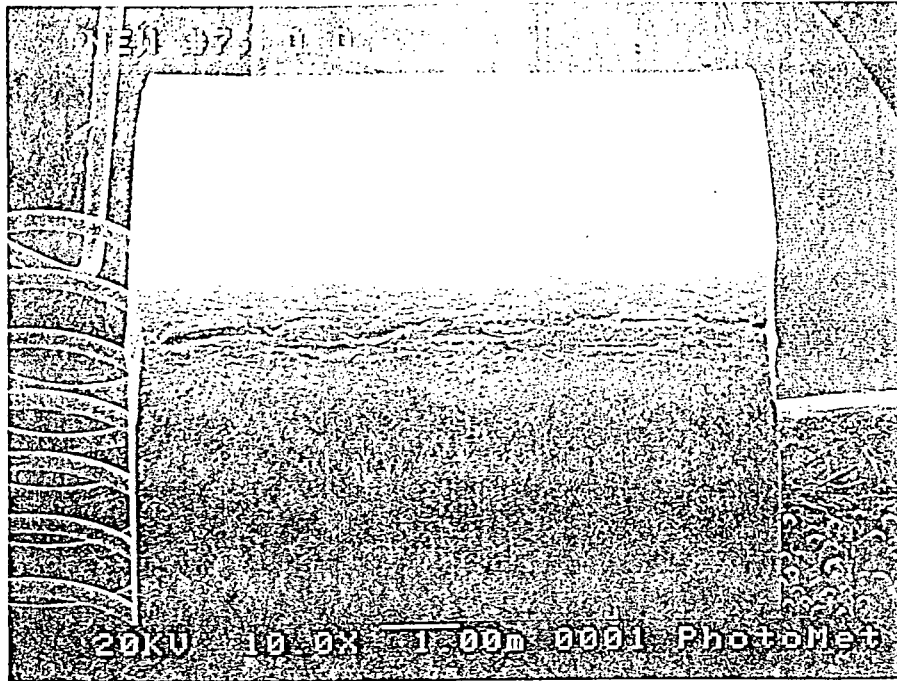
Figure 16: SEM photograph of contact finger #7 from the warehouse contact block showing the cracks at bend B.

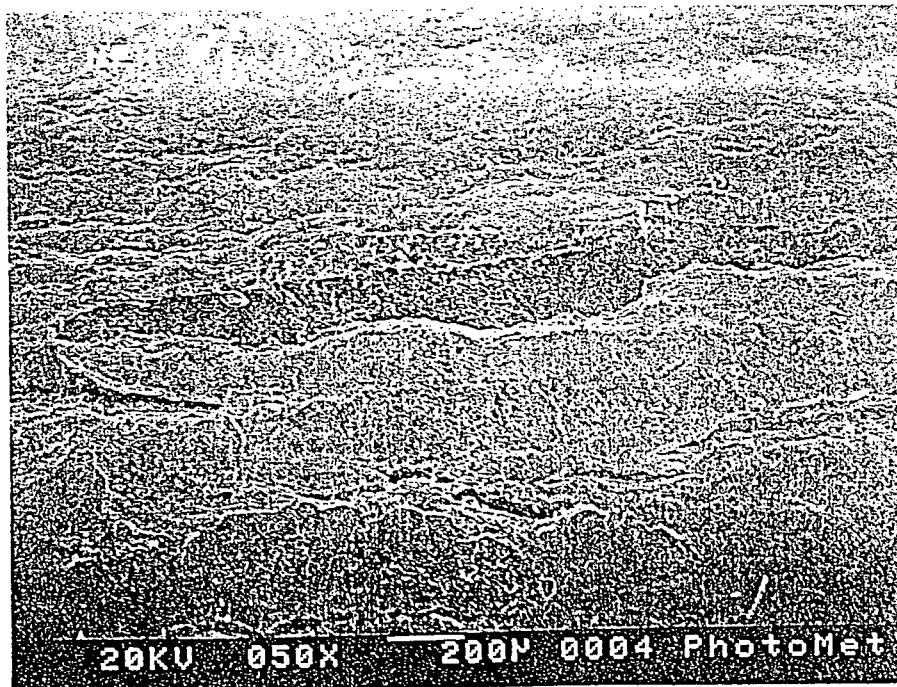
Figure 17: Close-up of the cracks in Contact #7, bend B, in Figure 16.

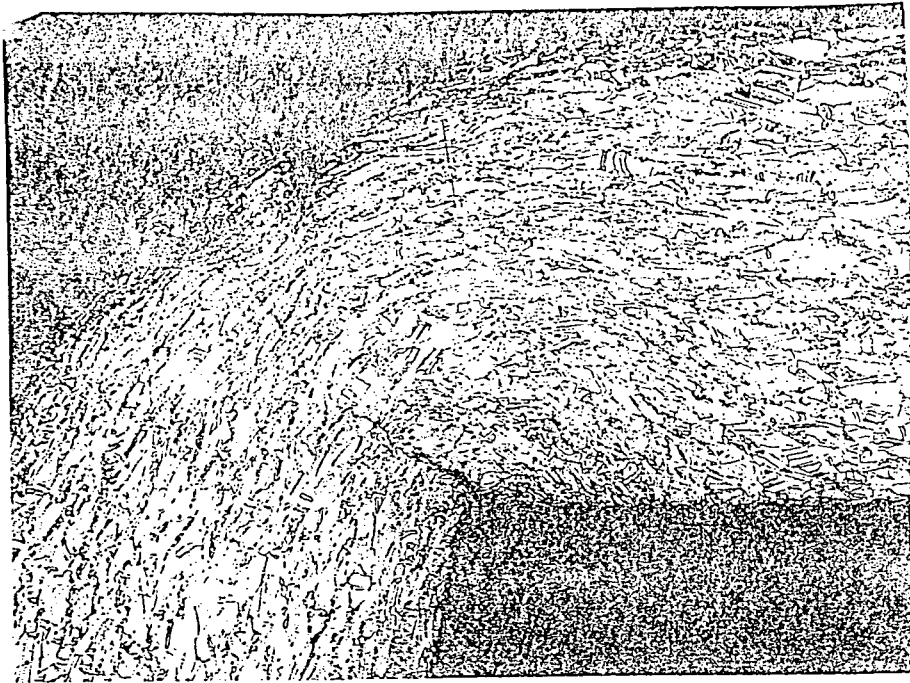
Figure 18: Optical micrograph of the cross section of contact finger #7, bend b, showing the depth of the cracks. Mag:50X

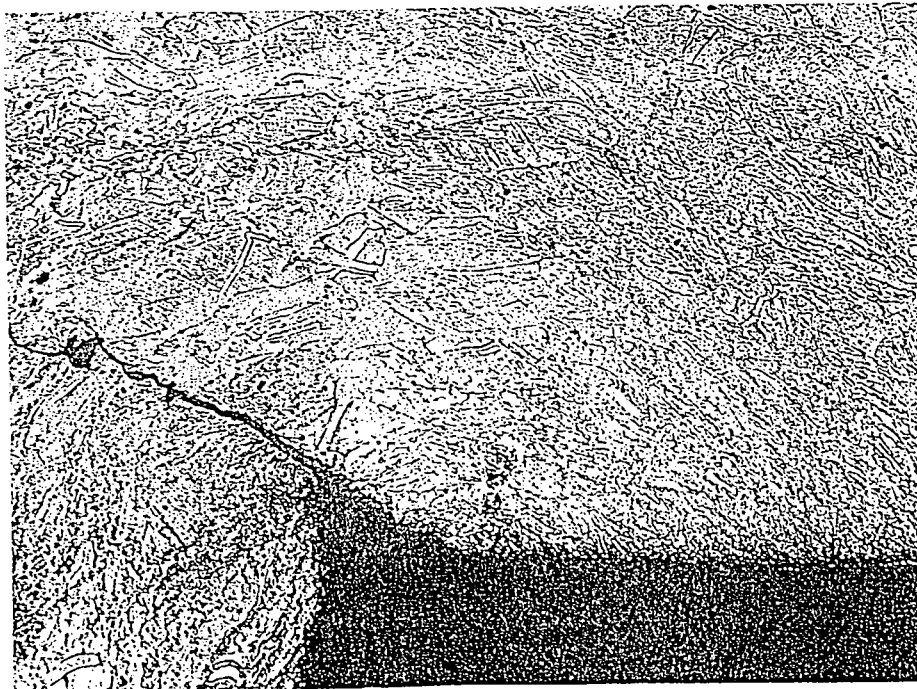
Figure 19: Close-up of the inner diameter crack in finger #7, bend B, in Figure 18. Mag:200X

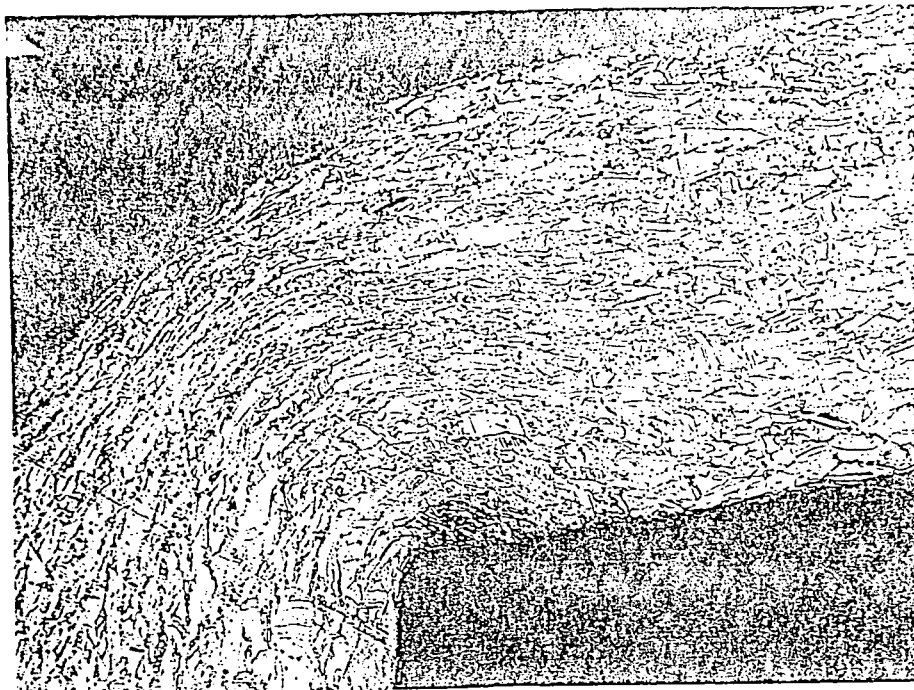
Figure 20: Optical micrograph of the cross section of contact finger #8, bend b, showing the depth of the cracks. Mag:50X

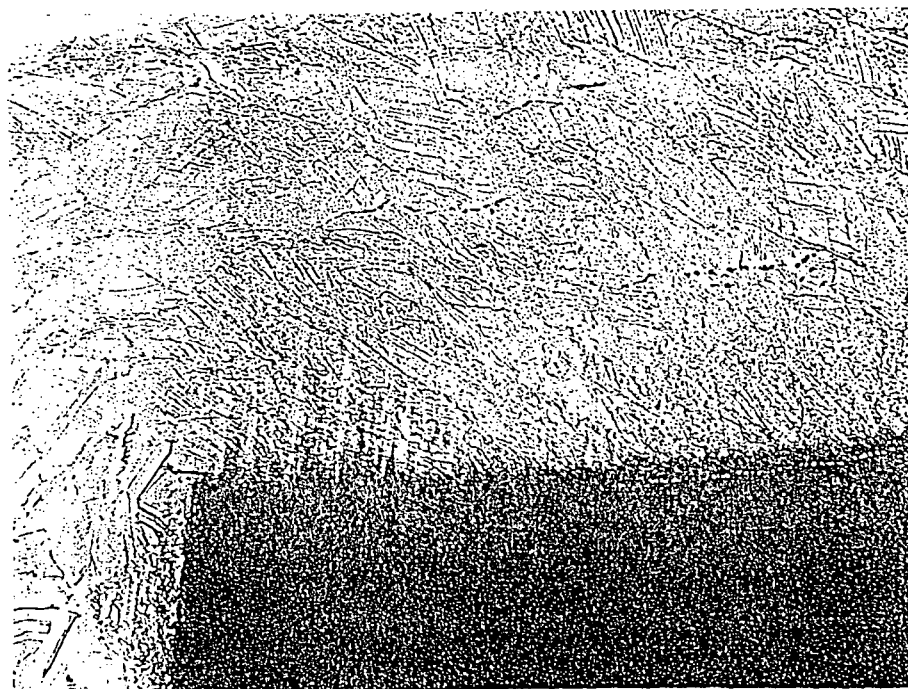
Figure 21: Close-up of the inner diameter crack in finger #8, bend B, in Figure 20. Mag:200X

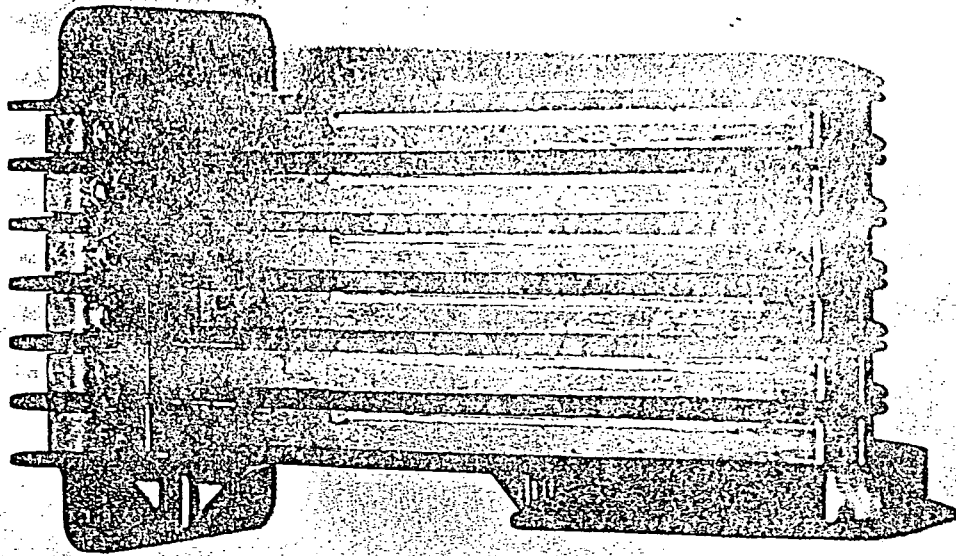
Figure 22: Optical photograph of the 2A0611 contact block after removal from the P114 breaker.

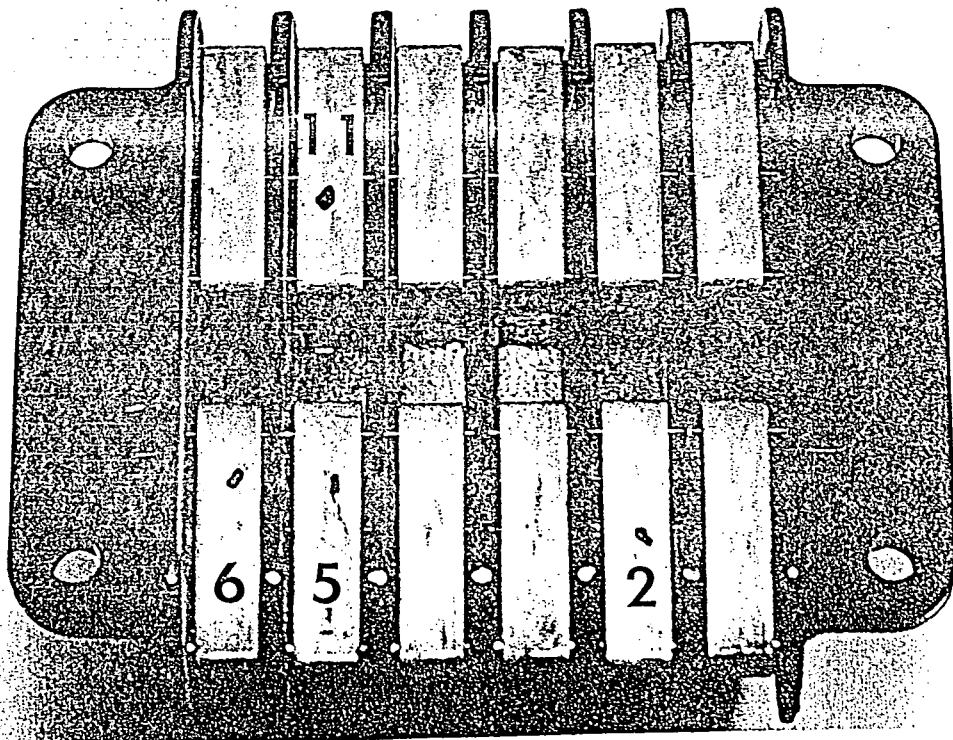
Figure 23: Optical photograph of back of the 2A0611 contact block showing the location of the cracked fingers.

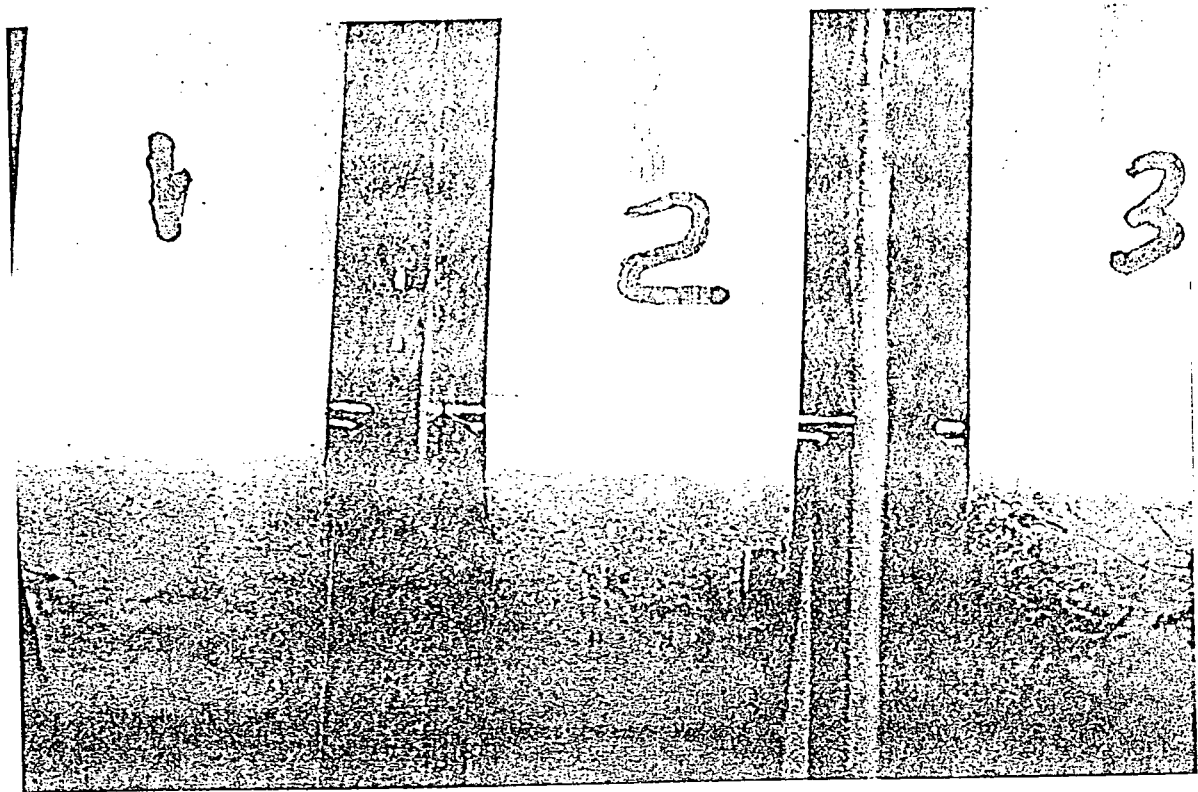
Figure 24: Close-up of the crack in finger #2, bend B, in contact block 2A0611.

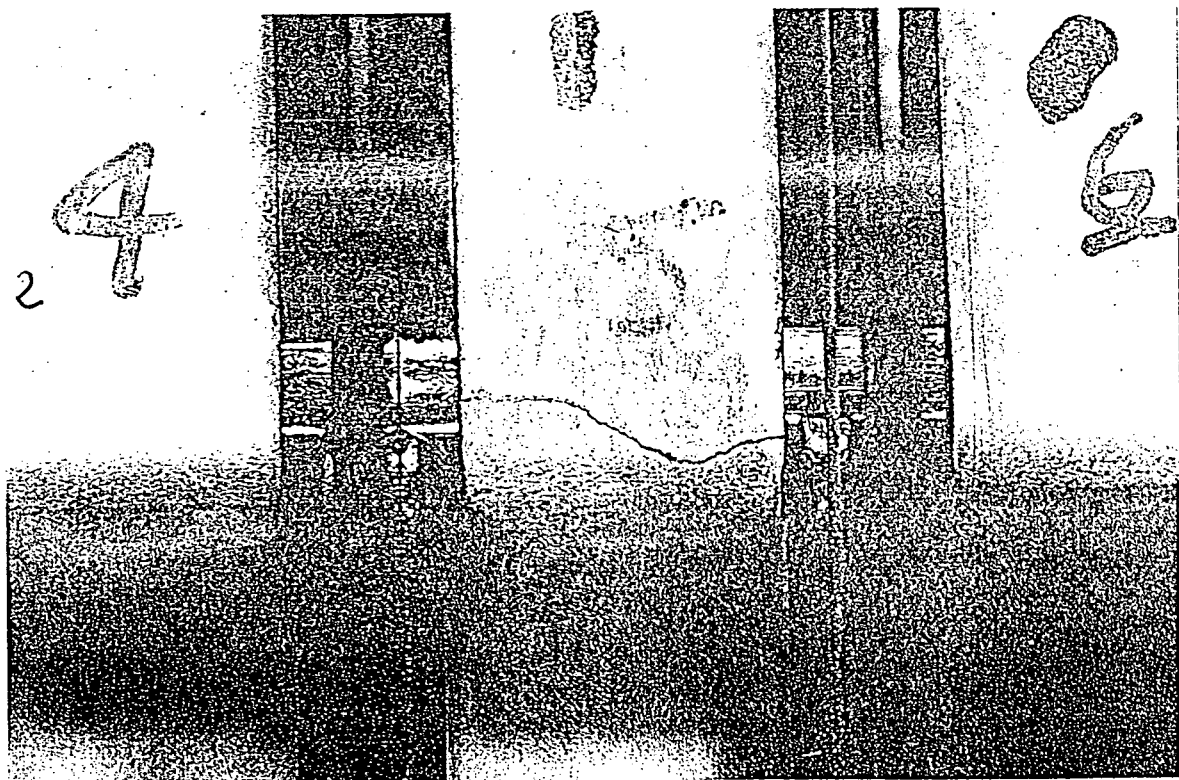
Figure 25: Close-up of the crack in finger #5, bend B, in contact block 2A0611.

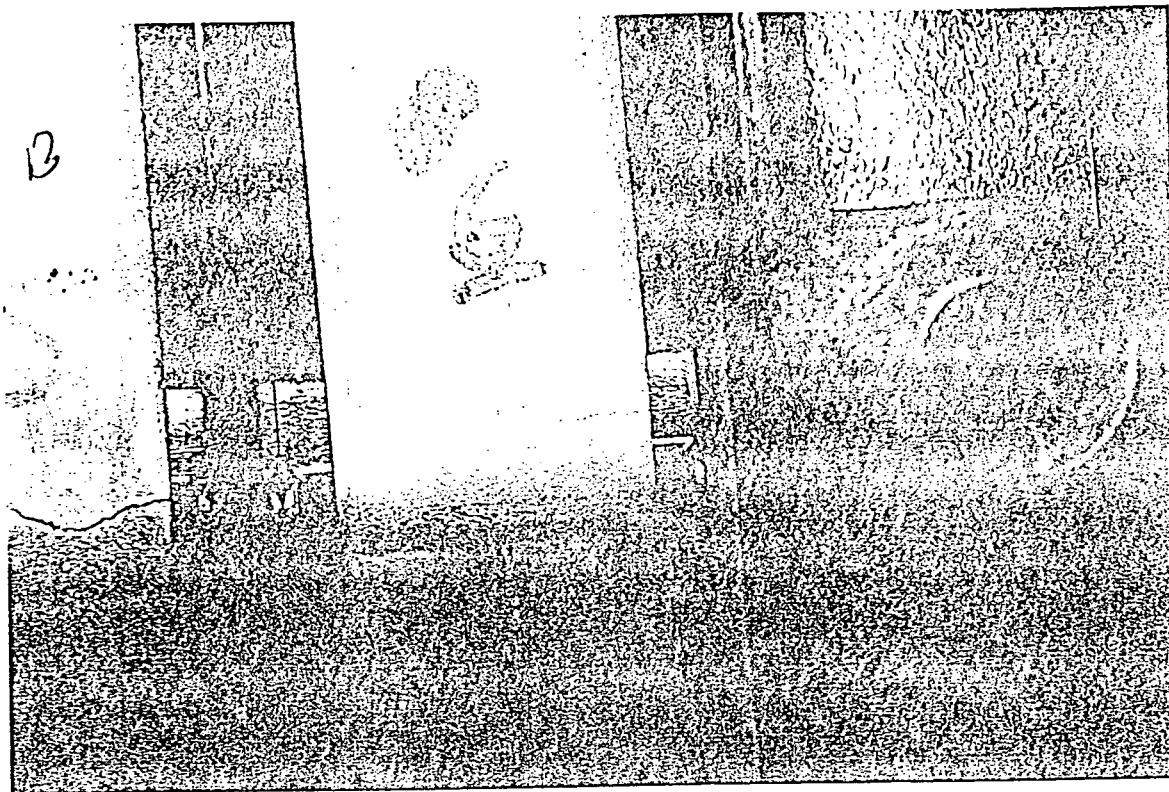
Figure 26: Close-up of the crack in finger #6, bend B, in contact block 2A0611.

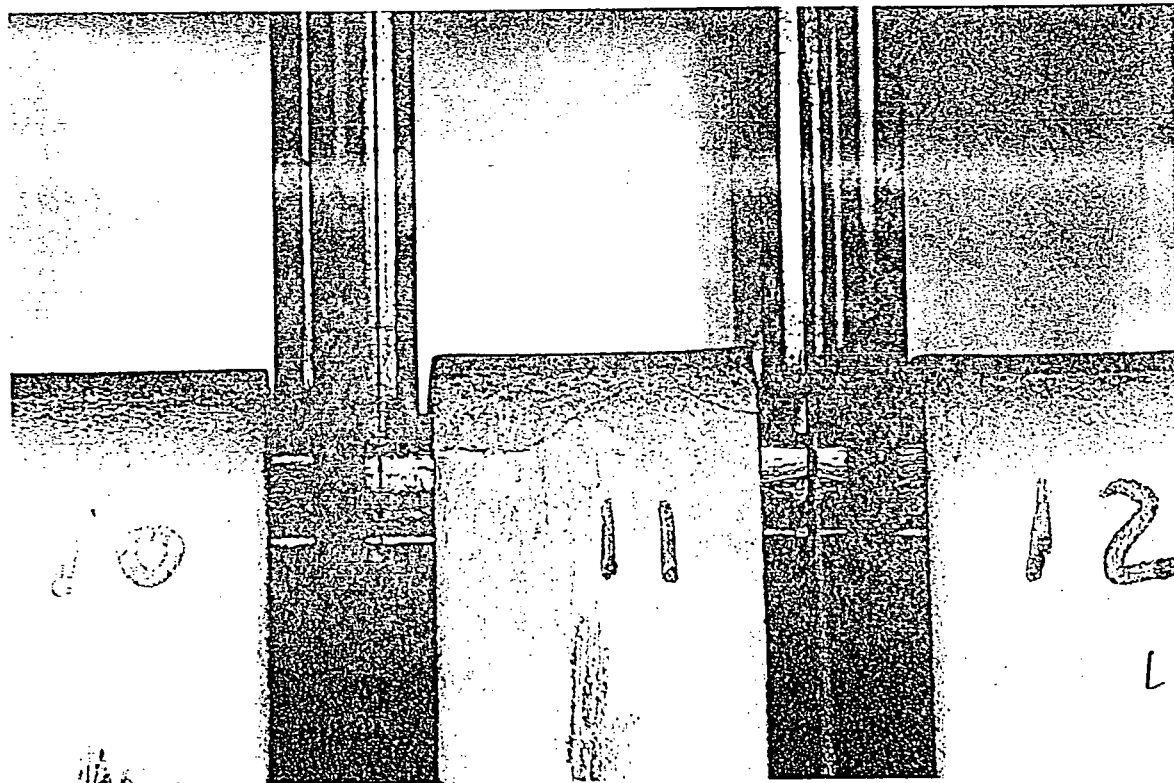
Figure 27: Close-up of the crack in finger #11, bend B, in contact block 2A0611.

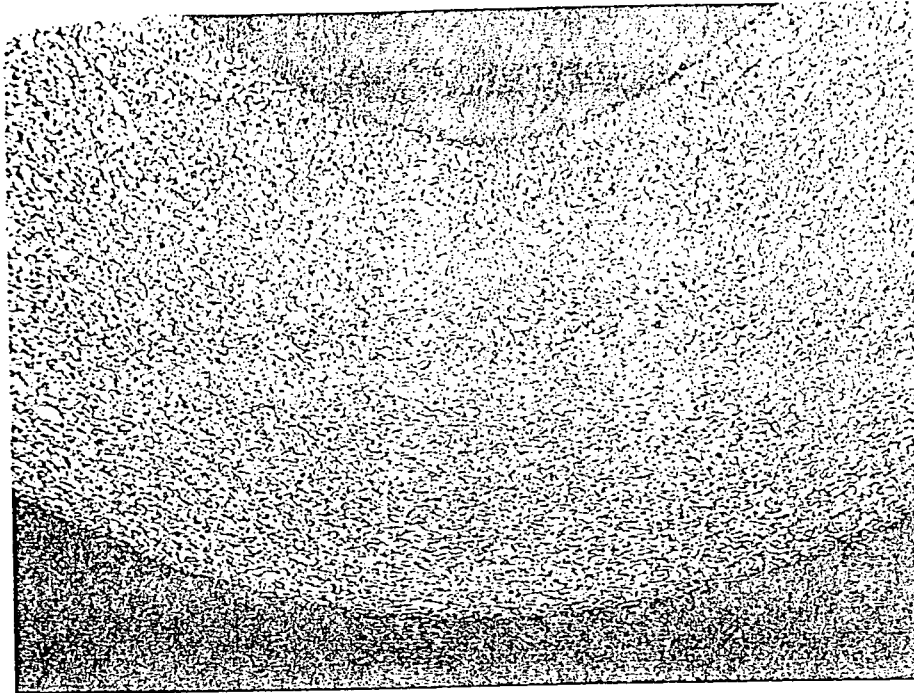
Figure 28: Cross sectional micrograph of the new contact finger material in the bend area showing a grain structure indicative of Half Hard temper. Mag:50X
