ROOT CAUSE EVALUATION OF
4KV BREAKER SECONDARY
CONTACT BLOCK FAILURE
RCE 95-010

ATTACHMENT #1

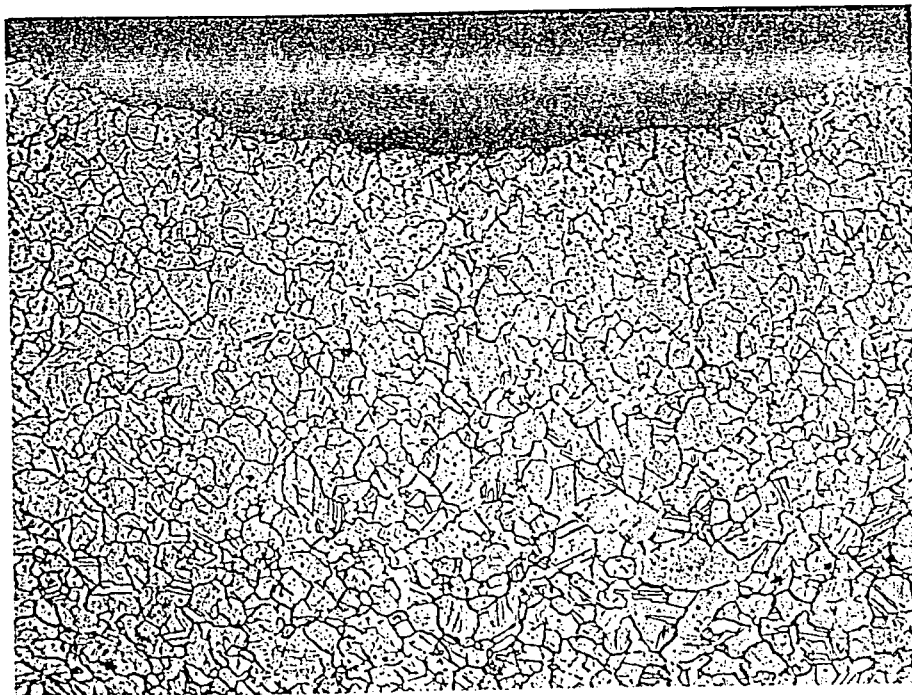
Figure 29: Magnified view of the new material at the bend area showing the absence of cracks. Mag:200X

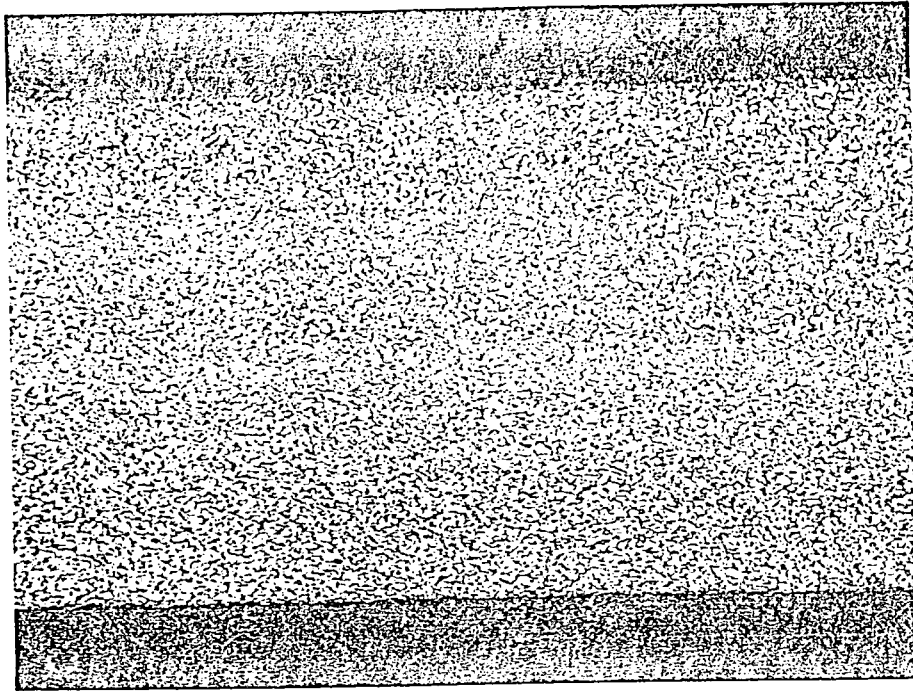
Figure 30: Cross sectional micrograph of the new contact finger material in the straight area showing a grain structure indicative of Quarter Hard temper. Mag:50X
