## San Onofre Nuclear Generation Site Unit 1

# FAILURE ANALYSIS OF SWING CHECK VALVES

## Chong Chiu Southern California Edison Company

January 27, 1986 Revision O

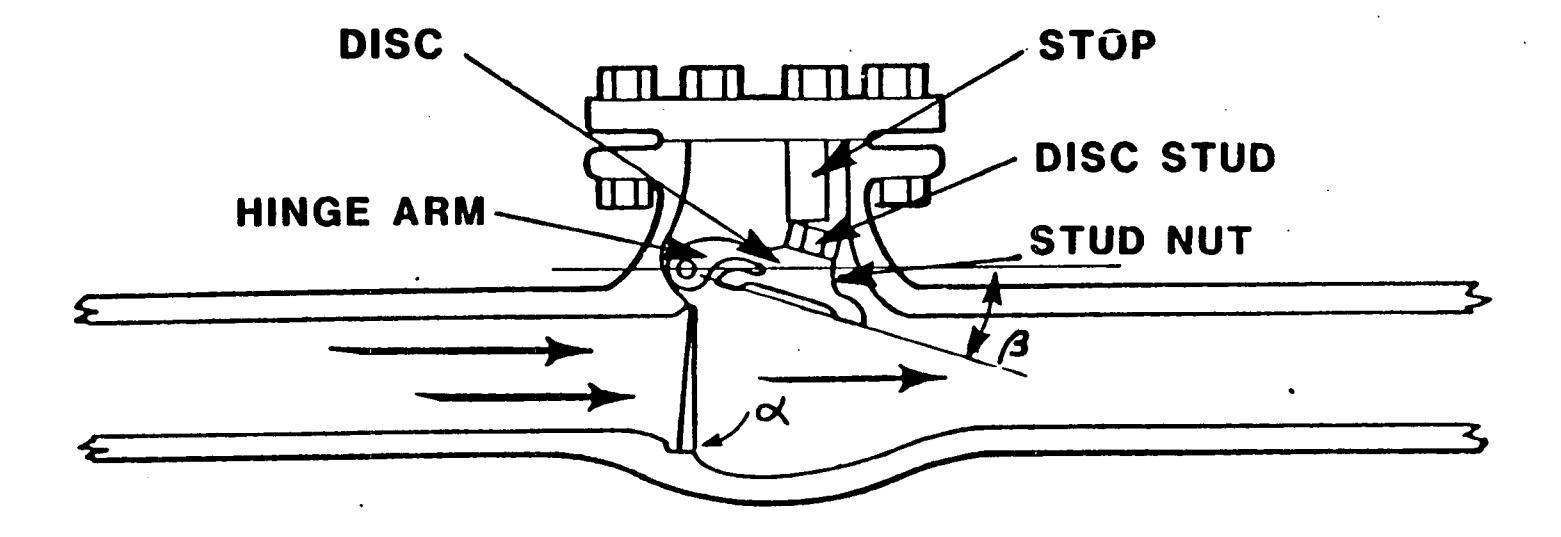
## FIGURE 1 CHECK VALVE CONFIGURATION

The force balance method equates the lifting force resulting from the impinging flow to the valve disc to the gravitational force from the disc and hinge arm weights. The impinging angle is defined in Figure 1.

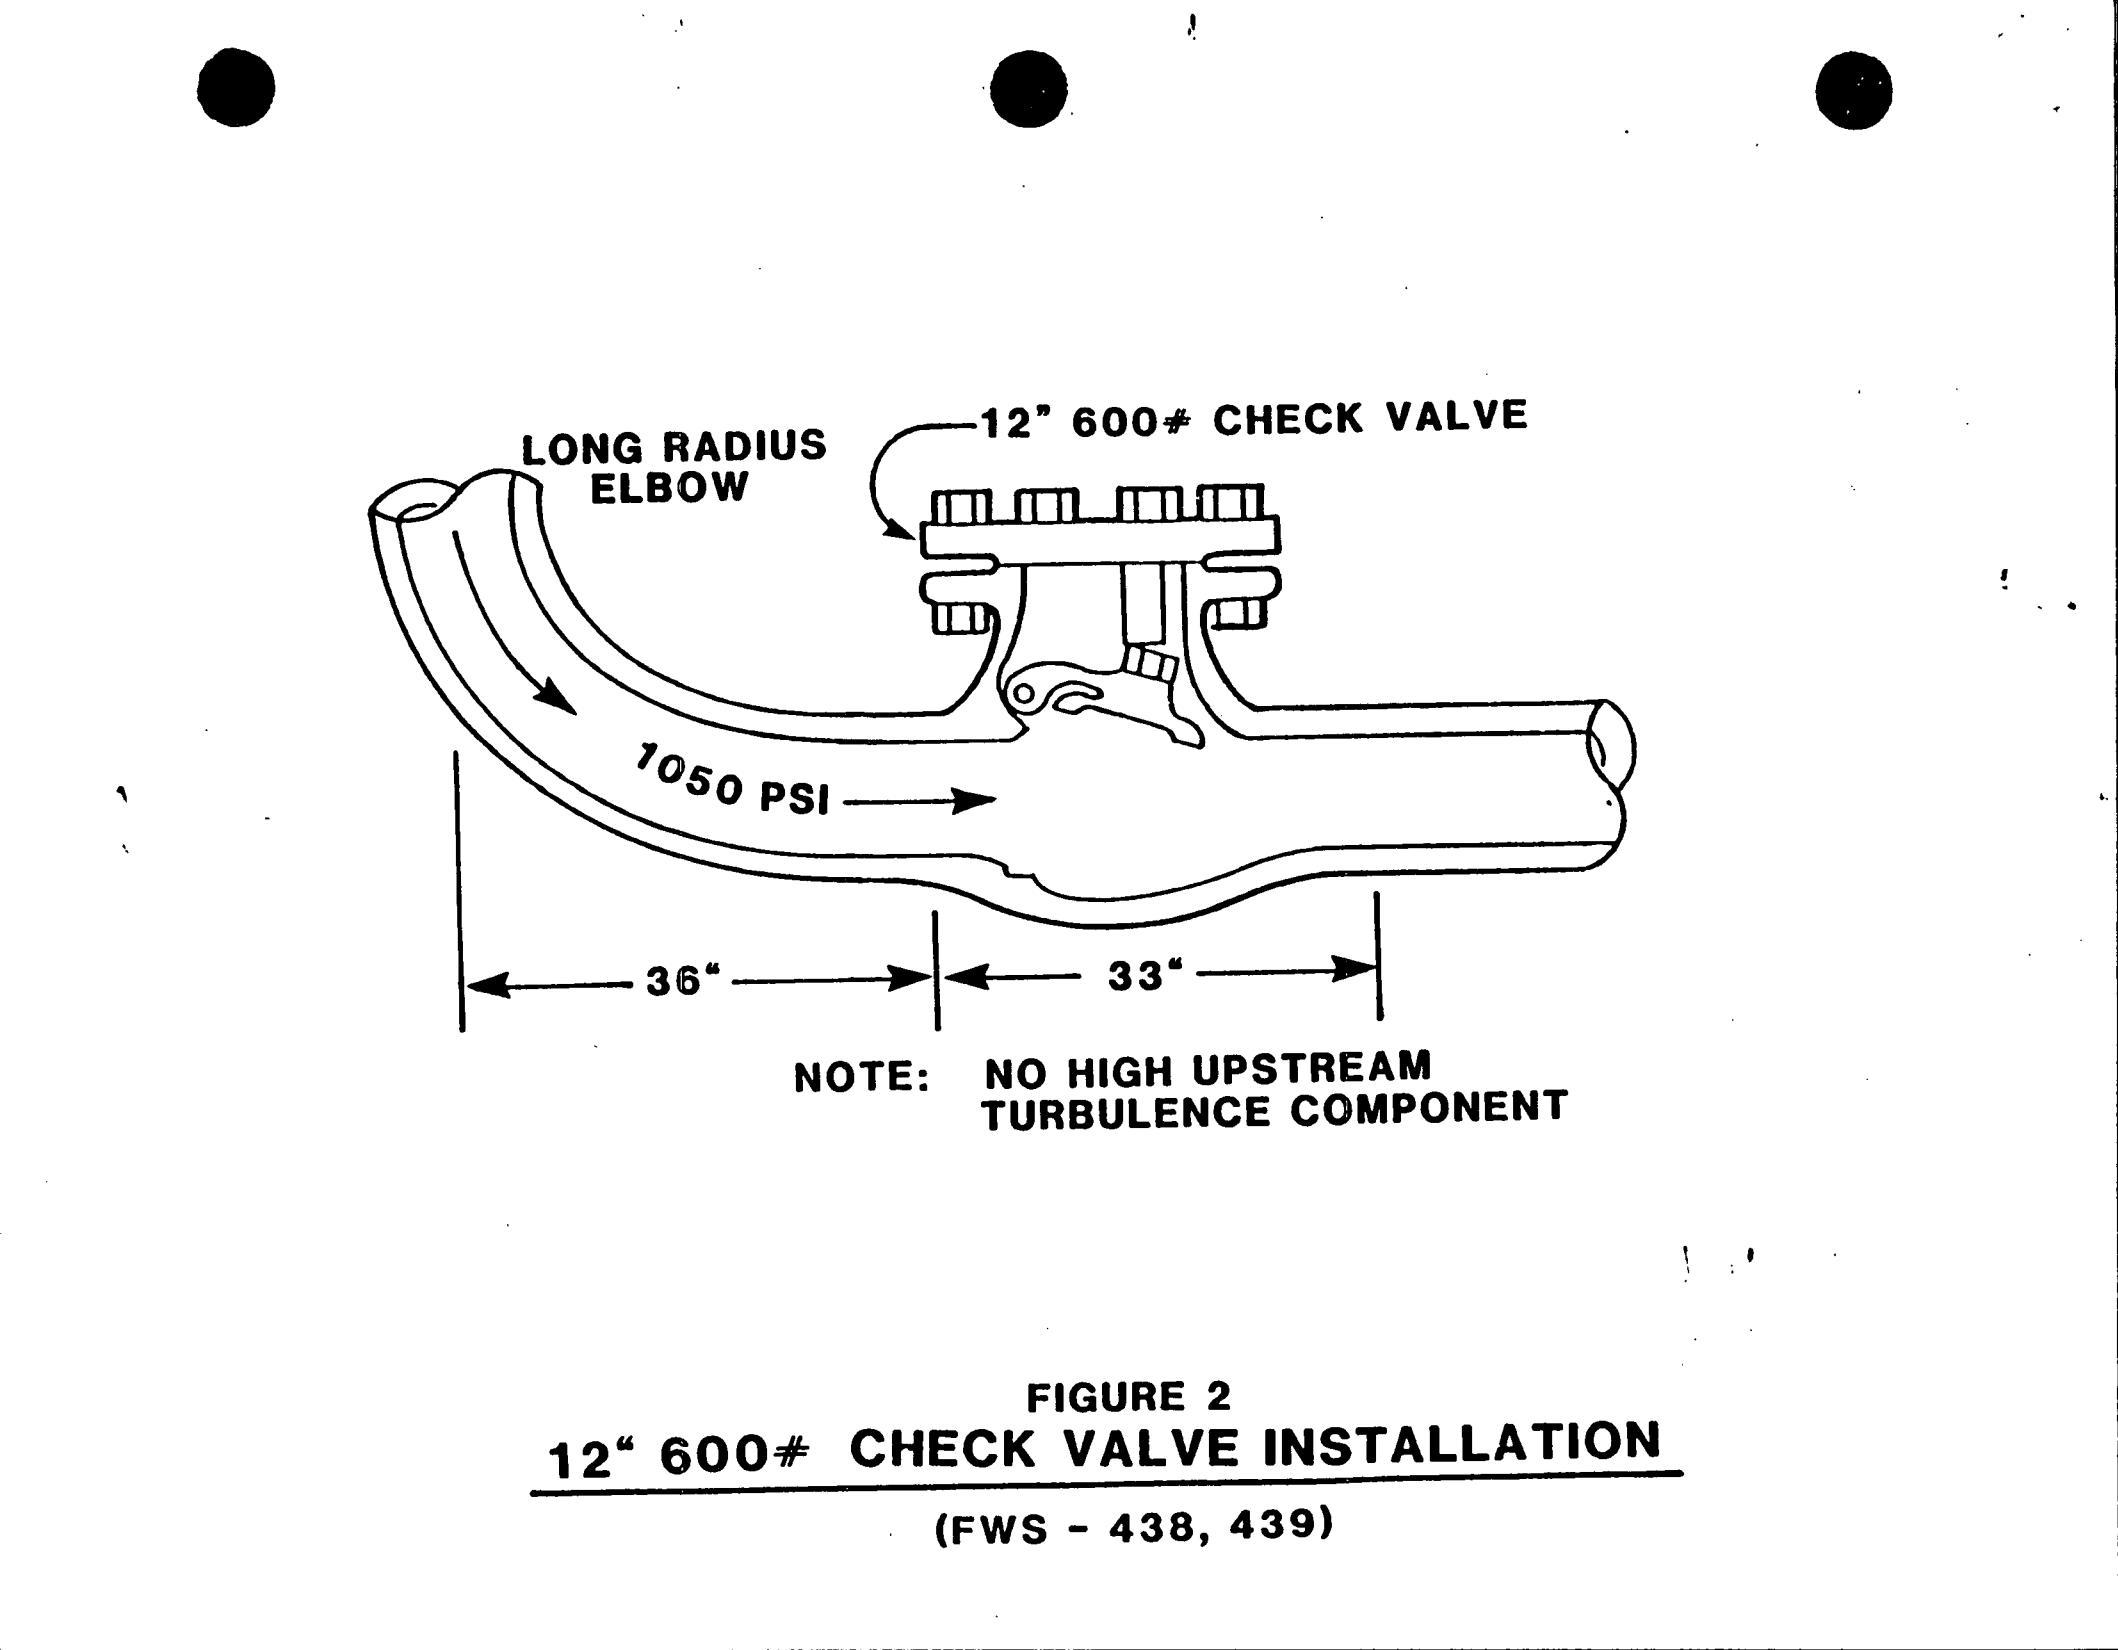
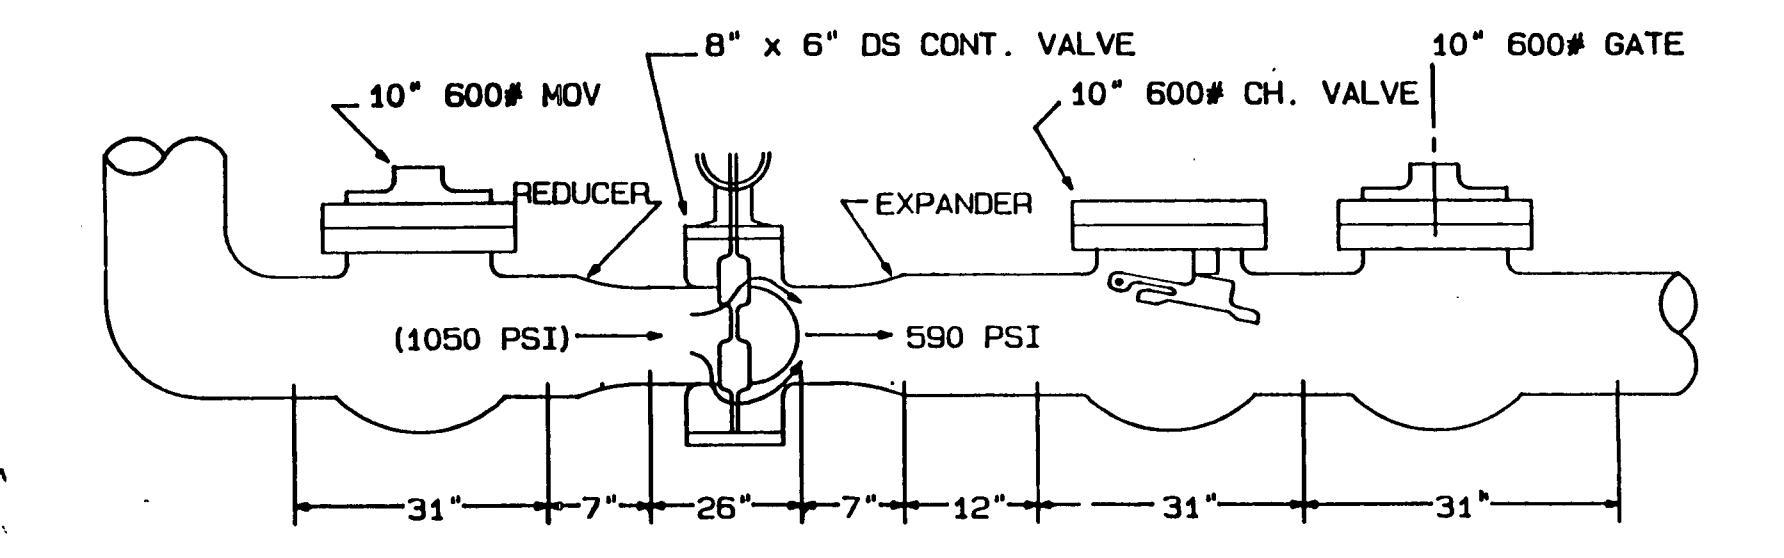
- 1) Because of the existence of high turbulence just upstream of FWS-345, 346 and 398, due to a large pressure drop in the upstream control valves (as shown in Figures 2 and 3), the turbulence intensity in these valves is much stronger than that in FWS-438 and FWS-439. Higher turbulence level will tend to excite the resonant vibration mode to a larger amplitude. The relationship is demonstrated by the proportionality of the acceleration response to the square root of the turbulence power spectrum density, as derived in reference 10.
- 2) Based on the minimum velocity requirement in reference 11, the actual seat port velocities in FWS-438 and FWS-439 have a larger margin to the minimum velocity of full open than those in FWS-345, FWS-346 and FWS-398.
