May 2, 2014

Subject: Missing Jam Nuts on Size 4, Pressure Class 600 Normally Open, In-Line Check Valve per Flowserve Drawing No. 07-45546-01

Attachment: Flowserve Drawing No.07-45546-01

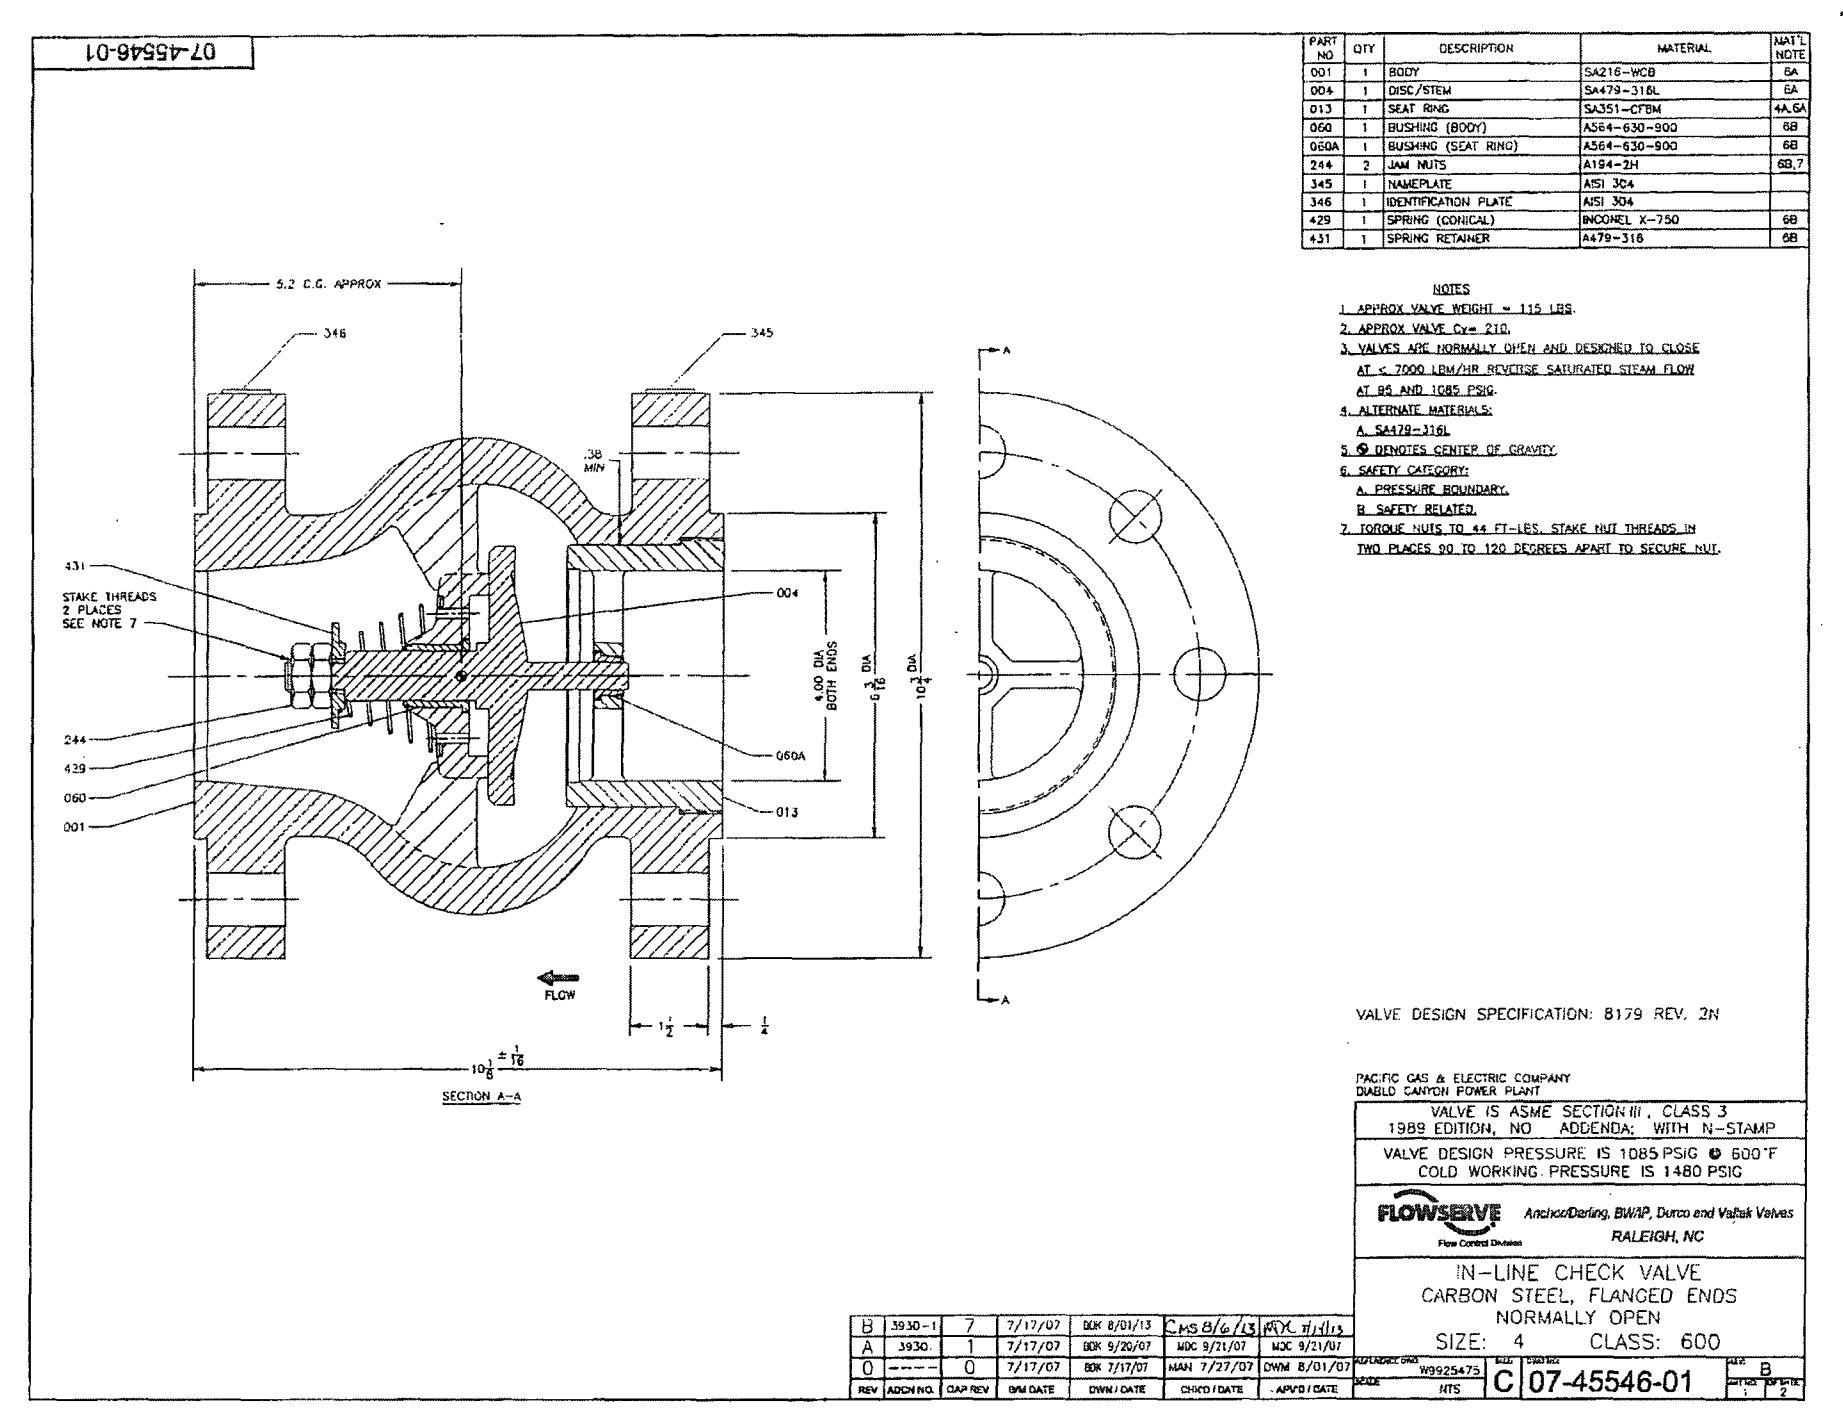
Nature of the Defect: In March of 2014, PG&E Diablo Canyon visual inspection discovered the outer jam nut was missing from the valve stem and was found downstream. This jam nut locks the inner jam nut which retains the spring and spring retainer. There were signs of one stake on the stem threads. These check valves include a conical spring which maintains the disc open in its normal position. Flow in the normal direction maintains the valve open and a minimum reverse flow is required to close the valve. The valve is used in saturated steam service and must close with a reverse flow of less than 7000 lbs/hr steam at 95 and 1085 psig. The PG&E supplied data sheet does not identify a specific safety related function. However, the valve operating parts are identified as safety related on the drawing.

The valve will not maintain an open position with limited reverse flow without the spring in place and the spring will not be available to assist holding the disc open and stable during forward flow.

Evaluation: Flowserve has completed an evaluation of the most recent failure and concluded that the root cause of the outer jam nut loosening and unscrewing from the stem, most likely is from inadequate nut tightening and staking. The original assembly drawings for the valves did not specify the required torque value and specified only one stake requirement. Based on the fact that this is the second failure of this type Flowserve no longer considers it to be an isolated incident and that it is reportable under the requirements of 10 CFR 21.

- As noted above after the initial failure, on March 7, 2013, PG&E Diablo Canyon was notified by letter to torque the jam nuts to 44 ftlbs and to stake the threads in two places when reassembling the valve.
- For future reference Assembly Drawings 07-45546-01 and W9925475 which cover the designs of the Diablo Canyon valves and a similar design used for the TVA Sequoyah Plant were revised to add jam nut torque and more detailed thread staking notes.
- In additional to the instructions given on the assembly drawing, in the future Flowserve's internal assembly instructions will include more detail regarding the torqueing and staking operations.

Based on the second valve failure, Flowserve recommends that PG&E Diablo Canyon and TVA Sequoyah inspect all in service valves for proper torque and provide dual thread staking per the revised drawings.
