SUBJECT: MANAGEMENT MEETING - H. B. ROBINSON

LIST OF ATTENDEES  
ROBINSON MANAGEMENT MEETING  
12/28/89

MANAGEMENT MEETING SUMMARY  
12/28/89

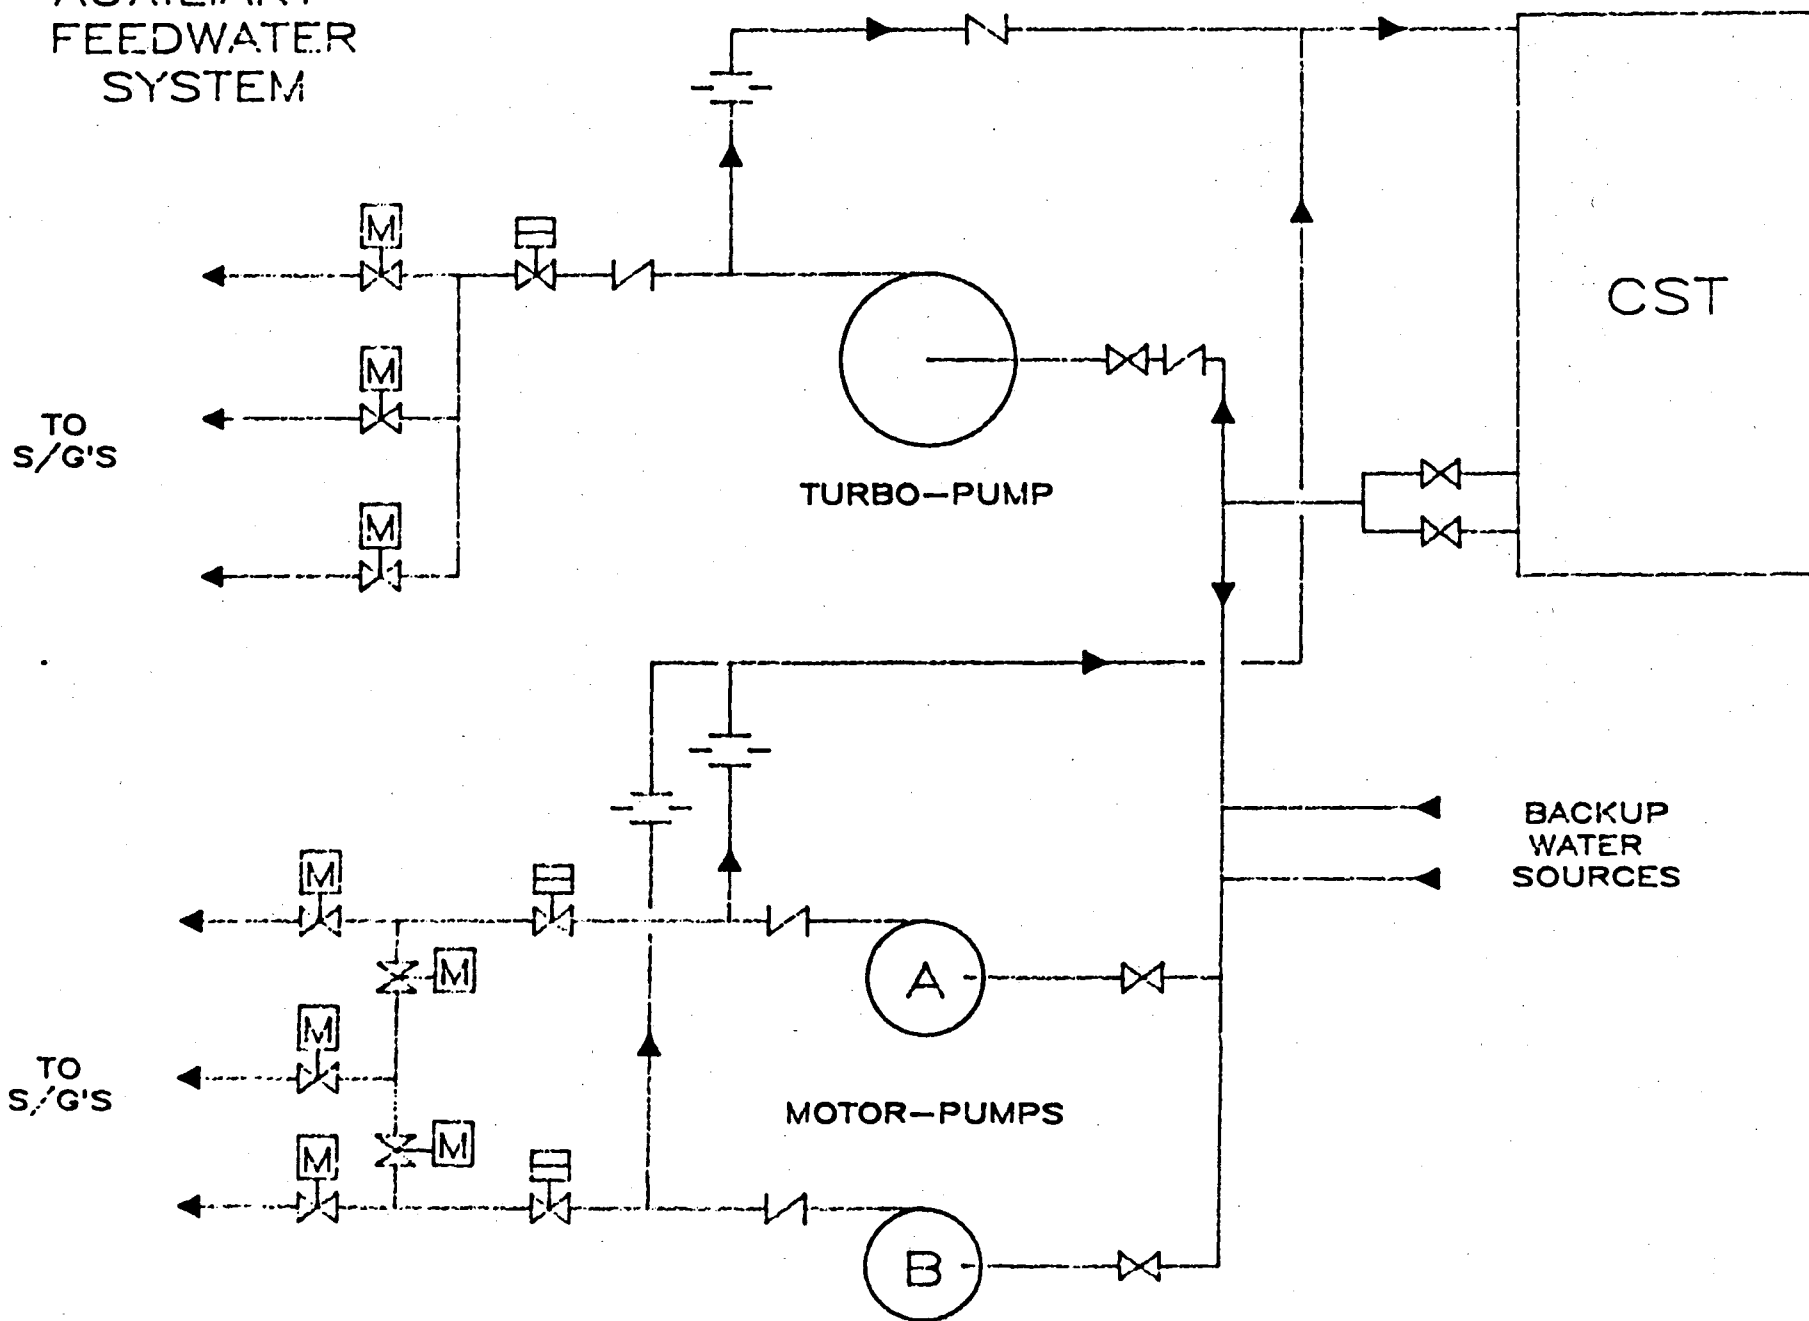
# AUXILIARY FEEDWATER SYSTEM

##### 1. INADEQUATE NET POSITIVE SUCTION HEAD

##### CAUSE

SUCTION PIPING SIZE AND  
GENERAL CORROSION

##### CORRECTIVE ACTIONS

REPLACEMENT OF SUCTION  
PIPING - INCREASED FROM  
6" TO 12"

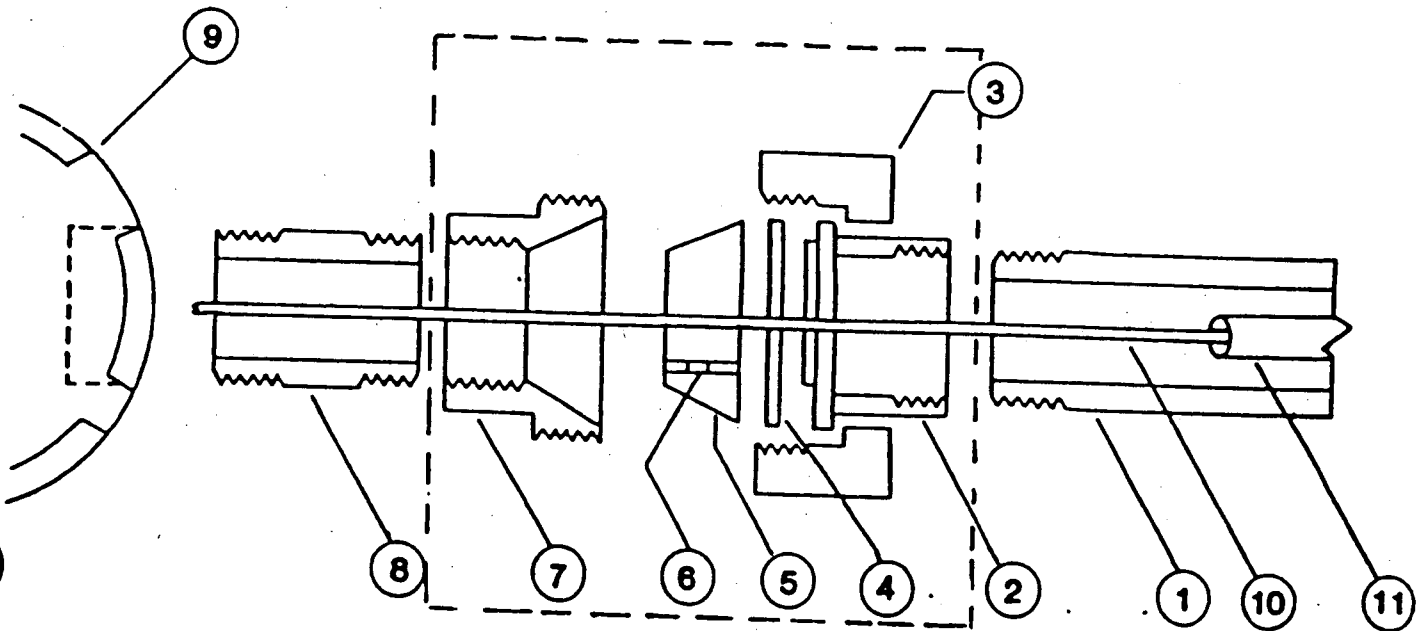
## I. DESCRIPTION OF THE CONDUIT SEAL

#### A. WIRE USE RANGE

- 98 SEALS INSTALLED
- 57 GROMMETS REPLACED
- 31 INSTALLATIONS  
MODIFIED
- 10 ACCEPTABLE AS FOUND

#### B. TORQUING

- 100% VERIFICATION
- APPROXIMATELY 1/2  
SHOWED SLIGHT MOVEMENT  
(LESS THAN 1/4 INCH OF  
ARC)
- ONE MOVED APPROXIMATELY  
1/4 TURN
- FOLLOW UP TORQUE  
VERIFICATION SCHEDULED

A. MANUFACTURER'S INSTALLATION  
INSTRUCTIONS

- MANUFACTURER HAS NOTIFIED OTHER USERS CONCERNING BOTH ISSUES
- NUCLEAR NETWORK NOTIFICATION MADE
- INSTALLATION PROCEDURES CORRECTED
- ADDITIONAL EQ PROCEDURAL CONTROL PROVIDED
  - MODIFICATIONS REQUIRE EQ REVIEW
  - NEW EQ EQUIPMENT MUST BE EVALUATED PRIOR TO MOD RELEASE
  - PROCEDURES ADDED AND REVAMPED
- ADDITIONAL EQ ENGINEERING SUPPORT
- EQ PROGRAM ASSESSMENT CONDUCTED IN 1988

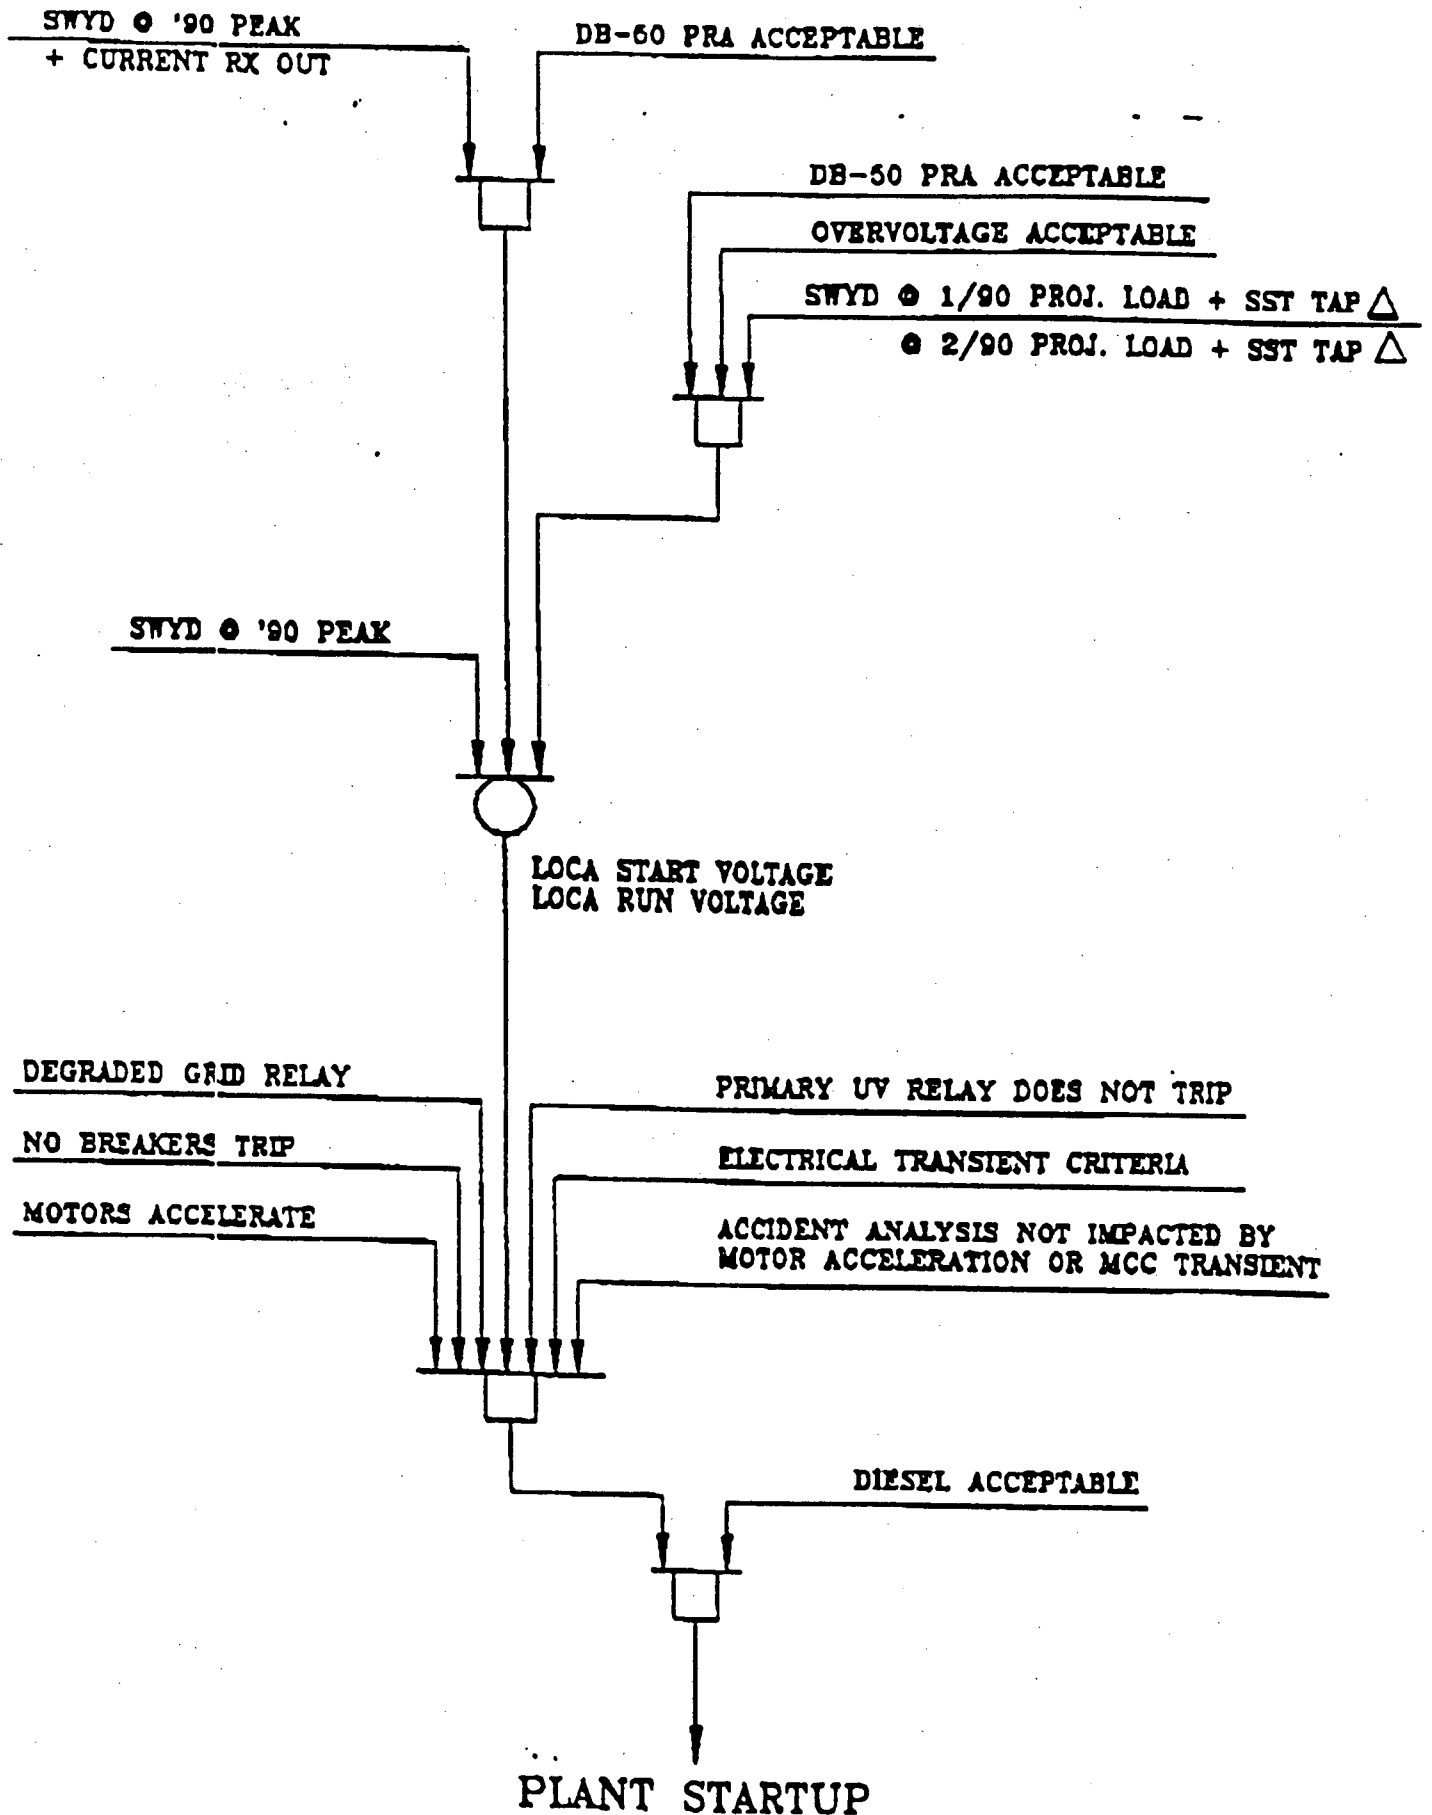
- NORMAL SCHEDULE 116.5 - 117.5KV
- IF AN ACCIDENT OCCURS, THE LOSS OF UNIT 2 CAUSES THE 115KV SWITCHYARD VOLTAGE TO DROP TO 113.7KV INITIALLY (LOCA START) RECOVERING TO 114.3KV (LOCA RUN)
- SEQUENCE RELAY TOLERANCE +/- 2 SEC.
- MOTOR OVERLAPPING COULD ACTUATE THE DEGRADED GRID RELAY. IT WILL NOT RESET AND WILL TIME OUT

- SEQUENCER RELAY CHANGE-OUT  
+/- 0.5 SECONDS
- OPERATIONAL CONSTRAINTS
- SYSTEM VOLTAGE CONTROLS
