# FOIA/PA NO: <u>2014-0508</u>

From:	Schmidt, Wayne
Sent:	Tuesday, December 24, 2013 3:06 PM
To:	Scott, Michael; McKinley, Raymond
Cc:	Lorson, Raymond; Trapp, James
Subject:	RE: FYI re: Millstone Unit 3 TDAFW - licensee is proposing asking for a one time TS amendment to extend LCO time to 7 days

The special inspection was conducted in response to the TDAFW pump overspeed trips on November 4, 2013, December 18, 2013, and January 23, 2014. The NRC's initial evaluation of this condition satisfied the criteria in NRC Inspection Manual Chapter 0309, "Reactive Inspection Decision Basis for Reactors," for conducting a special inspection. The basis for initiating this special inspection is further discussed in the inspection team's charter that is included in the enclosed report as Attachment B.

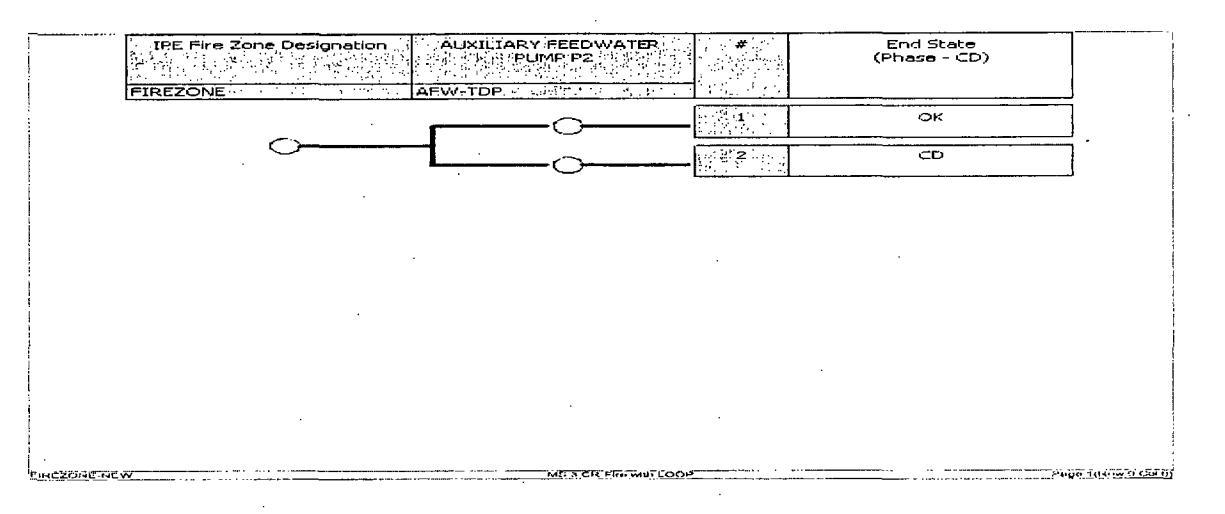
The SRA used a simplified event tree (see below) to represent the external fire risk per affected fire zone. As stated above, the fire frequencies were taken from IPE Table 3.5-4. The nominal TDAFWP fail to start (FTS) probability (6.49E-3) was taken from the Millstone 3 SPAR Model. The individual fire zone contributions are summarized in the following table.

Fire Zone	Fire Frequency	Nominal Case (FTS = 6.49E-3)	Condition Case (FTS = 0.12)	Delta CDF
CB-9	4.48E-4/year	2.91E-6	5.38E-5	5.09E-5
CB11A and 11B	1.50E-4/year	9.74E-7	1.8E-5	1.70E-5
CB-8	4.52E-5/year	2.93E-7	5.42E-6	5.13E-6
			Total	7.30E-5
