14.0 Rifle, Colorado, Disposal Site

14.1 Compliance Summary

Figure 14-1. 2014 Annual Inspection Drawing for the Rifle Disposal Site

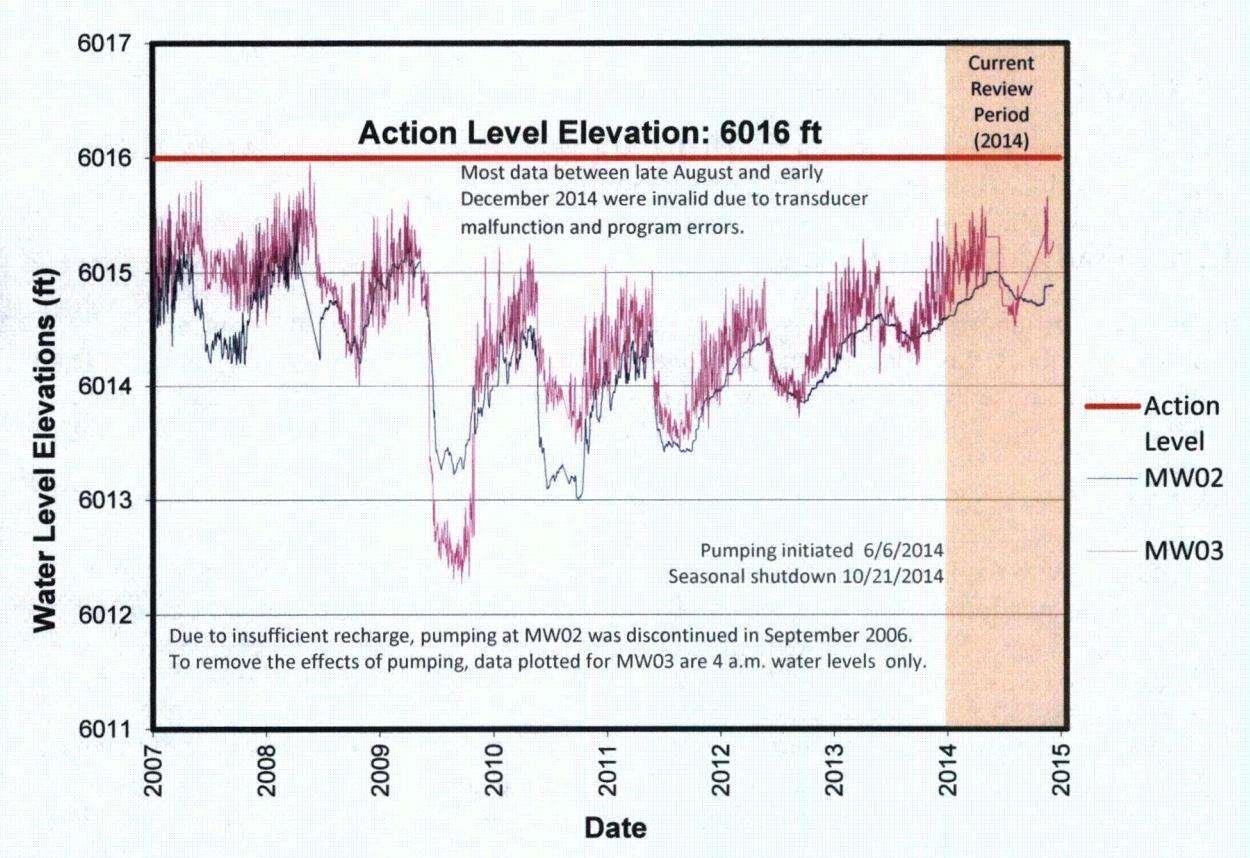
Figure 14-2. Disposal Cell Pore-Water Levels in Standpipes MW-02 and MW-03 at the Rifle Disposal Site

Datalogger information for the 2014 reporting period indicates that pore-water levels in both standpipes were always below the 6,016-foot action level (Figure 14-2). As observed historically, levels were highest during late fall and winter, when pumping is discontinued. In 2014, maximum water levels in MW-02 and MW-03 were 6,015.0 feet and 6,015.7 feet, respectively. Water levels declined to 6,014.7 feet and 6,014.5 feet, respectively, during pumping. According to the LTSP requirement, pumping will continue until the water levels in the standpipes stabilize at an elevation of 6,014 feet or lower.

This continued contingency operation has maintained the water level at an acceptable elevation (below the action level) and prevents water from overtopping the disposal cell liner. Dewatering of the cell will continue.

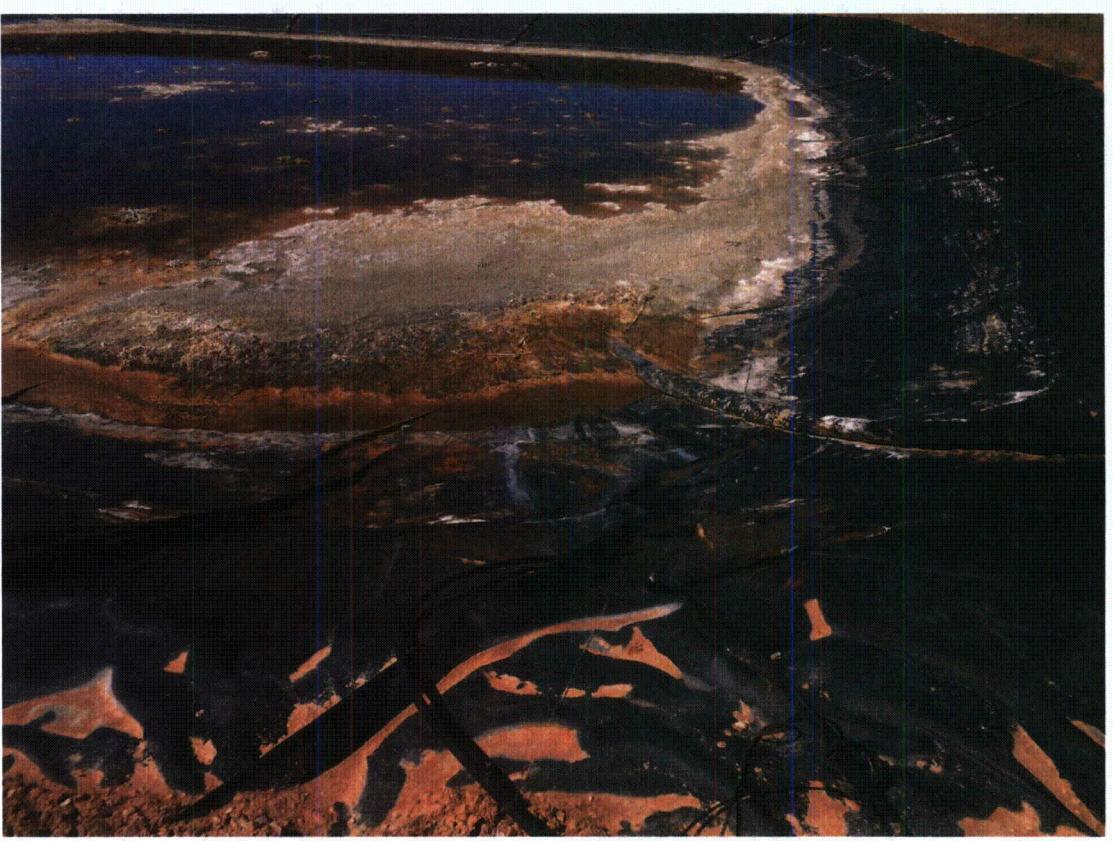
Pore water continues to be pumped from the disposal cell into a lined evaporation pond to maintain the cell water level below the action level of 6,016 feet above mean sea level. Maximum water levels in the monitoring standpipes remained below the action level in 2014. The evaporation pond liner was inspected and repaired in early 2014, and it was in good condition at the time of the inspection.

RFL 6/2014. PL-1. Disposal cell water entering evaporation pond.

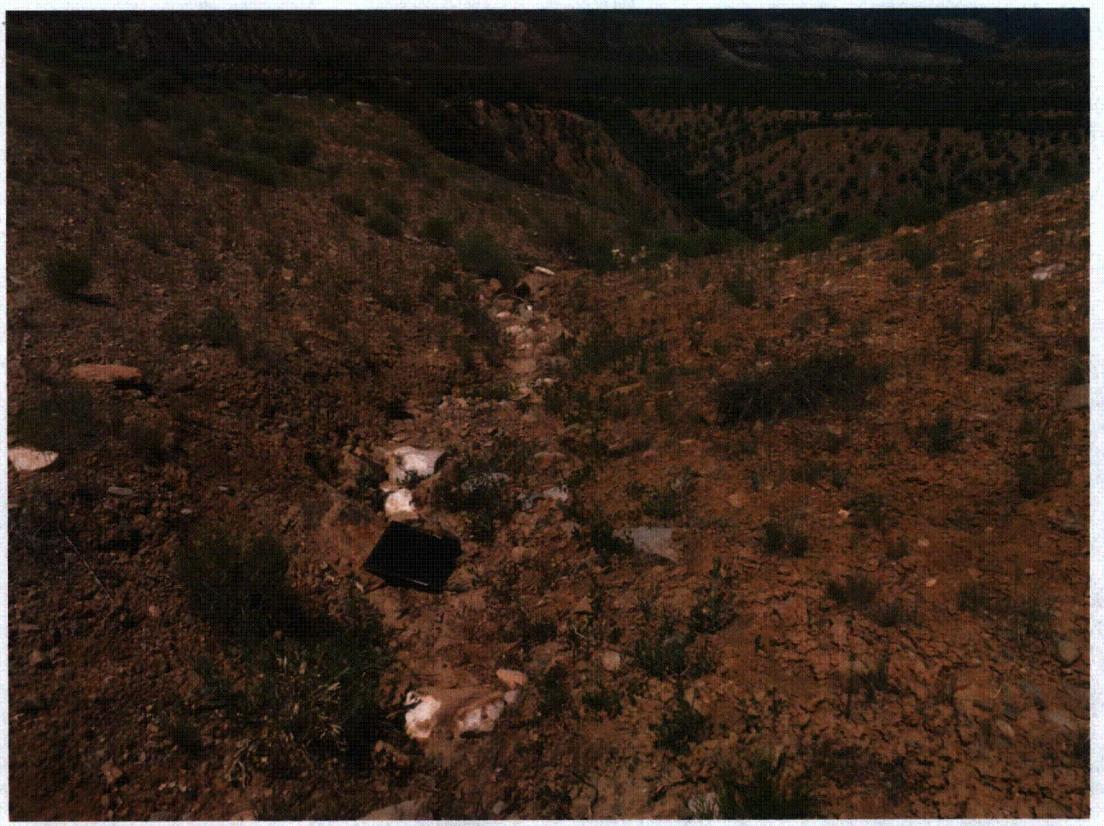
A revegetated interceptor trench was constructed at the top of the disposal cell to protect the cell from storm-water and snowmelt run-on. Recent minor erosion was observed in 2014 where the interceptor trench plunges into a large canyon to the west of the site (PL-2). Overall, however, the trench was functioning as designed and in good condition.

RFL 6/2014. PL-2. Minor erosion along interceptor trench at north end of cell.

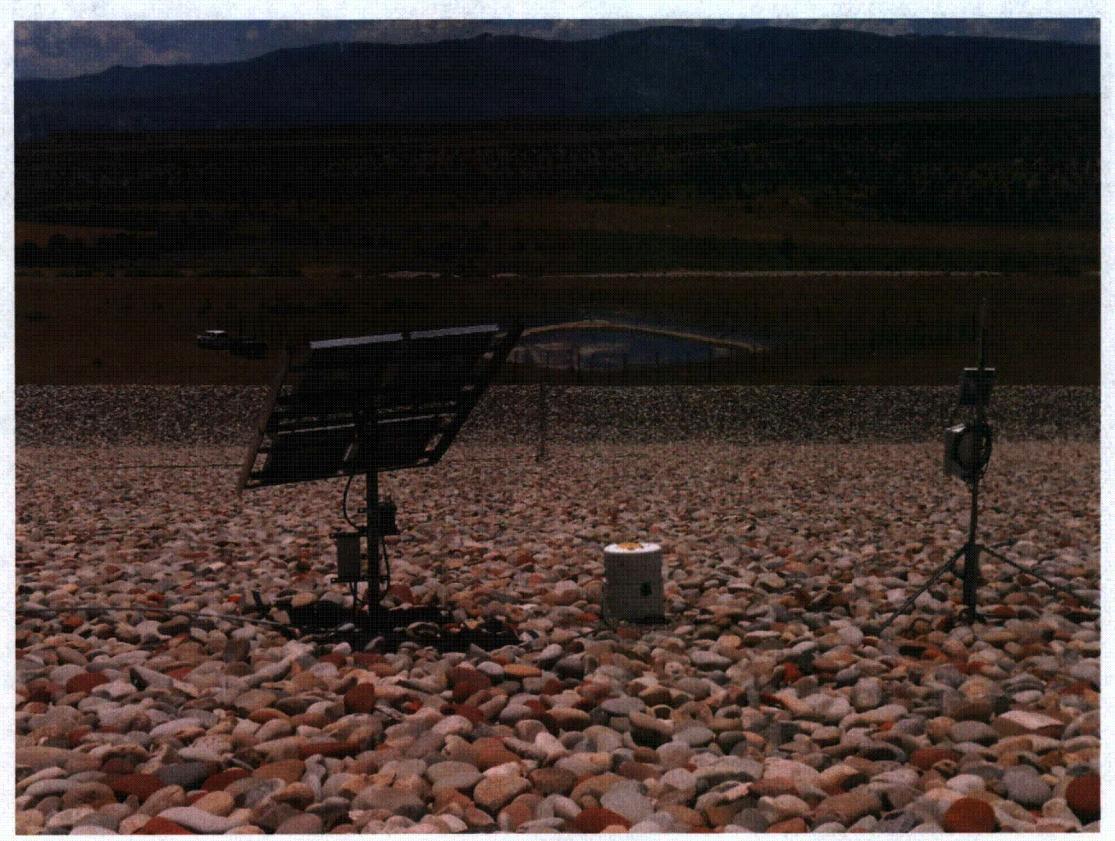
consistent with active pumping rates recorded the last several years. The two solar panels that power the pump were in good condition (PL-3).

RFL 6/2014. PL-3. Standpipe MW-02 and its solar panel and telemetry tower; evaporation pond in background.

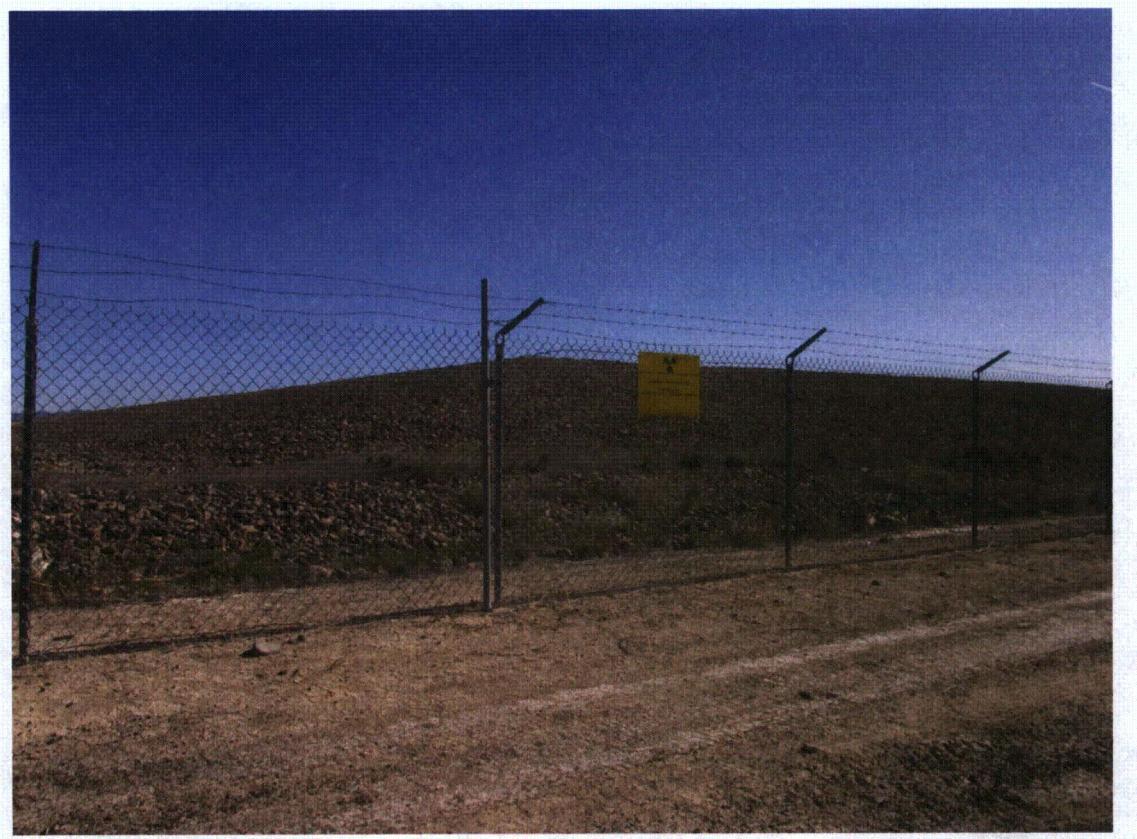
Two chain-link fences are at the site. The exterior EnergySolutions perimeter fence, located along the site boundary, and the interior DOE security fence (PL-1) were in good condition. Nineteen perimeter signs are attached to the DOE fence, and all of the signs were in good condition.

SLD 5/2014. PL-1. Interior fence and perimeter sign P-18.

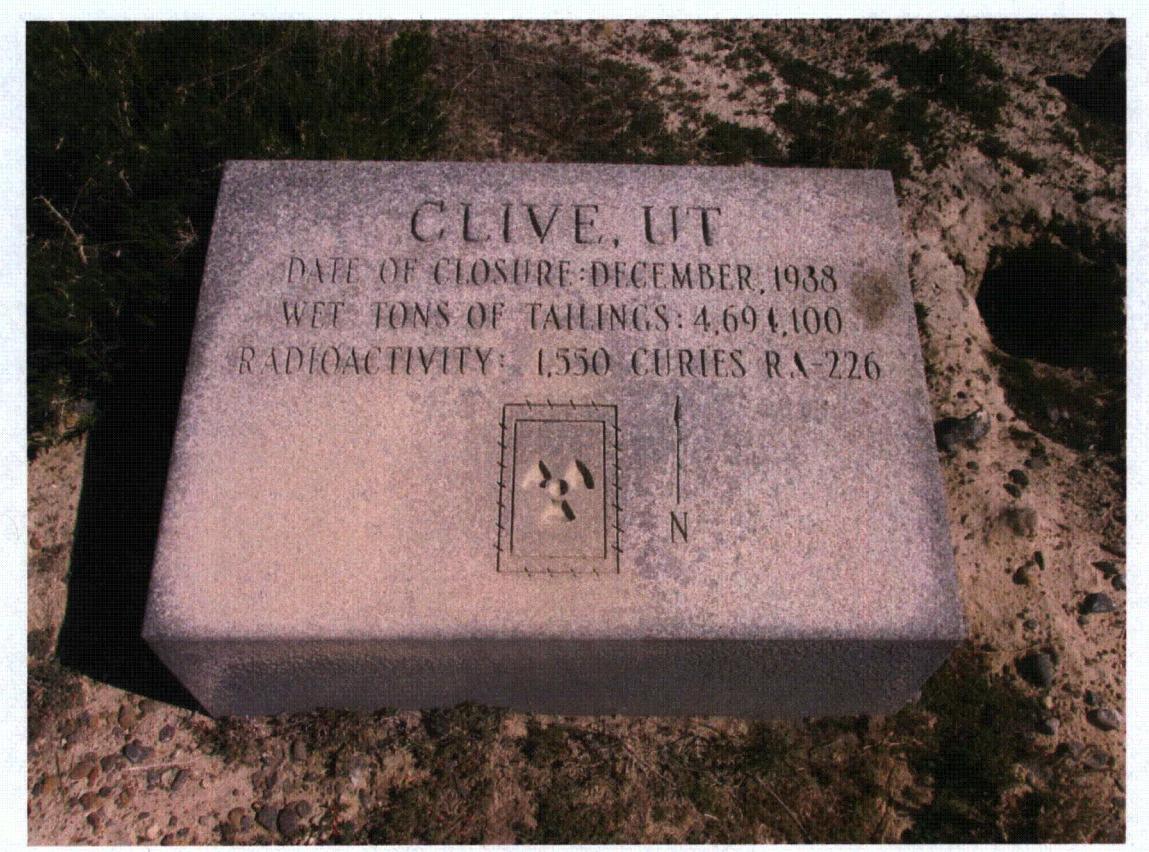
Granite site marker SMK-1 near the northwest site entrance gate was in good condition (PL-2). The site marker is etched from windblown sand and dirt but remains legible. EnergySolutions removed vegetation to clear the area surrounding SMK-1. Site marker SMK-2, located on top of the disposal cell, was in excellent condition (PL-3).

SLD 5/2014. PL-2. Site marker SMK-1.

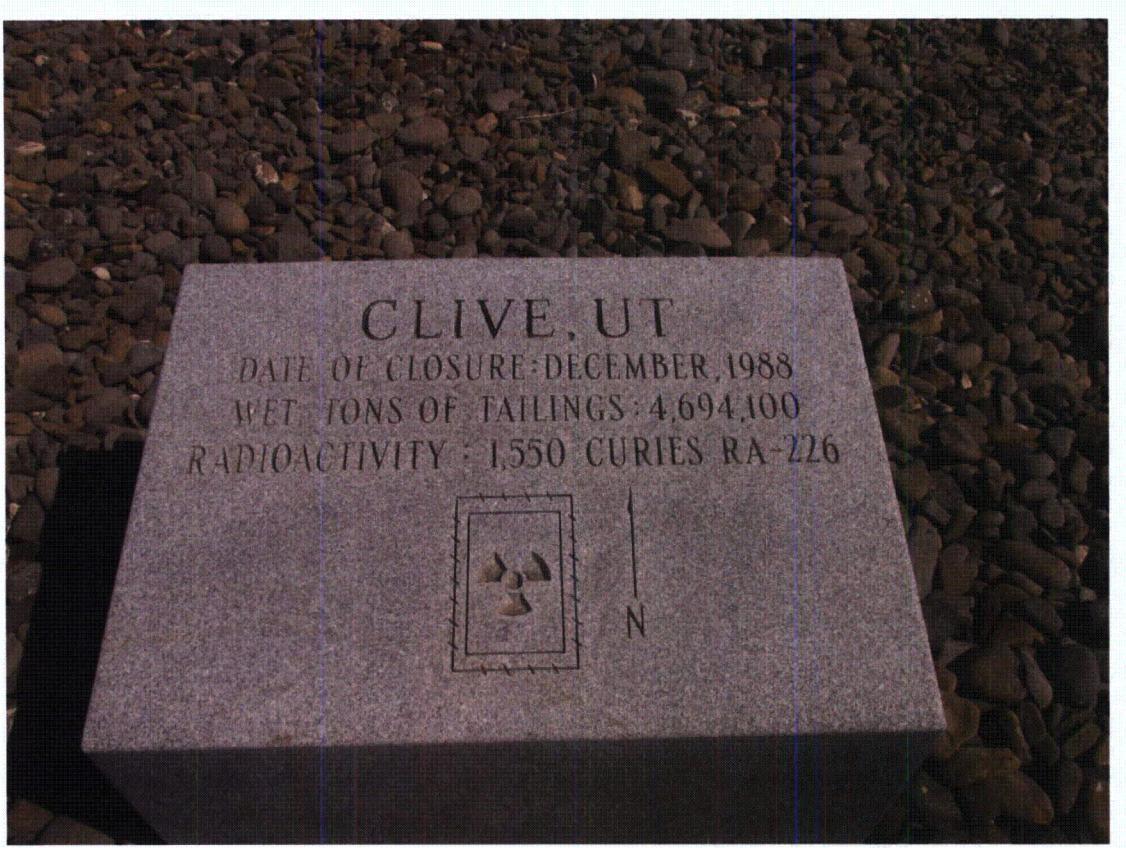
SLD 5/2014. PL-3. Site marker SMK-2.

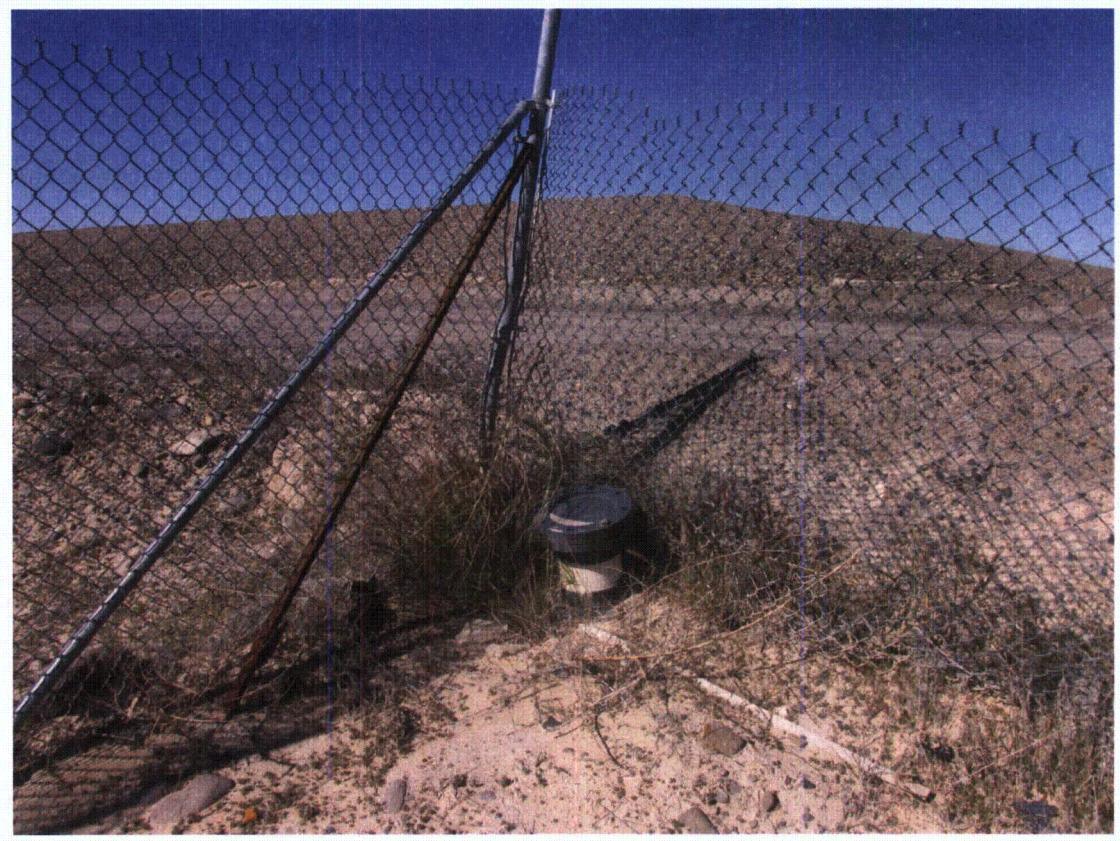
All four boundary monuments were in good condition. Protective casings installed over each monument by EnergySolutions (PL-4) continue to protect the monuments from damage by surrounding earth-moving activities.

SLD 5/2014. PL-4. Boundary monument BM-4 with protective cover.

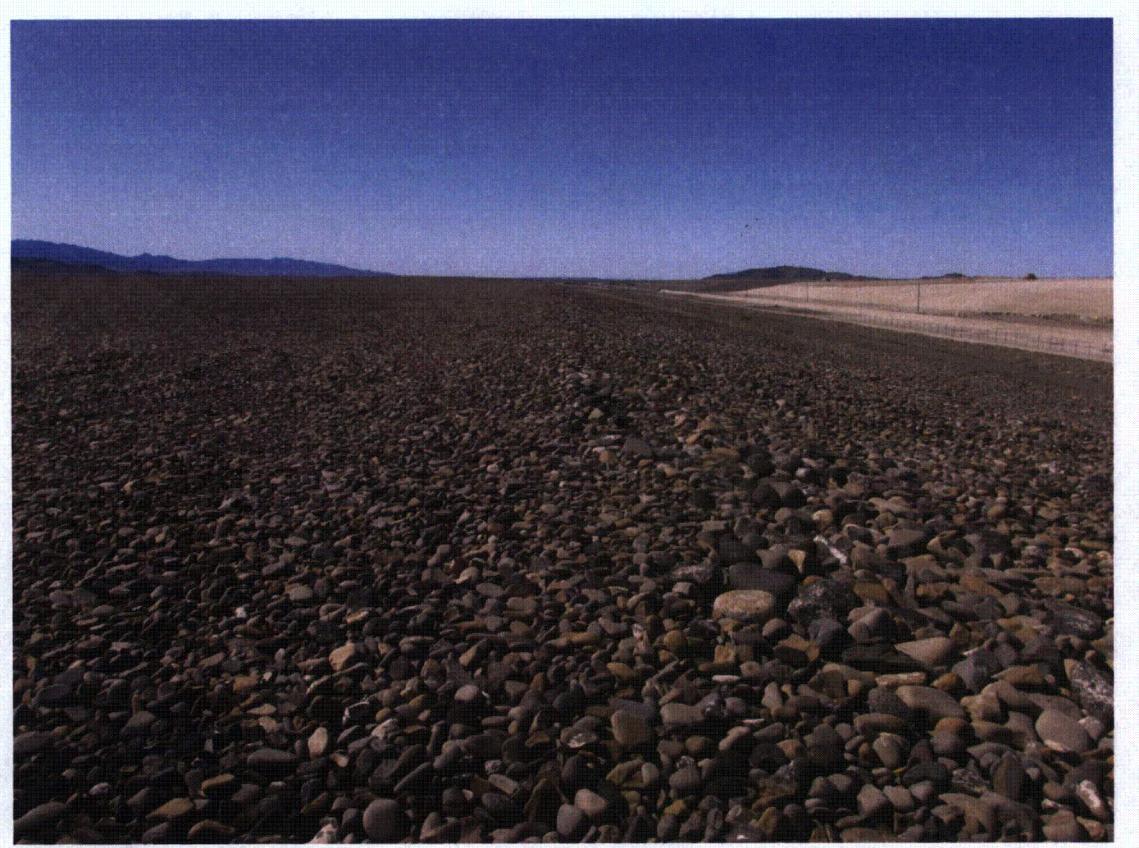
The disposal cell top and side slopes are armored with rock riprap. The top and side slopes were in good condition, and no evidence of erosion or slumping of the side slopes was observed (PL-5 and PL-6). Several slight depressions are present in the riprap on the top slope of the cell. They appear to be remnants of heavy equipment tracks that occurred during riprap installation. These depressions continue to be monitored to ensure that settlement is not occurring. No deep-rooted plants were growing on the top or side slopes of the cell.

SLD 5/2014. PL-5. Disposal cell top and west side slopes.

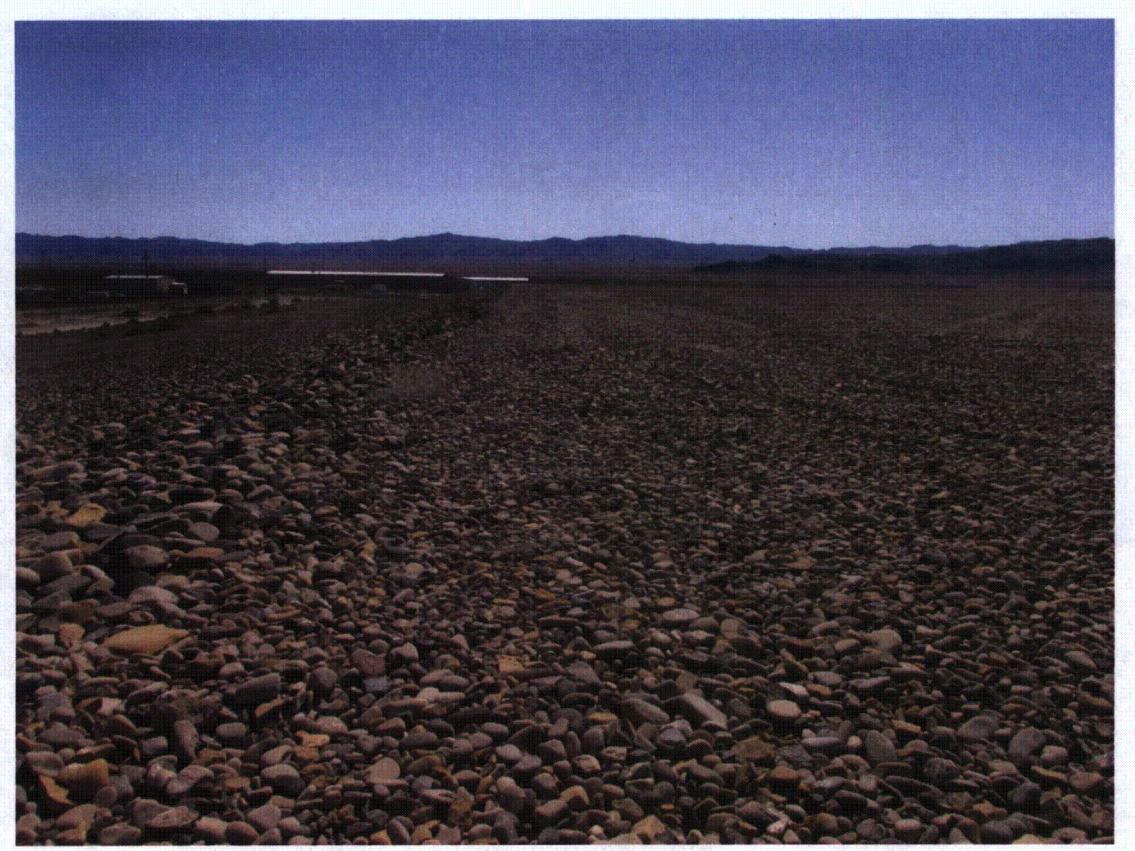
SLD 5/2014. PL-6. Disposal cell top and north side slopes.

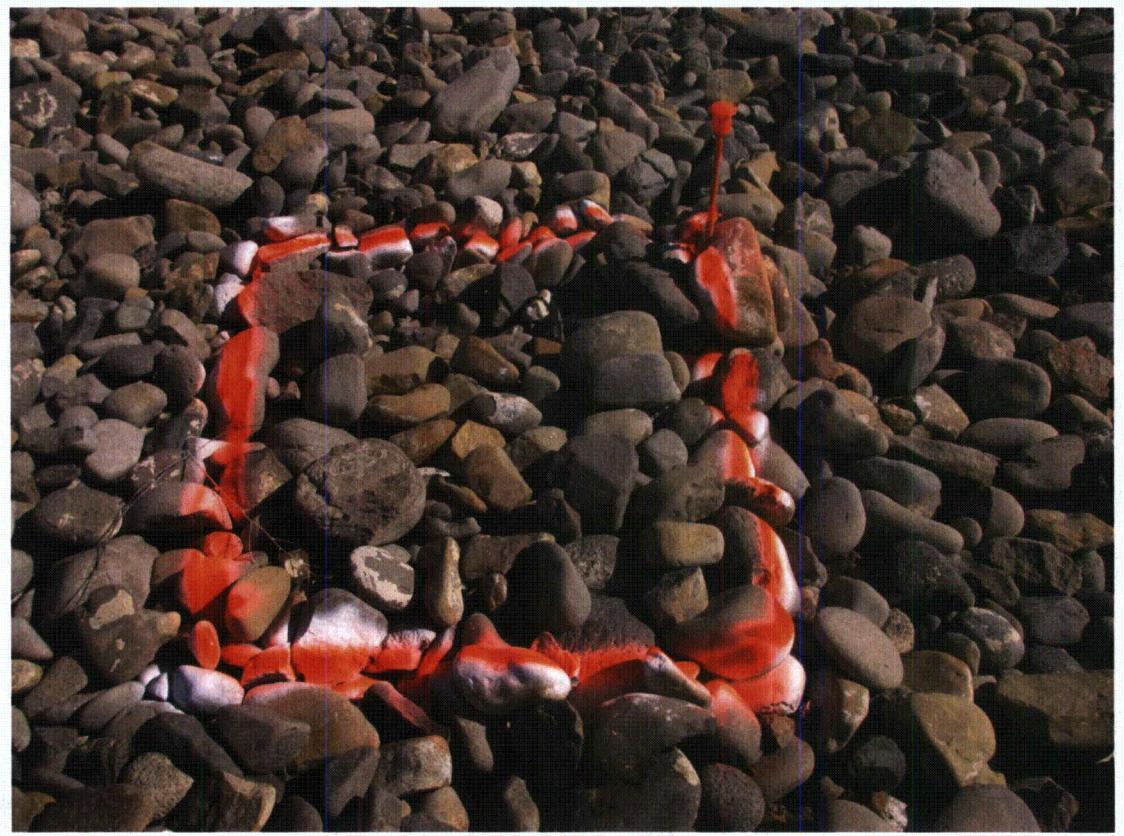
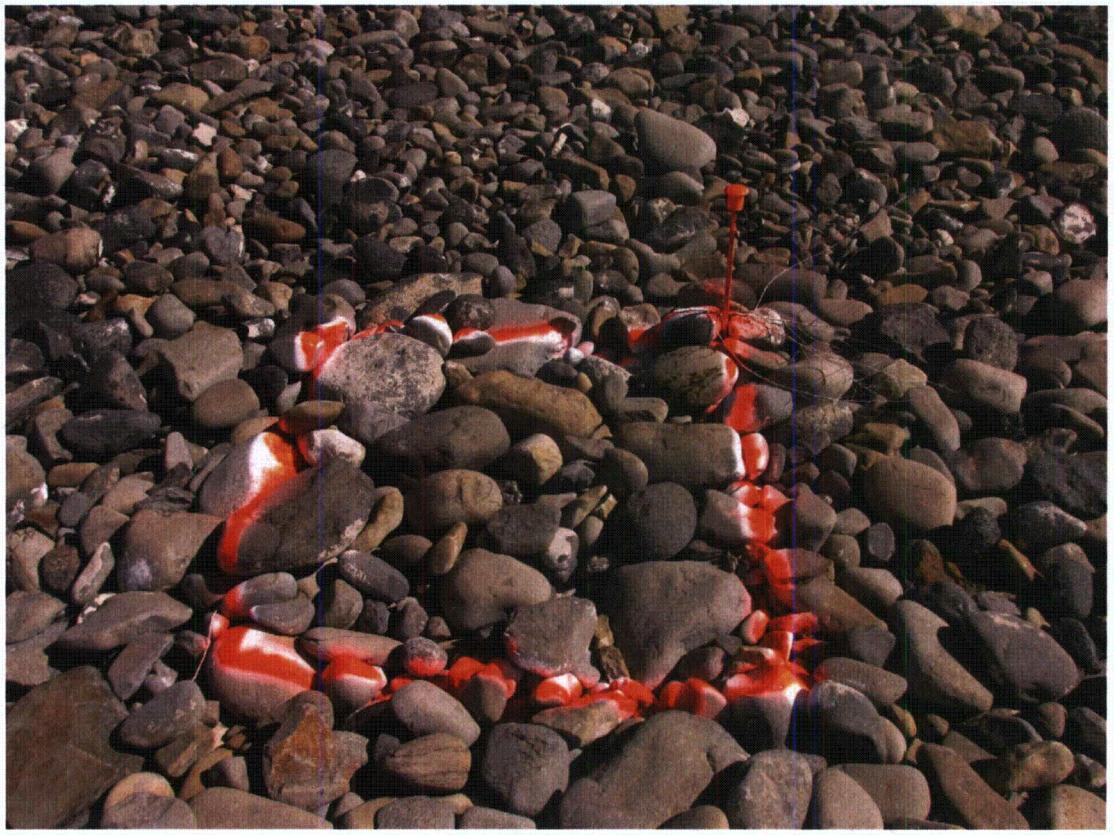
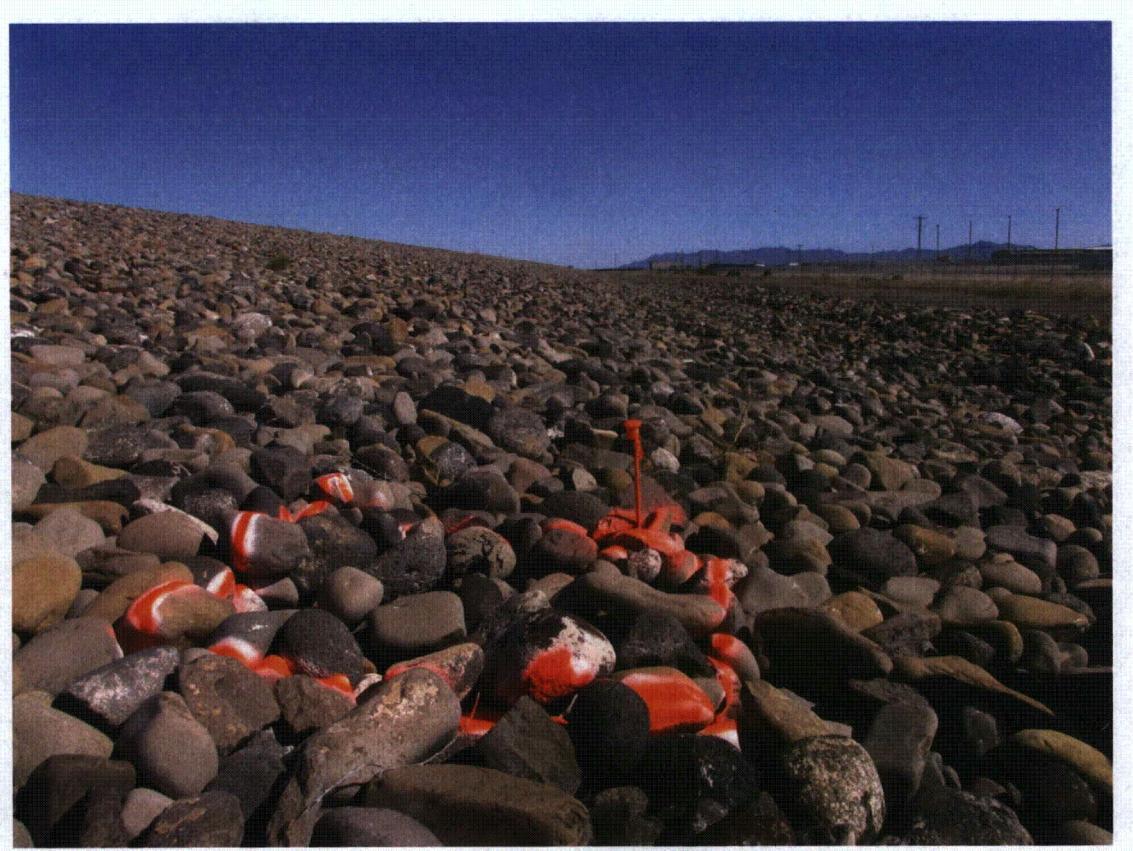
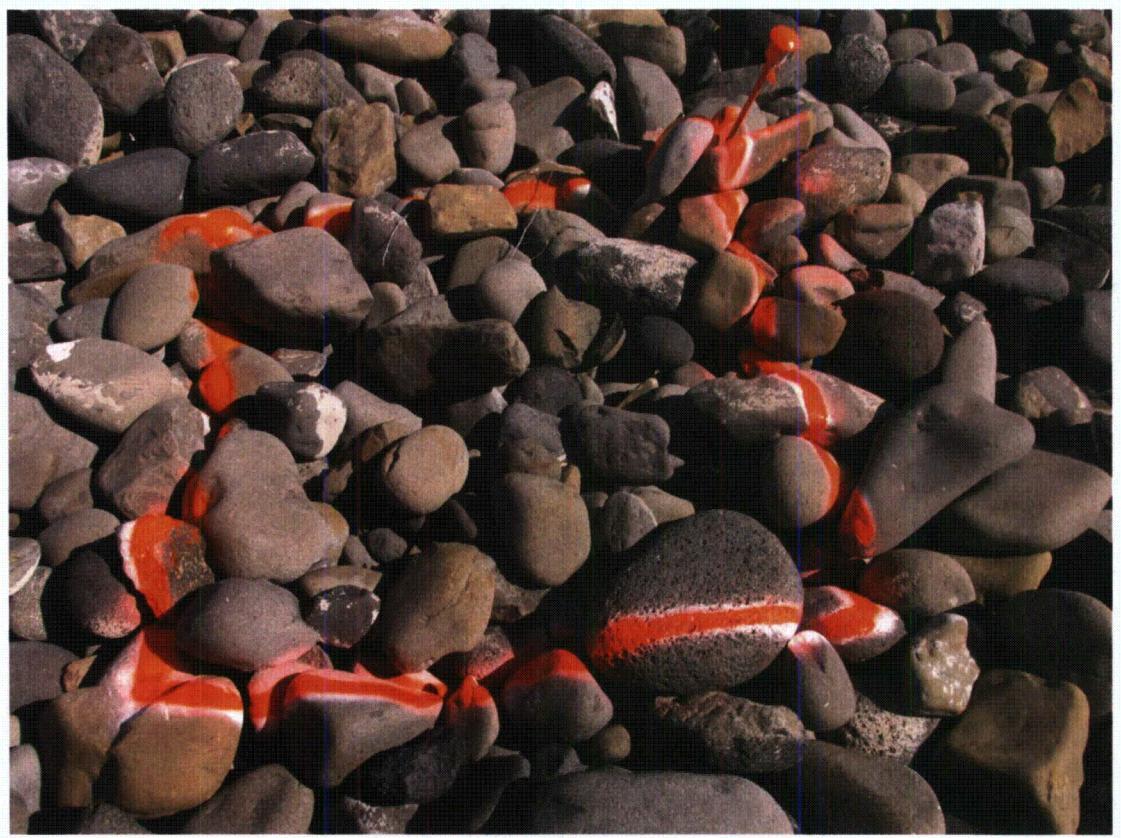
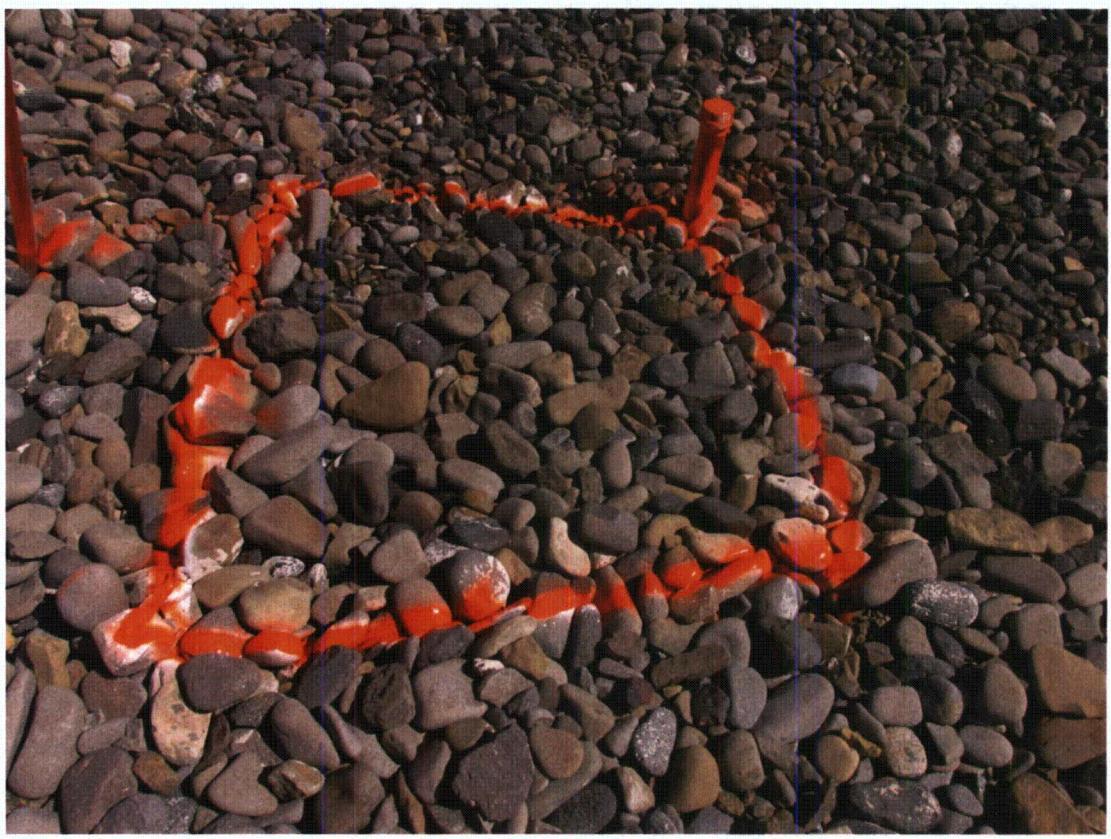
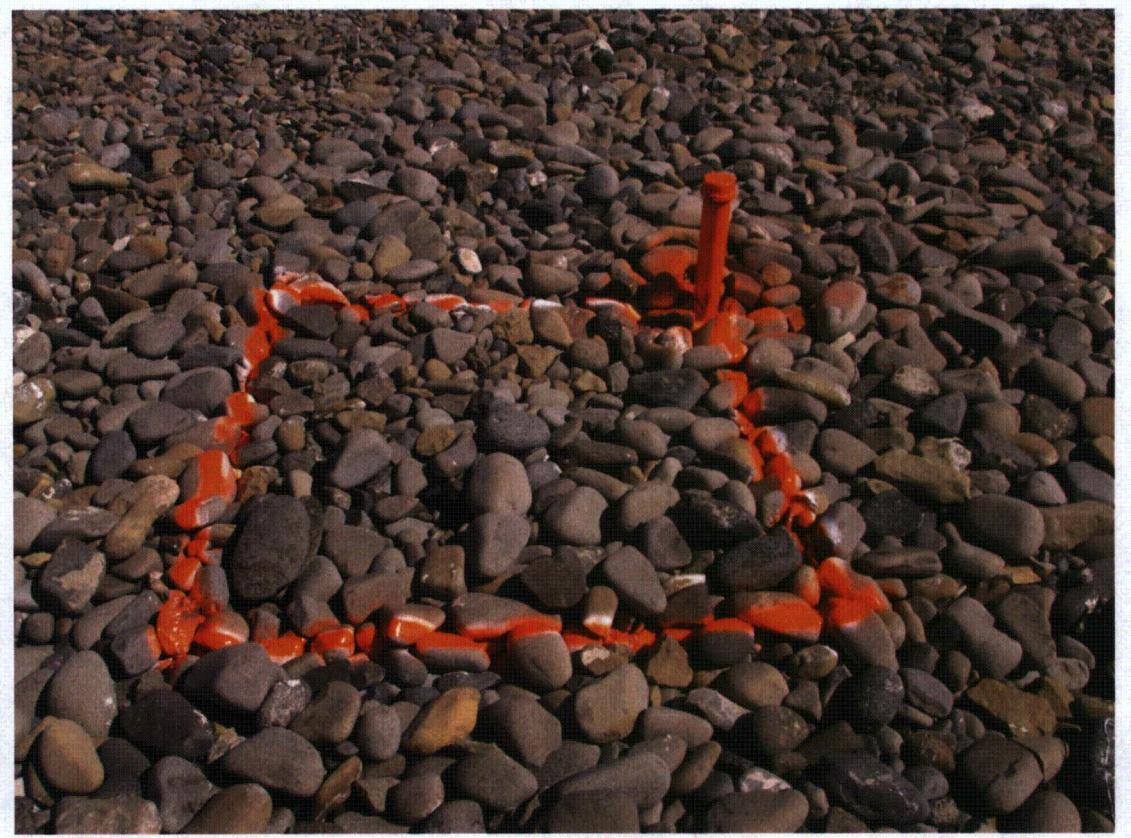
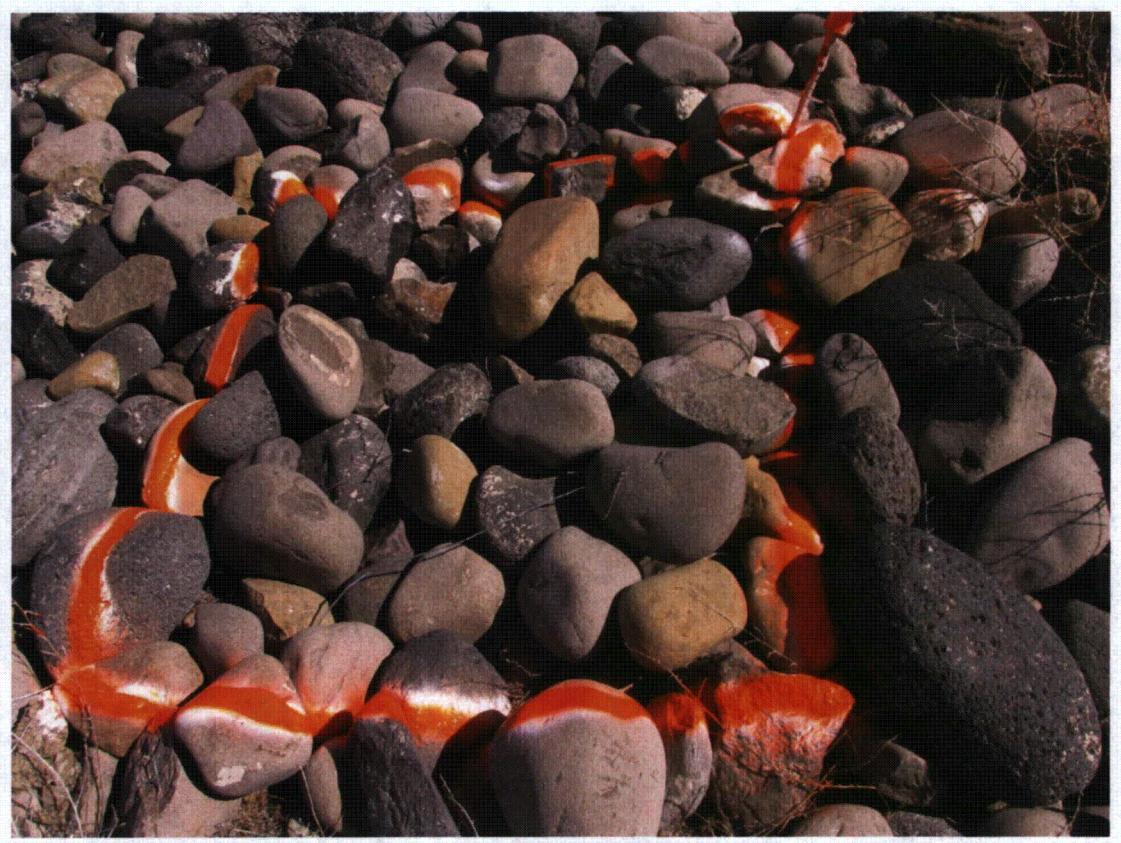
A minor portion of the riprap has exhibited some degradation due to weathering. Eight 1-square-meter plots were established during the 2010 inspection to visually monitor the degradation. The rock type is consistent in all the monitoring plots. Approximately 1–10 percent of the rock in the plots showed signs of weathering (PL-7 through PL-14), with no obvious change from the previous inspection. The minimal rock degradation has not reduced the effectiveness of the riprap, but the plots will continue to be monitored to ensure that the riprap protects the disposal cell as designed.

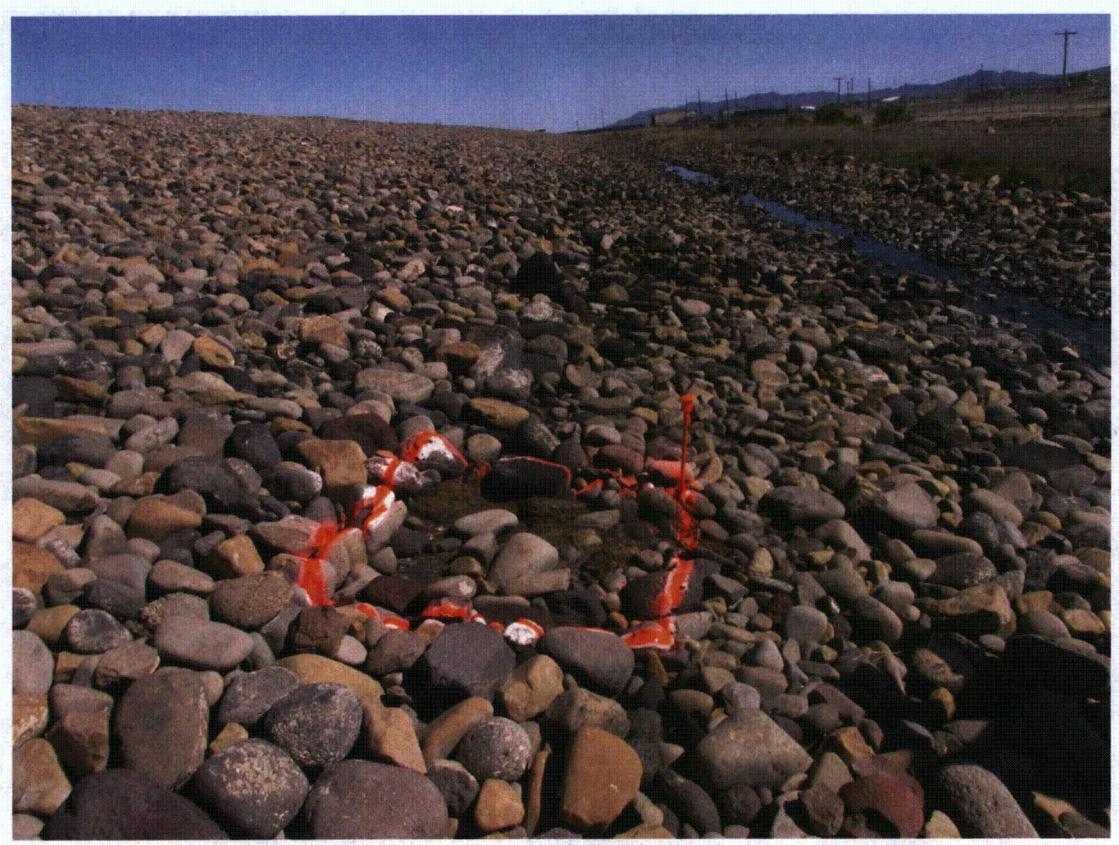
encroachment was seen. The surface water diversion channels along the toe of the disposal cell were functioning as designed and in good condition (PL-10).

SLD 5/2014. PL-10. Rock Degradation Plot No. 4 and east diversion channel.

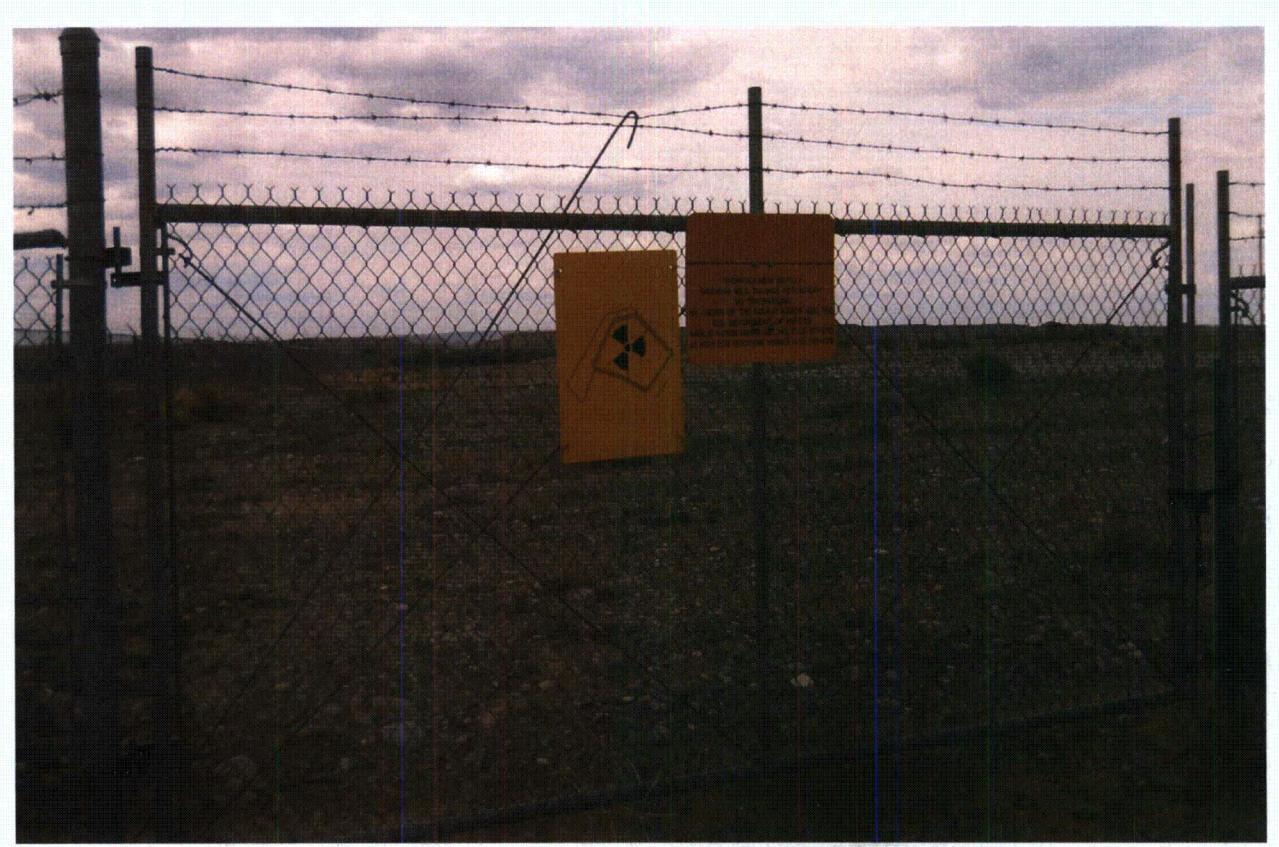
SHP 5/2014. PL-1. North entrance gate; note faded radiation symbol on textual sign.

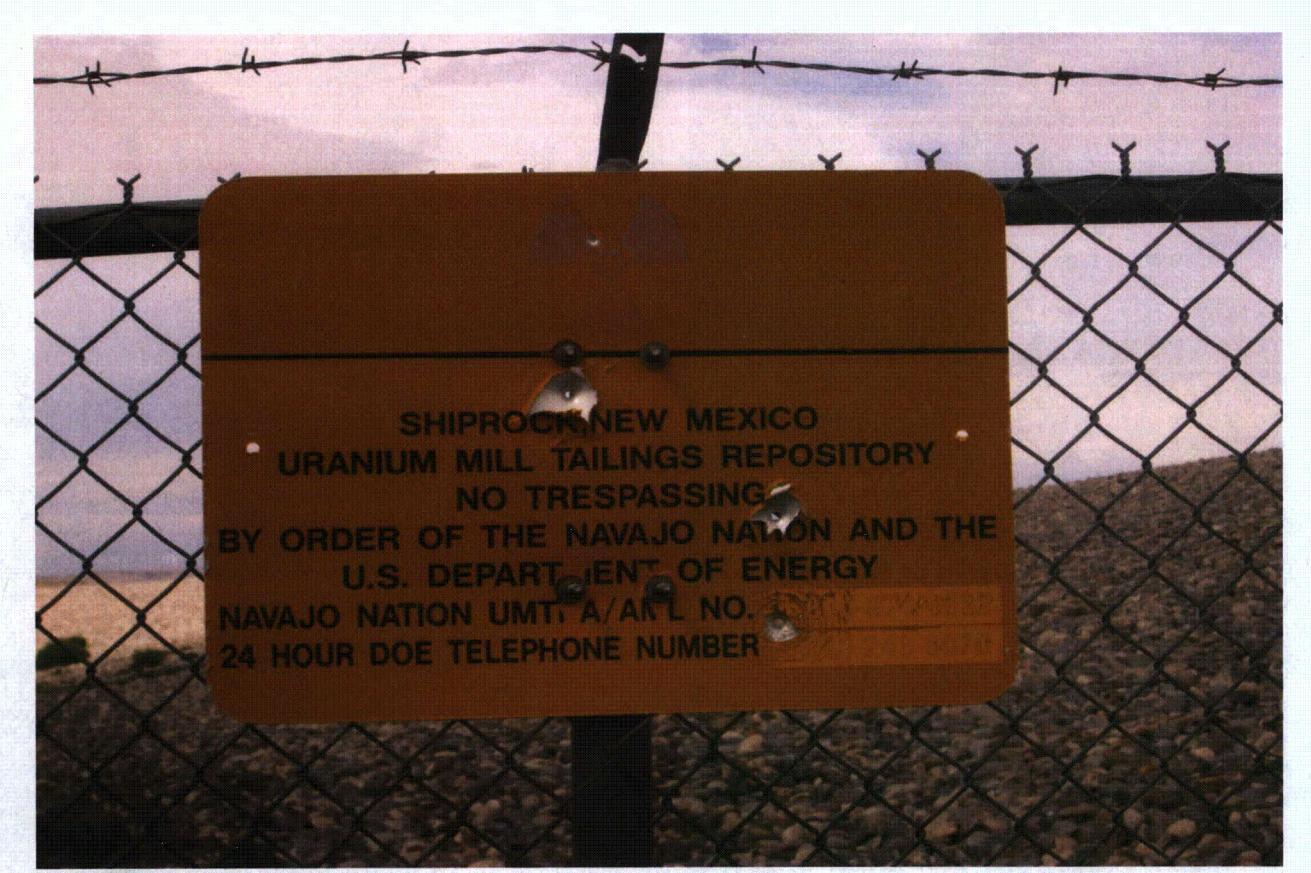
16A Entrance signs are present in pairs—one pictorial and one textual—near each gate. A missing pictorial sign at the north gate was replaced prior to the inspection. All entrance signs were in place and legible at the time of the 2014 inspection, but some had faded or cracked surfaces or had bullet damage (PL-1 through PL-4). These signs will be replaced in the next few years as they become illegible.

SHP 5/2014. PL-3. Bullet holes in west entrance textual sign; note faded radiation symbol and phone numbers.

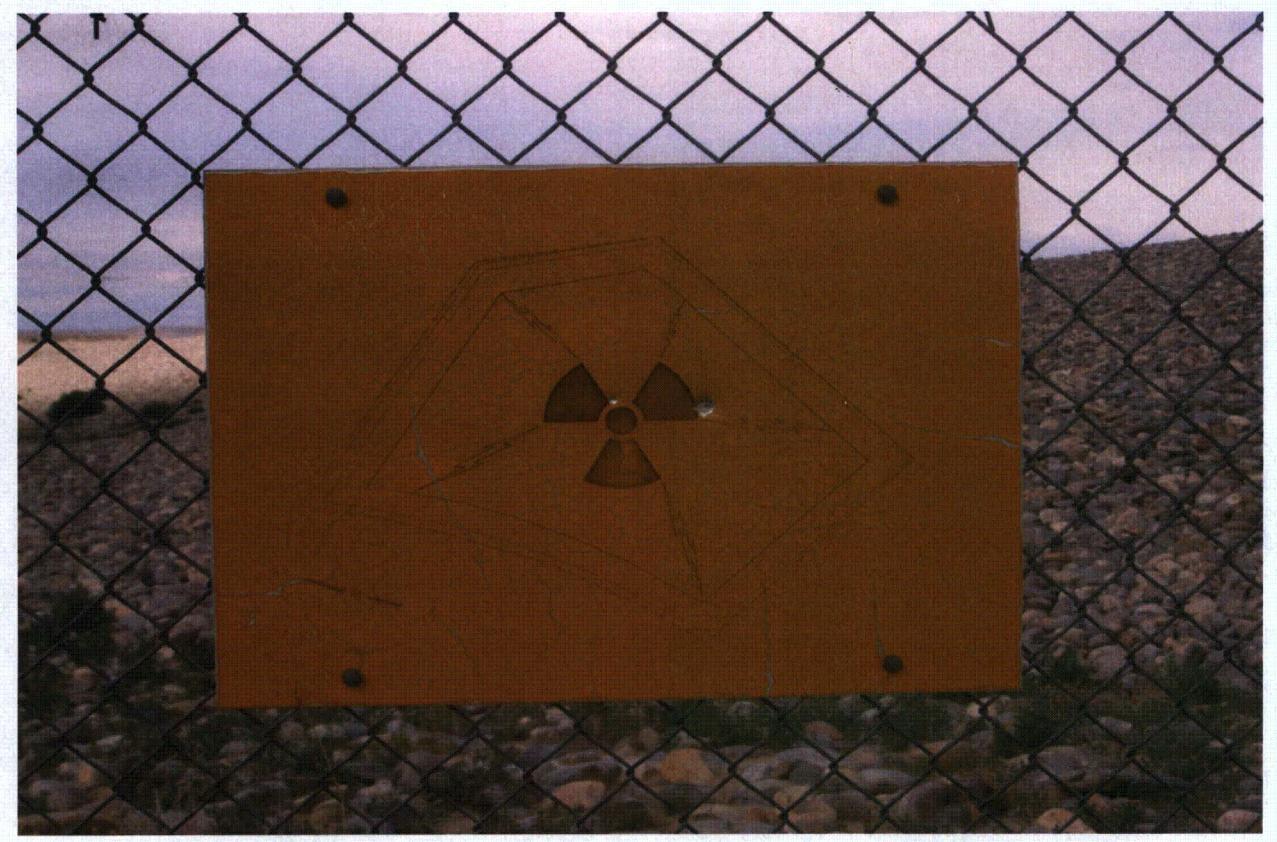
SHP 5/2014. PL-4. Bullet holes in west entrance pictorial sign; note cracked and faded surface.

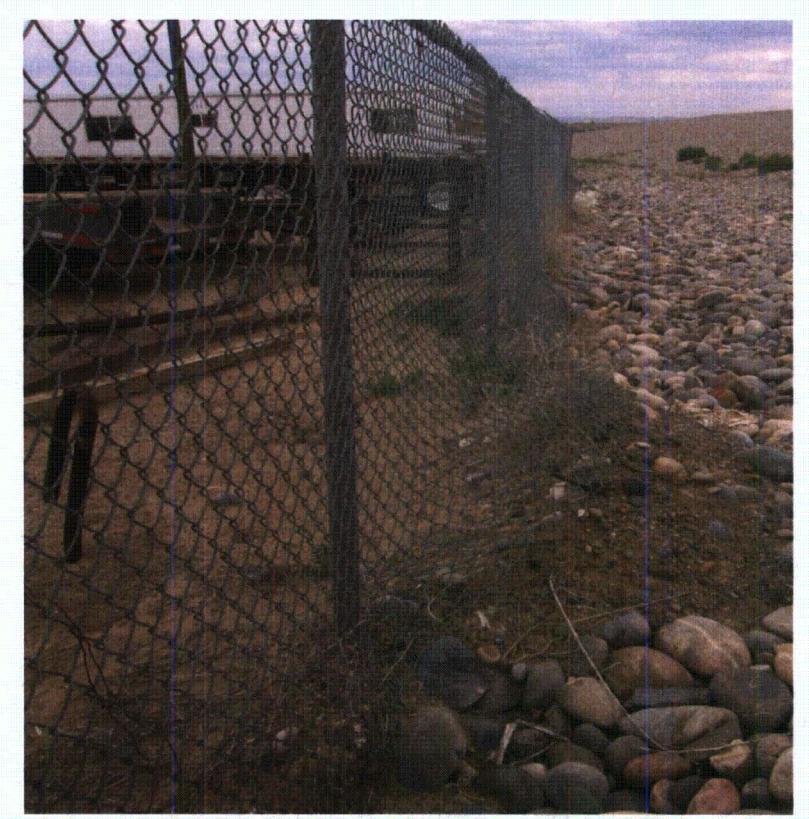
A chain-link security fence surrounds the disposal cell and drainage features. As observed in previous years, this perimeter fence was damaged in many areas. Damaged fence sections reported in previous years include bent posts and bent fence fabric between perimeter signs P11 and P12, dirt pushed through the fence between P11 and P12 (PL-5), dirt mounded against the fence and a section of bent fence near P13, bent posts near P14, a broken fence riser near P15, and fence risers separated from posts between P15 and P16. During the 2013 inspection, a large hole in the fence was found between signs P13 and P14. This hole was repaired prior to the 2014 inspection (PL-6). Damaged fence sections will continue to be monitored and repaired when necessary to maintain site security.

SHP 5/2014. PL-5. Dirt pushed through fence fabric between perimeter signs P11 and P12; no change from previous years.
