14.0 Rifle, Colorado, Disposal Site

14.1 Compliance Summary

Figure 14-1. 2014 Annual Inspection Drawing for the Rifle Disposal Site

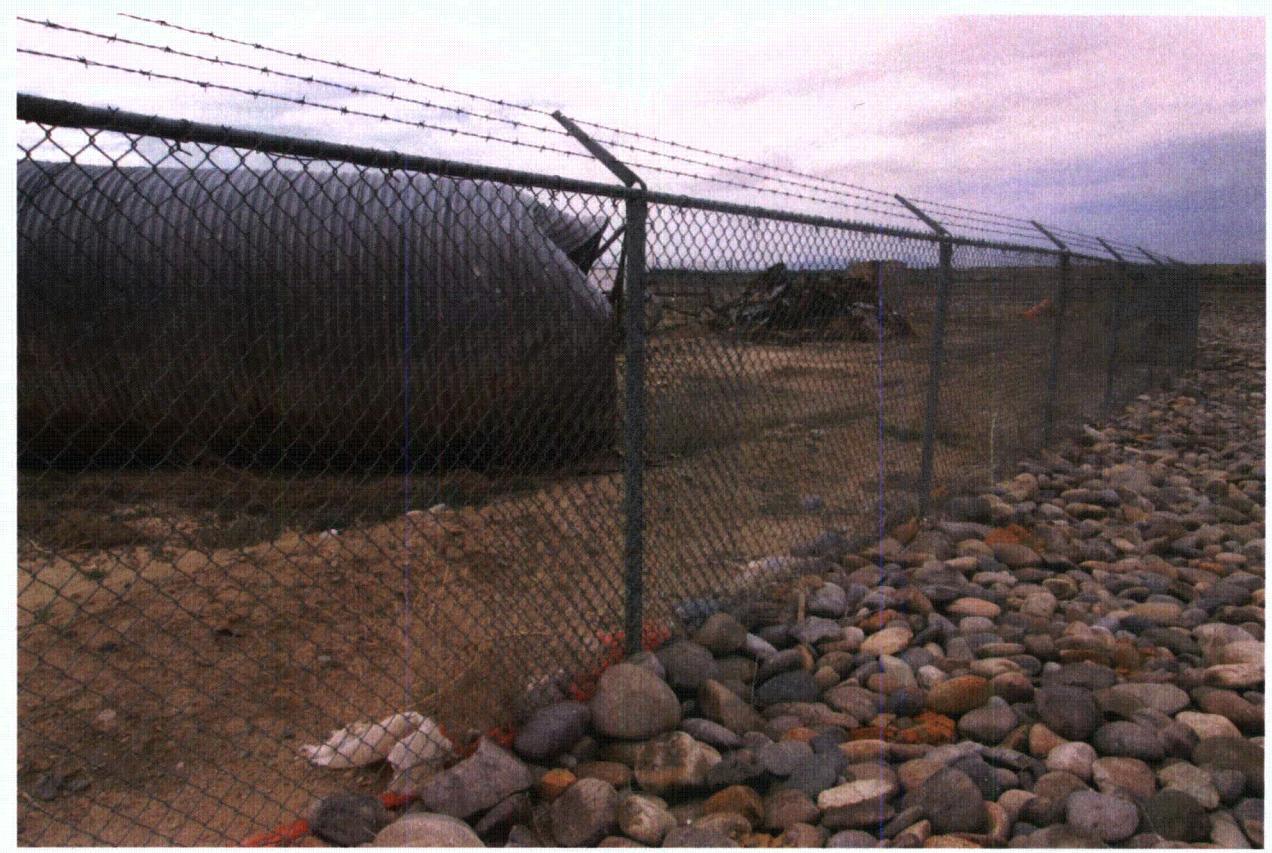
SHP 5/2014. PL-6. Repaired hole in fence, between perimeter signs P13 and P14.

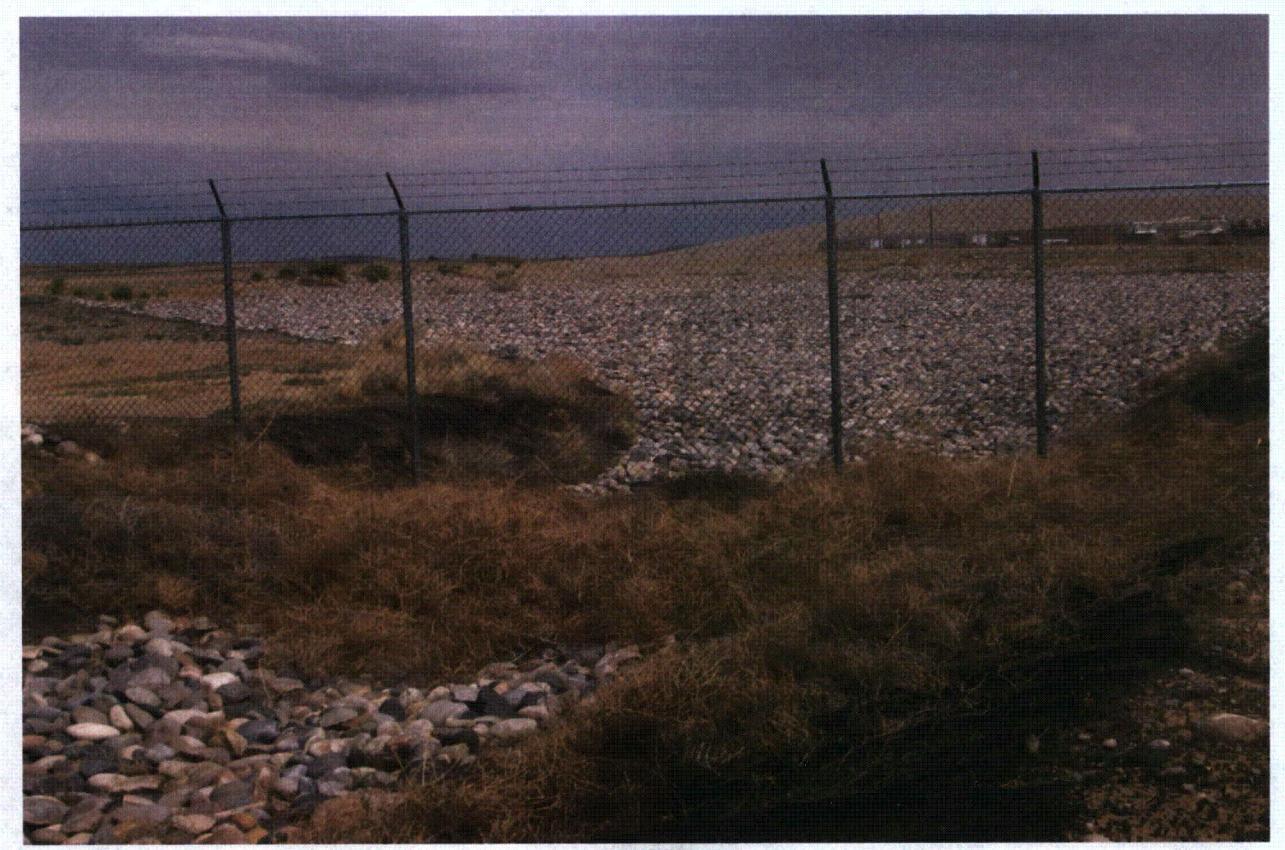
Trash and tumbleweeds continually accumulate in many places along the perimeter fence, particularly along the southwest fence line and a section of fence across the outflow channel (PL-7). Accumulations large enough to represent a fire hazard or increase the possibility of damage to the fence will be removed. During the inspection, inspectors picked up trash along the inside of the perimeter fence and also placed rocks in several gaps beneath the fence that were potentially large enough to allow site access.

SHP 5/2014. PL-7. Tumbleweed accumulation in outflow channel.

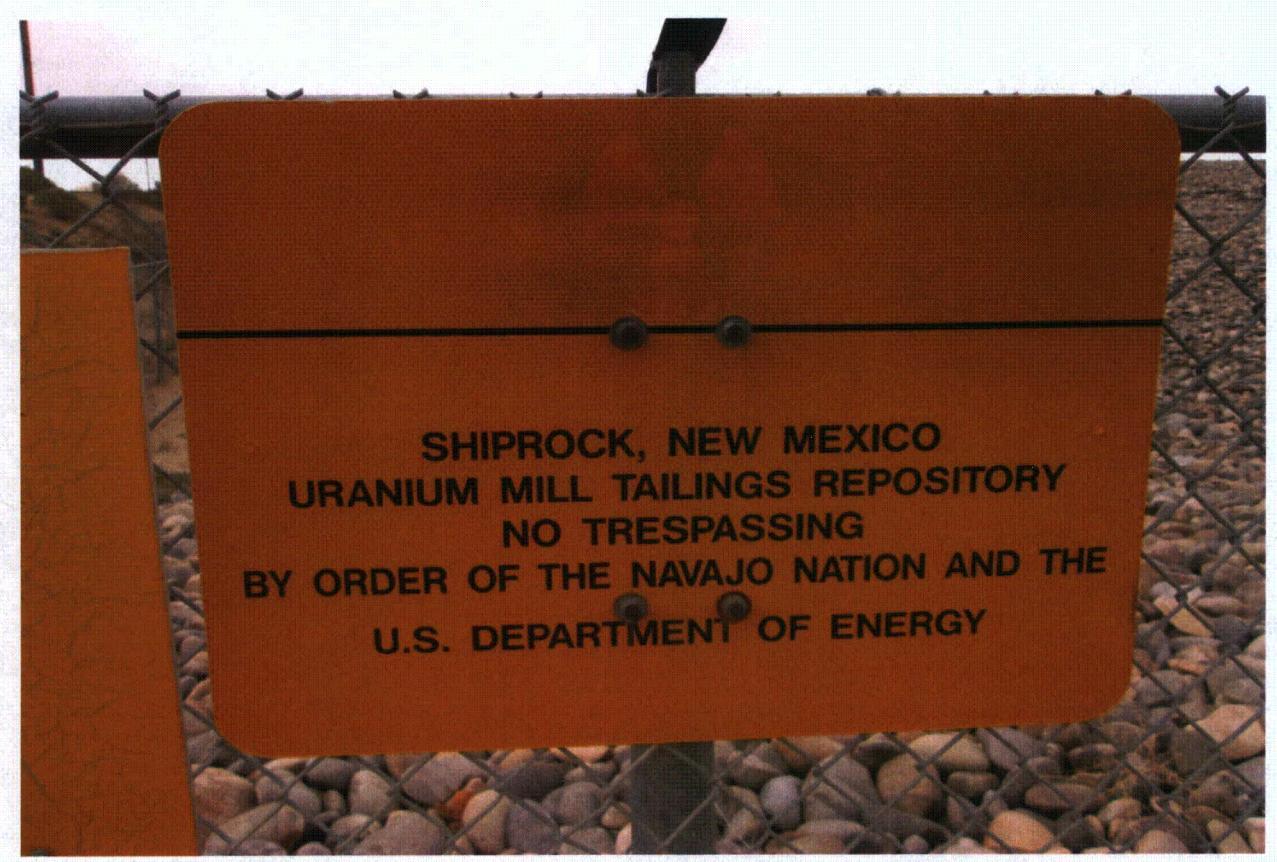
SHP 5/2014. PL-8. Textual perimeter sign P4, showing faded radiation symbol.

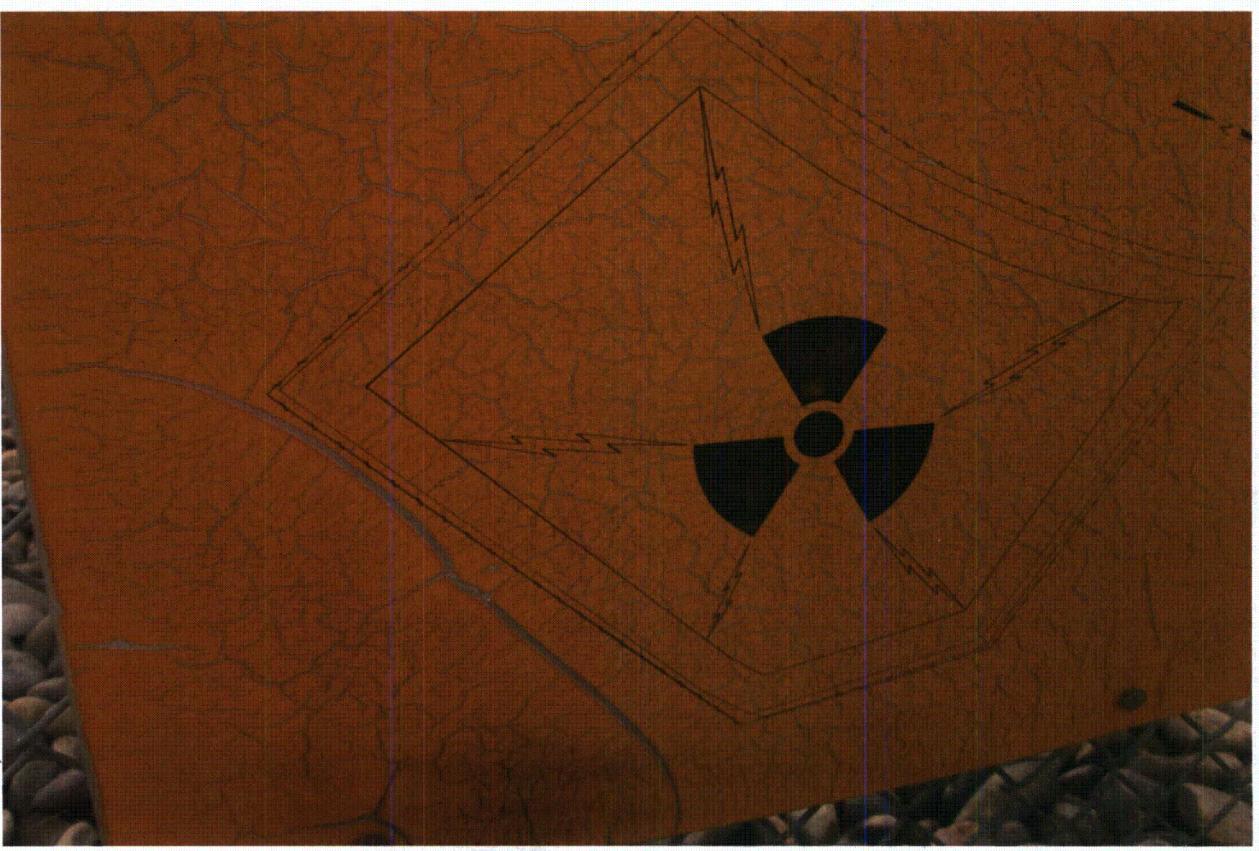
Seventeen pairs of signs, designated P1 through P17 (each pair consisting of one pictorial and one textual sign), are located on the fence around the perimeter of the site. All perimeter signs were in place and legible, and they showed no evidence of vandalism. However, most of the southeast- and southwest-facing textual signs had faded radiation symbols (PL-8), and many of the pictorial signs had cracked and faded surfaces (PL-9). These signs will be replaced as they become illegible.

SHP 5/2014. PL-9. Pictorial perimeter sign P4, showing faded and cracked surface.

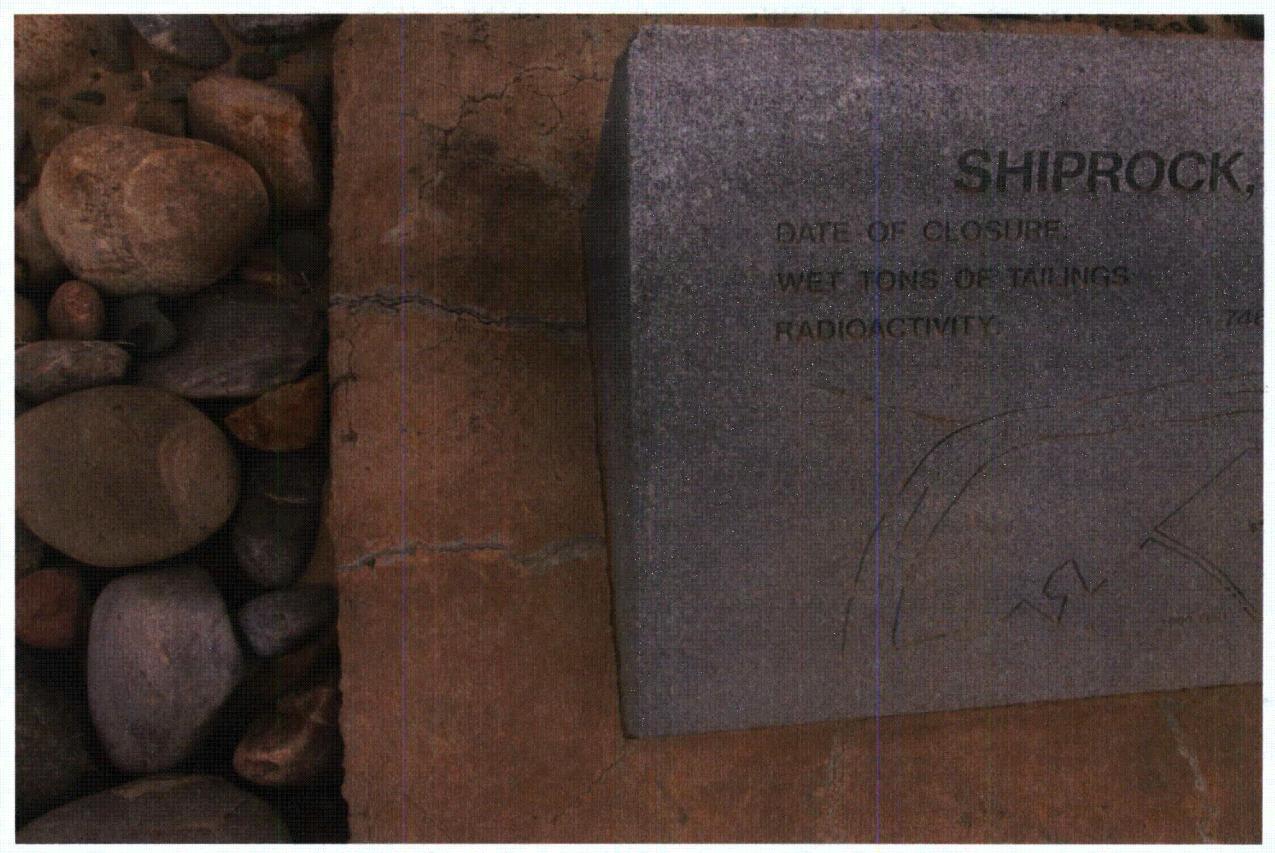
Site marker SMK-1, located just inside the southwest gate, and site marker SMK-2, located on top of the disposal cell, were both in good condition. Minor cracks in the concrete base of SMK-1 were sealed in May 2003 and have not changed significantly (PL-10).

SHP 5/2014. PL-10. Repaired cracks in base of site marker SMK-1.

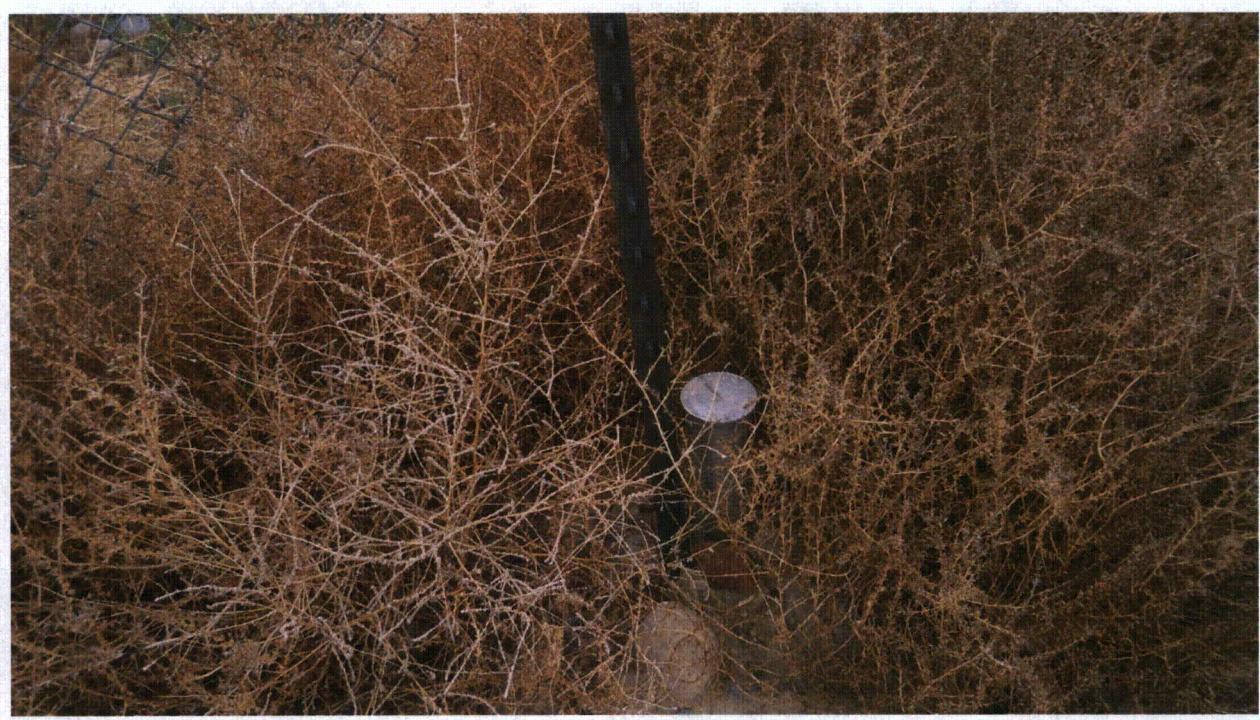
All three survey monuments (SM-1, SM-2, and SM-3) were located and in good condition. The concrete has been cracked at SM-1, but the crack does not threaten the integrity of the marker. Eight boundary monuments were originally installed at the site. Inspection of monument BM-7 was discontinued in 1999 because it is located offsite, on the unsafe, steep embankment below the terrace. Inspection of monument BM-8, also located beyond the site's boundary, was discontinued in 2003. Because they are offsite, inspection of these monuments will not resume. The remaining boundary monuments, marked with a reference post to help inspectors find them, were in good condition (PL-11).

SHP 5/2014. PL-11. Boundary monument BM-1.

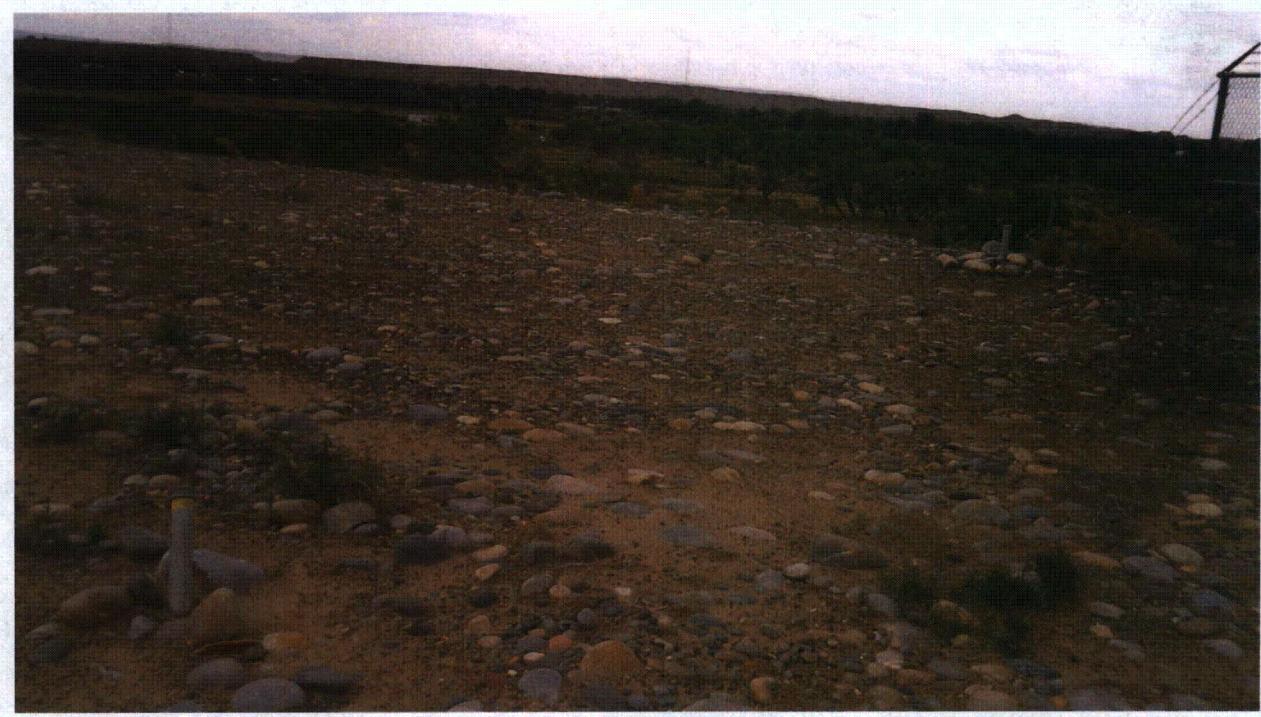
The four pairs of erosion control markers along the edge of the terrace escarpment (1, 1A, 2, 2A, 3, 3A, 5, and 5A) were in good condition except for marker 5A near the east entrance gate. This marker was previously bent by a vehicle, but it is still functional and does not require repair (PL-12). Erosion control markers 4 and 4A are not inspected; they were installed on the terrace east of the disposal site, in the gravel pit. Markers 5 and 5A replaced Markers 4 and 4A.

SHP 5/2014. PL-12. Erosion control markers 5A and 5; 5A (foreground) is bent.

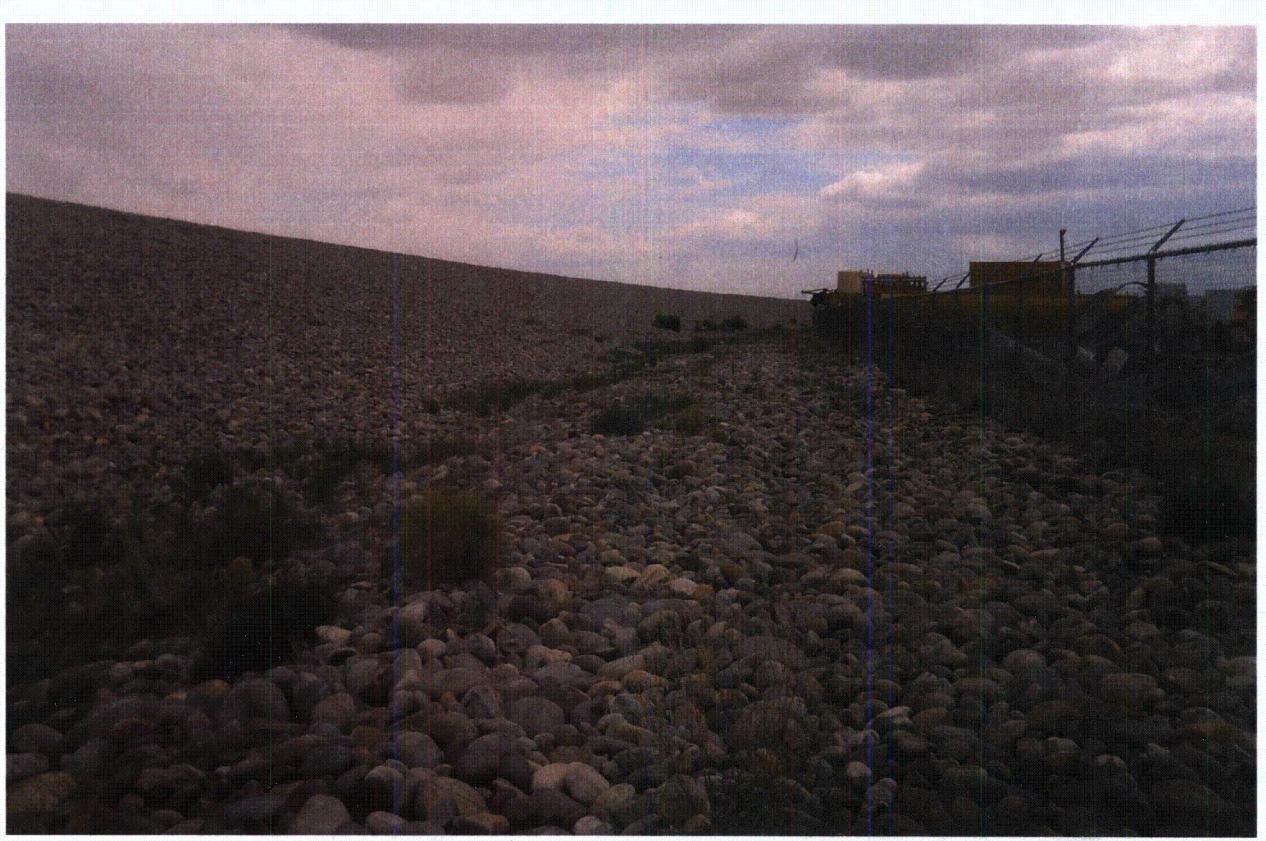
The riprap-covered top and side slopes of the cell were in good condition (PL-13). No evidence of slumping, erosion, animal intrusion, riprap deterioration, or other significant disturbance was

SHP 5/2014. PL-13. Cell side slope and fence near perimeter sign P14.

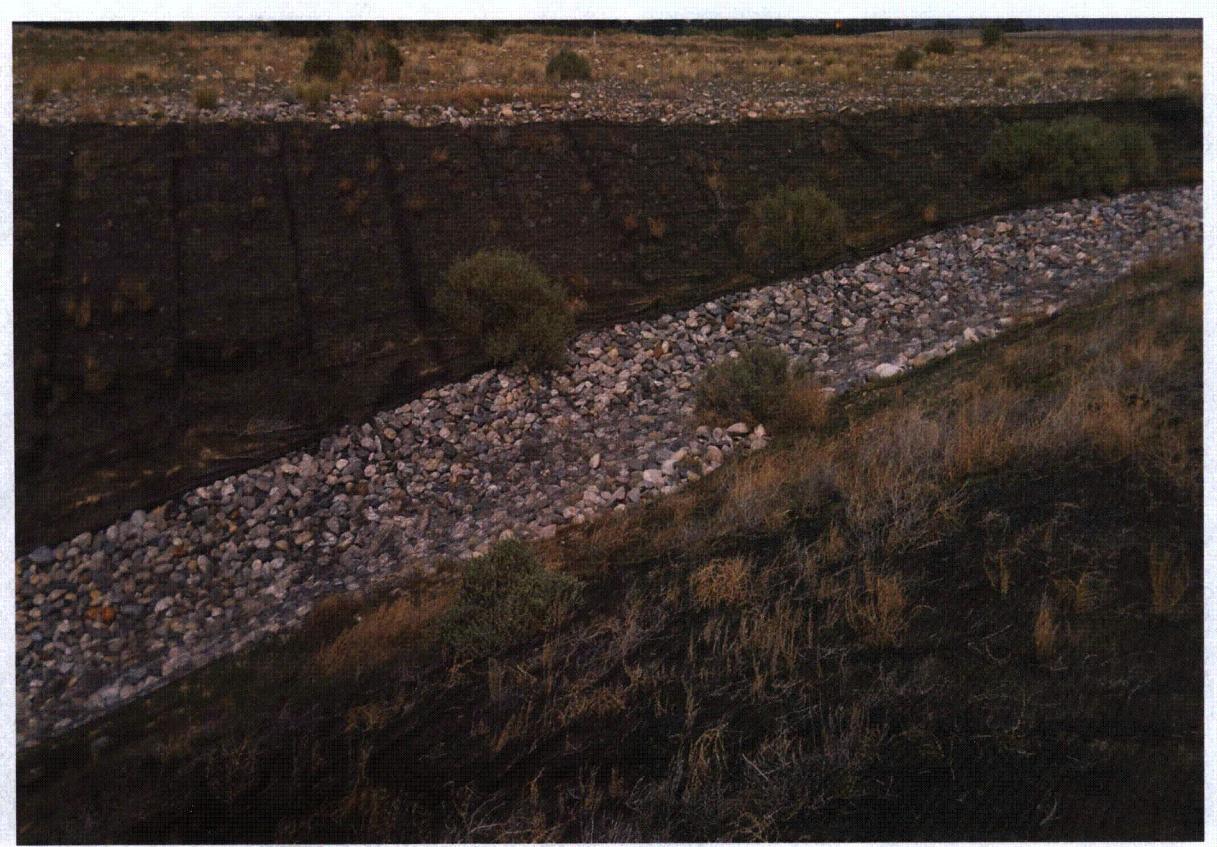
SHP 5/2014. PL-15. Outflow channel.

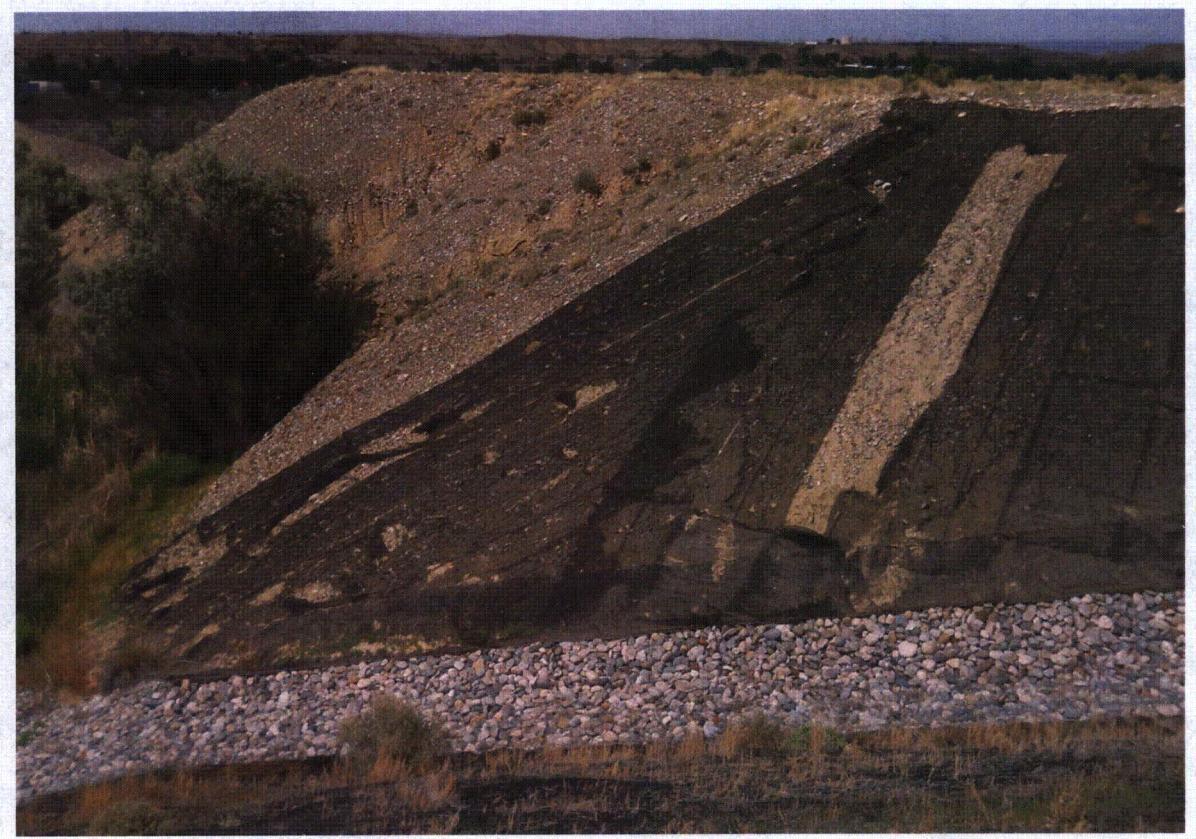
The offsite portion of the outflow channel was functional and in good condition (PL-15). A portion of erosion control fabric had previously come loose and been removed from one of the side slopes of the channel (PL-16). This area remained stable and does not need to be re-covered. Fences and warning signs posted in Bob Lee Wash are maintained under the groundwater compliance strategy and are not examined during the annual inspection.

SHP 5/2014. PL-16. Loose erosion control fabric along outflow channel side slope.
