POTENTIAL PART 21 INVOLVING STRUTHERS DUNN RELAYS WITH CONTACT RESISTANCE GREATER THAN ONE OHM

Subject: Potential 10CFR Part 21 Notification on Struthers Dunn Relays

Subject: Root Cause Analysis of a 219 Series Relay

To: Bryan Ohmert, (856) 339-2949, PSEG-Nuclear Lance Walls, 610-380-2309 lance.walls@exelonpowerlabs.com From: Project: PSE-72352 Subject: Failure Analysis of a Relay Manufacturer: Struthers Dunn Model: 219BBX200 Stock Code/Cat ID: X400405 Purchase Order No.: 4500850488-0 Qualtech Tag#: CJ358602-05 **Quantity Received: 1** Date: 19 March 2015

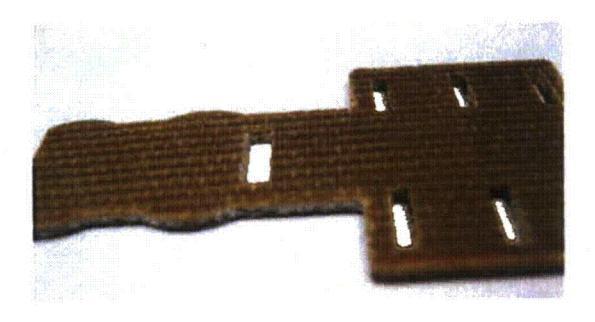
2010-2014 material

The actuator board on the evaluated relays is manufactured from a printed circuit board (PCB) type fiber board. The fibers from the edges of the board could become airborne. The attached design drawing and Struthers Dunn letter indicates that this specific board material was utilized beginning in March 2010. Since there have been no prior reports of this issue, it is possible that the 2010 material change introduced a foreign materials exclusion (FME) concern. Since then, and solely for those relays manufactured in the USA, the material changed again in November 2014 and was incorporated into the products starting January 2015. The newest version of the actuator board is a molded material that does not contain fiberglass fibers.

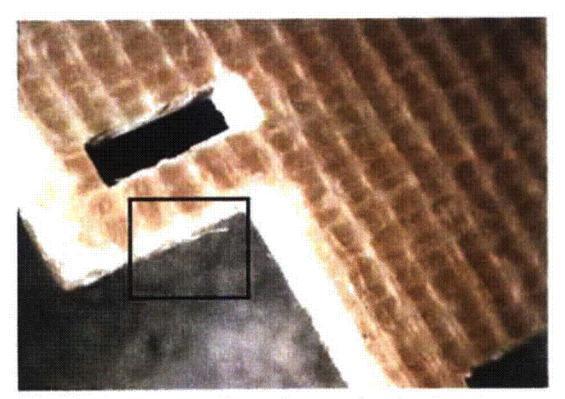
The Power Labs' Report(s) shows fiberglass fiber(s) embedded into gold plated contacts on one relay believed to result in a contact resistance greater than one Ohm (1.7 Ohm Max). The second relay, from stock, had evidence of fiberglass present but was not considered to have affected functionality.

Fiberglass Fiber shown in the box

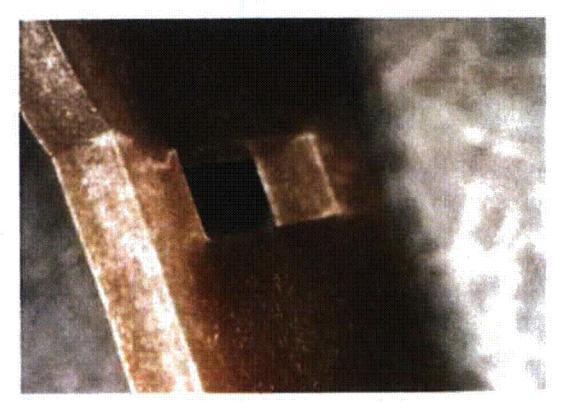
ULTEM 2300 material

The actuator card had been previously constructed from a fiberglass composite material (between March 2010 and December 2014). But now we have switched to a new and better material, ULTEM 2300. On the previous material the actuator card was stamped out of a fiberglass sheet. Where the current actuator card is being injection molded and does not have any edges that could have potential fibers breaking off. In order to keep our nuclear grade rating of this relay family series we contracted Curtiss-Wright to do an environmental analysis qualification in compliance with 10 CFR Part 50 Appendix B, ASME NAQA-1, ANSI/ASME N45.2-1977 and IEEE Std. 323-1974. As of January 1st 2015 all U.S. manufactured 219 family relays are manufactured with the upgraded actuator card.

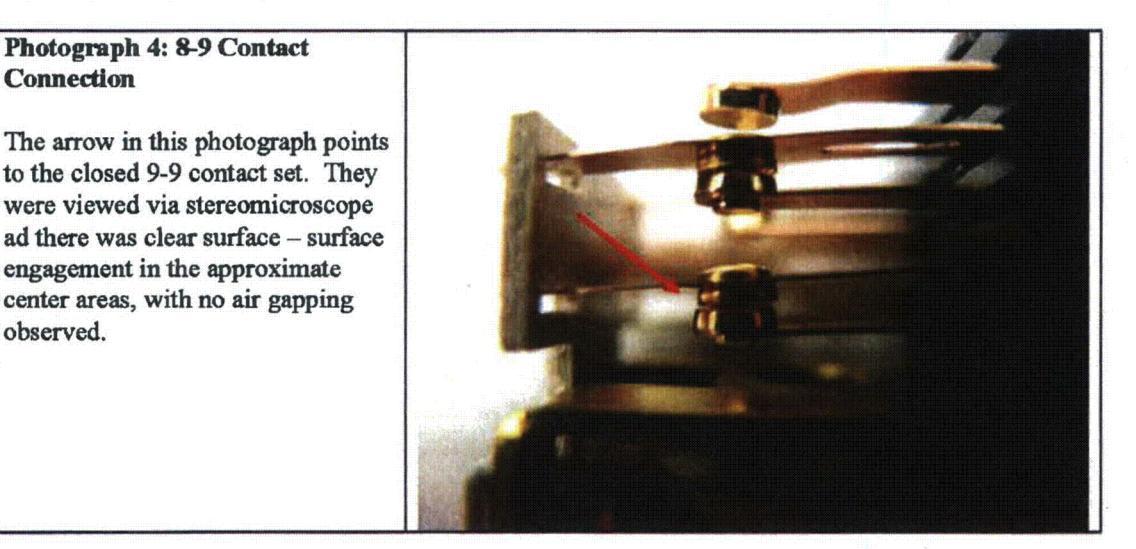
Contact 8 Exelon PowerLabs, LLC -

The striation / scratch marks observed with both the 8 and 9 contact surfaces are not a normal or expected observation with contacts that have not been mechanically burnished. Mechanically burnishing will produce scratched surface marks due to the inherent cleaning process, however it is not believed that either of these contacts were burnished.

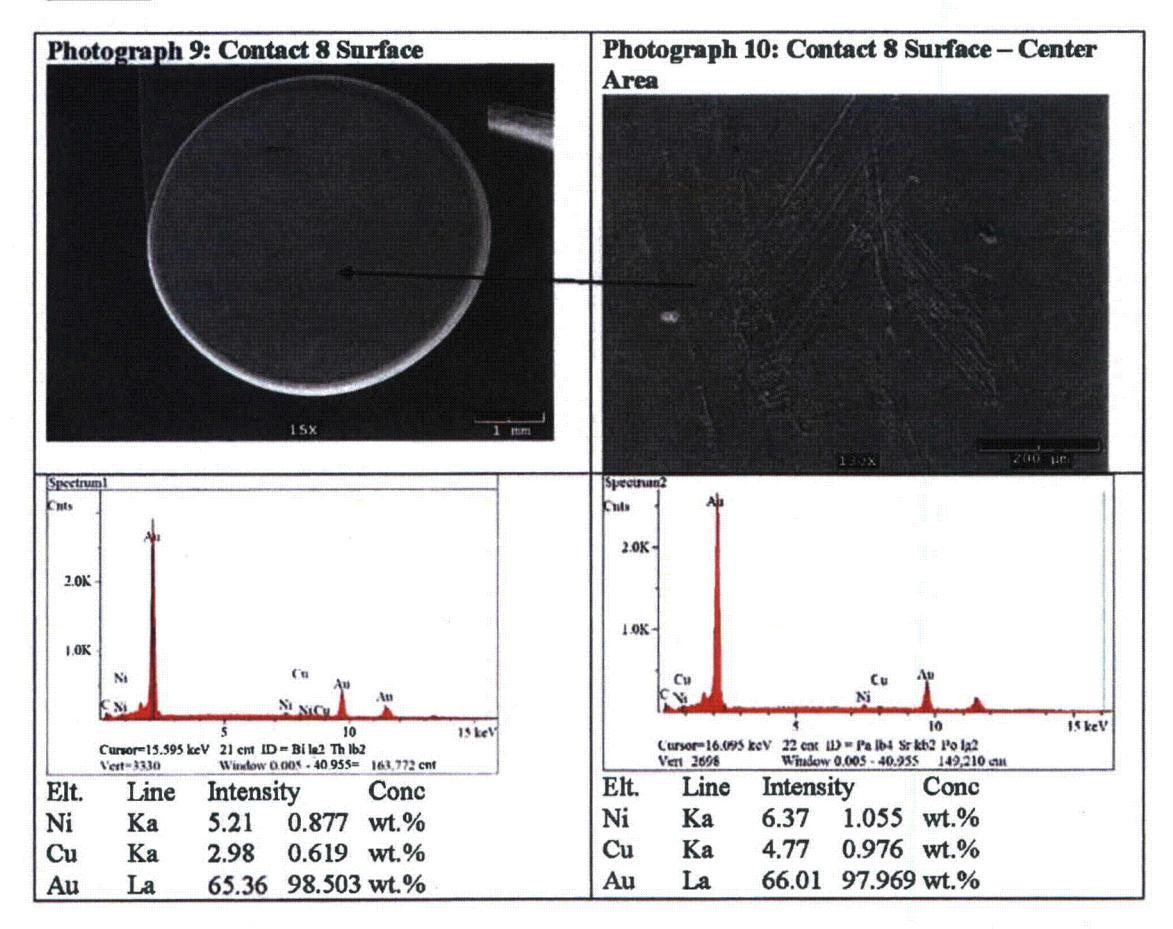
Contact 8

Photograph 10 exhibits the striation patterns that were present on the contact 8 surface. Again, these patterns are not a typical wear pattern observed relay contact make/break or wipe operations. Gold was primary elemental constituent in both snapshots, with similar concentrations of Nickel and Copper in both.

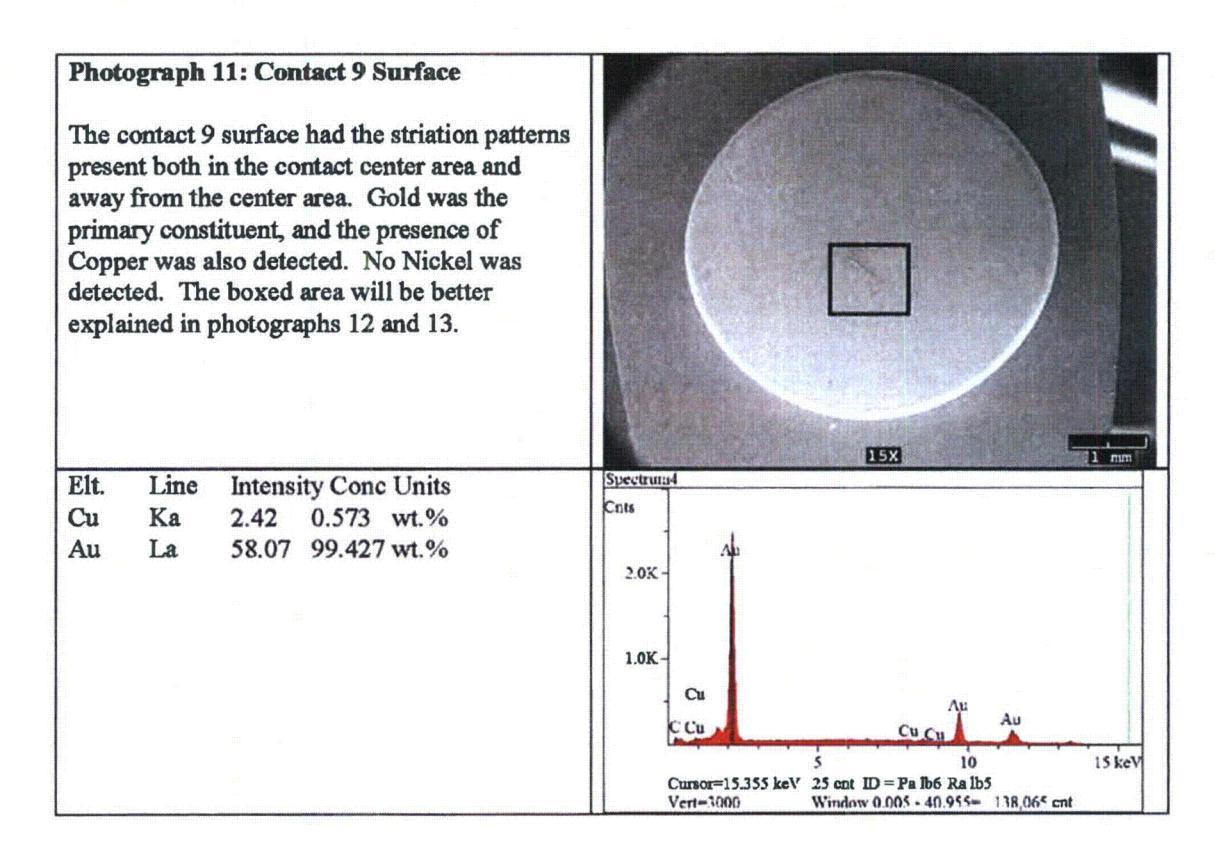
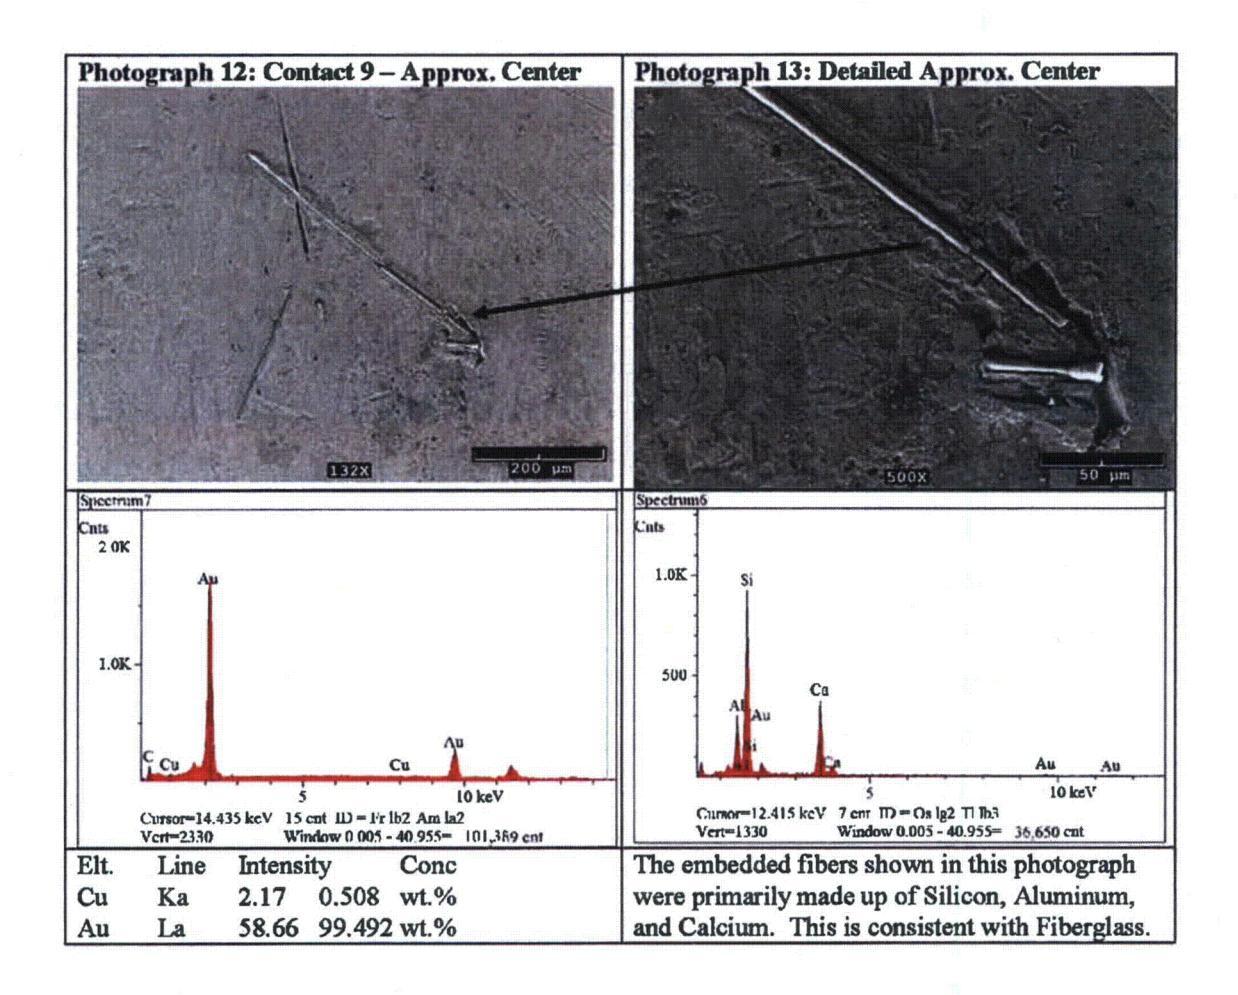
Contact 9

SEM/EDS Analysis of both contacts revealed the presence of Gold, Copper, and Nickel, with the Nickel being of unknown origin. The 8 contact had the presence of the striation patterns, which are not thought to be due to normal wear through make/break operations and wiping action. The 9 contact surface was comprised of Gold and Copper and also had the striation patterns, but additionally had the presence of several fiberglass strands that were embedded into the contact surface, as opposed to being surface contamination. The fact that they were embedded suggests that they were present during the surface plating process during manufacturing. There were other cavities on the contact surface that were similar in appearance, which increases the likelihood that there were other fibers present at one time, but became disassociated via contact make/break operations. The irregular contact surface patterns in conjunction with the presence of the embedded fiberglass fibers are the most likely cause of the excessive resistance. This finding is considered to be a manufacturing defect.

The embedded fibers in the contact surface, which are exhibited in photographs 12 and 13 had an elemental composition consistent with Fiberglass. The fact that they are embedded into the surface of the contact suggests that they were present at the time of manufacture when the surface was coated. The presence of other similar cavities into the contact surface may suggest that there were other fiberglass fibers present at one time, but that they became disassociated due to contact make / break operations. The irregular patterns in the contact surfaces and the presence of the fiberglass fibers in the approximate center of contact 9 are the most likely cause of the excessive resistance.

QualTech NP recommends an application review for the named relays. A review of the Exelon Power Labs reports and the vendor's report should also be completed by the utility to evaluate the impact on the safety function.

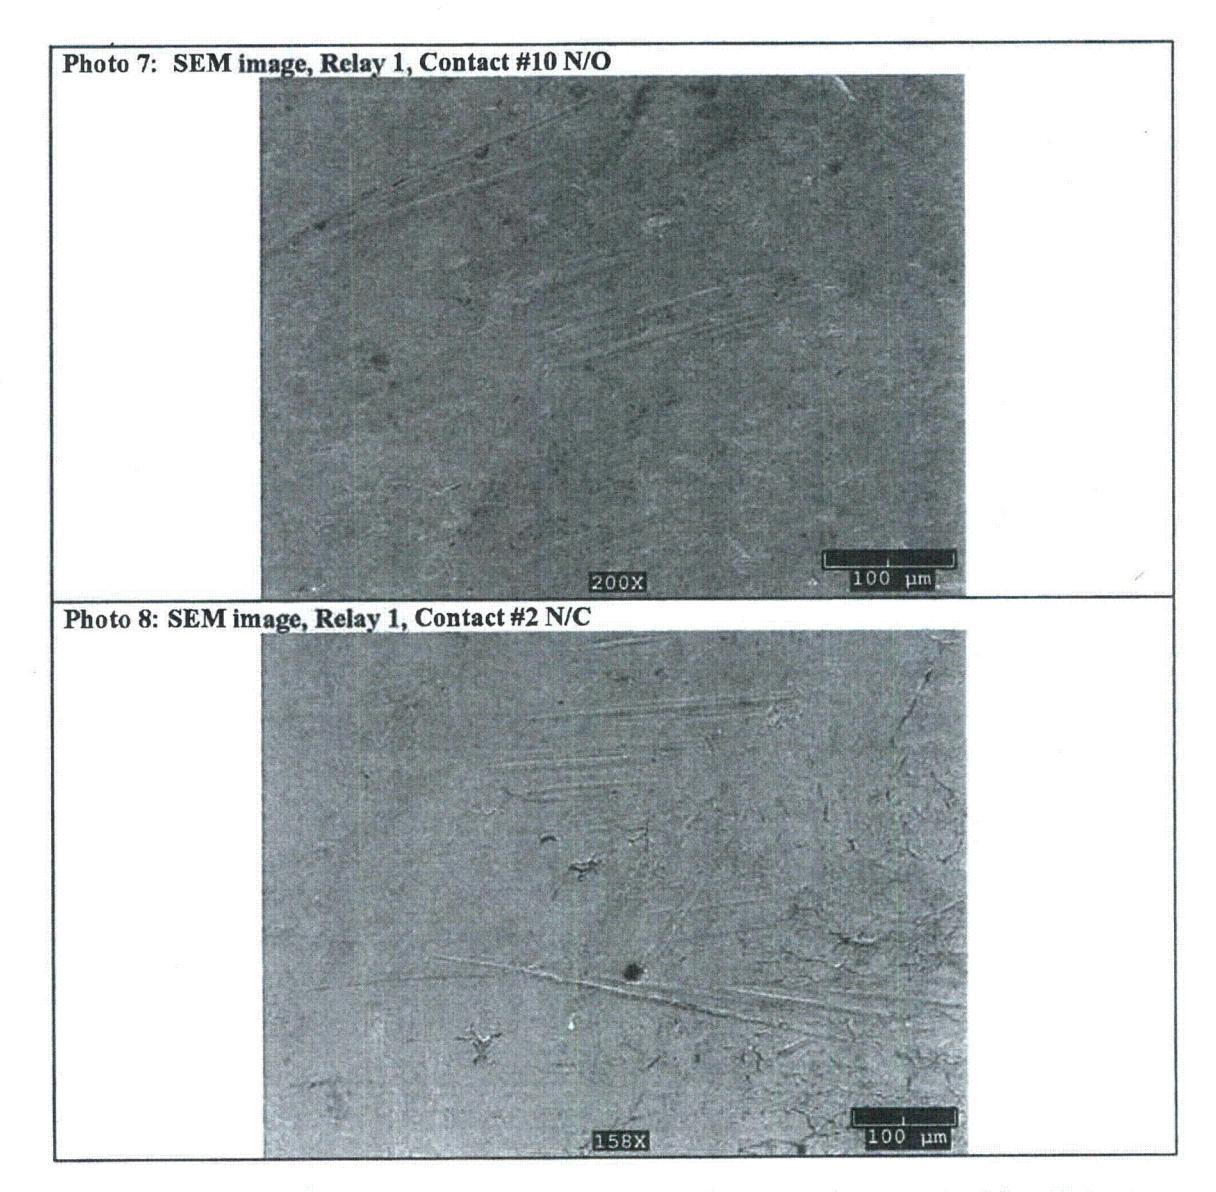
Embedded foreign material was observed on the #2 N/O contact surface. The embedded foreign material in the contact surface had an elemental composition consistent with fiberglass shown in the Energy Dispersive Spectroscopy spectrum shown above (Primary constituents are Si, Ca, Al, O).

The photographs above are representative of the remaining contact surfaces examined from Relay 1. All the other contact surfaces did not contain any foreign material, but revealed scratches on the contact surface.

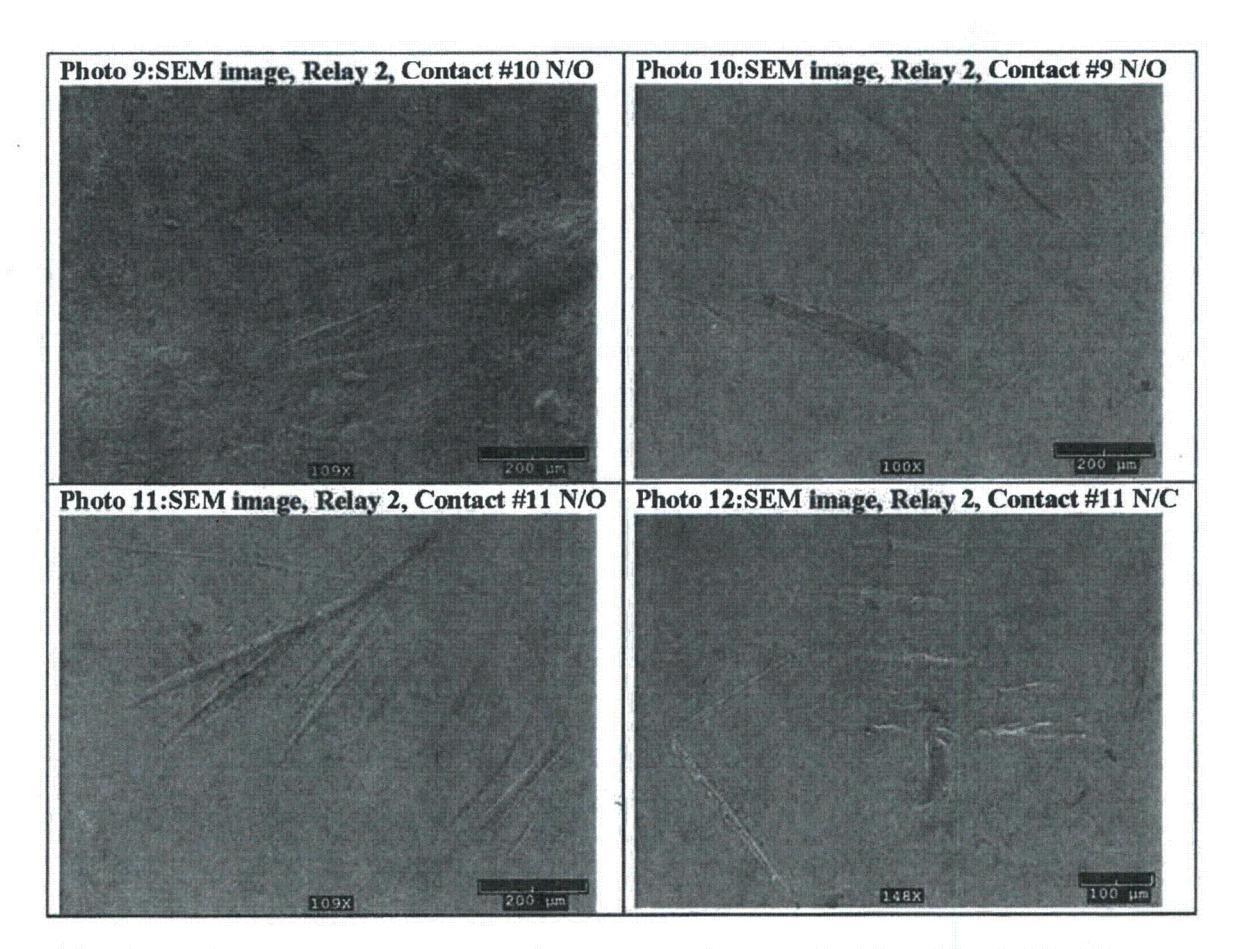
The photographs above are representative of the contact surfaces examined from Relay 2. All of the contact surfaces did not contain foreign material, but revealed scratches on the contact surface.
