Edwin I. Hatch Nuclear Plant – Unit 2 Inservice Inspection Program Owner's Activity Report for Outage 2R23

SNC and SI Evaluation Core Shroud Axially Oriented Flaw

Edwin I. Hatch Nuclear Plant – Unit 2 Technical Justification Regarding Scope Expansion of ASME Code Section XI B-N-2 Components

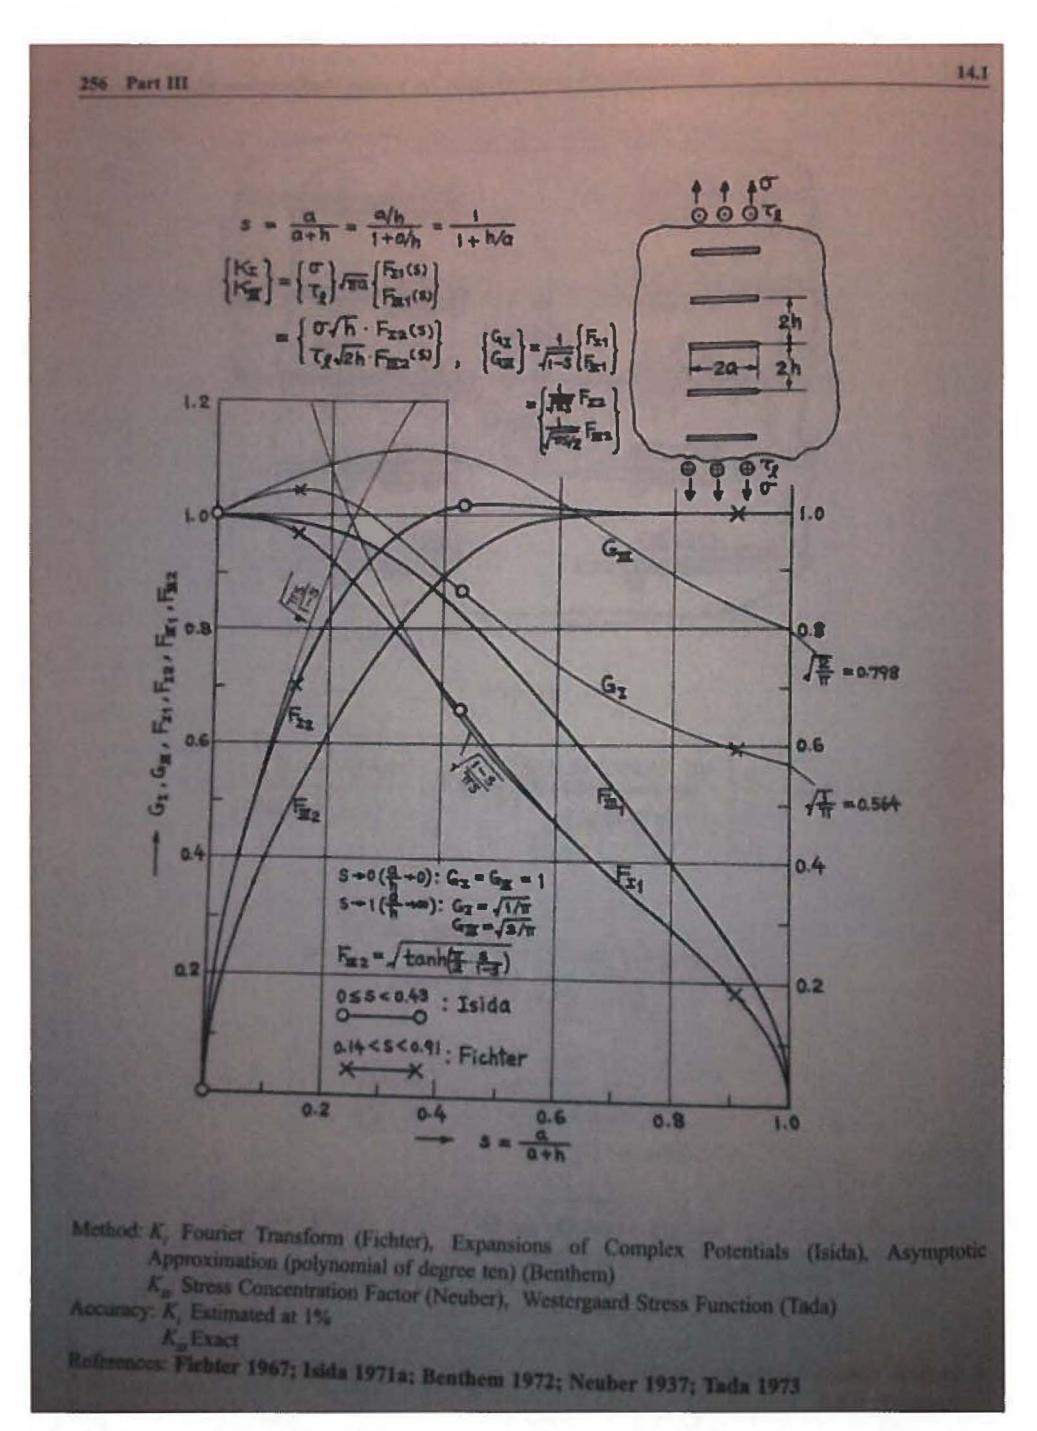
Figure 4. LEFM Solution for an Infinite Array of Through-wall Cracks in a Plate with a Membrane Load [10]

- Review of the LEFM solution shown in Figure 4 illustrates that the crack driving force for parallel flaws in a plate is reduced compared to the case of a single flaw in a plate, as shown by observation of the F₁₁ curve for s→0 which corresponds to a single flaw. Consequently, multiple aligned flaws can be bounded by treating each as a separate flaw.
- 3. The longest flaw reported near the H4/V3 intersection is selected for evaluation and clearly bounds all flaw lengths reported. This flaw is assumed to be a single continuous flaw passing through the H4 weld. The initial flaw size considered, before addition of uncertainty and crack growth, is 6.3 inches [1c].
