Re: Oconee Unit 2 Docket No. 50-270

Report No.: A0-270/74-15

Identification of Occurrence: Missing guide pin from valve 2LP-14

Report No.: A0-270-74-11

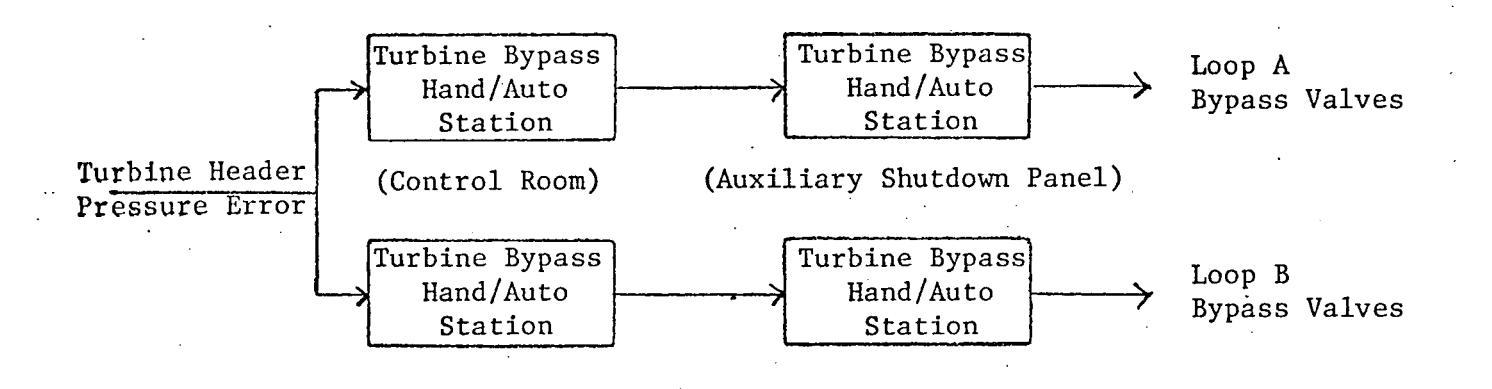
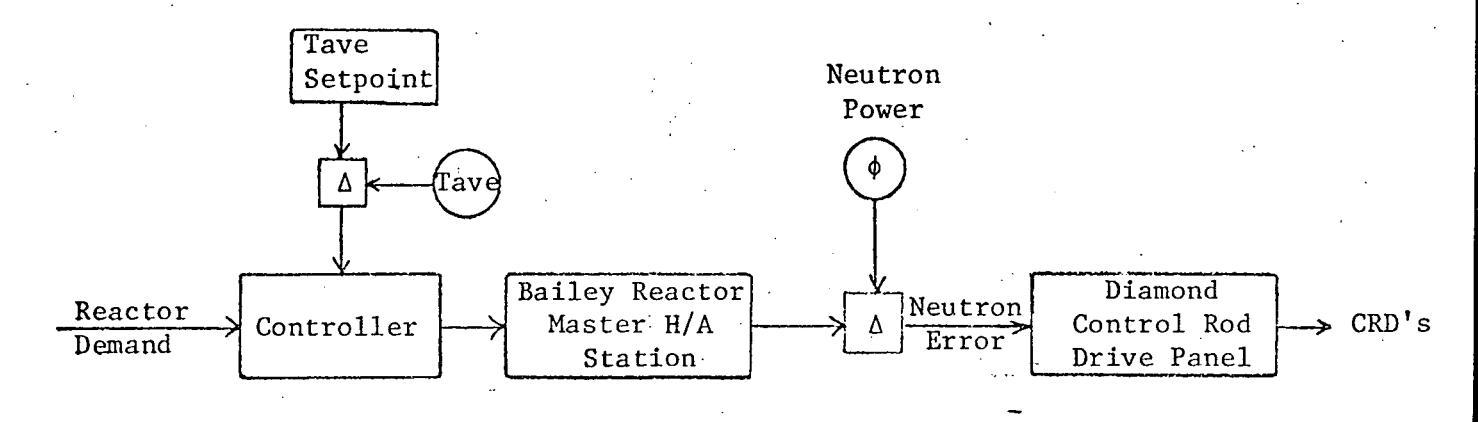
Refer to Figure 1 for a schematic arrangement of the ICS stations involved.

Oconee Technical Specification 3.5.2.5.d does not allow reactor power to be increased above 82.5 percent full power unless xenon reactivity is within 10 percent of the value for operation at steady-state rated power. Reactor power was increased above 82.5 percent full power each time by the Integrated Control System in response to the opening of the A loop turbine bypass valves. As the bypass valves opened, dumping steam directly to the condenser, the ICS increased reactor demand in order to hold unit load. The bypass valves opened improperly because of two failed modules within the turbine bypass valve controls. While reactor power was still above 82.5 percent full power, the control operator, in error, increased reactor power further above the power level cutoff in order to return the unit average temperature to normal.

The two failed modules in the turbine bypass valve control section of the ICS were replaced and a functional check performed to verify their correct operation.
