SUBJECT: NORTH ANNA POWER STATION, UNITS 1 AND 2 – STAFF ASSESSMENT OF  
RESPONSE TO 10 CFR 50.54(f) INFORMATION REQUEST – FLOOD-  
CAUSING MECHANISM REEVALUATION (TAC NOS. MF1106 AND MF1107)

RELATED TO FLOODING HAZARD REEVALUATION REPORT

NEAR-TERM TASK FORCE RECOMMENDATION 2.1

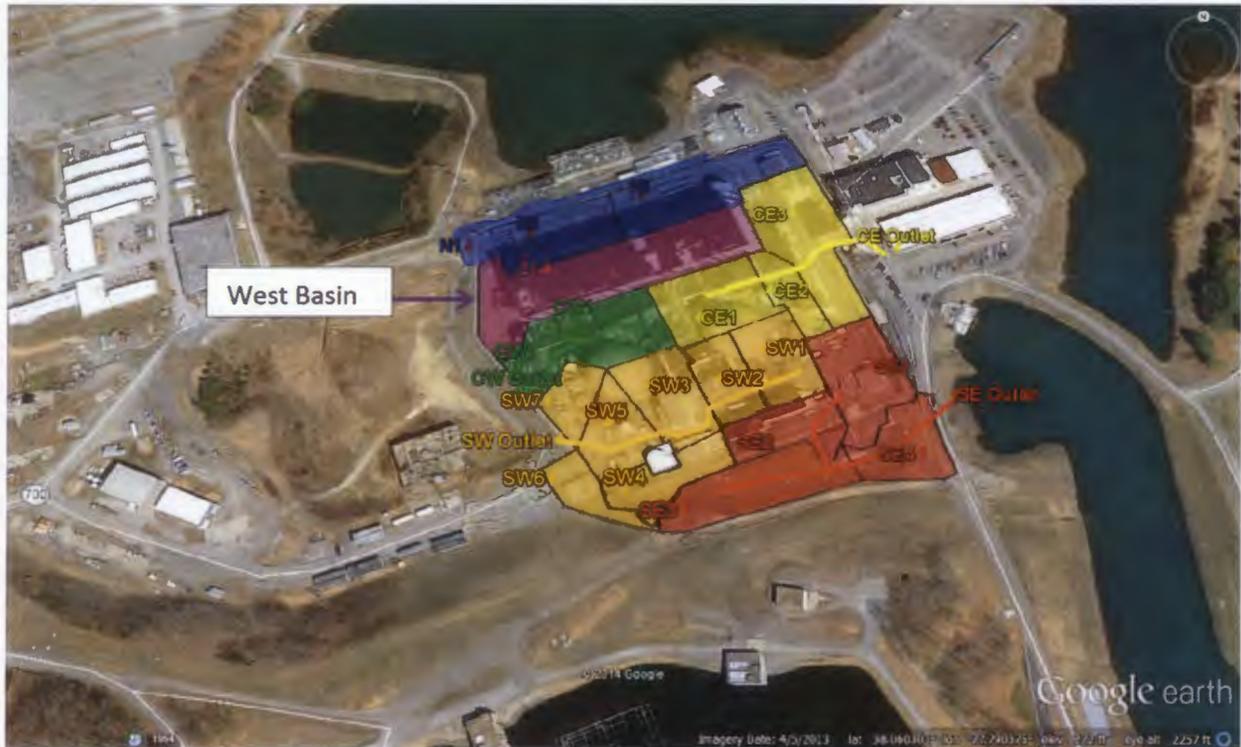
**Figure 3.1-3. HEC-HMS Drainage Subbasin Model and HEC-RAS Flowpaths for Protected Area, Including the West Basin**

modeling (Dominion, 2013a). The NRC staff noted that a significant fraction of the Protected Area is covered with buildings. The staff found that the licensee included buildings and the vehicle barrier system when developing the numerical model of the site, and reasonably delineated subbasins, subbasin interconnections, and flowpaths.

The reevaluated flood elevations caused by a postulated LIP event in the Protected Area outside the West Basin and the West Basin exceed the respective CDB levels. In the Protected Area, maximum LIP flood level occurs at the open area between Unit 2 Reactor and the Control Building.

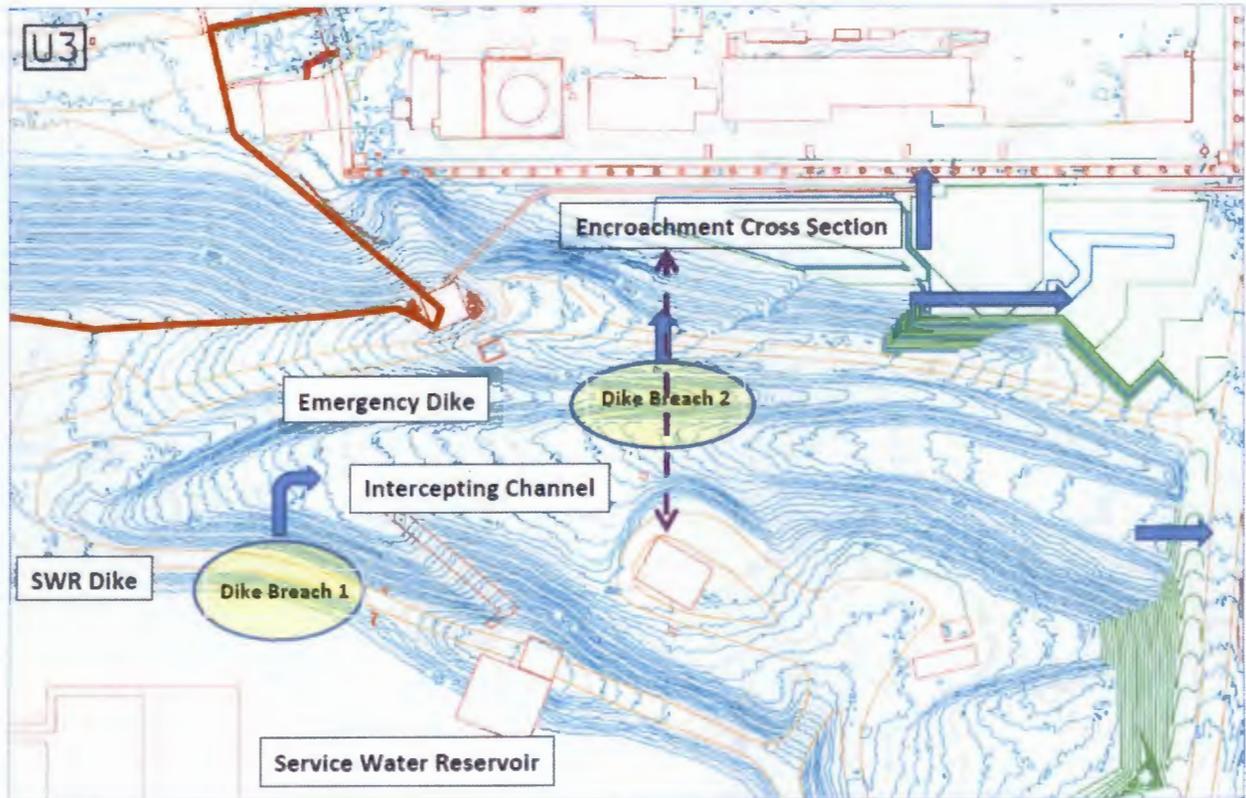
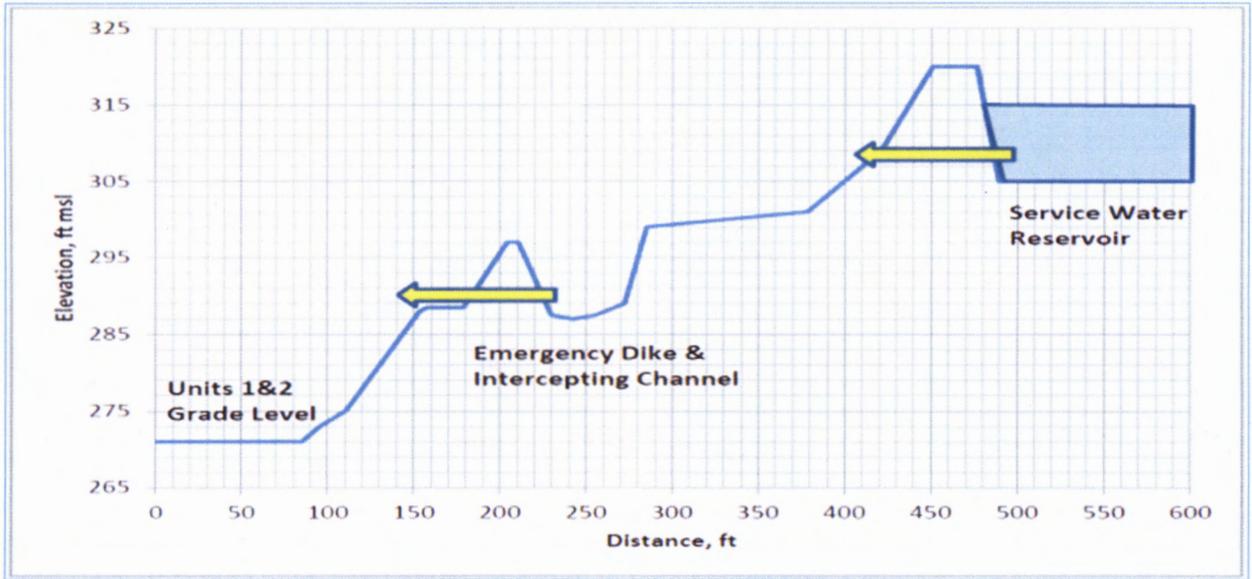
**Figure 3.4-1. Location of Postulated Dike Breaches on the Service Water Reservoir and Emergency Dike (Top), and Cross Section Profile (Bottom)**

The NRC staff noted in its review of the FHRR and RAI responses, that the licensee's v-notch shape of the breach could result in an underestimation of breach outflow rates. Alternatively, the staff assumed a trapezoidal-shape dike breach with 45-degree breach slopes on both sides. The NRC staff used several regression-based breach parameter equations, and determined an average breach width (e.g., an average of top and bottom widths) of 60 ft (18.3 m) and breach time of 0.24 h (NRC, 2015a). Using the HEC-RAS dam breach option, the NRC staff simulated a breach outflow hydrograph from a breach of the Impounding Dike. The resulting peak breach outflow rate was approximately 2,800 ft<sup>3</sup>/s (79 m<sup>3</sup>/s). This breach outflow hydrograph was used as an upstream input to simulate the stage hydrographs along the reach of the Intercepting Channel using the HEC-RAS unsteady flow option.

The NRC staff postulated two conservative dike failure scenarios using the following assumptions:

- A dike breach would occur on the northern section of the Impounding Dike between the Pump House and the junction of the Impounding Dike and the Emergency Dike (Figure 3.4-1, Dike Breach 1). A breach only on this critical section could potentially impact the Units 1 and 2 powerblock area. In other words, a breach flood occurring from outside this critical section will not impact the plant site.
- The NRC staff selected the encroachment section of the Intercepting Channel (Figure 3.4-1, Dike Breach 2) as a potential location for overtopping or piping failure of the Emergency Dike. This is because the velocity and head of the channel flow on this section could potentially increase due to the encroachment effects, resulting in overtopping and breaching of the Emergency Dike.
