NUCLEAR REGULATORY COMMISSION  
[Docket Nos. 50-269, 59-270, 50-287, 50-289, 50-302, 50-312, 50-313]

Issuance of Director's Decision Under 10 CFR 2.206

DIRECTOR'S DECISION PURSUANT TO 10 CFR 2.206

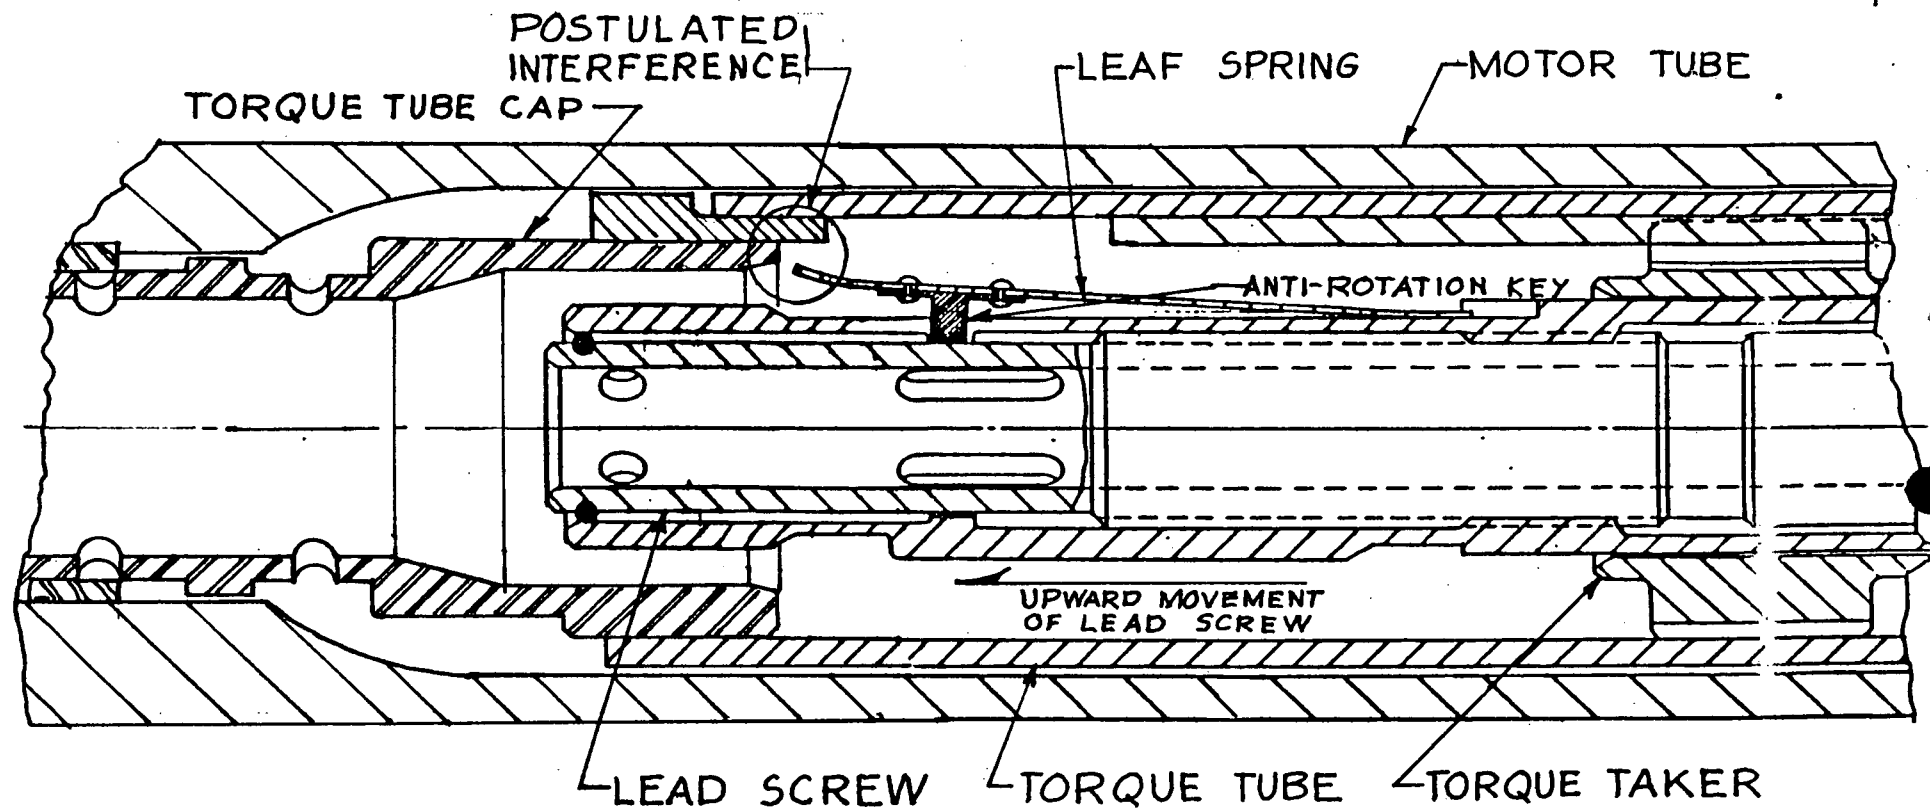
CROSS SECTION OF LEAD SCREW ASSEMBLY WITH LEAF SPRING IN UNLATCHED POSITION

all dimensional tolerances are stacked in the most adverse direction. In that circumstance, the tip of the spring will hit the torque tube cap when the CRDM is fully withdrawn (see Enclosure). If the leaf spring then breaks and if the right size of debris is generated, i.e., not too large or too small, either immediately or due to exercising the CRDM, then such a loose part can cause either improper functioning of the CRDM, or prevent the rod from being inserted, or prevent the rod from being withdrawn.

INTERFERENCE OF THE LEAF SPRING AT THE TORQUE TUBE CAP WAS THE RESULT OF THE ANTI-ROTATION KEY ON THE LEAF SPRING NOT PROPERLY BEING POSITIONED IN THE SLOT ON THE LEAD SCREW.
