Westinghouse Electric Company LLC Hematite Decommissioning Project 3300 State Road P Festus, MO 63028 USA

- Subject: Hematite Decommissioning Project Reply to a Notice of Violation Issued November 27, 2015 (License No. SNM-00033, Docket No. 070-00036)
- Reference 1: NRC (R. Orlikowski) letter to Westinghouse (G. Fussell), dated November 27, 2015, "NRC Inspection Report 07000036/2015003(DNMS) Westinghouse Electric Company (Hematite) and Notice of Violation" (ML15334A404)

Westinghouse Hematite Decommissioning Project Response to Notice of Violation Issued by NRC on November 27, 2015

Westinghouse Hematite Decommissioning Project Response to NRC Inspection Report 07000036/2015003 dated November 27, 2015 Extent of Condition Relating to Isolation Control Breaches

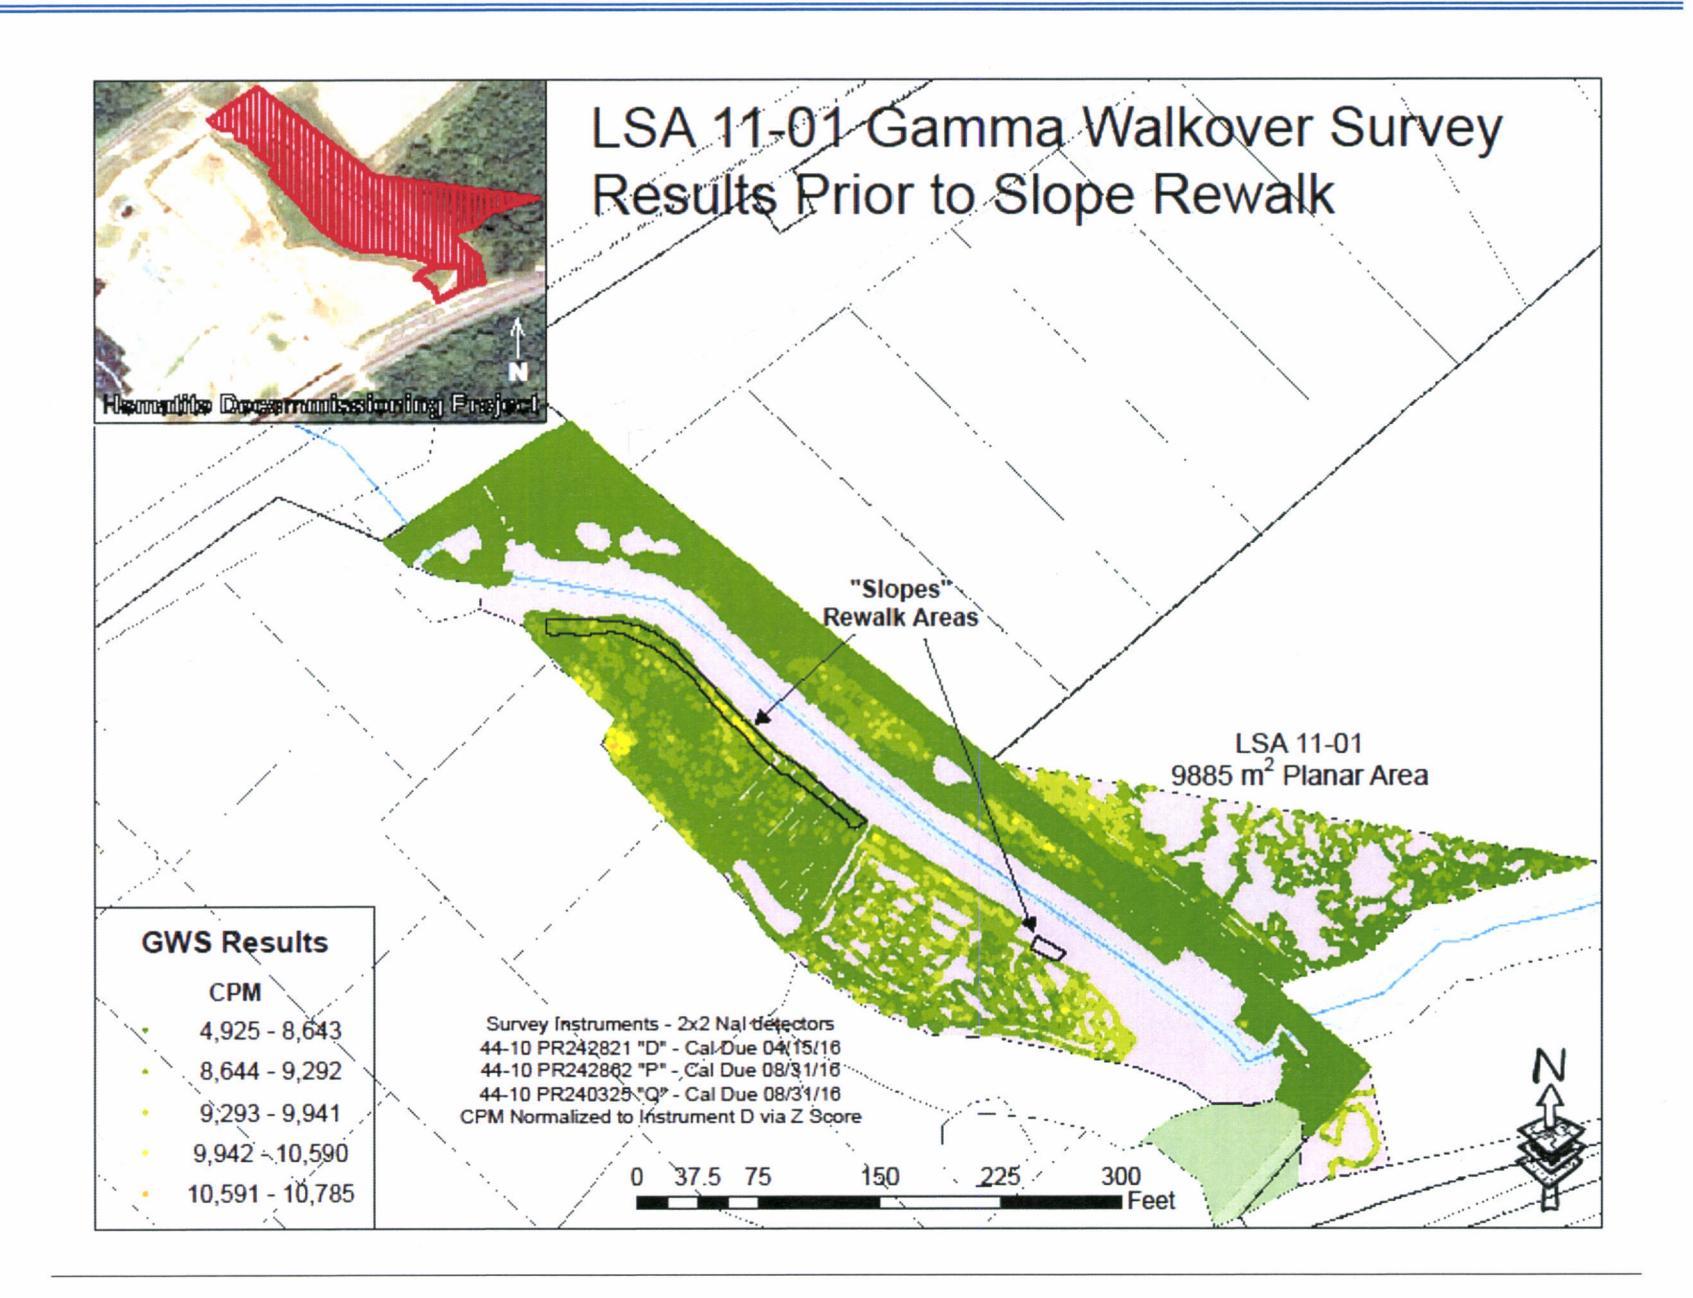
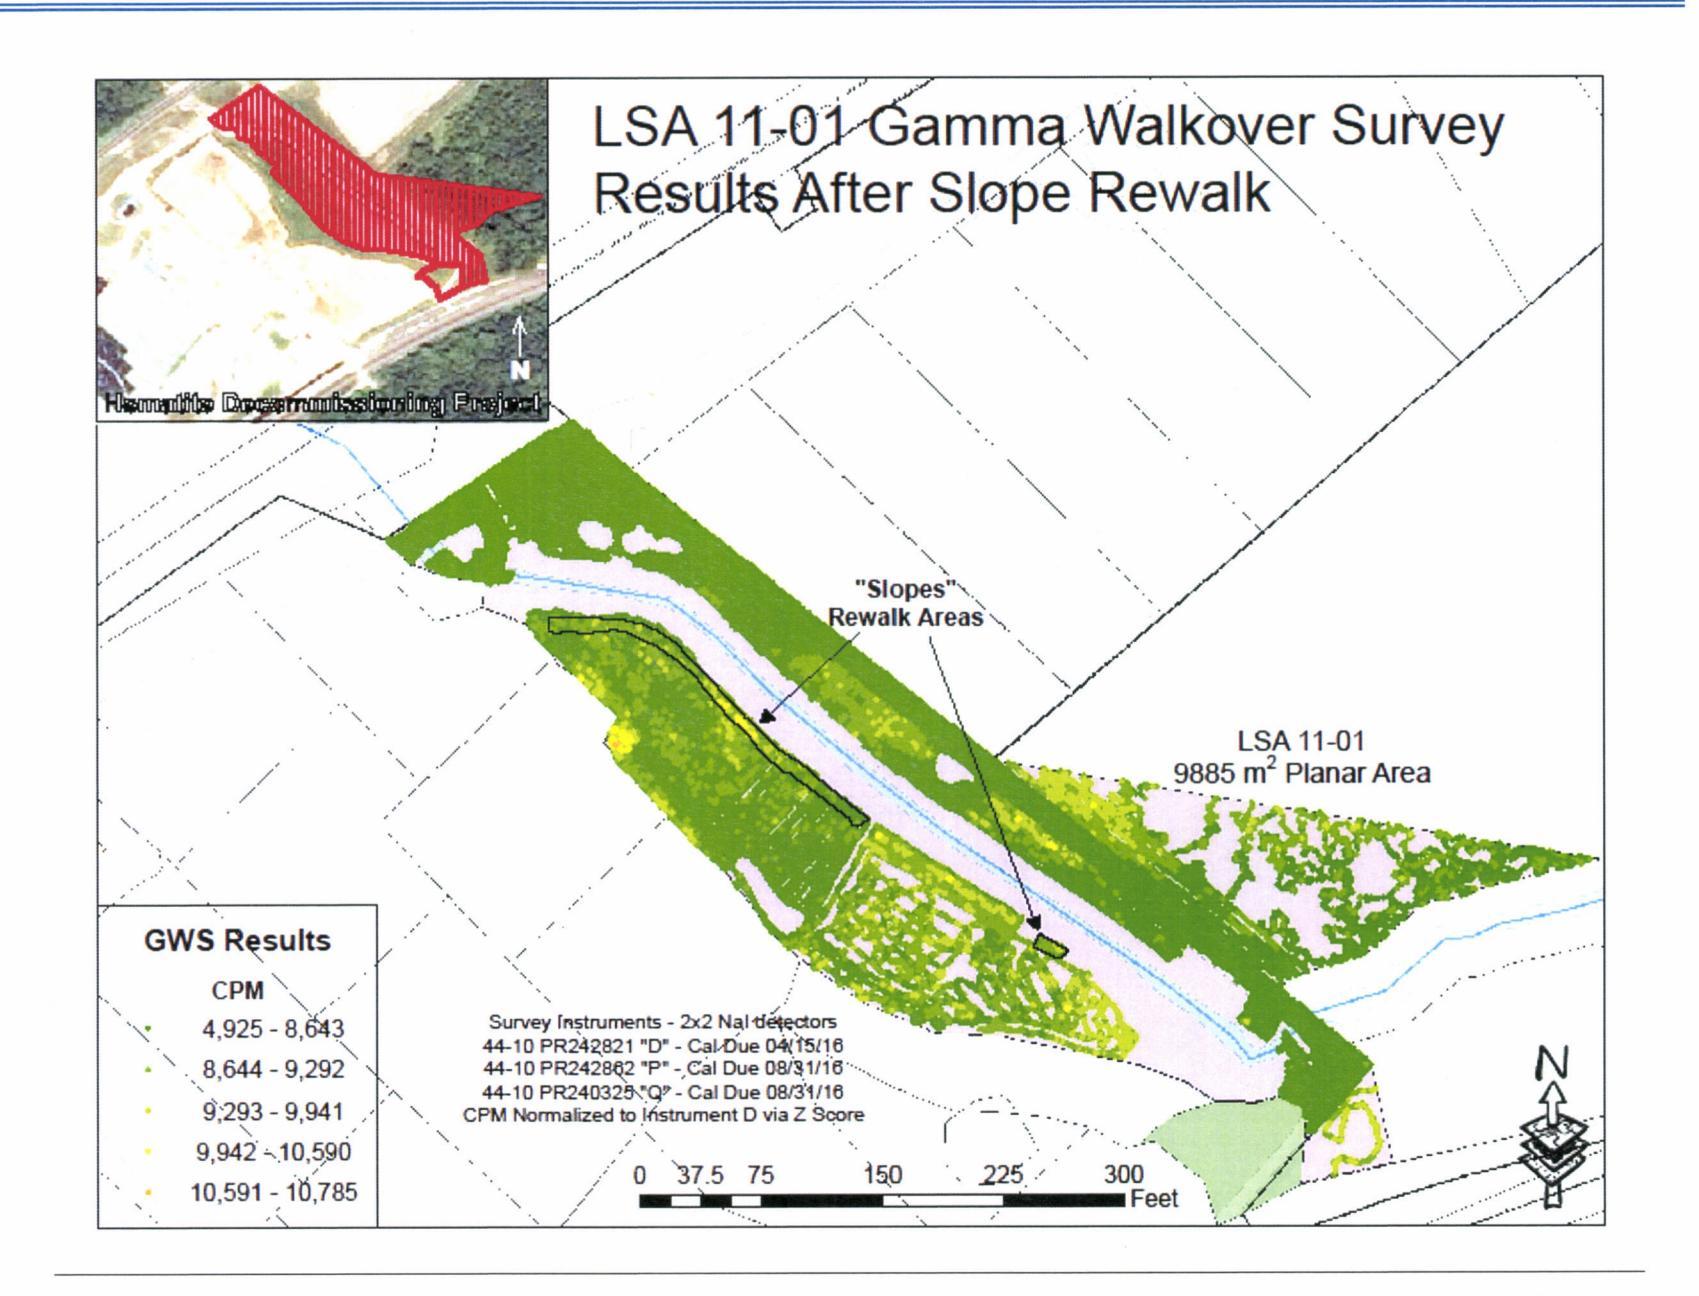
On December 15, 2015, during an on-site inspection by NRC Region III, the NRC Inspector noted a Health Physics Technician performing a gamma walk over survey in LSA 08-01 and noted that the probe was held greater than 3 inches from the ground surface. The NRC Inspector notified the RSO of the observation. In recognition of the issuance of this observation being a recurrence of the violation and not adhering to the procedural requirements for performance of gamma walk over surveys at 10:30 am on December 15, 2015, the RSO implemented a Stop Work Order on all FSS field work.

In regards to the September 30, 2015, NRC Inspector observation the corrective actions taken are 1) The Health Physics Technician was interviewed to determine the reason for not adjusting the survey meter probe to ground distance for the sloped area, 2) Conducting a supervisory discussion of expectations and procedural compliance with the Health Physics Technicians in regards to awareness of the probe to ground surface distance when surveying on a slope, 3) Performing a resurvey of the sloped area of LSA 11-01 to ensure compliance with the FSS program in regards to submittal of the survey area release record, 4) Performing a comparative assessment of the gamma walk over surveys in the sloped areas of LSA 11-01 as an indicator of the adequacy of the performance of gamma walkover surveys, and 5) Initiated Westinghouse Corrective Action Prevention And Learning (CAPAL) Issue #100348374.
