PNNL-SA-115353

Non-destructive Evaluation of Butt-fusion Joint Integrity in High Density Polyethylene Piping

INDUSTRY/NRC NDE TECHNICAL INFORMATION EXCHANGE
PUBLIC MEETING

JANUARY 21, 2016

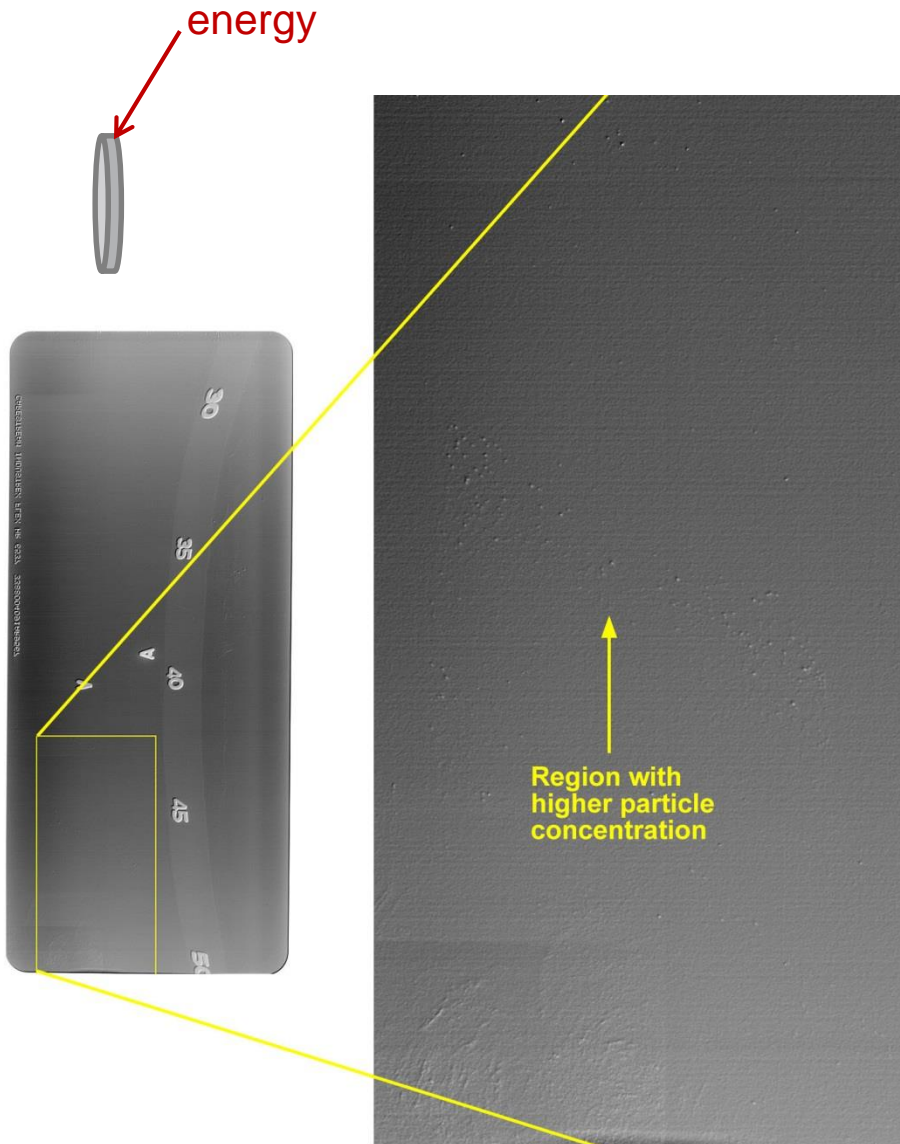
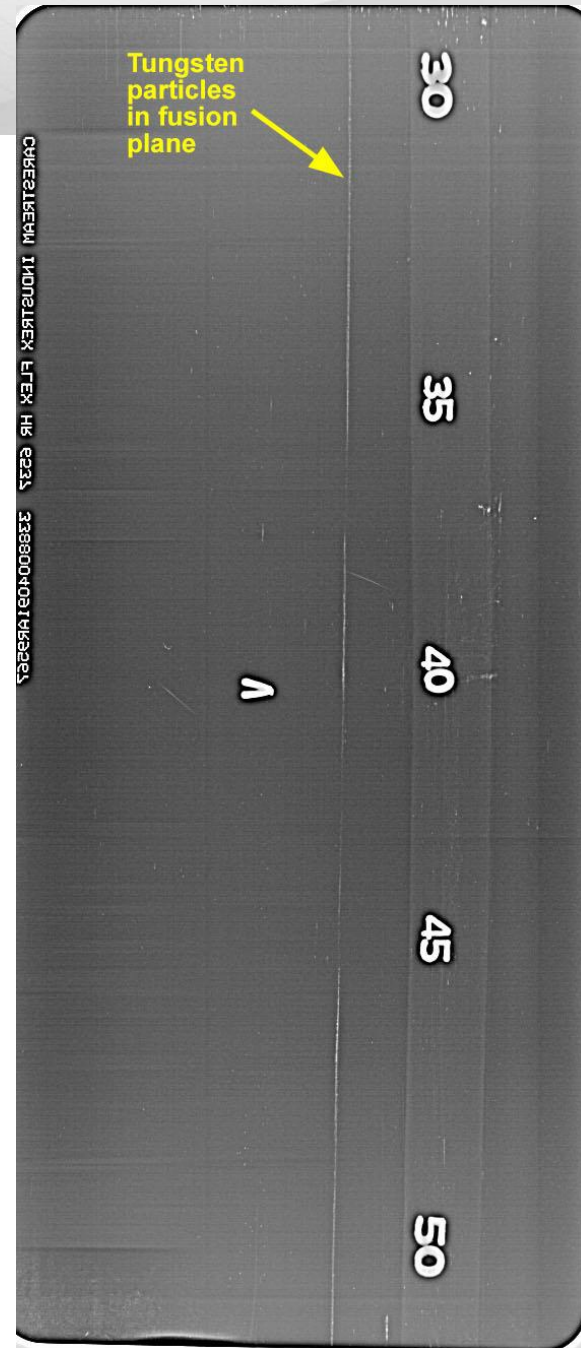
RT: Tungsten Powder

- ▶ Implanted “coarse” particulate contamination
 - 118-micron PSD d50
- ▶ Pre-fab: Applied OD to ID across circumference
- ▶ Fabricated per ASME Code

- ▶ RT confirms particulate is in the fusion joint
- ▶ Appears PA-UT/TRL can detect at a certain concentration level
 - Require better understanding of actual concentration across wall and circumference

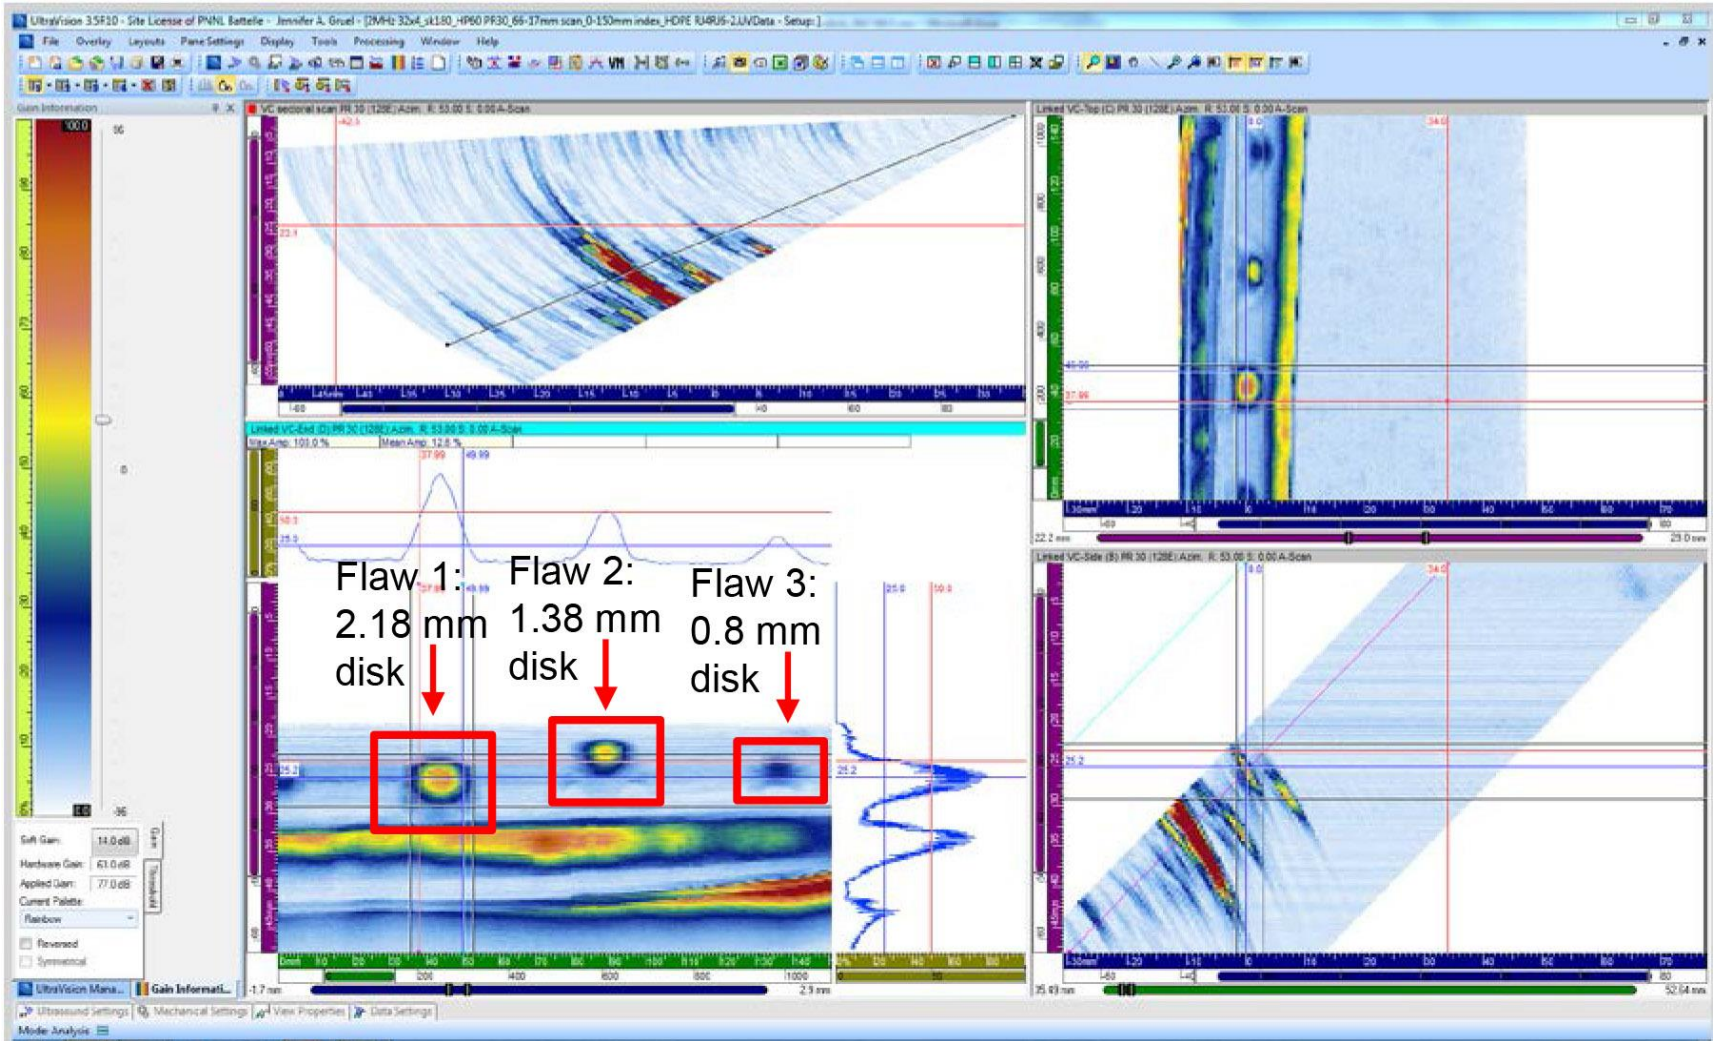
PA-UT/TRL Data Example: 128E Aperture

- ▶ Flaws 1, 2, and 3 in RJ4/RJ6-2 with 128E Aperture from Skew 180

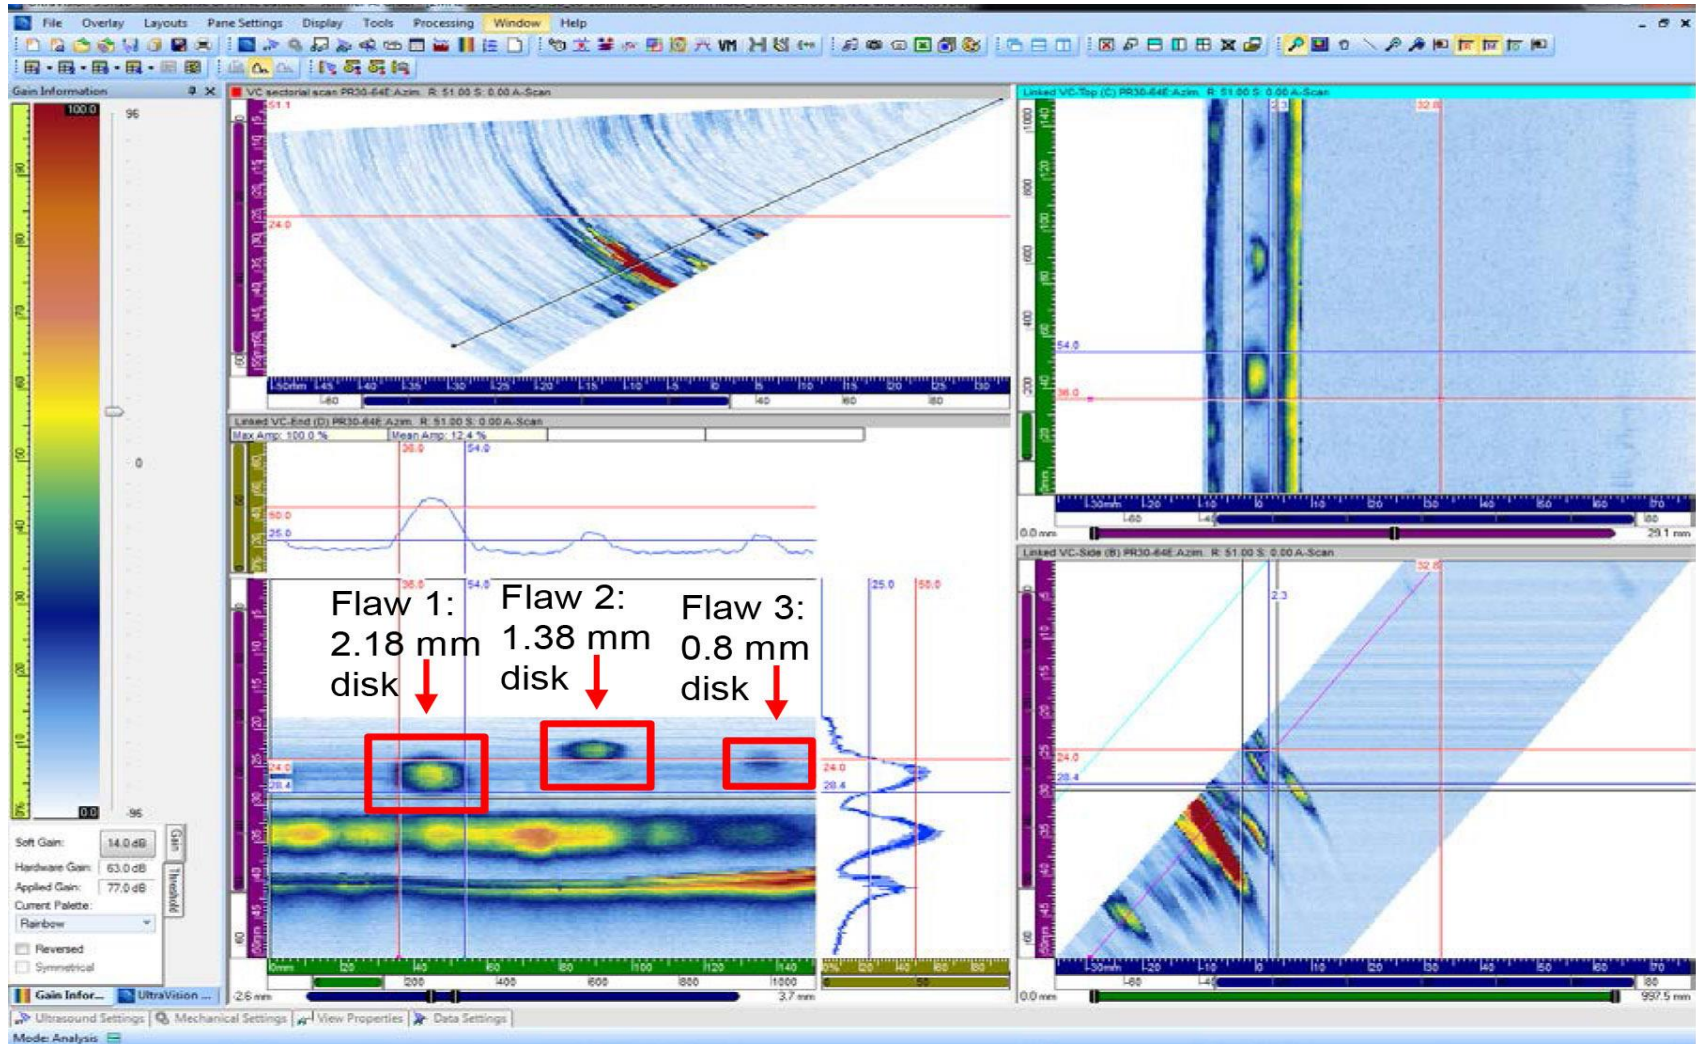
PA-UT/TRL Data Example: 64E Aperture

- ▶ Flaws 1, 2, and 3 in RJ4/RJ6-2 with 64E Aperture from Skew 180

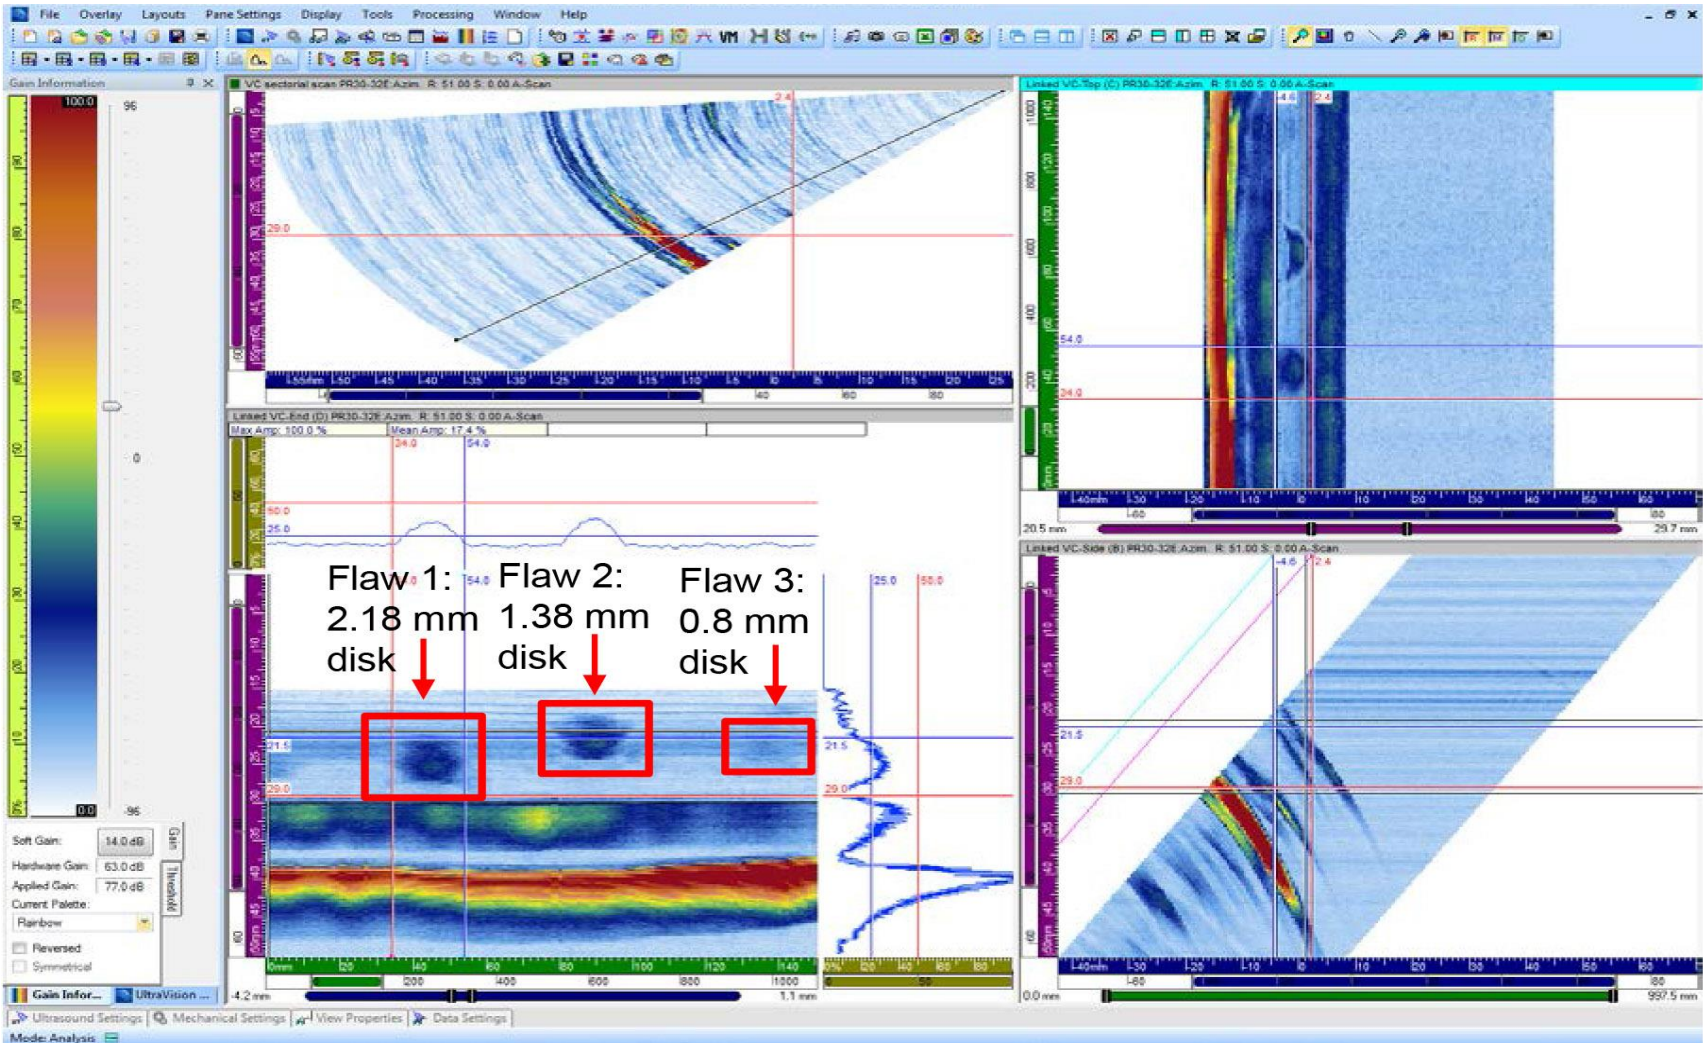
PA-UT/TRL Data Example: 32E Aperture

- ▶ Flaws 1, 2, and 3 in RJ4/RJ6-2 with 32E Aperture from Skew 180

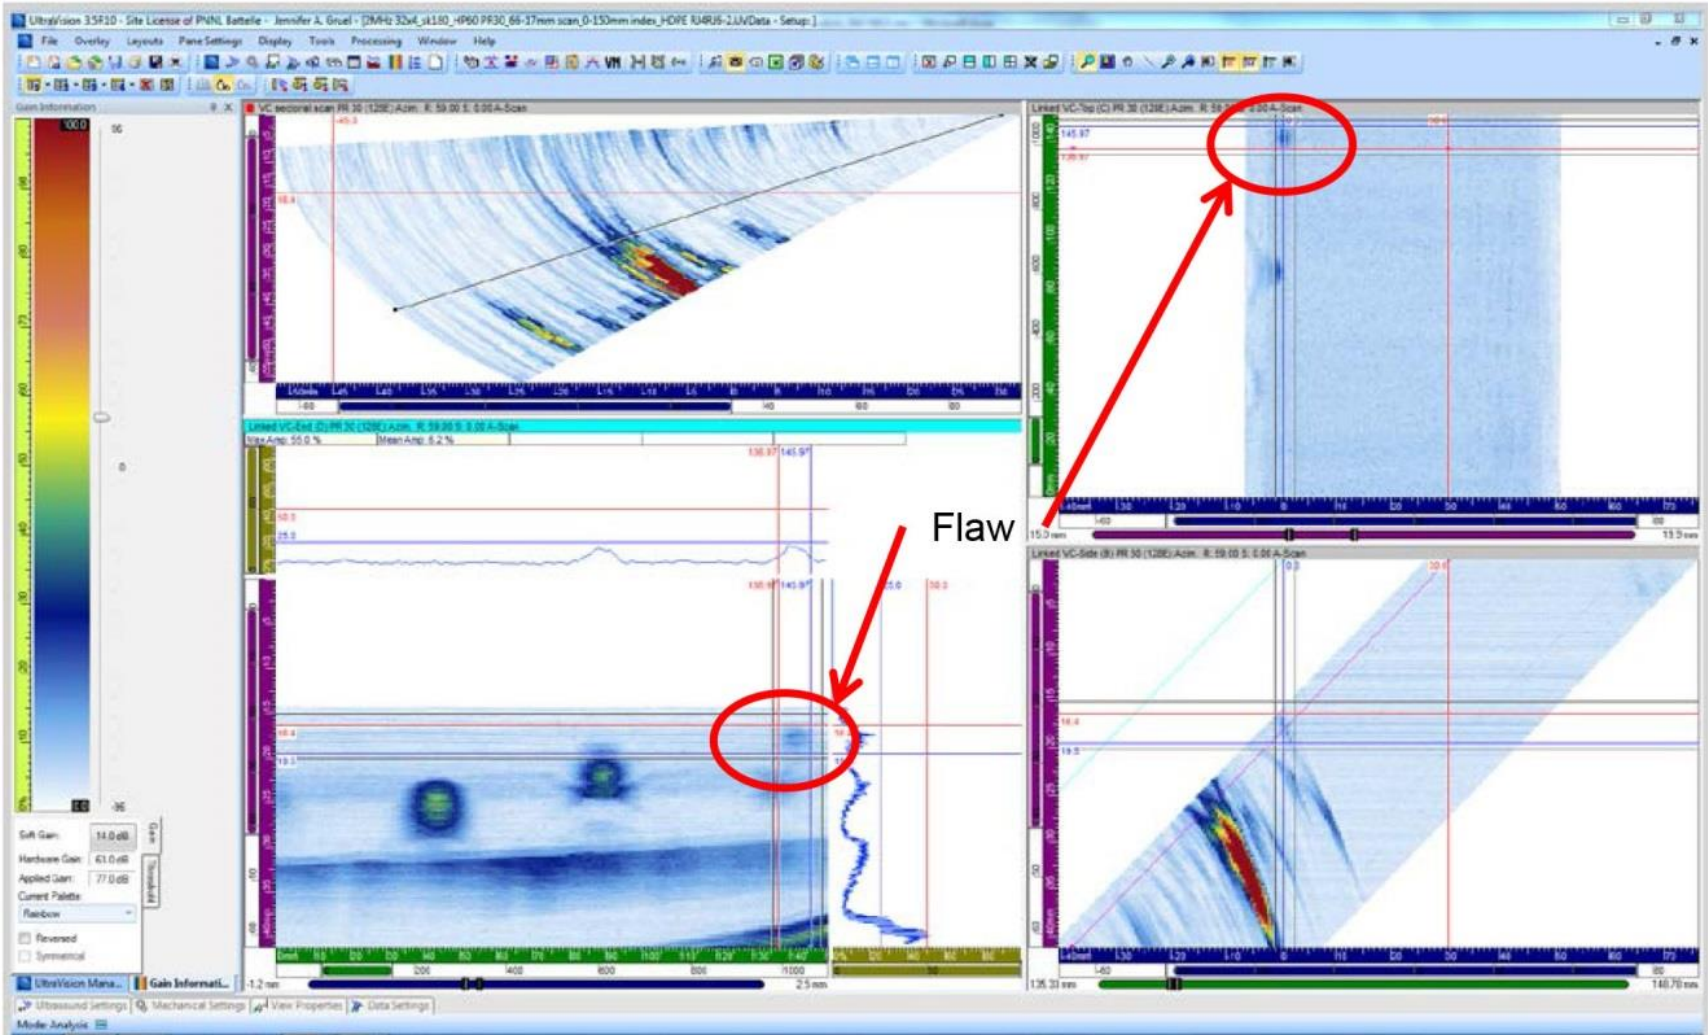
Other Fusion Joint Indications

- ▶ Not implanted, meets flaw/indication reporting criteria
- ▶ RJ4/RJ6-2, “Flaw 6” 137–146 mm, 128E Aperture, Skew 180

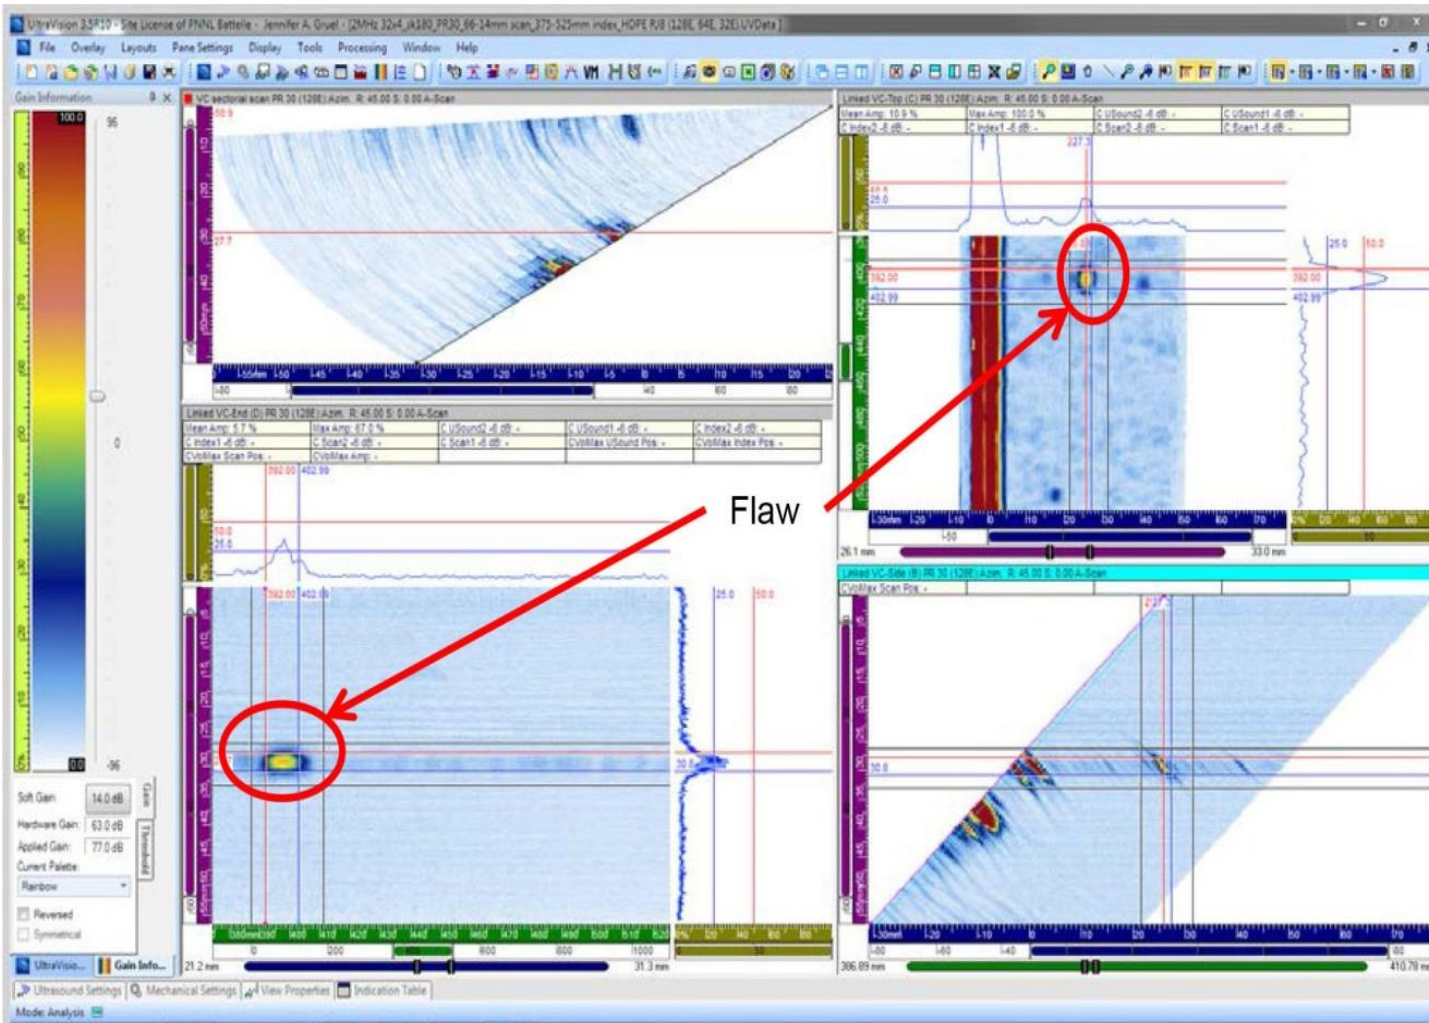
Parent Material Indications

- ▶ Adjacent to fusion joint
- ▶ Example: RJ-8, 128E, skew 180 (“Flaw” PM12, 392–403 mm)

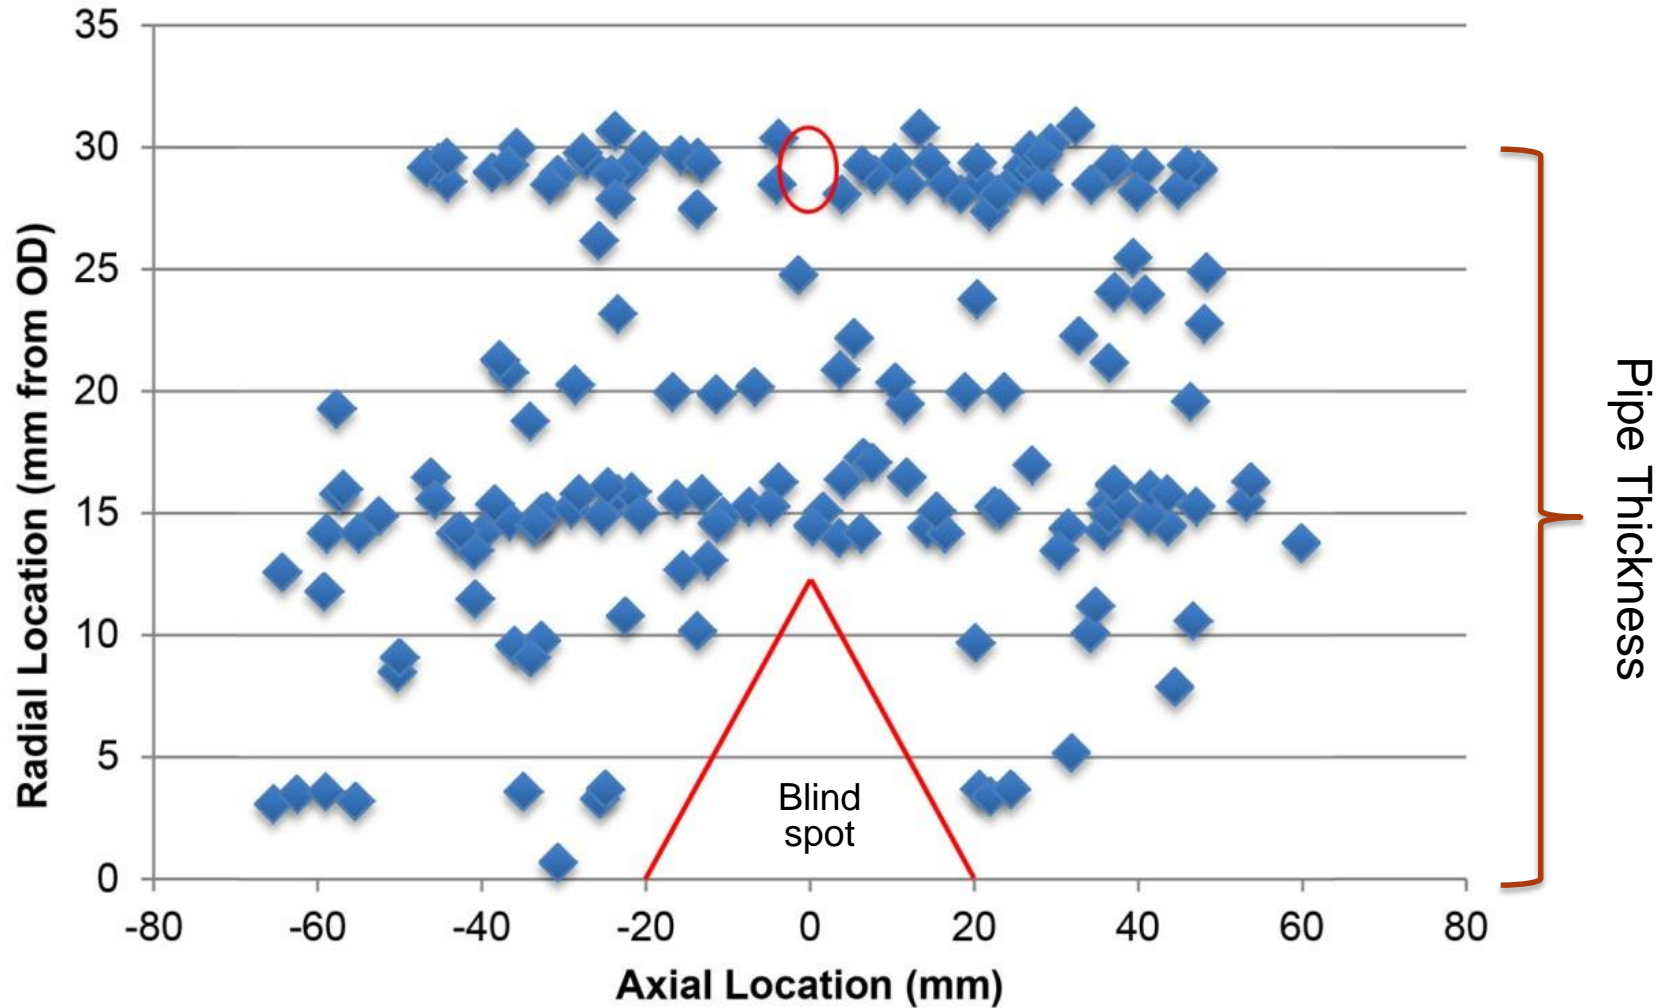
Parent Material Indications

- Distribution from OD to ID (128E aperture)

- ▶ PA-UT/TRL detected more fusion joint “flaws” than were implanted
 - Forensic testing necessary to characterize these indications
- ▶ Parent material indications were persistent in PA-UT/TRL data sets
 - These potentially represent another flaw source beyond those associated with fabrication
 - Examples of larger indications were provided here
 - High spatial density
 - High probability of parent material “flaws” entering the fusion joint
 - Non-metallic indications in the fusion joints may be the result of parent material “flaws” that entered the fusion joint during fabrication
