Jocassee and Keowee Dams, Breach Parameter Review

Breach Parameter Review

February 2013

Jocassee Dam – Breach Parameter Independent Review

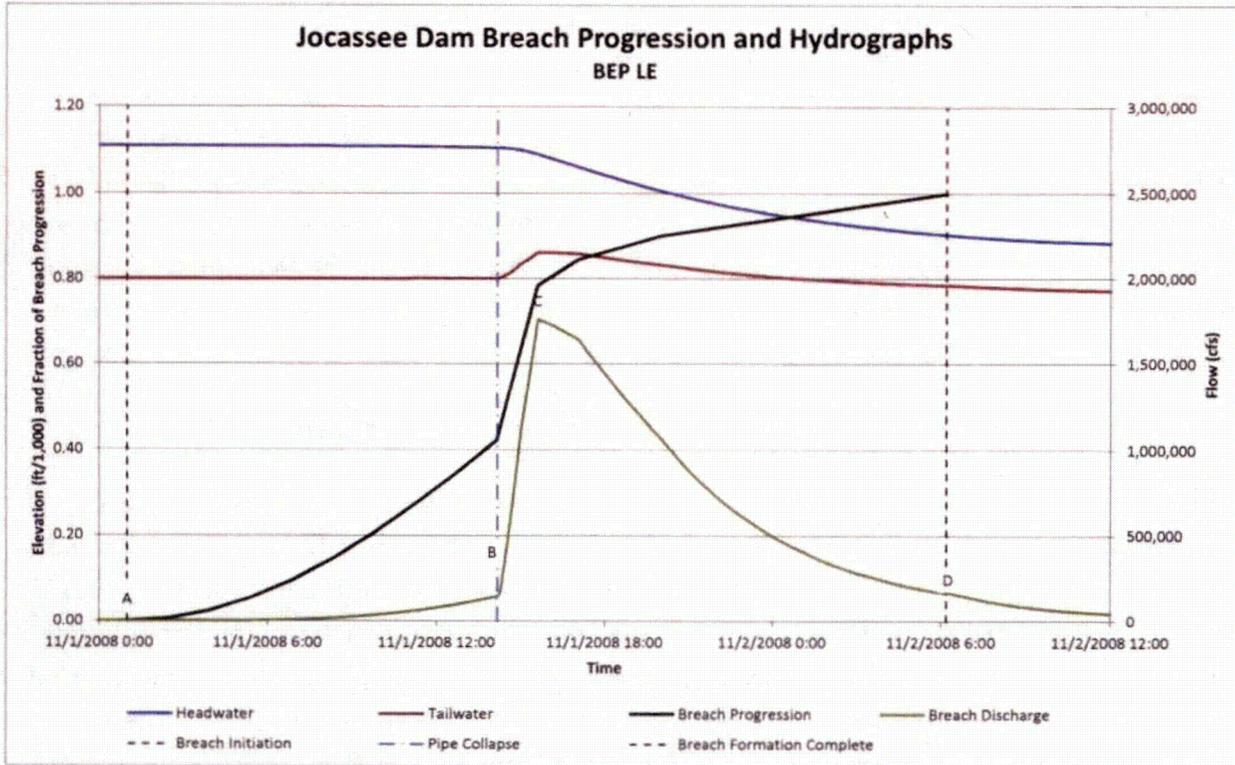
The importance of consistency between the definition of the Xu and Zhang (2009) failure time when using failure time estimates in the HEC-RAS breach model is pointed out in Section 5.0. Figure 6 contains breach hydrographs for headwater (blue line related to left scale * 1,000), tailwater (brown line related the left scale * 1,000) and breach discharge (green line related to the right scale) obtained by HDR for a piping failure of Jocassee Dam at a location immediately downstream of the internal boundary in HEC-RAS model that represents the dam. The rate of breach progression that is defined as a HEC-RAS input is shown by the black line (related to the left scale). Points A, B and D are equivalent to points that are defined in Figure 3 for the Teton Dam failure in Section 5.0.

To achieve a compatible implementation of the Xu and Zhang breach parameter estimates in HEC-RAS the Xu and Zhang mean breach failure time (between points A and D) and mean breach geometry estimates were input to the HEC-RAS model. The Xu and Zhang mean peak breach flow rate estimate was then closely matched by adjusting the piping coefficient to a value of 0.1, the breach weir coefficient to a value of 2.0, and the sinusoidal rate of breach progression relationship was adjusted between points B and D as shown in Figure 6.

Figure 6. HDR's HEC-RAS Jocassee Dam breach hydrographs

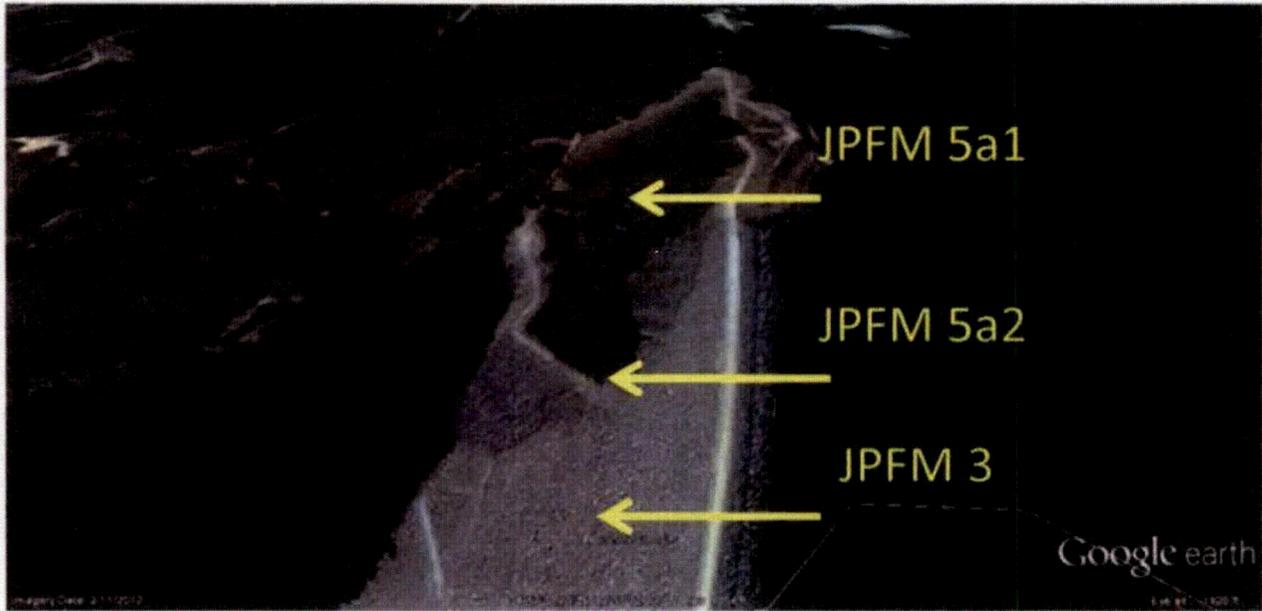
Figure A.3. Google view showing the locations of failure modes JPFM 5a1, 5a2 and 3 in the (b)(7)(F)

this (b)(7)(F) is shown on Figure A.3 and is labeled as "JPFM 5a2." The process of piping through the foundation for JPFM 5a1 and 5a2 is essentially the same. For both cases the flow is through joints and fractures in the bedrock, eroding infilled material, and does not emerge from the bedrock fractures until well downstream beyond the location of the cutoff trench and core projected into the (b)(7)(F). The primary difference between JPFM 5a1 and 5a2 is that for JPFM 5a2 the seepage exits from the foundation into the downstream rock shell of the dam causing unraveling¹ of the shell, and for JPFM 5a1 the seepage exits from the foundation into the downstream natural slope causing sloughing and slope instability.

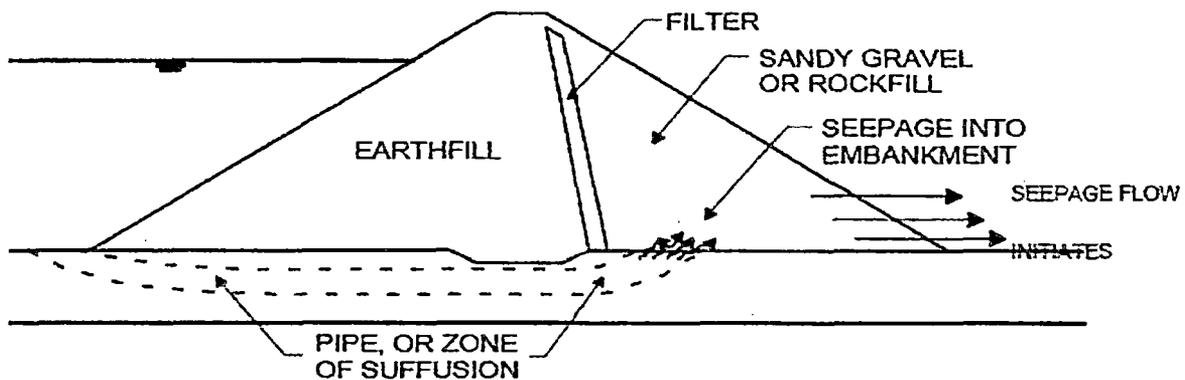
Breach by unraveling or sloughing of the downstream slope (Reclamation-USACE-URS-UNSW 2008).

8. The upstream filter material fails to fill the pipe (crack) and to plug the exit into the downstream shell.
9. The seepage may or may not be detected but intervention is not successful.
10. A breach develops by sloughing and unraveling or by sinkhole development.

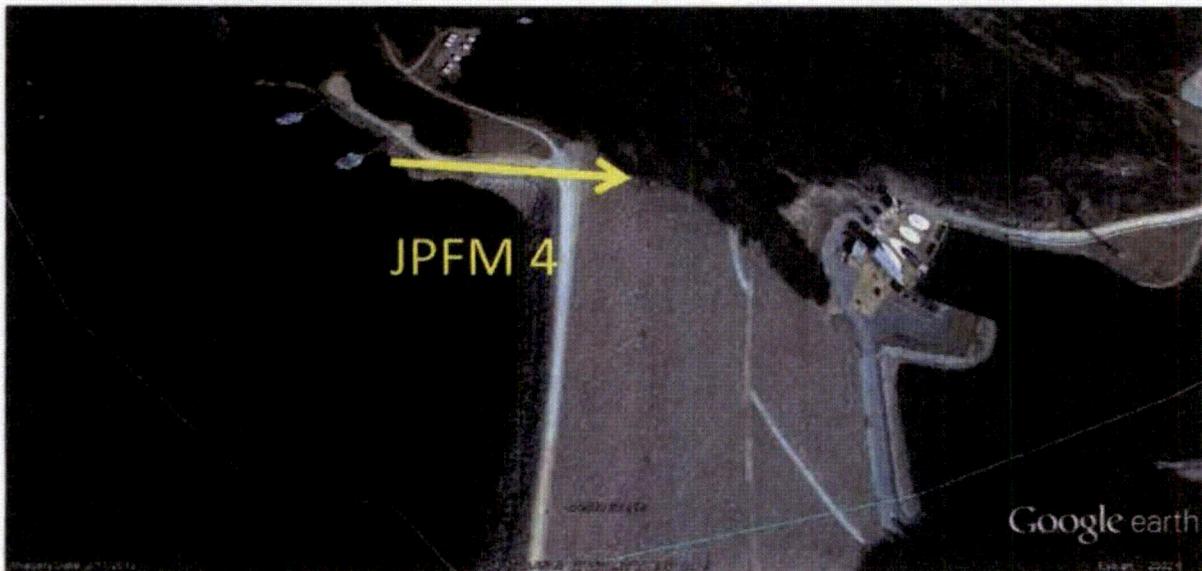
Figure A.4. Location of foundation piping failure mode JPFM 4 in the (b)(7)(F)
