**From:** Bower, Fred  
**Sent:** Friday, April 29, 2016 1:18 PM  
**To:** Finney, Patrick; Ziedonis, Adam  
**Subject:** FW: Neil's blog post on the subject is on the NRC website

## **An Outage Twist: Degraded bolts at New York Nuclear Plant Warrant Attention**

# Baffle-Former Assembly Bolts

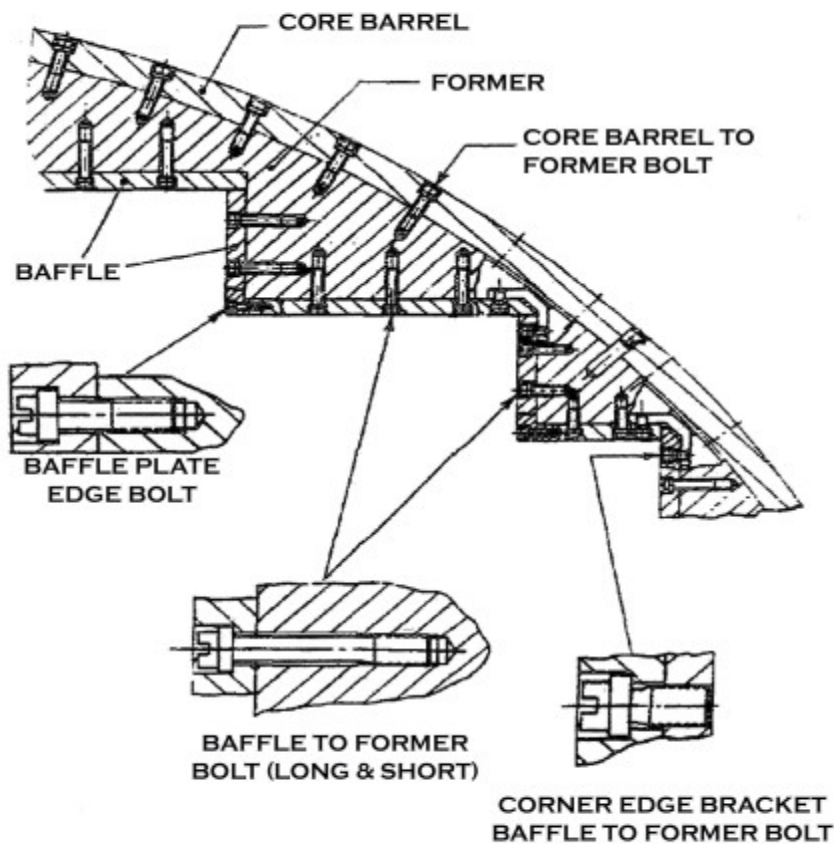
Measuring about 2 inches in length and 5/8ths of an inch in diameter, the bolts hold in place a series of vertical metal plates. Known as baffle plates, they help direct water up through the nuclear fuel assemblies, where it is heated and subsequently used for power production.

The baffle plates are attached to eight levels of horizontal plates called baffle-former plates, which are in turn connected to the reactor core barrel.

As far back as the late 1980s, cracking was identified in baffle-former bolts – the bolts securing the baffle plates to the baffle-former plates — in pressurized-water reactors (PWRs) in France. (Both Indian Point Units 2 and 3 are PWRs.) The degradation is caused by what is known as irradiation-assisted stress corrosion cracking.

former bolt cracking reported in foreign PWRs had occurred at the juncture of the bolt head and the shank, a location not accessible for visual examination.

This is exactly what was being done at Indian Point Unit 2 during the current outage. It was adhering to the standards of MRP-227-A. In the course of this review, it was determined that 227 of 832 baffle-former bolts at the plant were degraded, which means any indication of cracking. What's more, two bolt heads were missing.

The number of degraded baffle-former bolts was the largest seen to date at a U.S. reactor.

Entergy, Indian Point's owner, is in the process of analyzing the condition and replacing the degraded bolts. It will also assess any implications for Indian Point Unit 3, though that reactor is believed to be less susceptible to the condition for several reasons, including fewer operational cycles.
