Docket Nos.: 50-269, 50-270, 50-287 License Nos.: DPR-38, DPR-47, DPR-55 EA 94-125

#### SUBJECT: ENFORCEMENT CONFERENCE SUMMARY AND NOTICE OF VIOLATION (NRC INSPECTION REPORT NOS. 50-269/94-21, 50-270/94-21, AND 50-287/94-21)

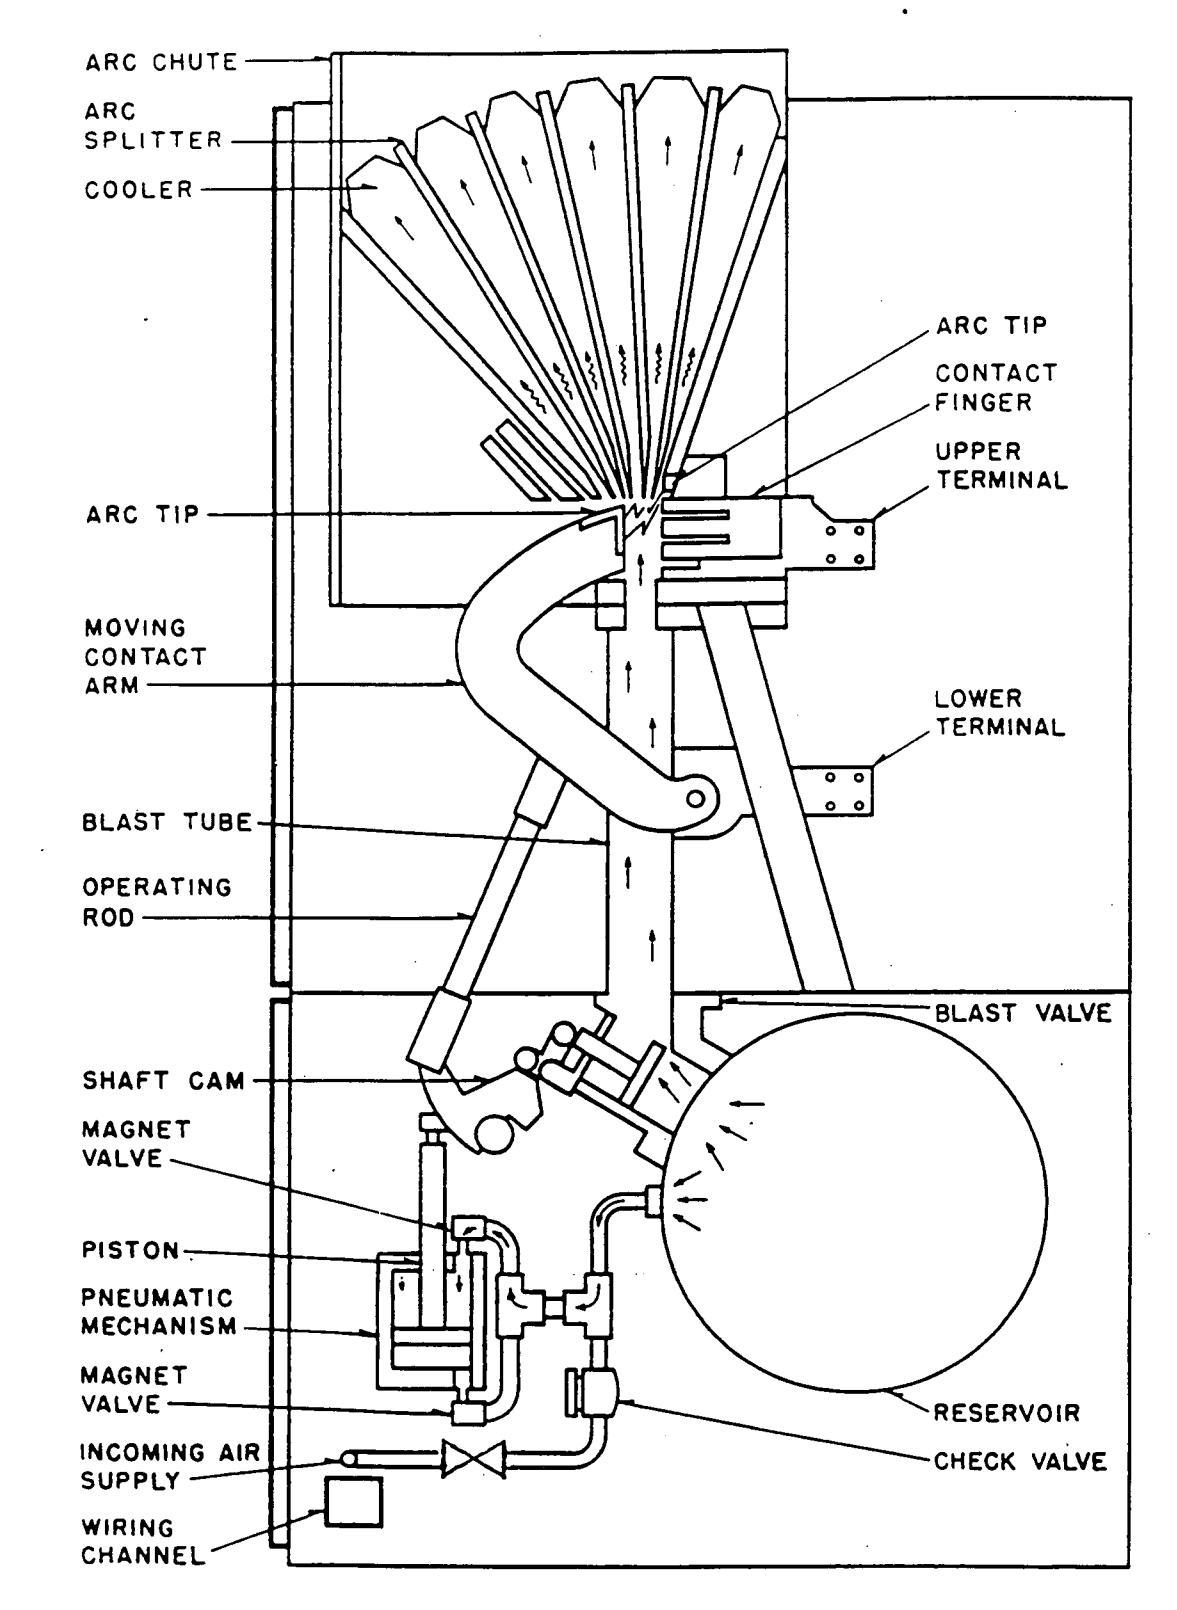
Breaker Side View Showing Compressed Air Flow Photo 326022
