Subject: Inspection Report NO. 50-443/87-07

- Report No. 50-443/87-07
- Docket No. 50-443

Facility Name: Seabrook Unit No.1

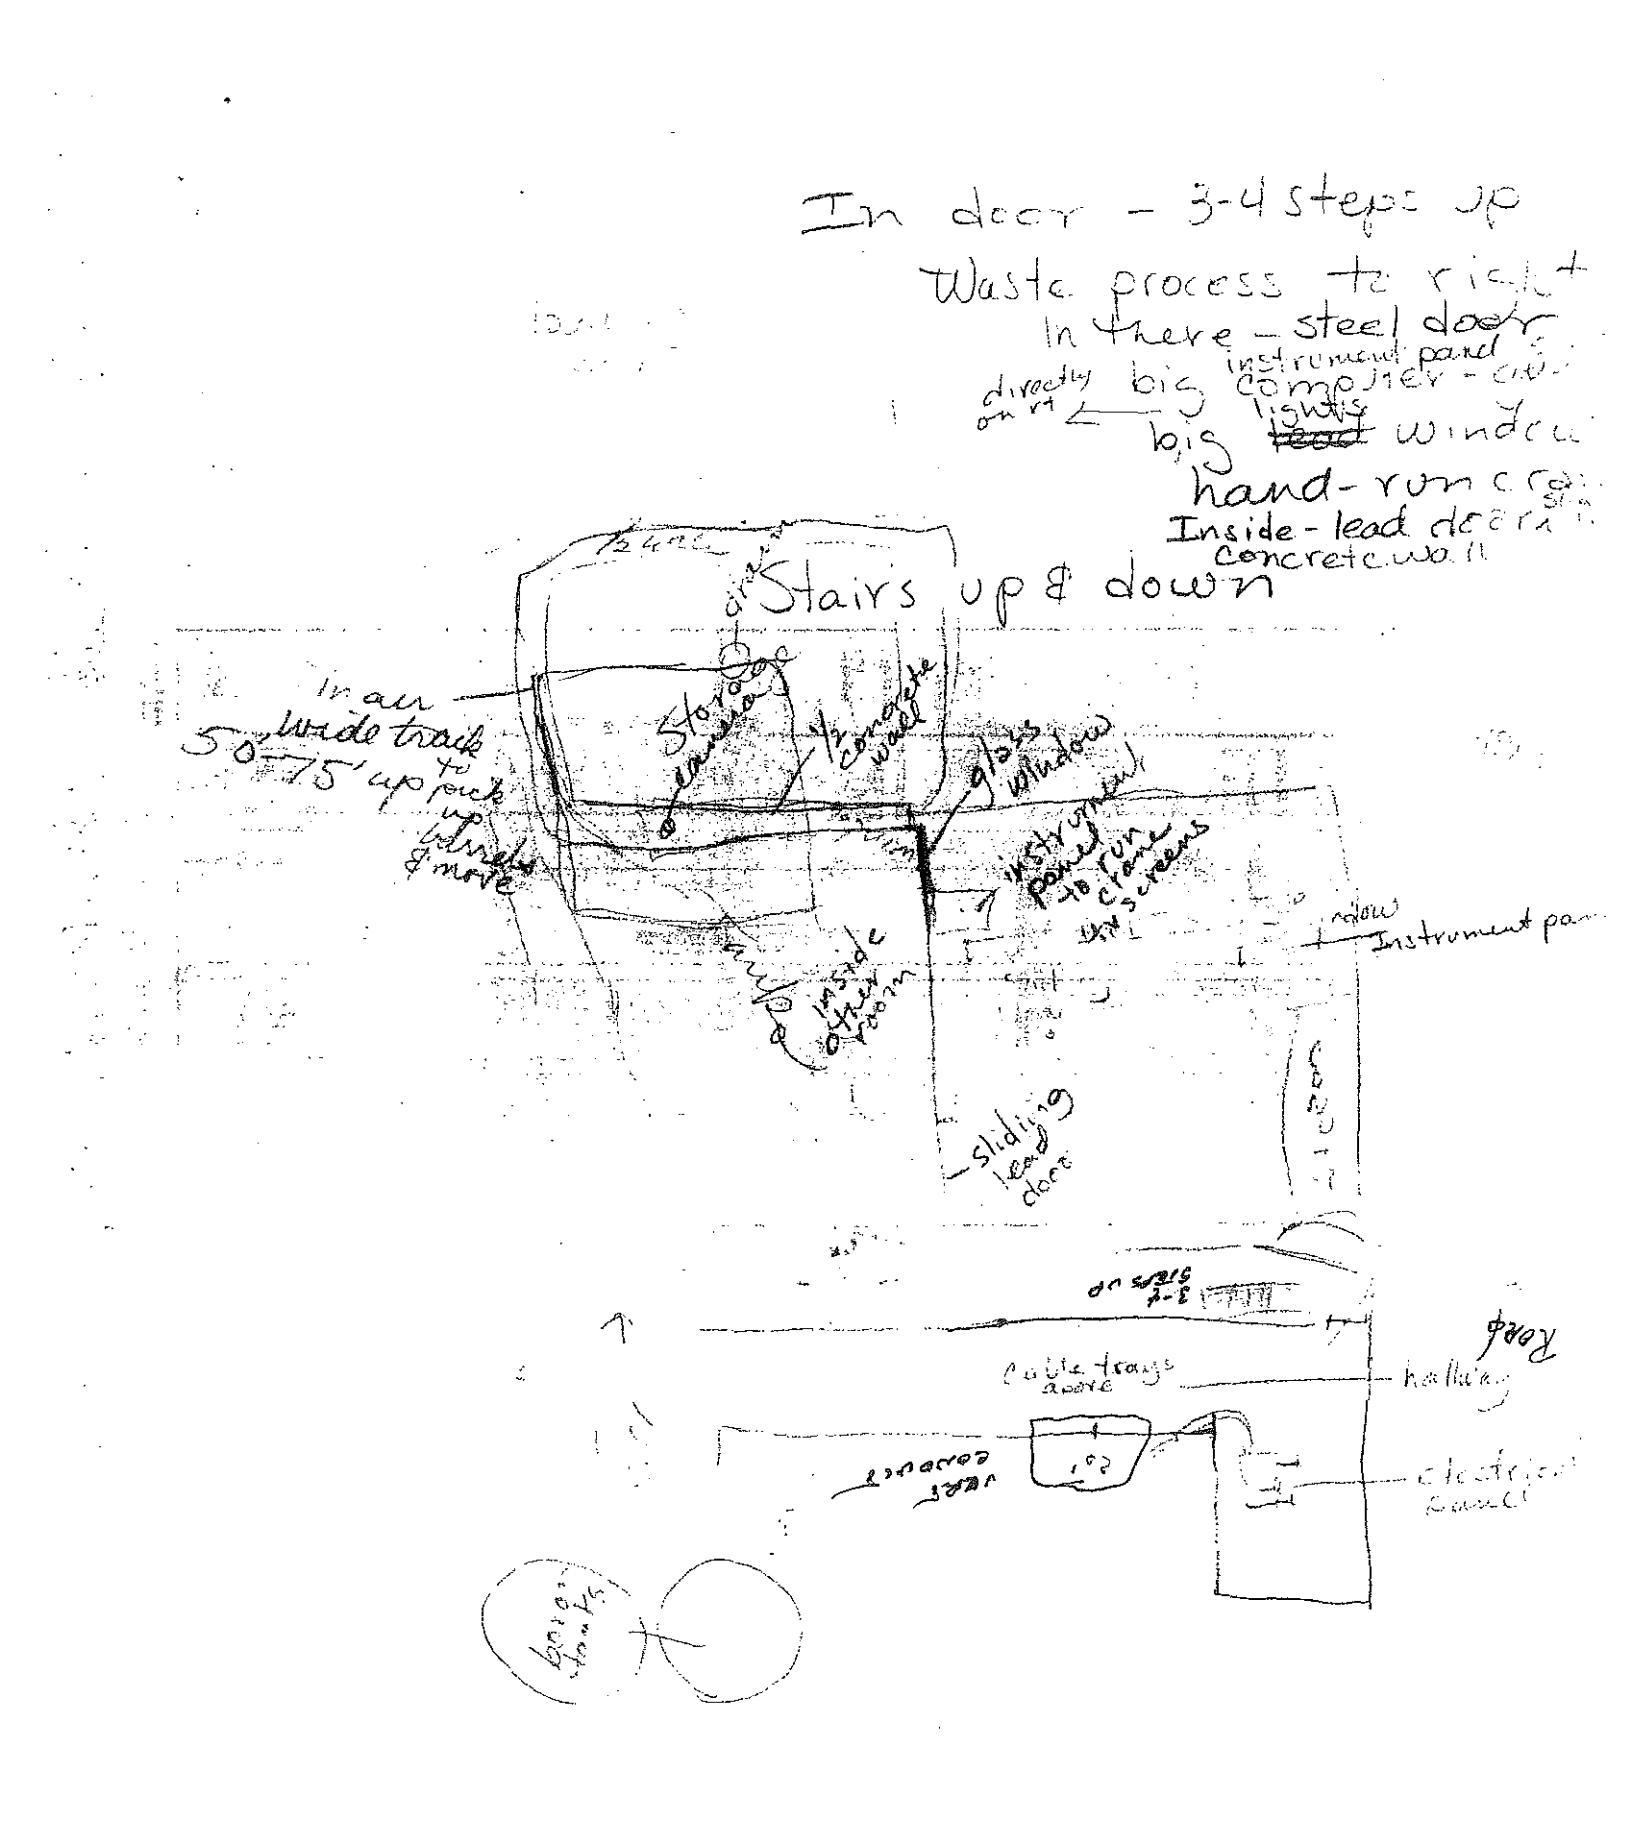
ALLEGERS' DRAWING DRAWING NO. 1

Subsequent to the April 20, 1987 meeting with the ELP, a second hand-drawn sketch of the location of the alleged conduit fire was provided by the alleger through the ELP (See Drawing No. 1). This sketch provided enough detail for the NRC to determine that the location was in the Waste Processing Building, elevation 25 ft., in a corridor running adjacent and parallel to column line 2 (See Drawing No. 2).

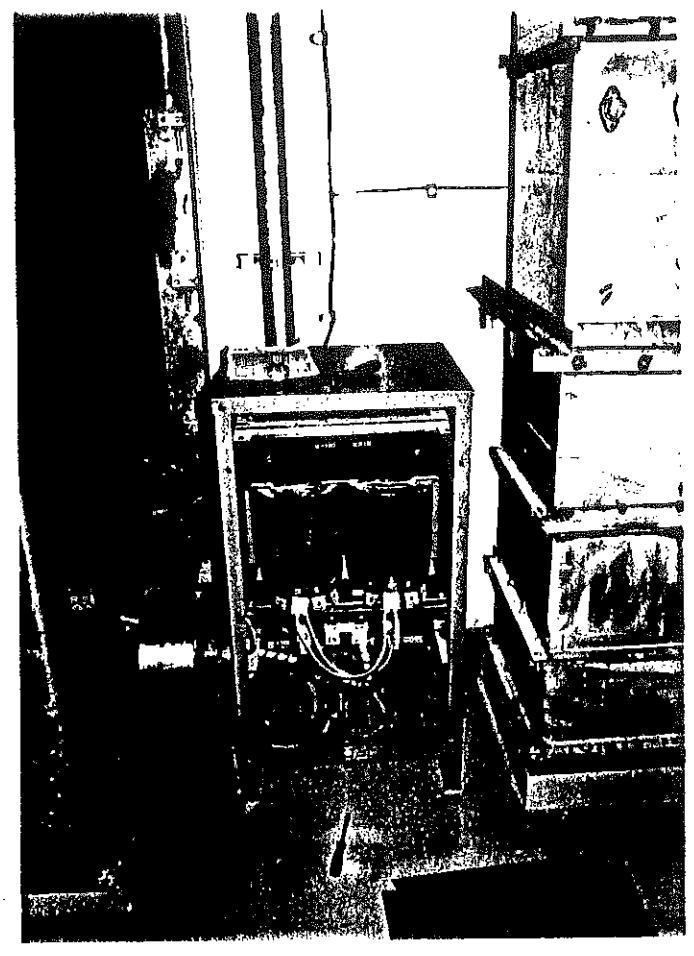
PHOTO NO. 4 LIGHTING TRANSFORMER 1-ED-X-11C

The licensee was requested to perform insulation resistance measurements on the transformer and lighting panel cables located in the two conduits. The test was performed on May 5, 1987 and witnessed by the NRC. The test results indicated that the insulation resistance exceeded the minimum values and was acceptable. Further, the NRC inspector requested that the conduit covers be removed for visual inspection to determine if there was any evidence of a fire. The visual inspection revealed that the conduits were clean and no combustion products were evident.

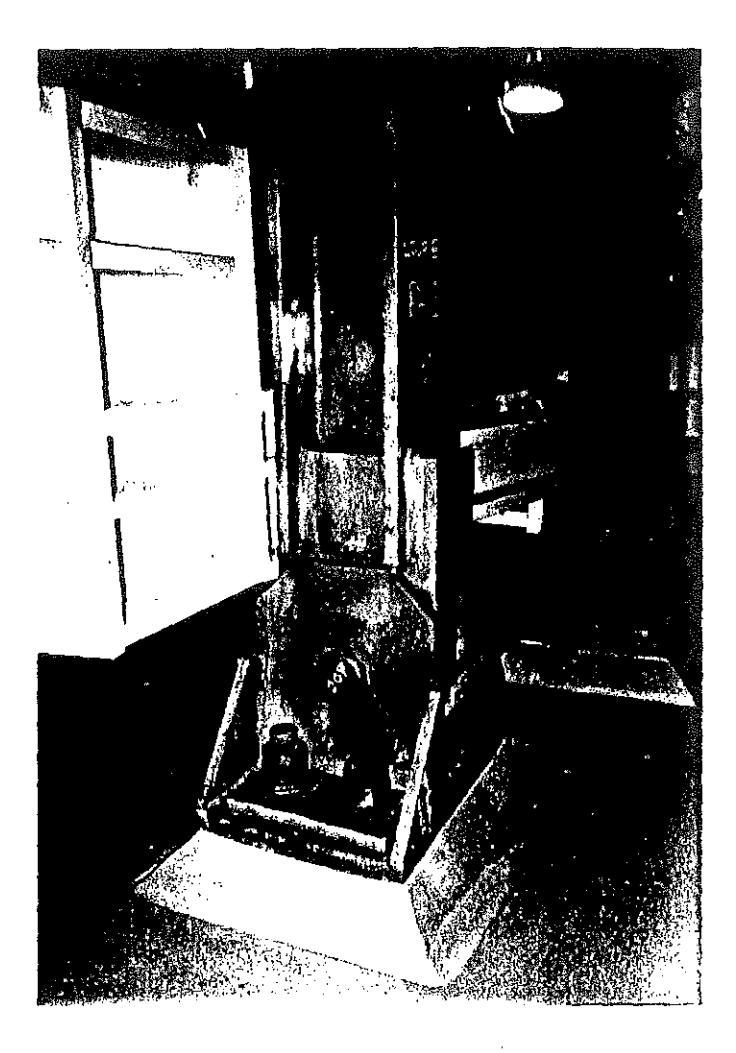
PHOTO NOS. 10 AND 11 REACTOR COOLANT PUMP SUPPORTS

The NRC staff reviewed revisions A, B & C of the Engineering Change Authorization (ECA) No. 1557 which addressed the above modification. Other documents reviewed by the NRC staff included:

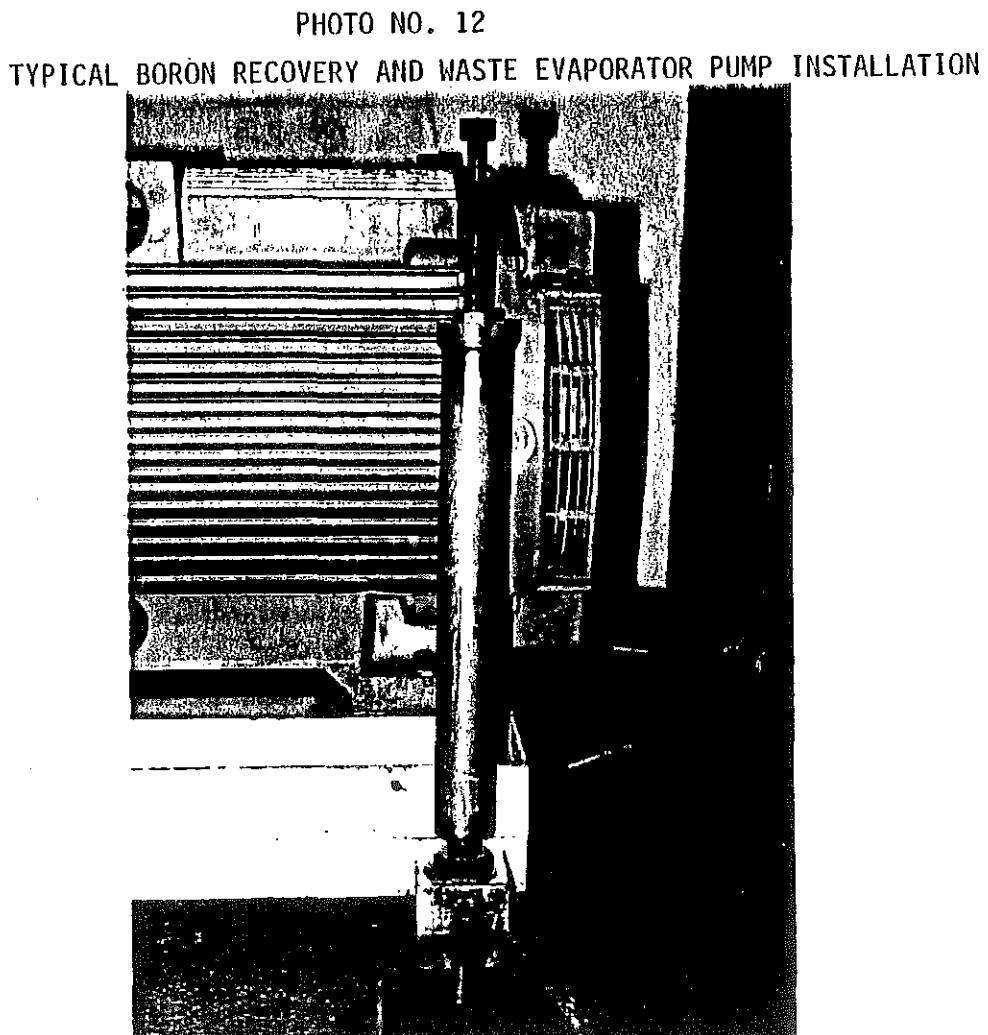
PHOTO NO. 13

A tour of the waste process building disclosed that the pumps being described by the alleger are located at elevation - 3 and are the recovery evaporator reboiler pumps, BRS-P-87A and BRS-P-87B, and the waste evaporator reboiler pump, WL-P-93 (See photos No. 12 & 13 and Drawing No. 7). These pumps have 30" diameter suction piping and 24" diameter discharge piping and the pump baseplates are mounted on spring loaded supports to compensate for expansion. These pumps service the boron recovery and the liquid waste system, respectively, and are not safety related. The boron recovery system processes reactor coolant and primary drain water for possible reuse as primary grade water and boric acid, or for offsite disposal. The liquid waste system is non-nuclear safety class and designed to provide a central collection point for radioactive liquid waste.

The aforementioned pumps did recently experience a failure of the spring support system and a Request for Engineering Services, dated 12/23/86, and a Design Coordination Report, dated 1/3/87, were initiated. The failures were two adjacent spring mount isolators on pump BRS-P-87A base plate which broke at the relieved area above the threads. The licensee is currently processing a design change to strengthen this area on the supports. At the time of this inspection, the design change had not been completed.
