UNITED STATES NUCLEAR REGULATORY COMMISSION

SUBJECT: THREE MILE ISLAND, UNIT 2, INDEPENDENT SPENT FUEL STORAGE INSTALLATION INSPECTION REPORT 072-00020/2016-001

United States Department of Energy NRC Inspection Report 072-00020/2016-001

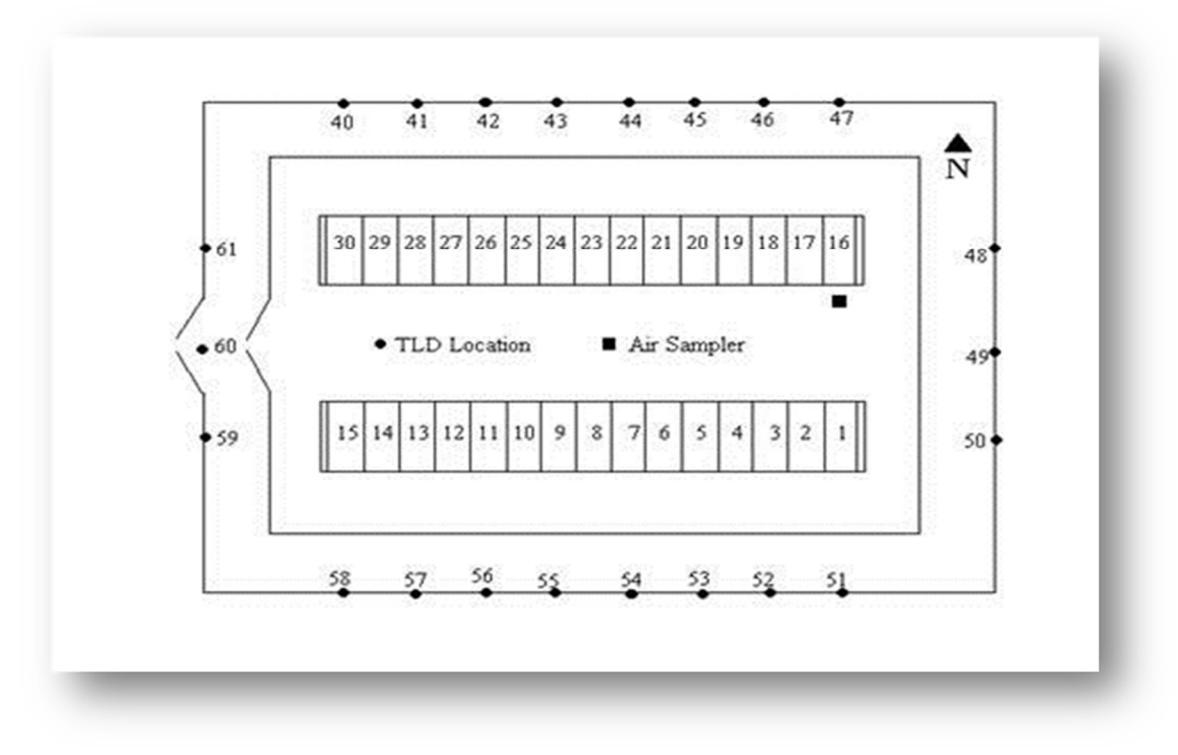
Figure 1, TMI-2 ISFSI

An inspection of the physical condition and radiological characteristics of the TMI-2 ISFSI was performed during this NRC inspection. The DOE ISFSI Facility Director, Contractor ISFSI Manager, NRC License Manager, and others accompanied the NRC inspector during the inspection of the ISFSI site. Thirty HSMs were situated on the TMI-2 ISFSI pad, with all but one containing spent fuel from the damaged TMI-2 reactor. The additional HSM situated on the pad was to serve as a backup storage location if problems arose with existing HSMs or DSCs. The 30 storage casks were arranged in two east-west rows of 15 with the door openings facing inward. The HSM casks 1–15 were situated in the southern row and casks 16–30 on the northern row (see Figure 1, above).

The inspection of the physical condition of the ISFSI found the concrete to be in good condition. The NRC inspector did not observe any vegetative growth in or around the concrete pad or any flammable or combustible materials stored on the ISFSI pad. A low volume air sampler was situated on the ISFSI pad in close proximity to HSM #16. The purpose of the air sampler is to determine radiological effluent releases from the TMI-2 ISFSI.

The physical condition of the concrete HSMs was observed to be very good. Signs of past concrete repairs were evident on many of the storage modules; however, all concrete repairs to the ISFSI were intact and appeared to be free from further degradation. All hardware, doors, latches, and ports installed in the TMI-2 HSMs inspected were in good condition. The NRC inspector utilized a Ludium Model 19 sodium-iodide gamma survey meter (NRC #033906, calibration due 3/8/2017) to measure gamma exposure rates in microRoentgens per hour ($\mu R^{1}/h$). Radiological conditions were observed and recorded by the NRC inspector on approach to the TMI-2 ISFSI, at the outer boundary locations of the pad, and at the HSM front and rear door locations. Ambient radiation levels at the INL site were elevated due to the influence of radioactive materials stored onsite that were unrelated to materials stored in the TMI-2 ISFSI. Ambient levels were approximately 150 µR/h on approach to the ISFSI pad front gate. Measurements taken by the NRC inspector at various locations around the pad ranged from 70 – 190 µR/h. Contact measurements were taken at various HSM front door locations and ranged from 190 – 1100 µR/h (1.1 milliRoentgens/h). The HSM rear door panel contact measurements ranged for the HSMs from 40 – 500 µR/h. All measurements were determined by the NRC inspector to be well below Technical Specification 3.2.1 and 3.2.2 dose rate limit requirements of no more than 100 millirem/hour for the front and rear access doors.
