SUBJECT: Provides description & analysis of revised alignment of Keowee auxiliary power sys.

Subject: Oconee Nuclear Station
Docket Nos. 50-269, -270, -287
Alignment of Keowee Auxiliary Power

DESCRIPTION AND ANALYSIS OF THE REVISED ALIGNMENT OF THE KEOWEE AUXILIARY POWER SYSTEM

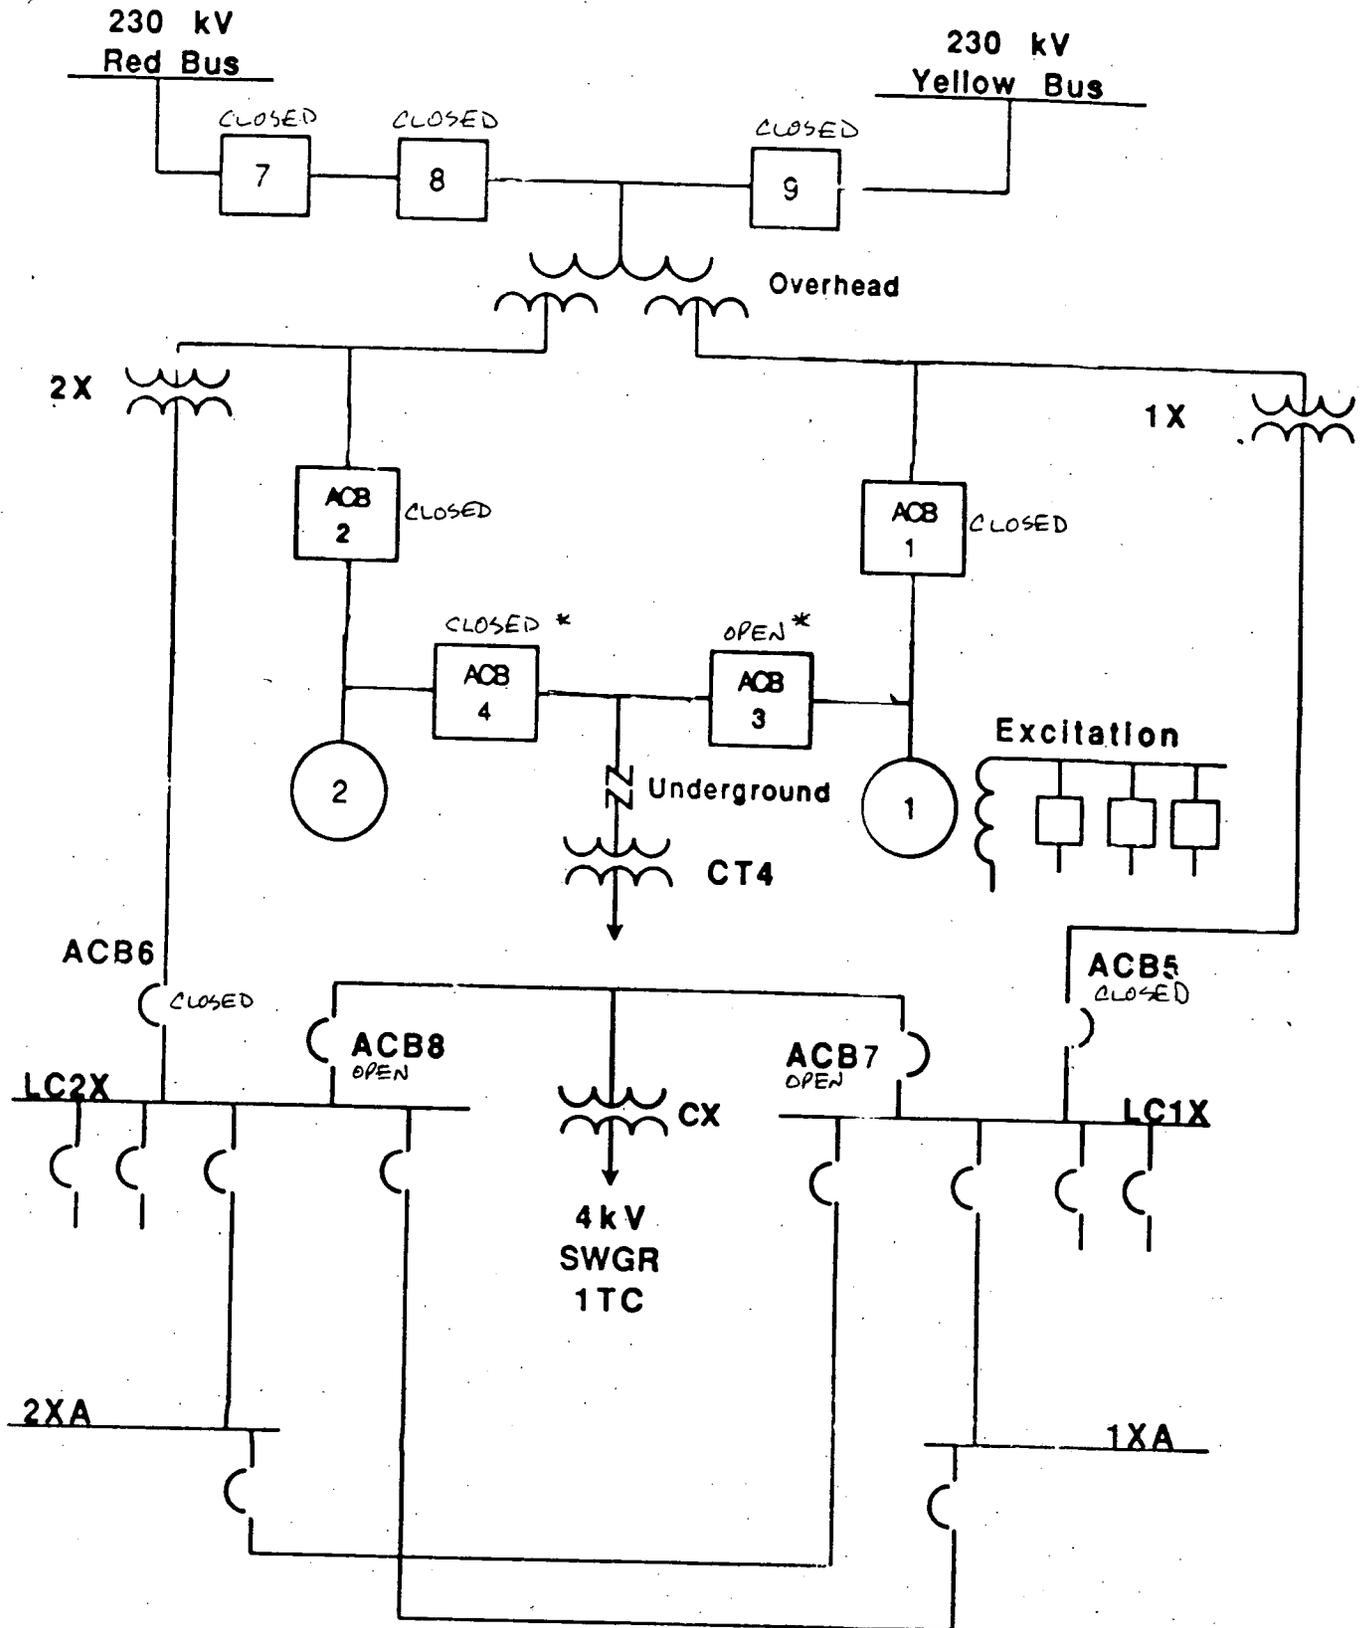
FIGURE 1 : NORMAL ALIGNMENT
 BOTH KEOWEE UNITS GENERATING TO GRID

The normal Keowee configuration (Figure 1) consists of having both units available for generation to the system grid, using the overhead path (Air Circuit Breaker (ACB)-1 for Keowee Unit 1, and ACB-2 for Keowee Unit 2), with one Keowee Unit aligned to the underground emergency power path by having its underground breaker closed (ACB-3 for Keowee Unit 1 or ACB-4 for Keowee Unit 2). If a Keowee Unit is aligned to the underground emergency power path and is generating to the system grid, the emergency start signal will open the overhead ACB and supply power to the underground emergency power path. The 600V auxiliary load centers (1X and 2X) are normally powered from the overhead path (ACB-5 for Keowee Unit 1, and ACB-6 for Keowee Unit 2) through the respective 1X and 2X transformers, the Keowee Main step-up transformer and the 230kV switchyard. They also have a backup power path (ACB-7 for Keowee Unit 1, and ACB-8 for Keowee Unit 2) from the CX transformer which receives power from Oconee Unit 1 4kV switchgear 1TC. The isolation breakers for the 1X and 2X load control centers (ACBs 5 and 7 for Keowee Unit 1 and ACBs 6 and 8 for Keowee Unit 2) are designed to provide an automatic switch to backup power if normal power to the auxiliaries is lost.

In response to an emergency start signal, both Keowee Units are isolated from the switchyard, and then the Keowee Unit aligned to the underground will provide power to the underground power path. The Keowee Unit aligned to the overhead path will provide power to the overhead path as well as its auxiliaries via transformers 1X or 2X and the auxiliaries of the Keowee Unit aligned to the underground.

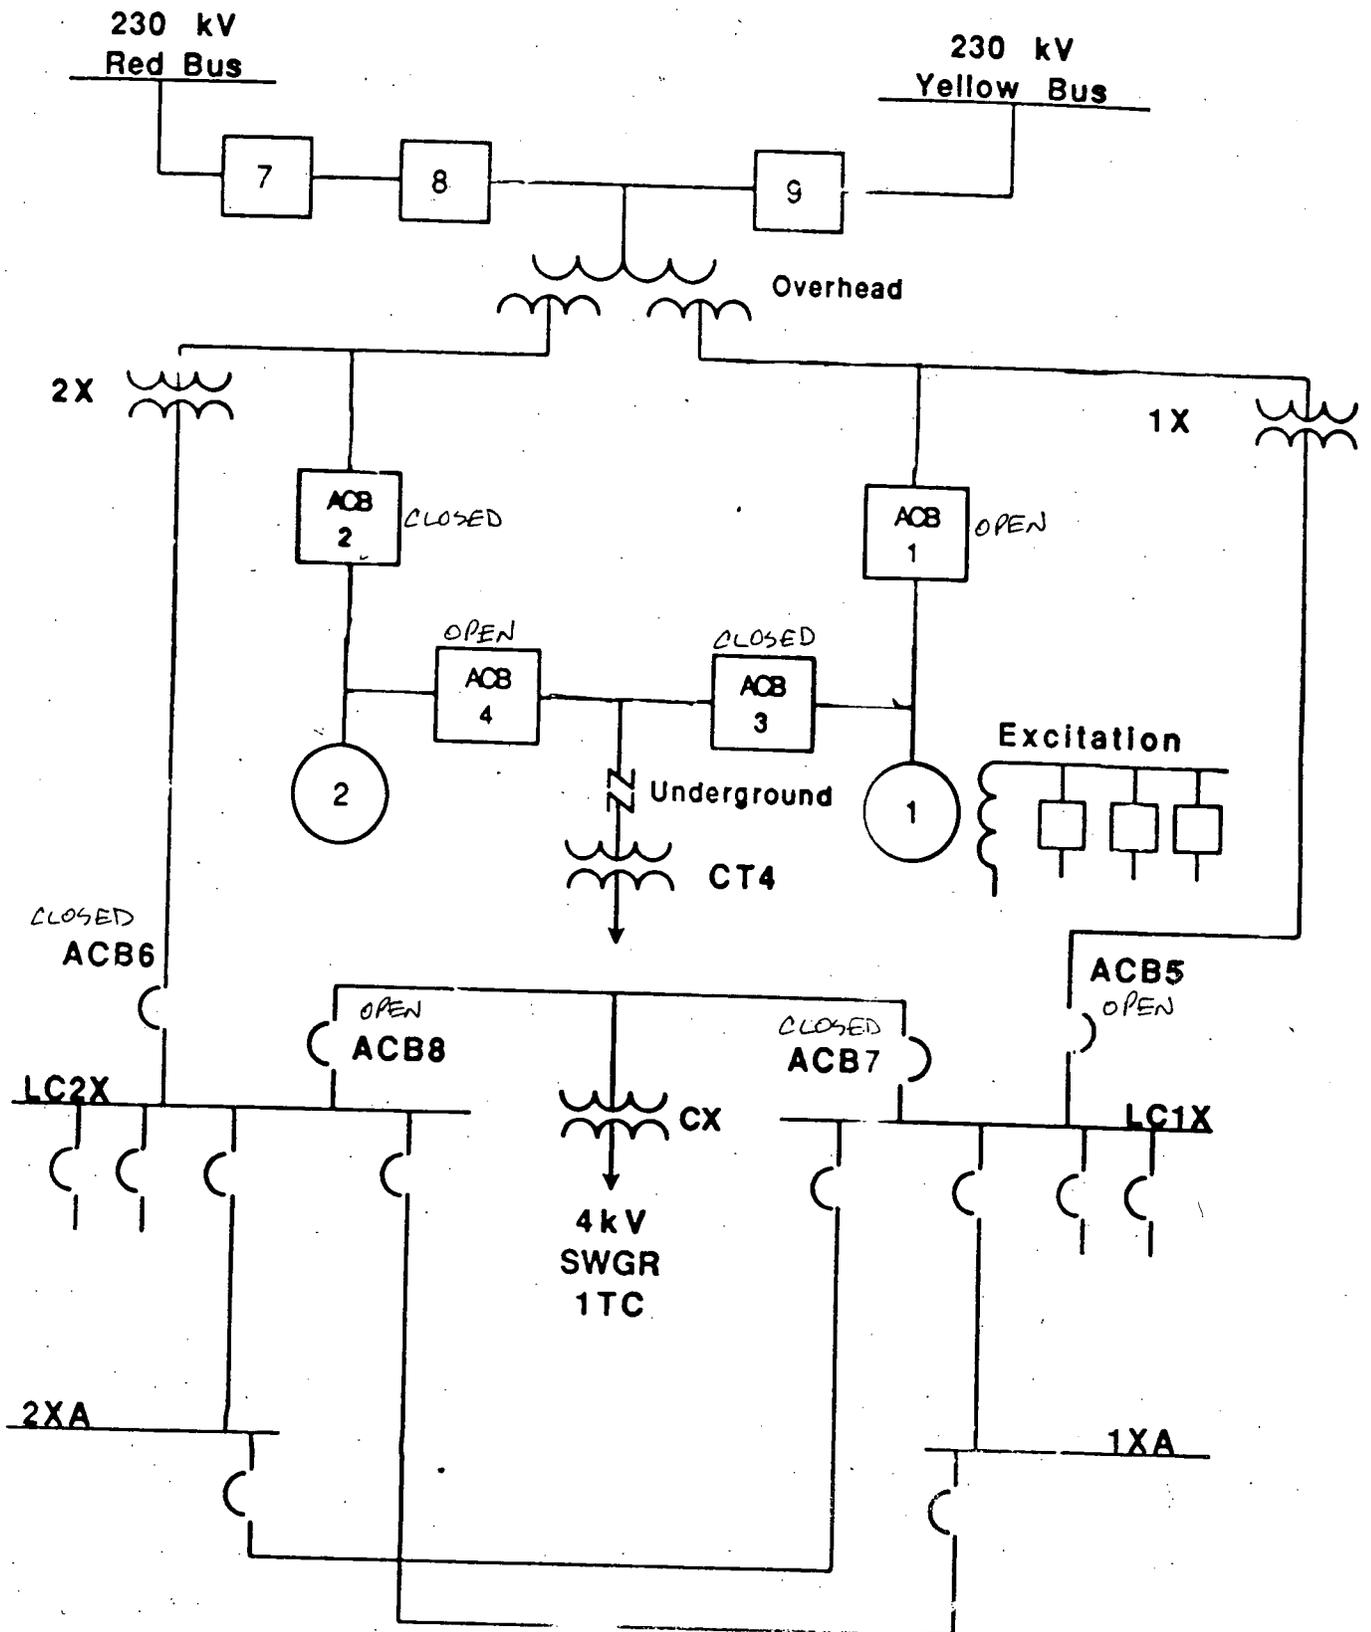
FIGURE 2: KEOWEE UNIT 1 TO UNDERGRAD
 KEOWEE UNIT 2 TO OVERHEAD
 TECH SPEC 3.7.2 (A)(4)

Technical Specification 3.7.2(a)(4) and 3.7.2(a)(5) include provisions for alignment in this type of configuration. Figure 2 illustrates the configuration permitted by TS 3.7.2(a)(4). Figure 3 illustrates the configuration permitted by TS 3.7.2(a)(5).

Keowee Unit 1 auxiliary power revised alignment, with Keowee Unit 1 aligned to the underground emergency power path (Figure 2).

ACB-7 is maintained closed (e.g., in manual) in order to supply power from the CX transformer, thus control components that could prevent ACB-7 closure would not be challenged. Assuming a lockout of the main step-up transformer occurred, ACB-5 is already maintained tripped and would be locked out. ACB-7 is unaffected by a main step-up transformer lockout. ACB-7 would remain closed providing a path from Oconee Unit 1 switchgear 1TC to feed the Keowee Unit 1 auxiliaries from Keowee auxiliary transformer CX, thus allowing Keowee Unit 1 to continue to provide power to Oconee through the underground emergency power path.

Keowee Unit 2 auxiliary power revised alignment, with Keowee Unit 2 aligned to the overhead emergency power path (Figure 2).

Assuming the abnormal conditions in the 230kV switchyard, ACB-6 would trip due to lockout of the Keowee main step-up transformer. Keowee Unit 2 would have emergency started (or continued to run if already running) until either the DC system degraded or until governor oil pressure was depleted. For this scenario, the main step-up transformer had locked out which rendered the overhead emergency power path inoperable. Therefore, loss of auxiliary power to Keowee Unit 1 has no further impact on the overhead emergency power path. Auxiliary power could be restored if the Keowee operator manually closed ACB-8. Lockout of the main step-up transformer would result in inoperability of the overhead emergency power path, however the overhead path would already be unavailable due to lockout of the yellow bus. Since the 230kV switchyard DC system is no longer in an alignment which could result in the abnormal conditions experienced on October 19, the lockout of the yellow bus and Keowee main step-up transformer at this time would be considered to be a single failure. Keowee Unit 1 supplying the underground would be unaffected by the lockout.

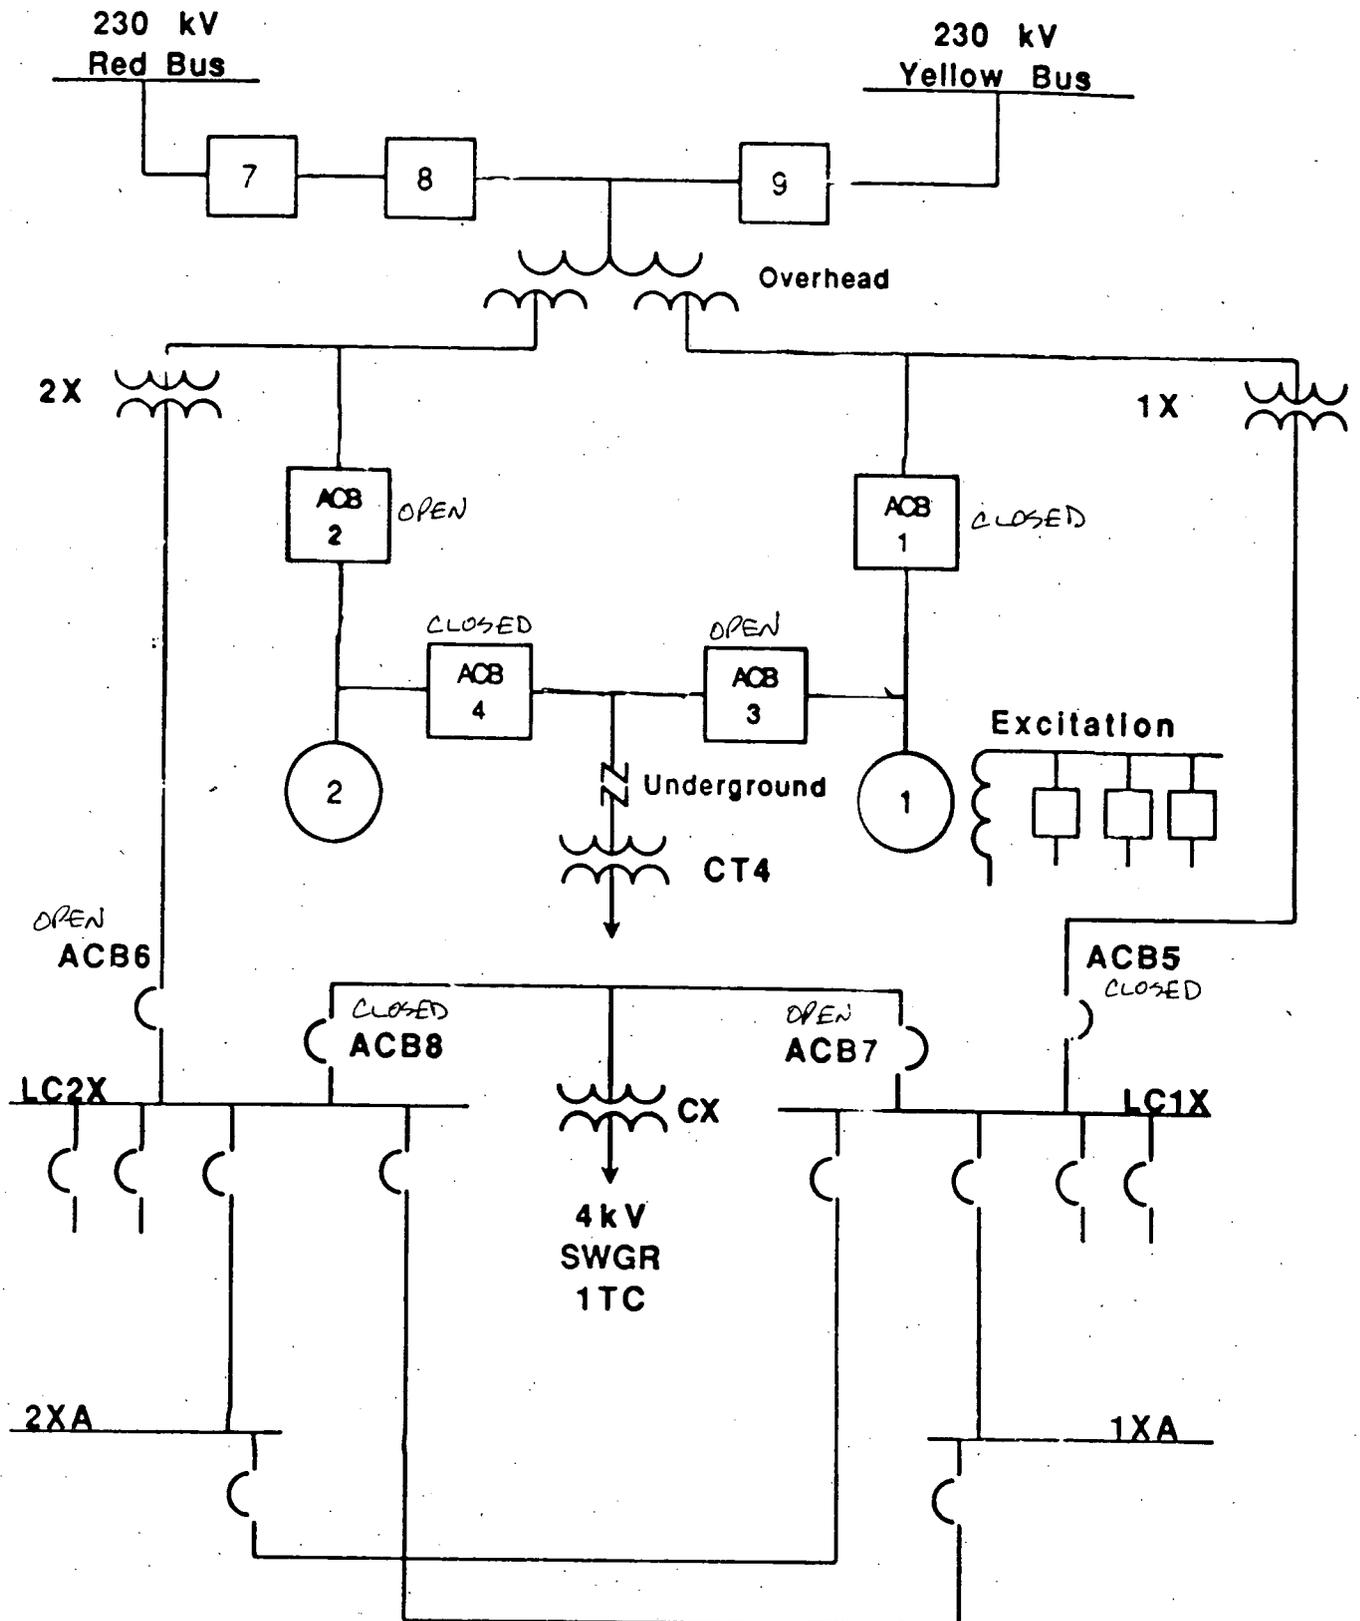
FIGURE 3: KEOWEE UNIT 1 TO OVERHEAD
 KEOWEE UNIT 2 TO UNDERGROUND
 TECH SPEC 3.7.2 (a)(5)

Keowee Unit 1 auxiliary power revised alignment, with Keowee Unit 1 aligned to the overhead emergency power path (Figure 3). Assuming the abnormal conditions in the 230kV switchyard, ACB-5 would trip due to lockout of the Keowee main step-up transformer. Keowee Unit 1 would have emergency started (or continued to run if already running) until either the DC system degraded or until governor oil pressure was depleted. For this scenario, the main step-up transformer had locked out which rendered the overhead emergency power path inoperable. Therefore, loss of auxiliary power to Keowee Unit 1 has no further impact on the overhead emergency power path. Auxiliary power could be restored if the Keowee operator manually closed ACB-7. Since the 230kV switchyard DC system is no longer in an alignment which could result in the abnormal conditions experienced on October 19, the lockout of the yellow bus and Keowee main step-up transformer at this time would be considered to be a single failure. Keowee Unit 2 supplying the underground would be unaffected by the lockout.

Keowee Unit 2 auxiliary power revised alignment, with Keowee Unit 2 aligned to the underground emergency power path (Figure 3). ACB-8 is maintained closed (e.g., in manual) in order to supply power from the CX transformer, thus control components that could prevent ACB-8 closure would not be challenged. Assuming a lockout of the main step-up transformer occurred, ACB-6 is already maintained tripped and would be locked out. ACB-8 is unaffected by a main step-up transformer lockout. ACB-8 would remain closed providing a path from Oconee Unit 1 switchgear 1TC to feed the Keowee Unit 2 auxiliaries from Keowee auxiliary transformer CX, thus allowing Keowee Unit 2 to continue to provide power to Oconee through the underground emergency power path.
