Subject: 2016 Annual Site Inspection and Monitoring Report for Uranium Mill Tailings Radiation Control Act Title II Disposal Sites

2016 Annual Site Inspection and Monitoring Report for Uranium Mill Tailings Radiation Control Act Title II Disposal Sites

November 2016

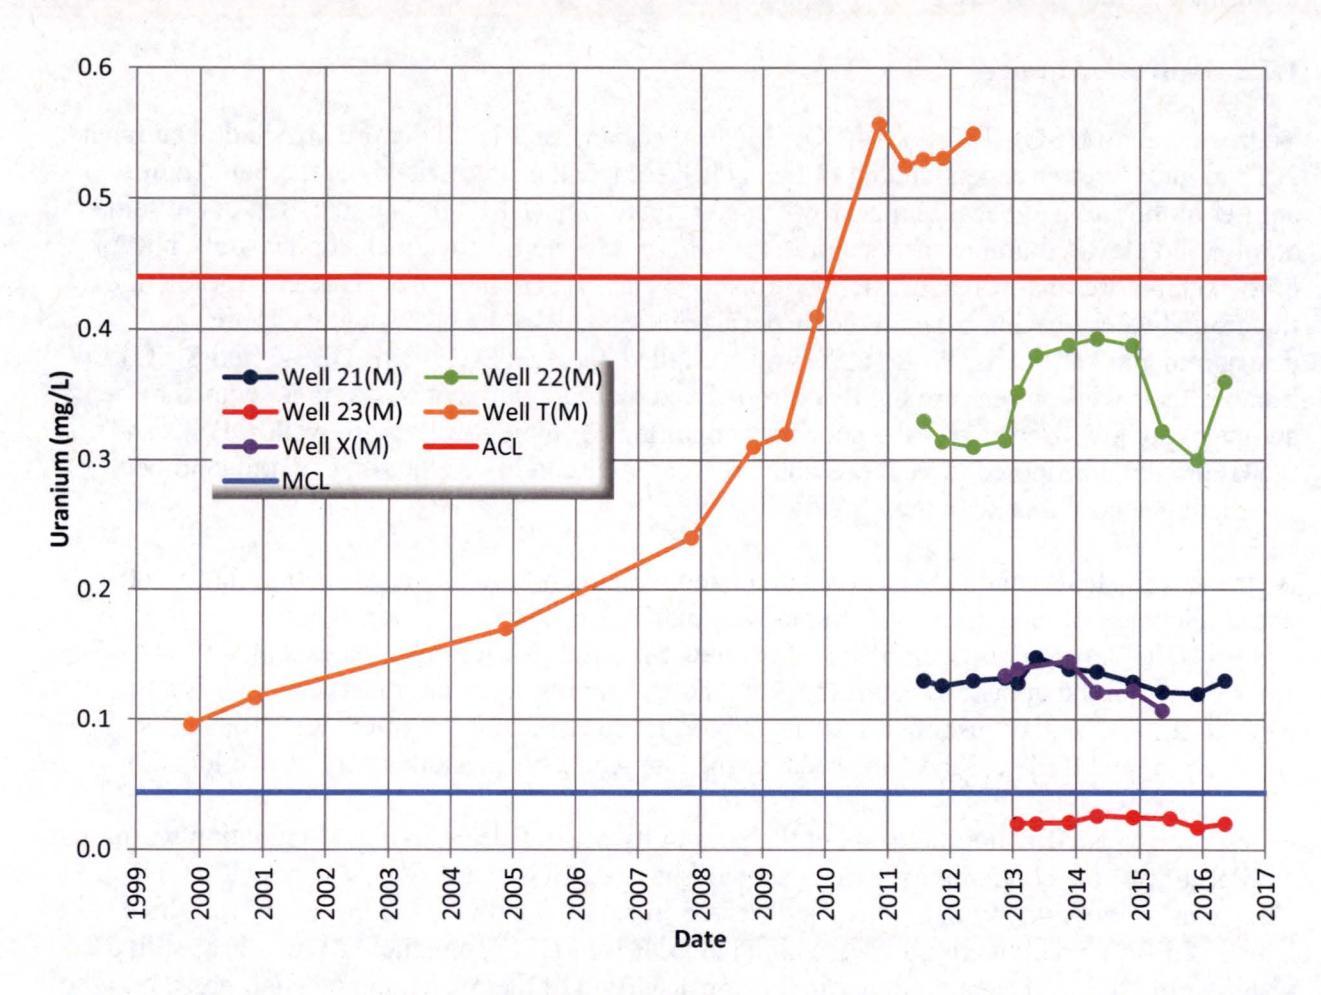
Figure 1-3. Uranium Concentrations in Alluvial Aquifer POC Well T(M) and Downgradient Wells at the Bluewater, New Mexico, Disposal Site

Alluvium well 21(M), installed in 2011, is adjacent to the southern site boundary, where the estimated deepest part of the ancestral Rio San Jose channel coursed before being buried by basalt lava flows. Alluvium well 22(M), also installed in 2011, is approximately halfway between POC well T(M) and well 21(M). The uranium concentrations in these two newer wells are less than the ACL (Table 1-4). However, the uranium concentrations in both wells, shown on

Figure 1-3, continue to exceed the UMTRCA MCL of 0.044 mg/L (40 CFR 192, Table 1) and the State of New Mexico drinking water standard of 0.03 mg/L. The elevated uranium concentrations in well 21(M) and POE well X(M) indicate that alluvial groundwater with uranium concentrations exceeding the drinking water standard is leaving the site.

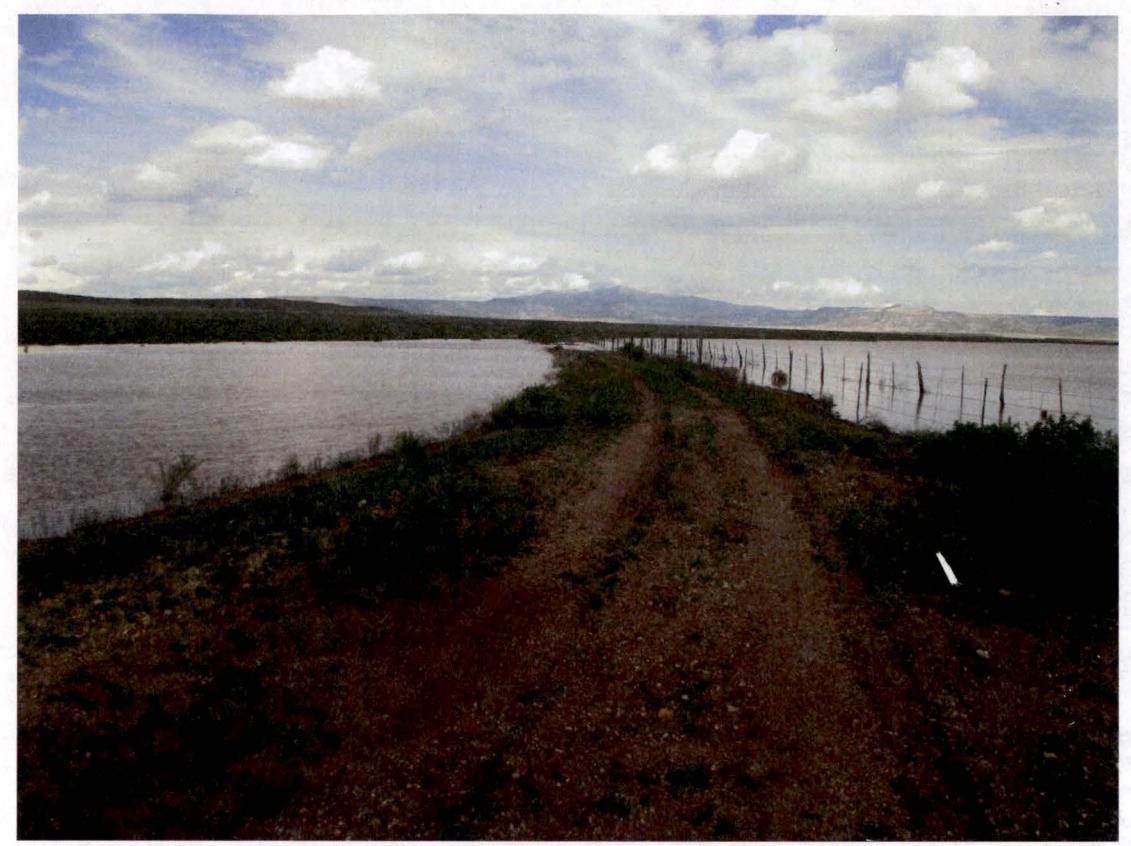
PL-1. Large Ephemeral Pond in East Portion of Site

Interior tertiary roads used to access DOE assets consist of a dirt track covered at places with crushed basalt. The roads are susceptible to erosion and are repaired when they become impassable. All roads were passable except for a location that was covered by a large ephemeral pond (PL-1).

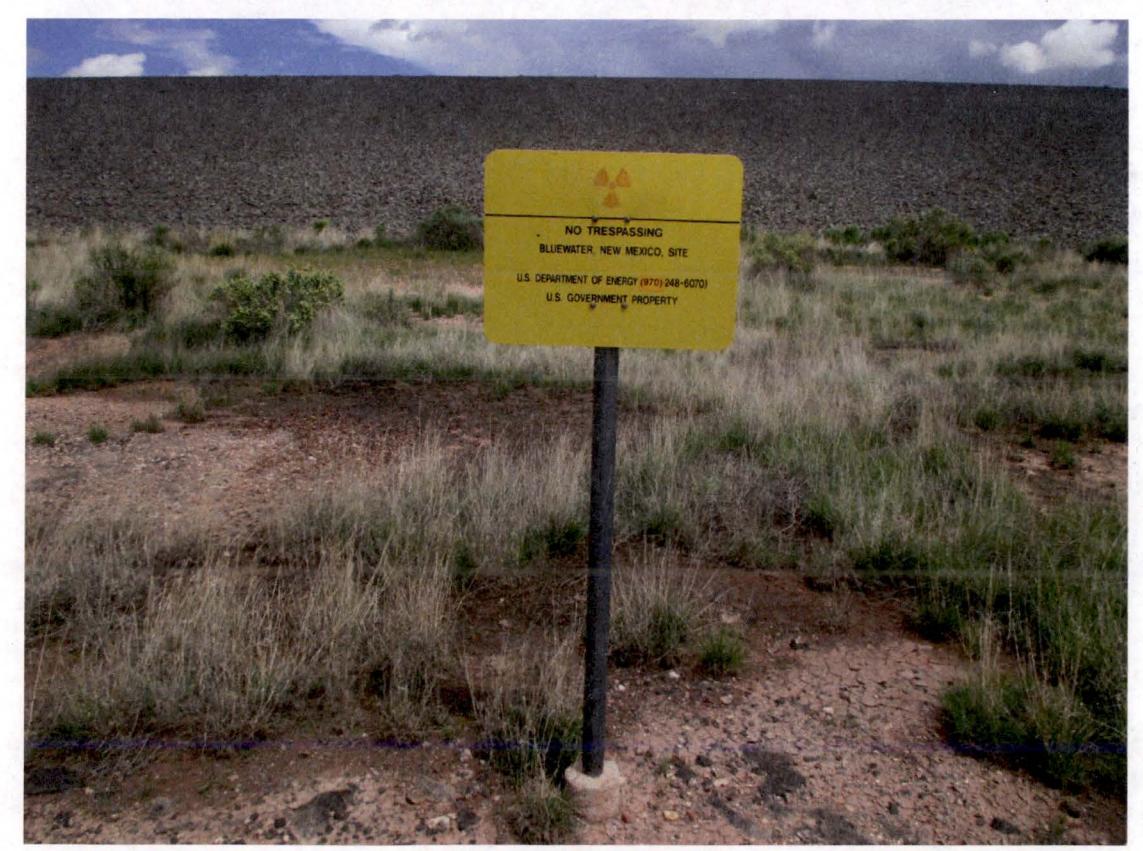
PL-2. Perimeter Sign P51

Fifty-five perimeter signs (warning and no-trespassing signs) are mounted on steel posts along the site boundary and around the main and carbonate tailings disposal cells (PL-2). Perimeter signs P3 and P10 have gunshot damage but are still legible. No maintenance needs were identified.

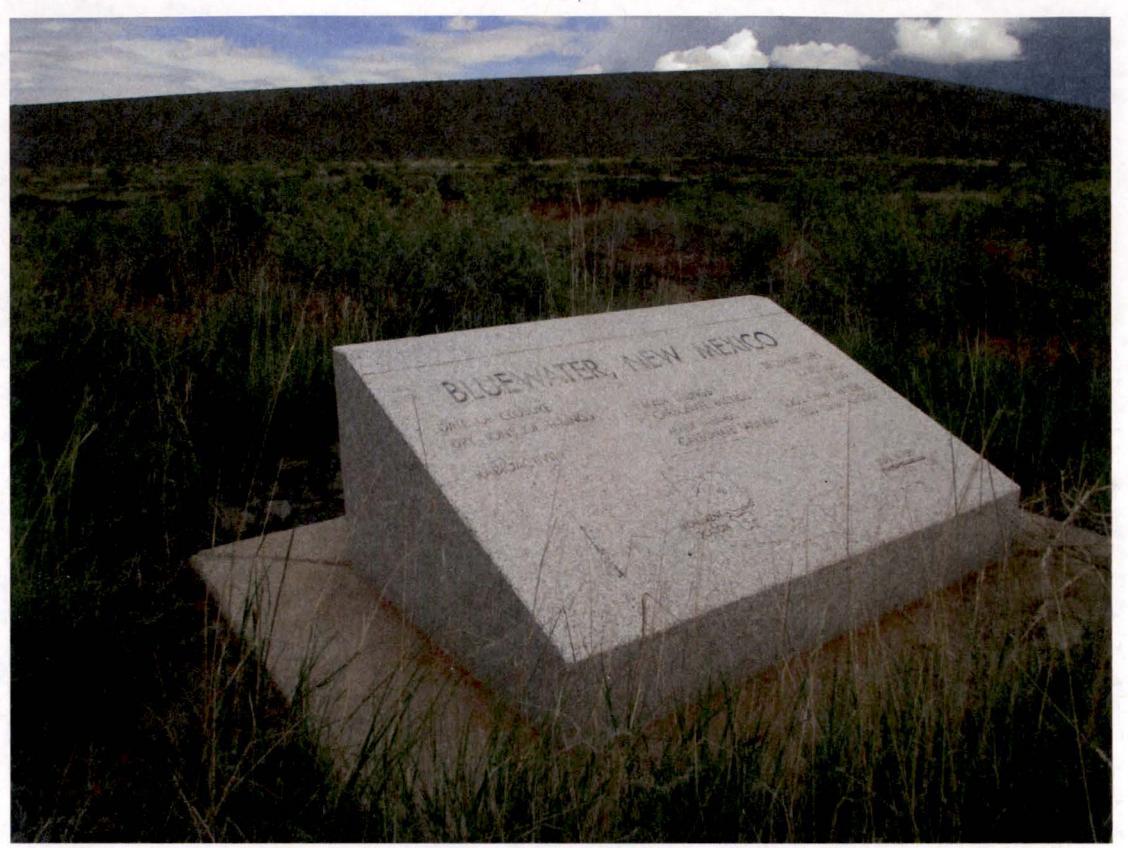
PL-3. Site Marker and South End of Main Tailings Disposal Cell

A granite site marker is between the southwest corner of the main tailings disposal cell and the northwest corner of the carbonate tailings disposal cell (PL-3). No maintenance needs were identified.

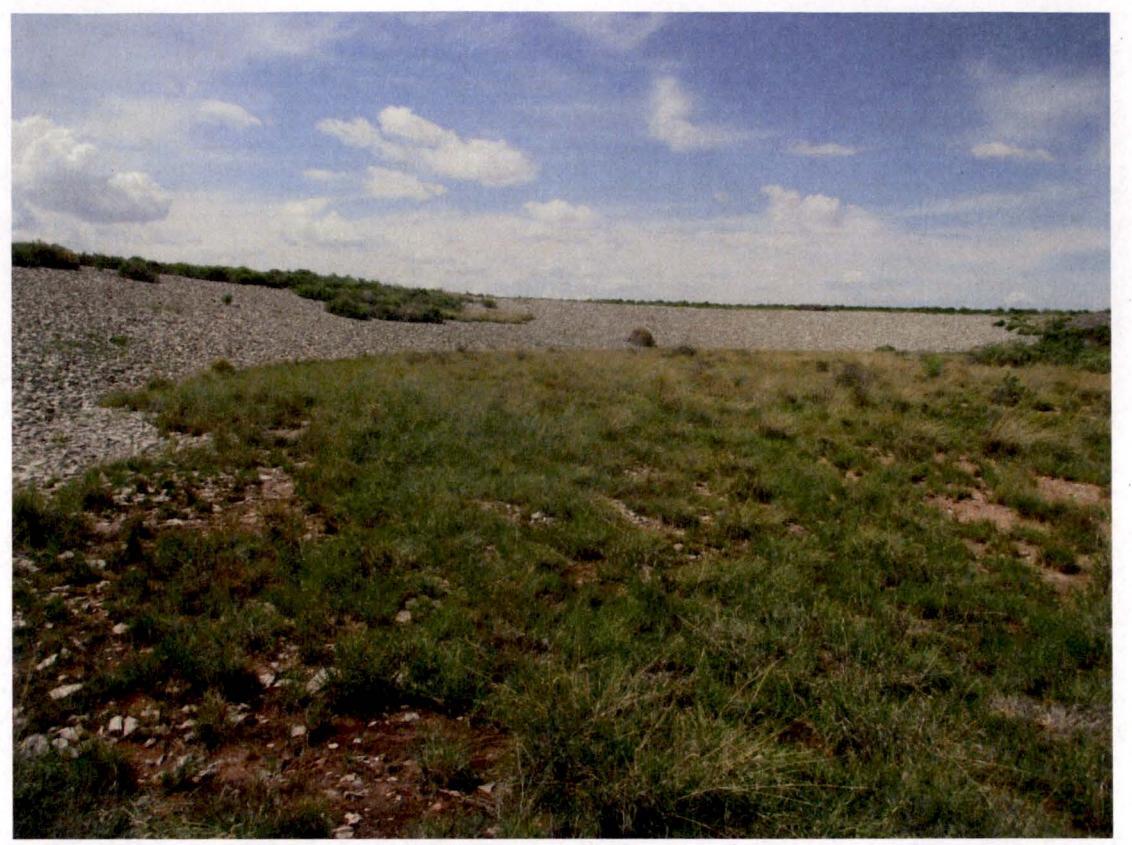
PL-15. Asbestos Disposal Area

The 2-acre asbestos disposal area is a bowl-like feature just south of the carbonate tailings disposal cell (PL-15). The north, west, and south side slopes of this feature are covered by limestone riprap; the bottom of the bowl (the asbestos cell cover) is grass-covered. Several small depressions are present around the perimeter of the disposal area where relocated clean soil (placed for slope grading) has filtered down through basalt joints and fractures. These depressions do not affect the integrity of the disposal area. No maintenance needs were identified.

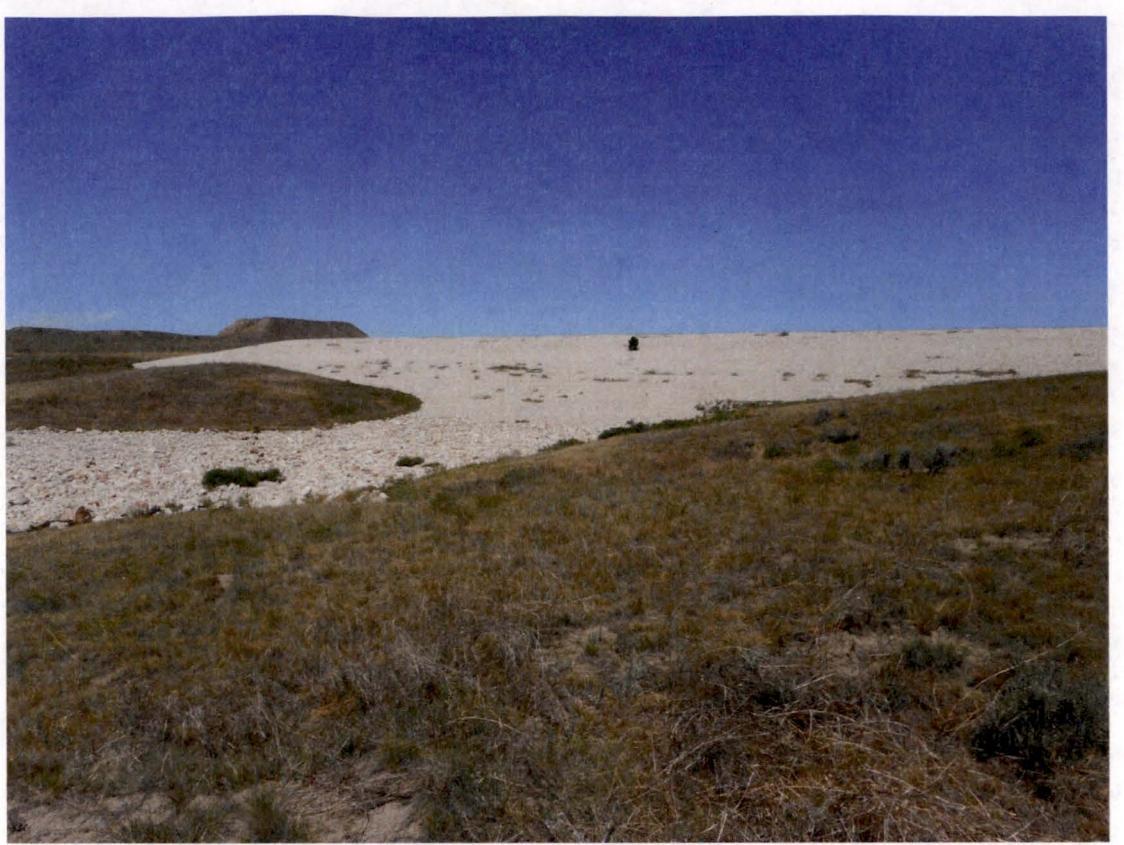
PL-5. Drainage Channel and Embankment, July 12, 2016

The tailings embankment face, the steepest man-made slope onsite, is covered with riprap and was intact and stable (PL-5). The riprap showed no signs of degradation. Scattered plants, mostly grass and annual weeds, grow in the riprap. These plants do not threaten the stability or function of the embankment face.

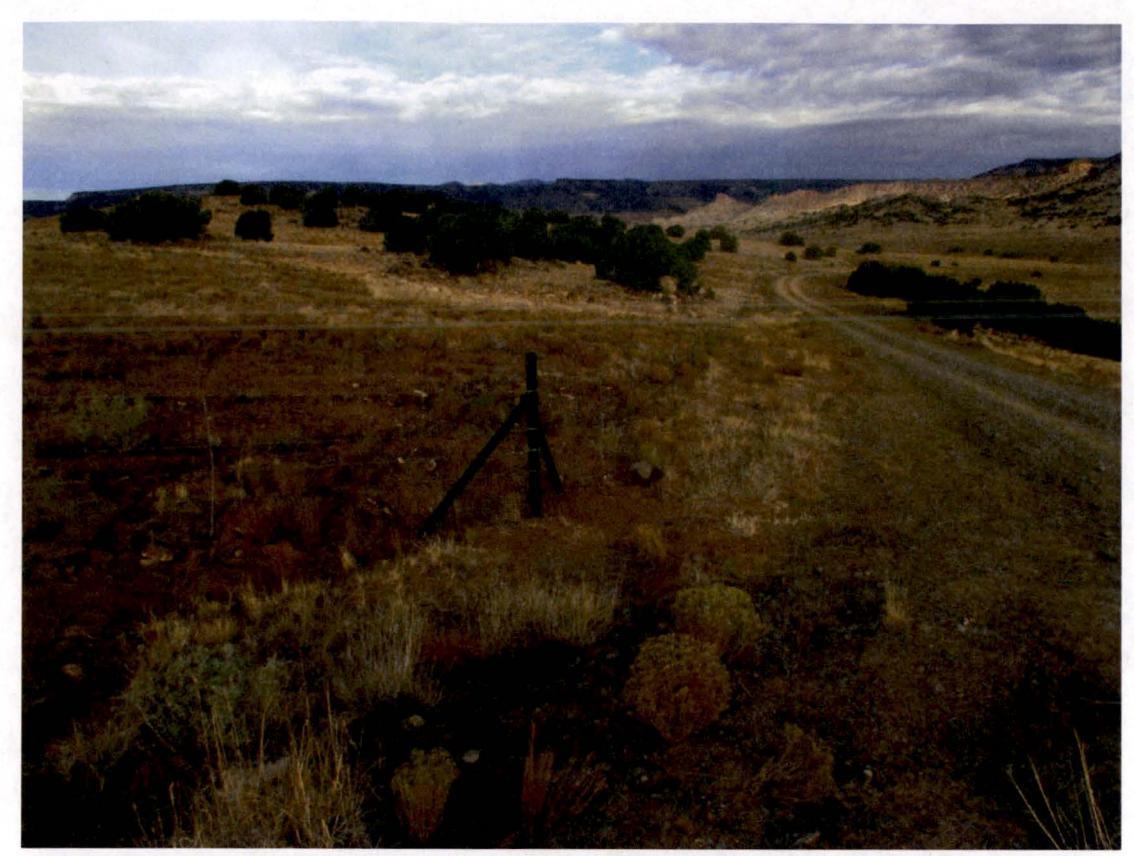
PL-3. New Fence Along East Site Access Road

- L-Bar, New Mexico: Culvert installation was completed at a site access road to prevent further damage from an erosional gully. The section of fence along the east site access road was re-aligned to address impacts from erosion.
- Sherwood, Washington: An erosion feature is present at the toe of the tailings dam, and a forest fire on August 2016 impacted portions of the site. A follow-up inspection is planned for late 2016.
- Shirley Basin South, Wyoming: Concentrations of radium-226 and radium-228 continued to exceed their respective alternate concentration limits at three wells. NRC concluded that there is no current risk to human health and the environment. Groundwater monitoring will continue in accordance with the LTSP.
