SUBJECT: LER 95-009-00:on 950906, turbine trip & reactor trip occurred. due to failure of auto stop oil pilot seat matl.Caused by vendor substitution of pilot valve seat matl.Solenoid valve replaced.W/951004 ltr.

Docket No. 50-275, OL-DPR-80 Diablo Canyon Unit 1 <u>Licensee Event Report 1-95-009-00</u> <u>Turbine Trip and Reactor Trip Due to Failure of Auto Stop Oil Pilot Valve Seat</u> <u>Material</u>

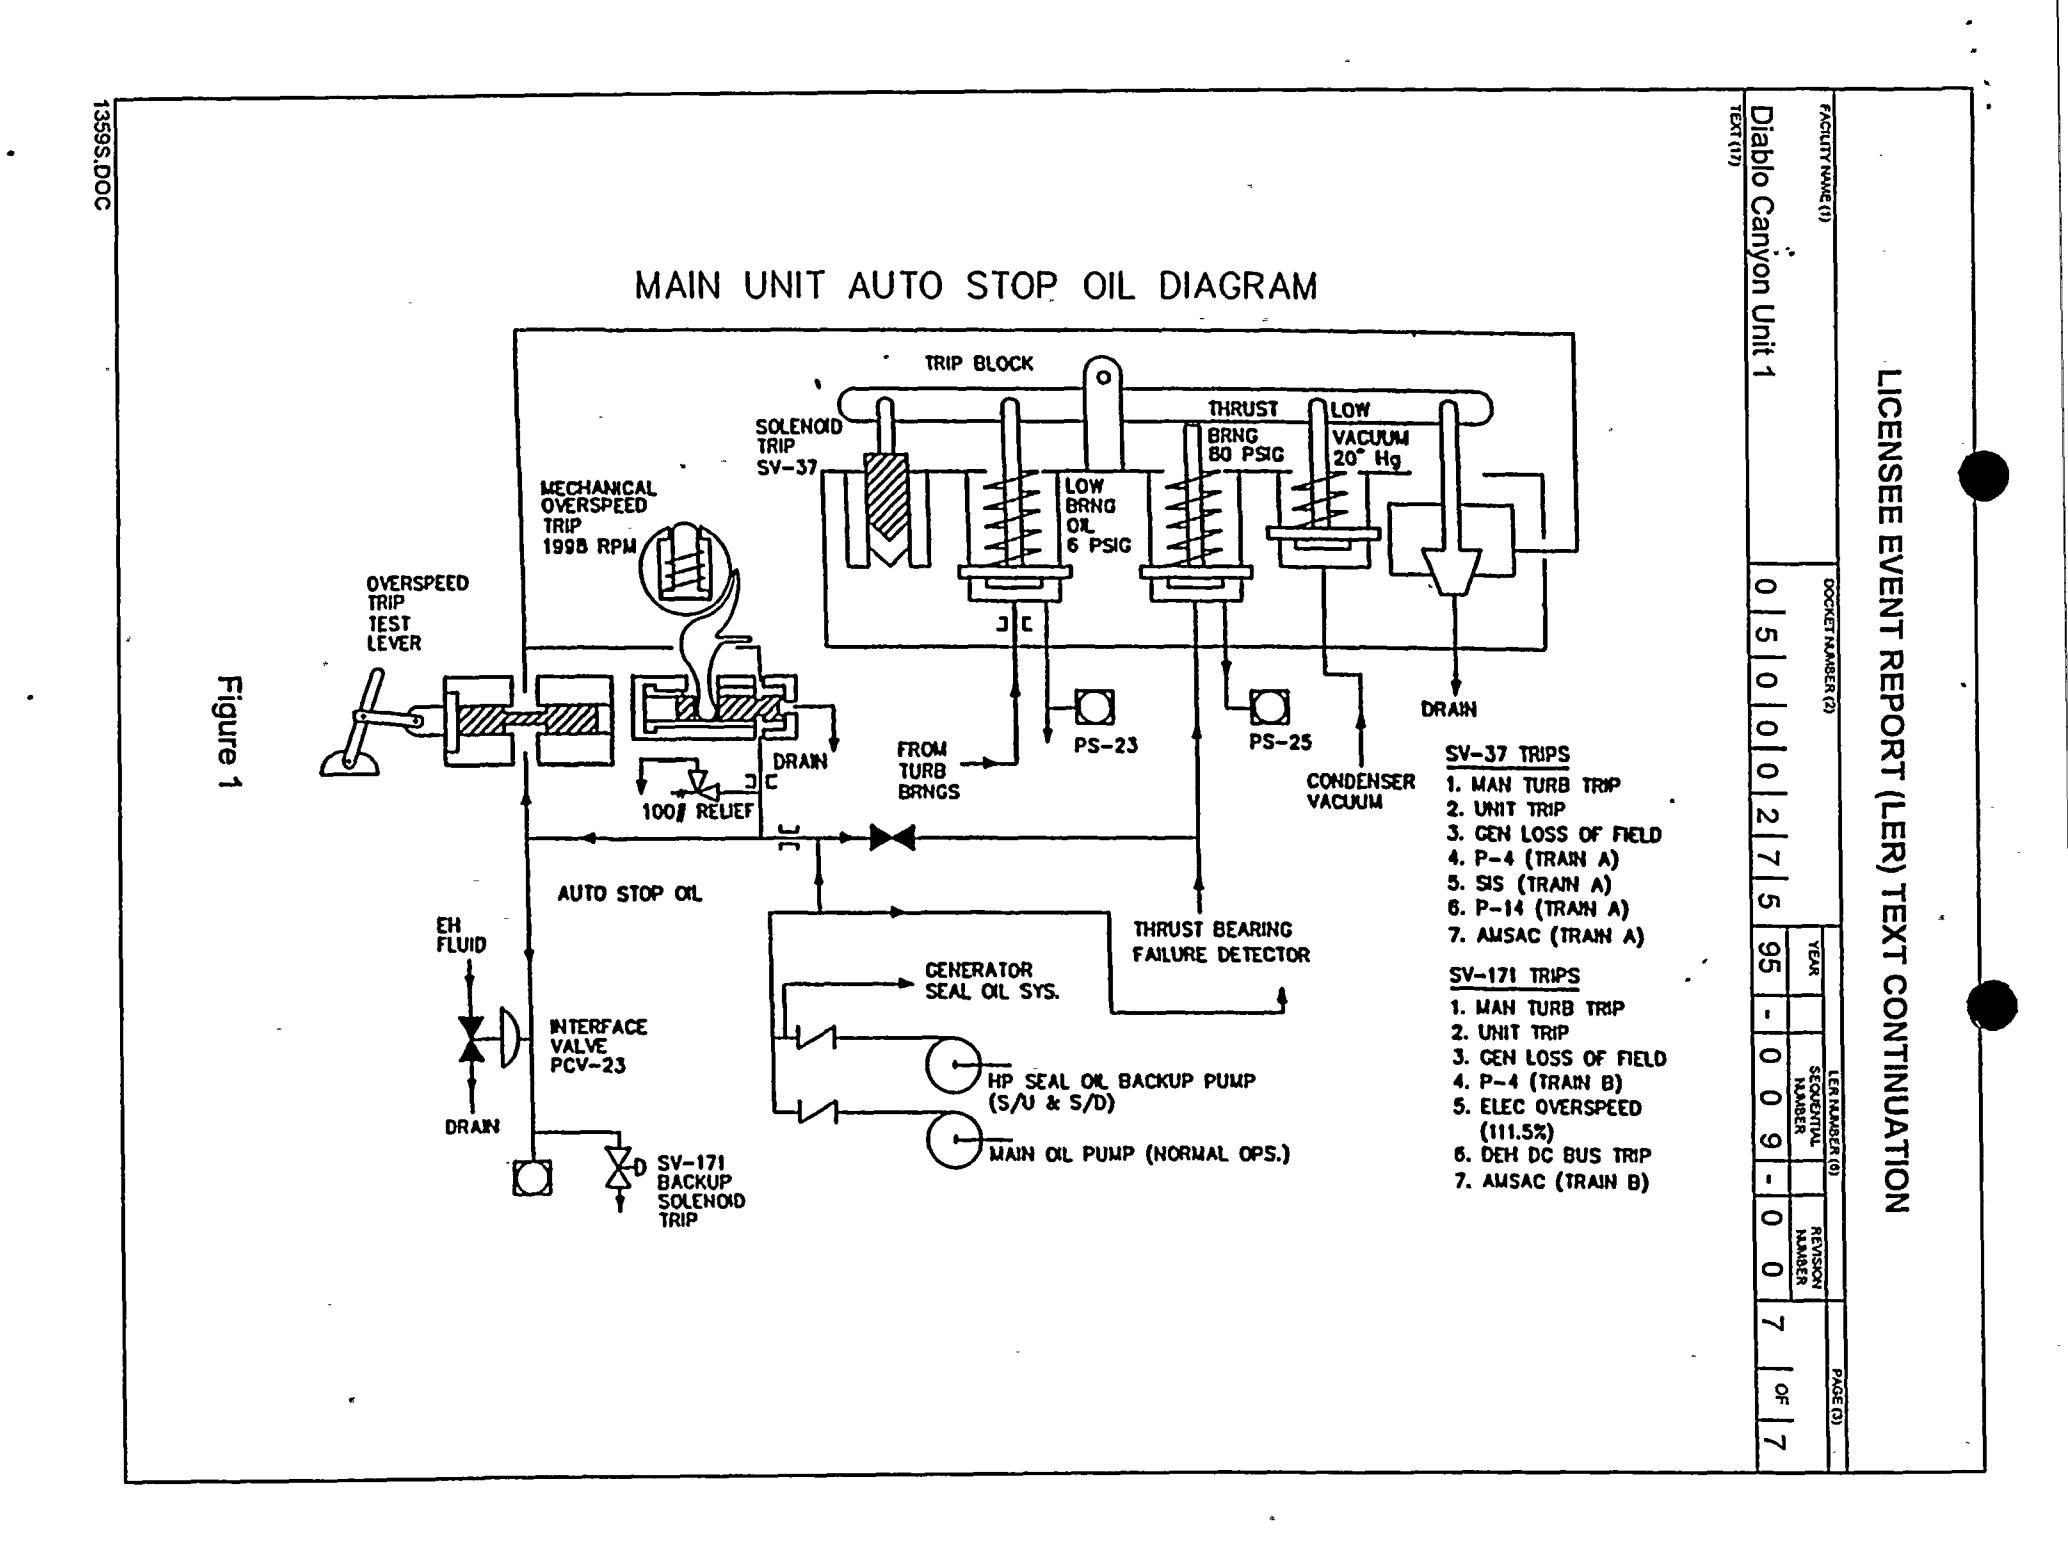
B. Backgro	ound:														
The tur turbine. the elec an inter overspe several solenoi protecti ASCO   main ar valves	The turbine auto stop oil system (fig. 1) provides protective trips for the main turbine. The trips depressurize the auto stop oil system, which depressurizes the electro-hydraulic fluid trip headers to turbine steam supply valves through an interface valve (PCV-23). The trips include low vacuum trip, mechanical overspeed trip, low bearing lube oil pressure trip, thrust bearing wear trip, and several electronic trip signals that activate a trip solenoid (SV-37). A backup solenoid trip valve (SV-171) provides redundancy to SV-37, as well as turbine protection, during on-line testing of the auto stop oil system. SV-171 is an ASCO pilot actuated solenoid valve which was originally supplied with Teflon main and pilot seat material. During the 1980s, ASCO started supplying these valves with cast urethane seats

LICENSE	EEVENI	REPU		ER) 11									
FACILITY NAME	(1)		DOCKET	NJM8ER (2)			YEAR	1 T	EVISION	PAGE (3)					
Diablo (	Canyor	Unit 1	0 5	5 0 0	02	75	95	-	0 0	9	- 0	0	5	OF	7
IEXT (17)				1								ŝ			
	В.	Root Cause:													
		An incorrect s valve SV-171 users. The un incompatibility	eat mater . The ver rethane s y.	rial (ure ndor sul eat app	ethane bstitut ears t	e) was ed ure o have	used Ihane faileo	in ti witi d du	he pil hout le to	ot va notify chem	alve f /ing o nical	or so distri	butc	oid ors o	r
IV.	<u>Ana</u>	lysis of the Eve	ent								,				
	A re des of E follo pres pres of th	eactor trip due to cribed in the Fin xternal Electric owing a turbine ommodates the ssure do not sig ssure control sy ssurizer pressure ne public were r	o a turbin nal Safety al Load a trip/reacto excess s pificantly stem (JD) re control not advers	e trip is Analys nd/or Trip, t or trip, t team ge increas are fur system sely affe	a pre sis Re urbine he au he au enerat se if th nction s func ected l	viously oort (F Trip." omatic ion. R e stea ng pro tioned by this	y analy SAR) The stear eacto m dun perly. as de event	yze Up FS/ m d r co np s sig t.	d Cor date, AR U ump oolani system ince t ned,	nditic Sect pdate syste t tem m an he st the h	on II e tion 1 e sho em (S pera d pre team nealth	event 15.2. ows ti SB) tures essur dum n and	t hat izer ip ar d sat	.oss d nd fety

- **Corrective Actions to Prevent Recurrence:** B:
  - 1. A search was conducted to identify other valves of this type installed in either unit. None were found in high risk systems.
  - 2. Solenoid valve SV-171 was replaced with a valve having a Teflon seat in the pilot valve.
  - 3. Instructions were previously issued to the Purchasing Department in March 1995 to restrict acquisition of this type of valve.
  - 4. Restrictions were placed on issuing valves of this type from the warehouse until the pilot valve seat material has been verified to be the correct material.
