From: Tom Gurdziel <tgurdziel@twcny.rr.com>
Sent: Saturday, December 10, 2016 8:16 AM
To: CHAIRMAN Resource
Cc: Screnci, Diane; ESTRONSKI@aol.com; T Holden; Lyon, Jill:(NMP); Bridget Frymire; Barkley, Richard
Subject: [External_Sender] Three Mile Island, Unit 2 Accident
Attachments: M.O. Bypass Valve.jpg

I have just finished reading the description of the Three Mile Island, Unit 2 accident in Section 2.1 of NUREG/CR-6042, Rev. 2. I am having some trouble with the explanation given in the paragraph at the top of page 2.1-2, left hand column.

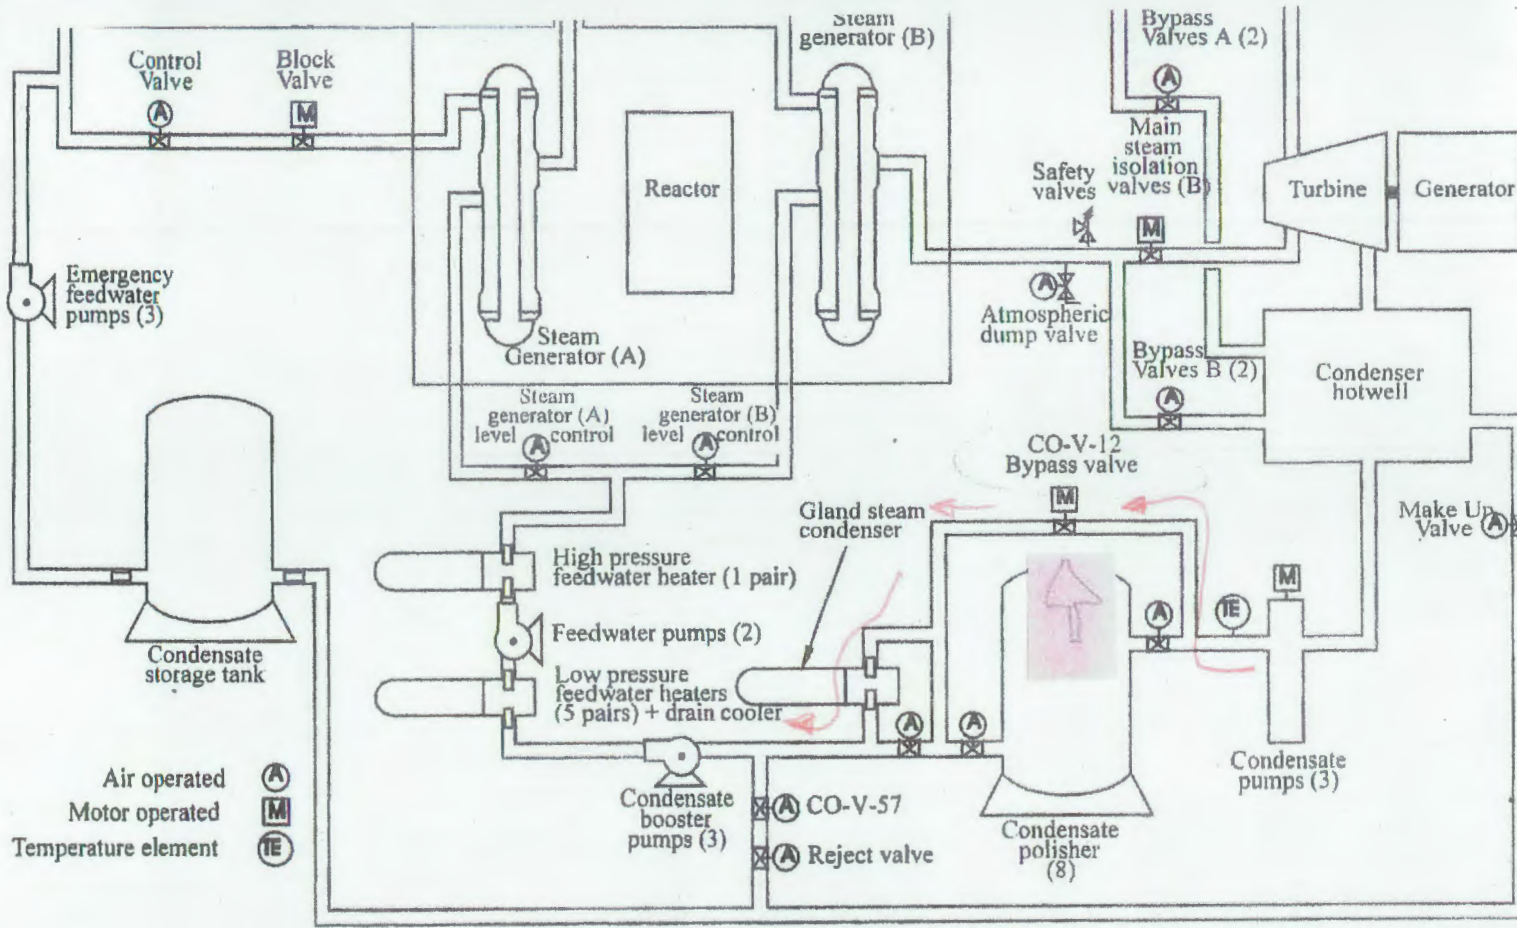
Figure 2.1-3 Condensate and feedwater systems

The operators couldn't move the resin (they were attempting to transfer) by using service air as their source of compressed air, so they switched over to instrument air. (I believe instrument air would have been at a higher pressure than service air.) During the process of applying (instrument) air pressure and releasing it (to dislodge the stuck resin), demineralizer resin flowed backwards, into the instrument air system. It then prevented adequate instrument air pressure from keeping the isolation valves for the demineralizers/condensate polishers open. Those (air operated) isolation valves closed and the accident began.

Looking at Figure 2.1-3 on page 2.1-27, (attached), there appears to be one action that might have restored condensate (water) flow: open demineralizer/condensate polisher bypass valve CO-V-12. Would this one action have been sufficient to prevent core destruction? (This valve is not air operated.)
